Official information request for a geotechnical engineers' report.

From: [REDACTED]@engeo.co.nz>
Sent: Thursday, June 15, 2023 2:34 PM
To: [REDACTED]
Cc: [REDACTED]
Subject: [EXTERNAL] FW: REVIEW - Email for Matai Tce Slip Assessment
Attachments: 21700.000.008 - 10 Matai Terrace Site Location Plan.pdf

ENGEO visited the site at 10 Matai Terrace in Eastbourne on 9/06/2023, to observe a landslide that had occurred in the days prior. We have provided a site location plan which is attached to this email.

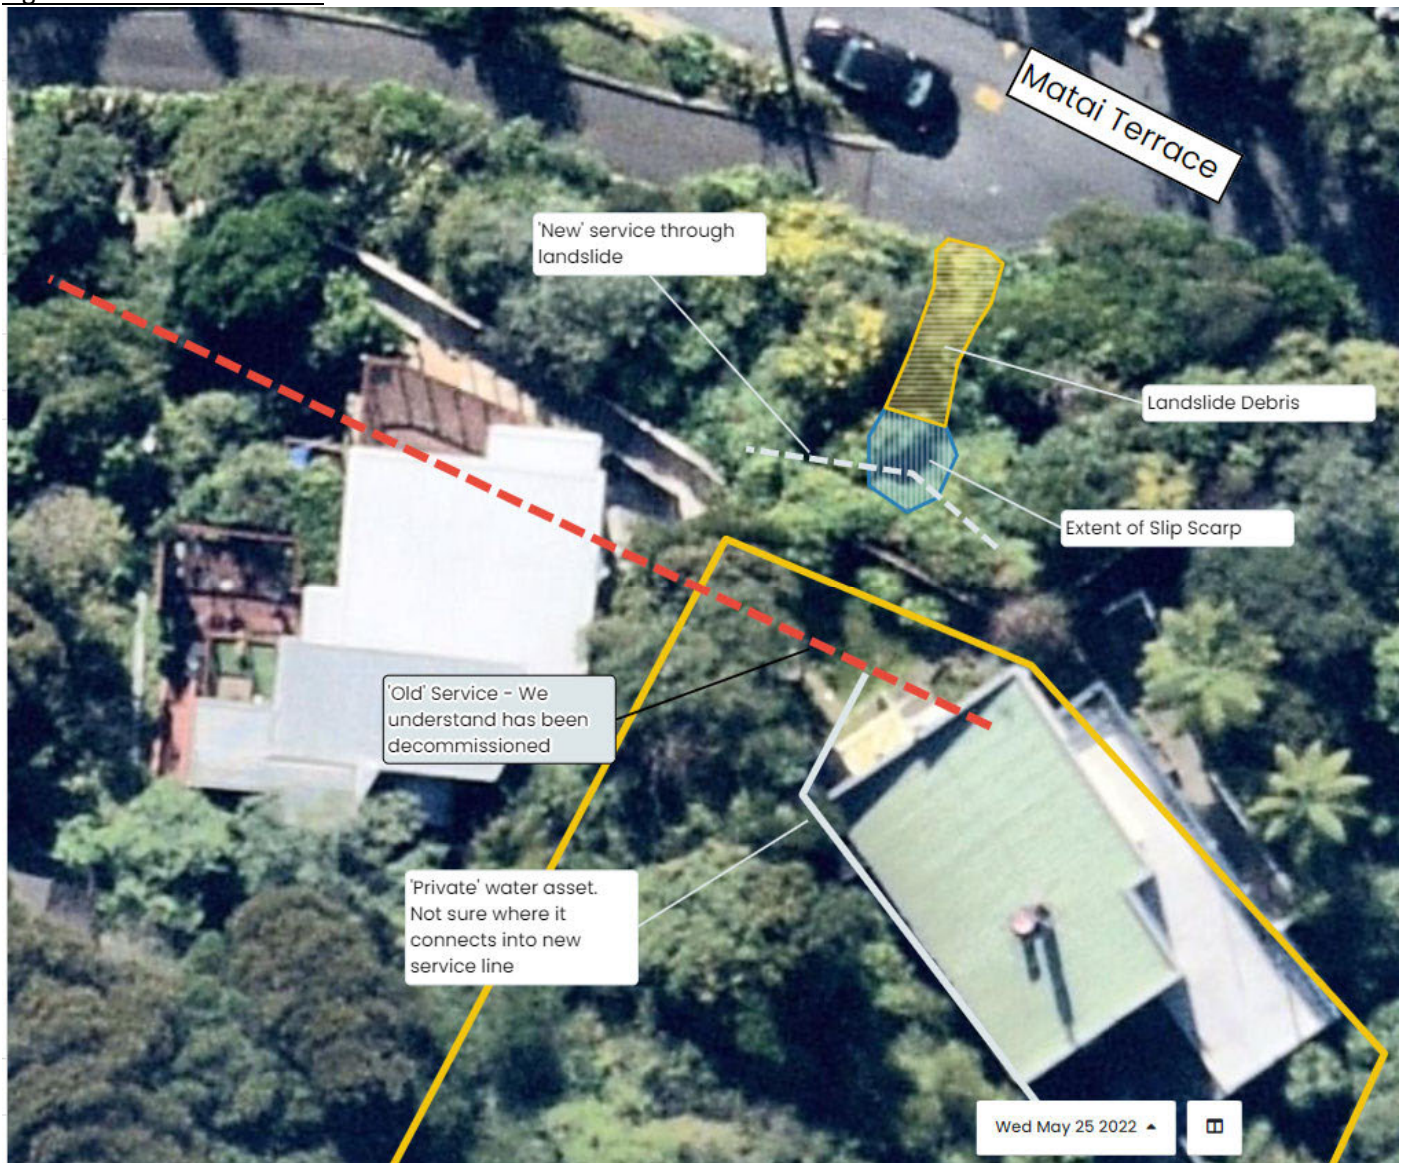
Figure 1: Site Location Plan

- The landslide had occurred approximately 9 m upslope from Matai Terrace, towards the north-western side of the dwelling at 10 Matai Terrace (Figure 1). The landslide scarp was approximately 2 m wide, and approximately 3 m in length. It appeared that the failure had occurred over a relatively small area, and then deposited the debris down the 9 m bank. The natural slope was resting at approximately 45°.

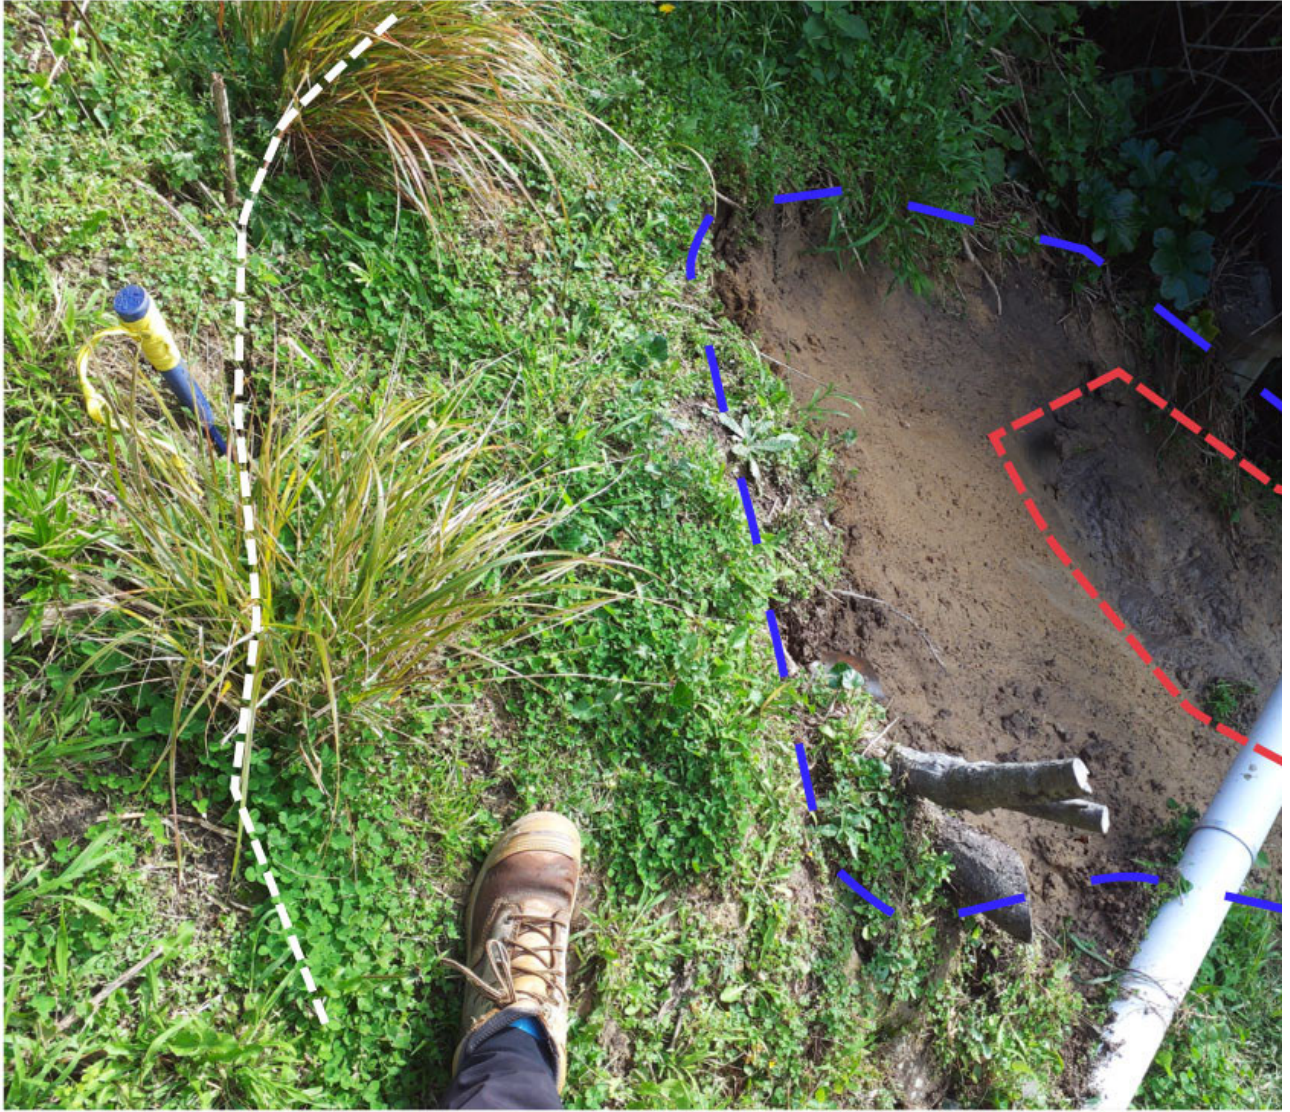
Figure 2: Slip Scarp

- We understand that cracks had begun appearing in the slope in the week prior to the slip occurring and were shown photos by the homeowner. It appears that the landslide has propagated from the bottom of the two observed cracks (tension crack), the top-most crack is still visible within the slope.

- Some saturated soil had accumulated on the slip face, that appeared to have been water transported (Figure 2). No running water was observed, however. It is possible that the concavity of the slip face has concentrated rainwater flow in this area, or it could be that there is a hidden water source such as a leaking pipe. We were informed by the homeowner that they filled their bathtub and drained it, and that no extra water was observed flowing over the slope.

Tension Crack

Slip Scarp

- The section of ground that has cracked could be removed in a controlled fashion, to prevent it from failing suddenly and impacting the service.
- The slope should continue to be monitored for further signs of instability. This may take the form of ground cracks opening in a similar fashion to what was observed prior to the most recent slip, particularly after heavy rainfall or seismic events.
- Care should be taken to prevent water flow being concentrated over the landslide.
- Planting of small trees or shrubs on the surface of the slip will help to stabilize the slope and reduce the likelihood of future shallow landslides along with hydroseeding and contouring of the landslide area.
- The stability of the service should be observed by the appropriate stakeholder, and some form of support for the service pipe may be necessary or relocating of the service.

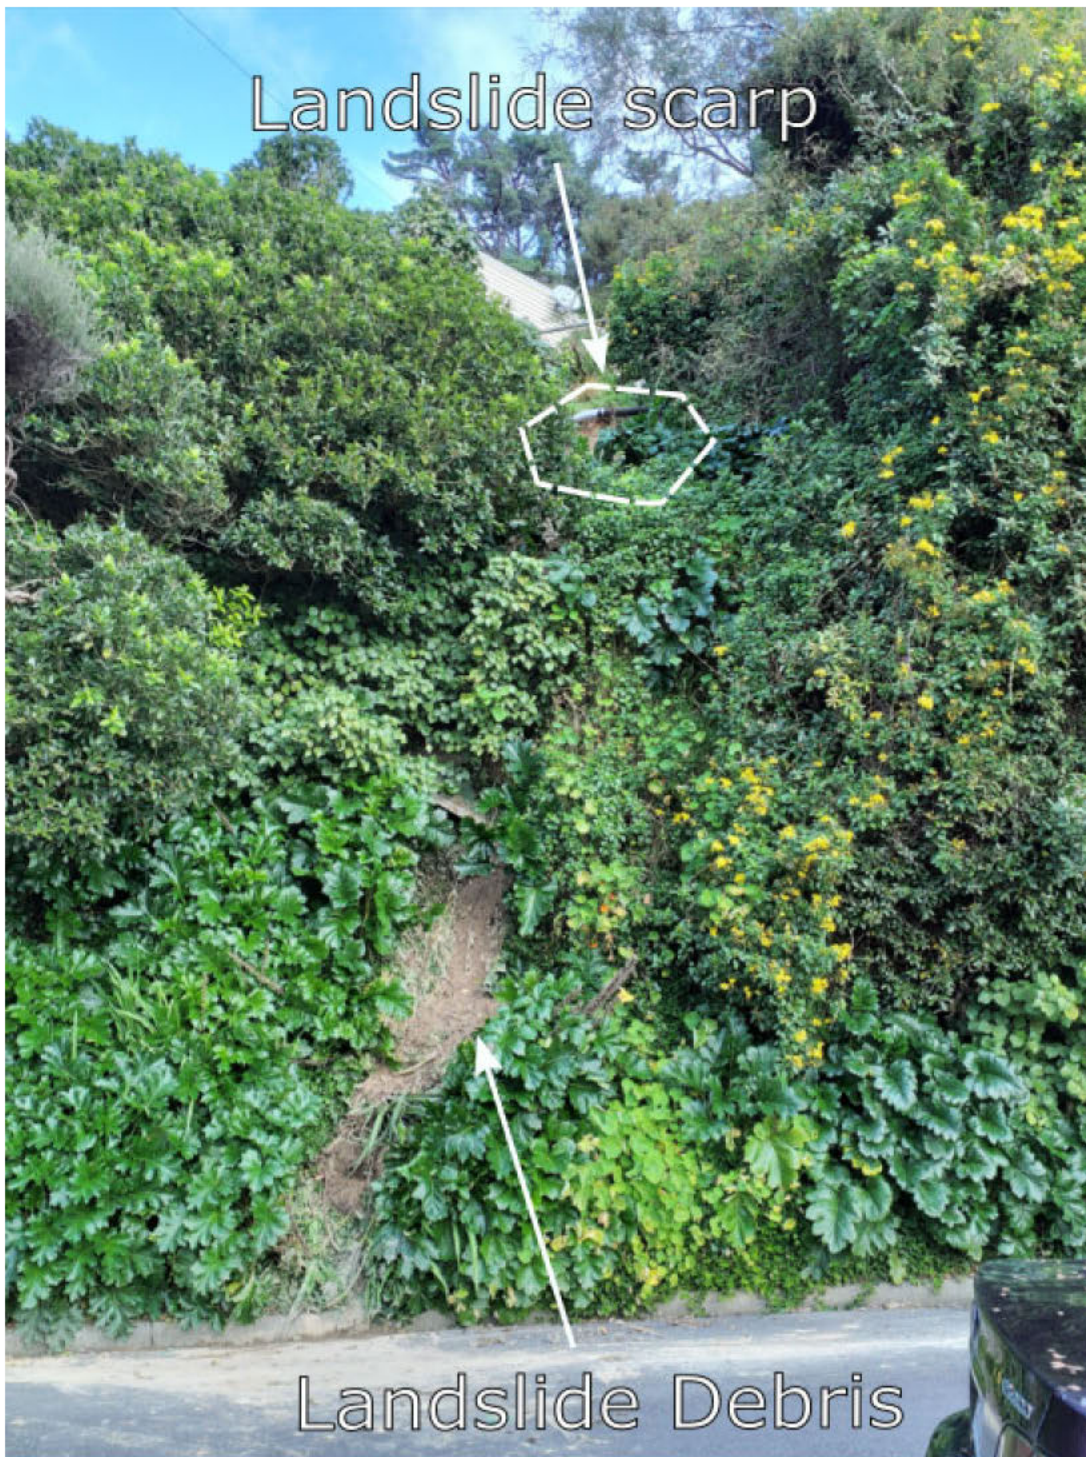
Figure 3: Landslide from Matai Terrace

- Less than 1 m³ of debris was observed at the base of the slope, in the vegetation next to Matai Terrace, and on the road.
- Highly Weathered Greywacke Rock was observed behind the house, at the back of the lawn area at the crest of the slope. We also observed Moderately Weathered Greywacke Rock outcrops to the immediate east of the slip, down on Matai Terrace.

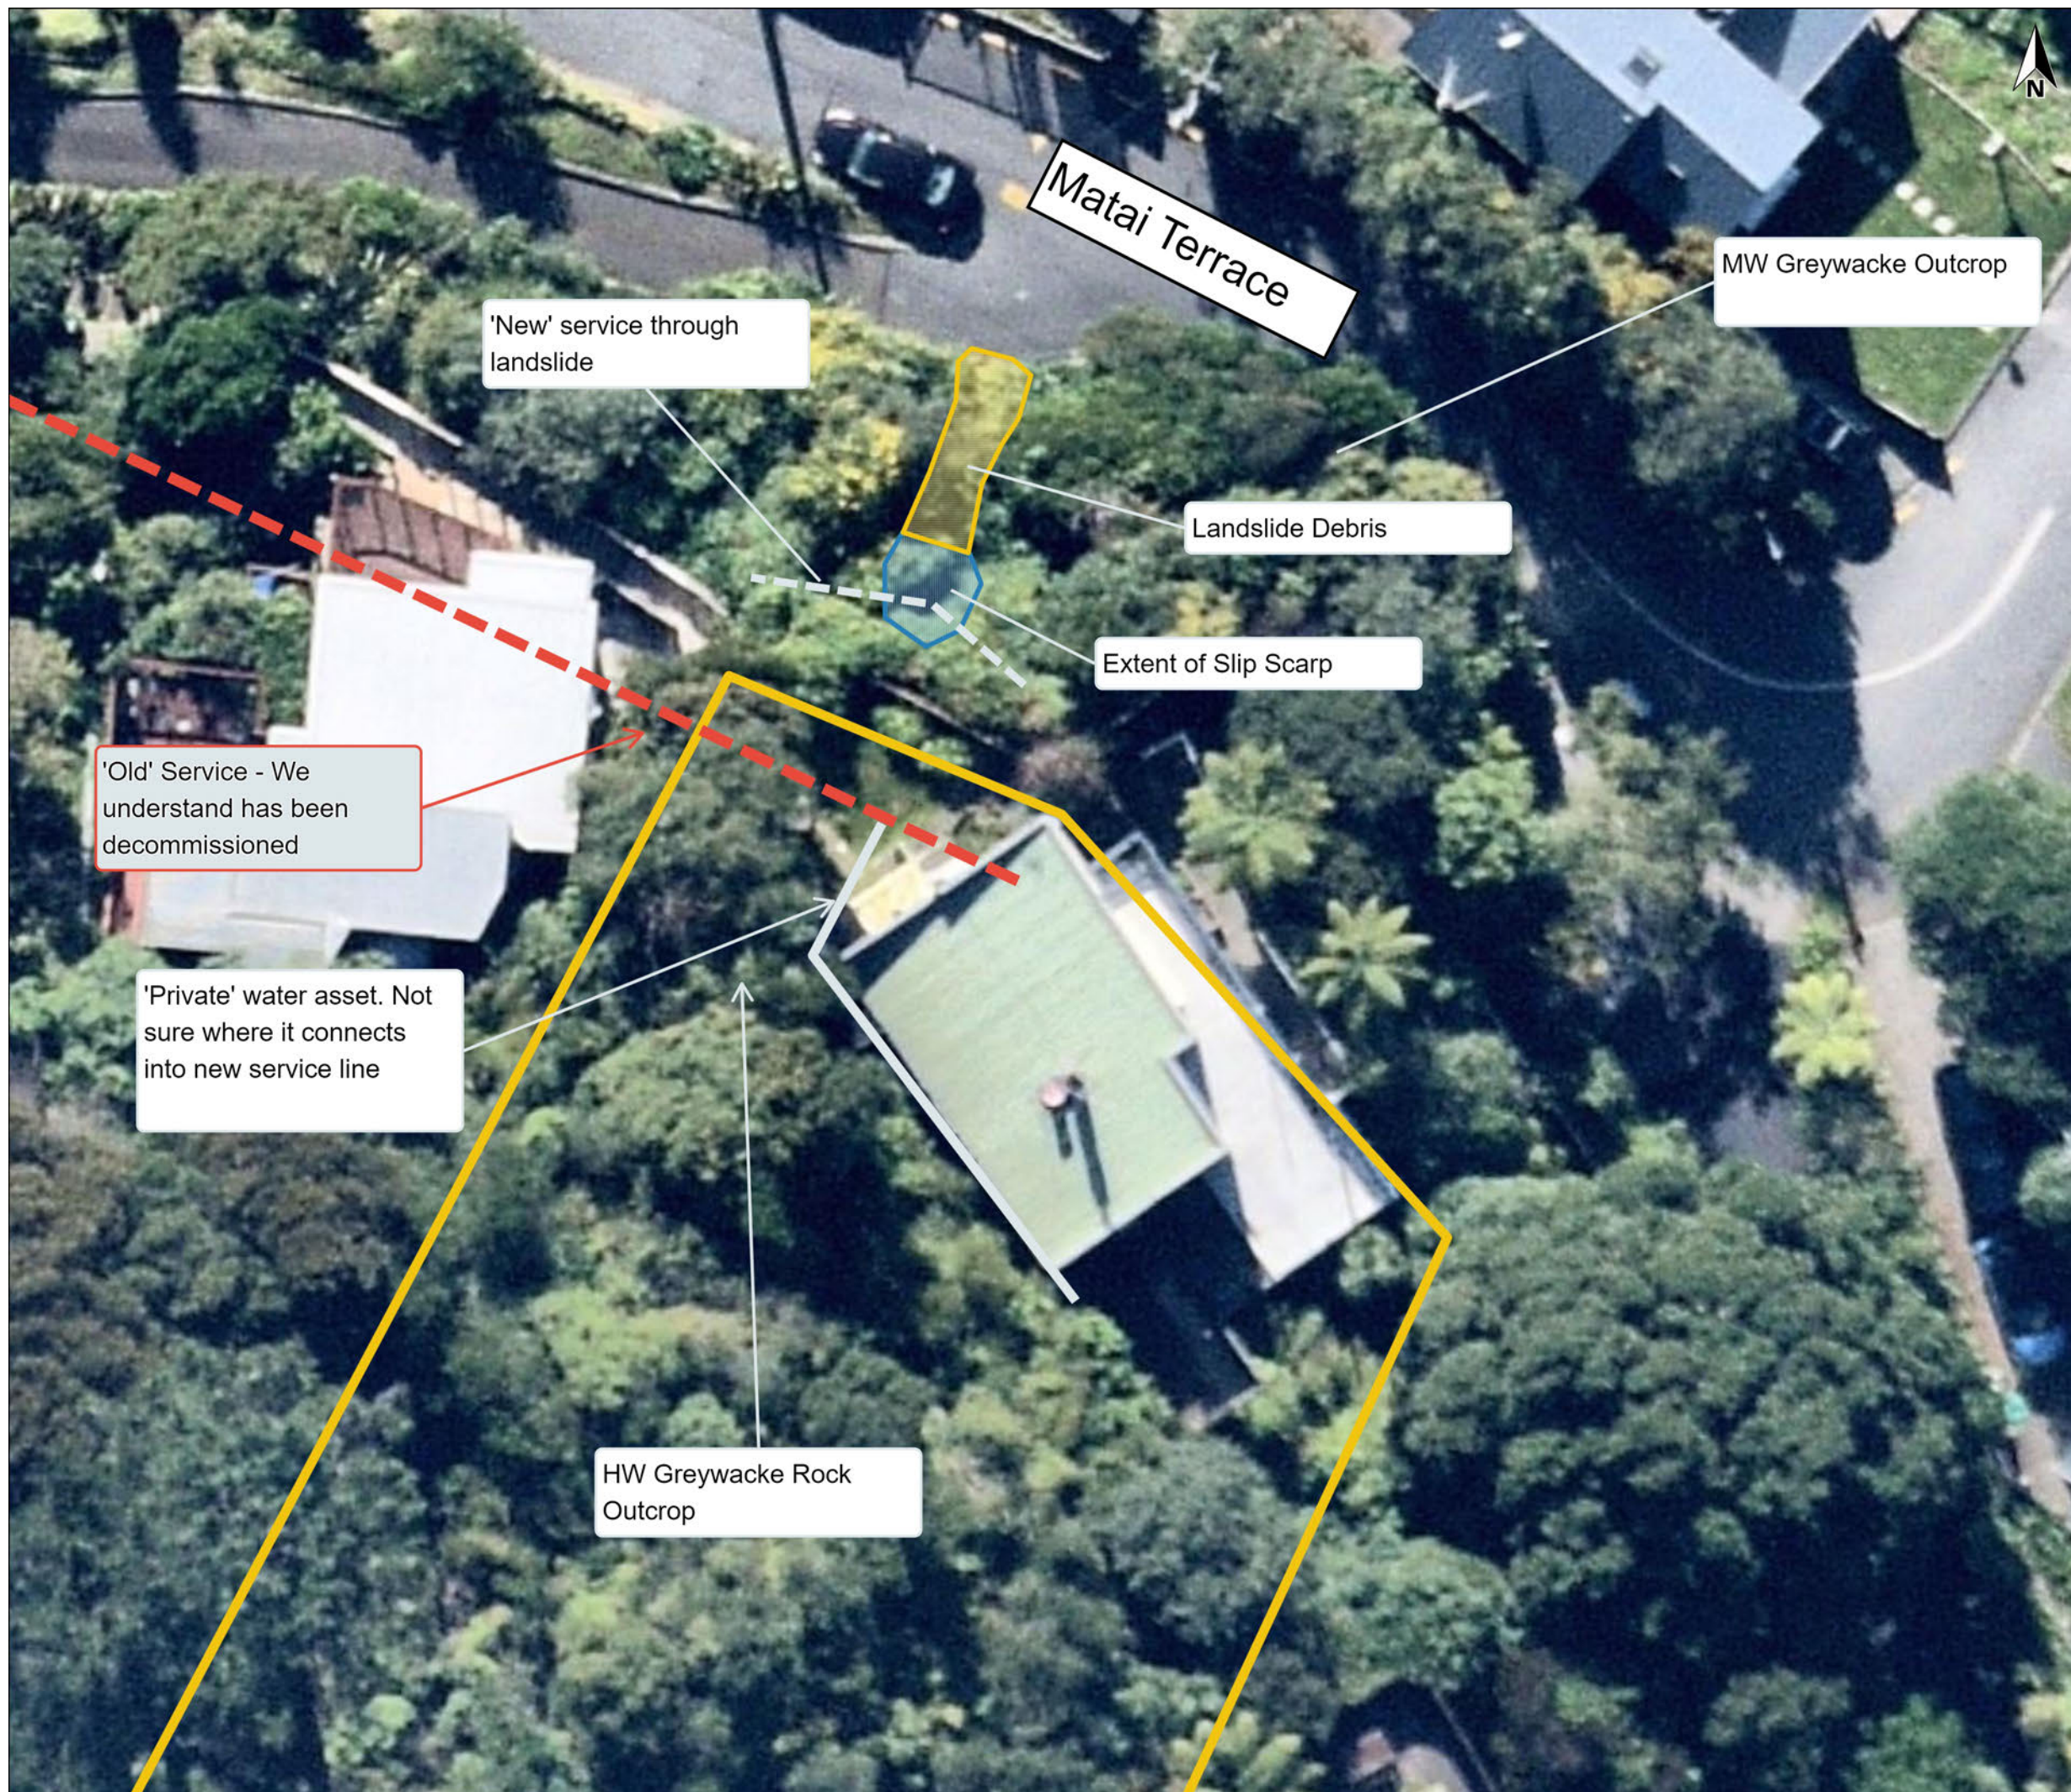
Title: Untitled Figure		
Client: Hutt City Council		
Project: 10 Matai Terrace, Eastbourne	Drawn:	Figure No.: 1 Size: A3
Date:	Checked:	
Proj No.: 21700.000.008	Scale: 1:184	Version:

- The failure was shallow and had occurred within the silty colluvial soil. No bedrock had been exposed under the failure.
- The landslide had occurred underneath, and around a service pipe. We were informed by the homeowner that this was a waste-water pipe, that had been installed around 2 years ago. We understand that when the service pipe was installed, a trench was dug, and later backfilled around the service. The homeowner showed us photos of the trenches. This new service was installed to replace the original waste-water service at the crest of the slope, which we understand was suitably blocked at the time with concrete or similar (Figure 1). We understand that the service from the rear of the house (solid white line in Figure 1) was extended to meet the new service pipe down the bank (new service dashed white line), although we can not find a record of this on council service maps.
