**Pre-construction Pavement
Condition Assessment**

**Omāroro Reservoir, Mt Cook,
Wellington**

Prepared for
HEB Construction Ltd

Prepared by
Tonkin & Taylor Ltd

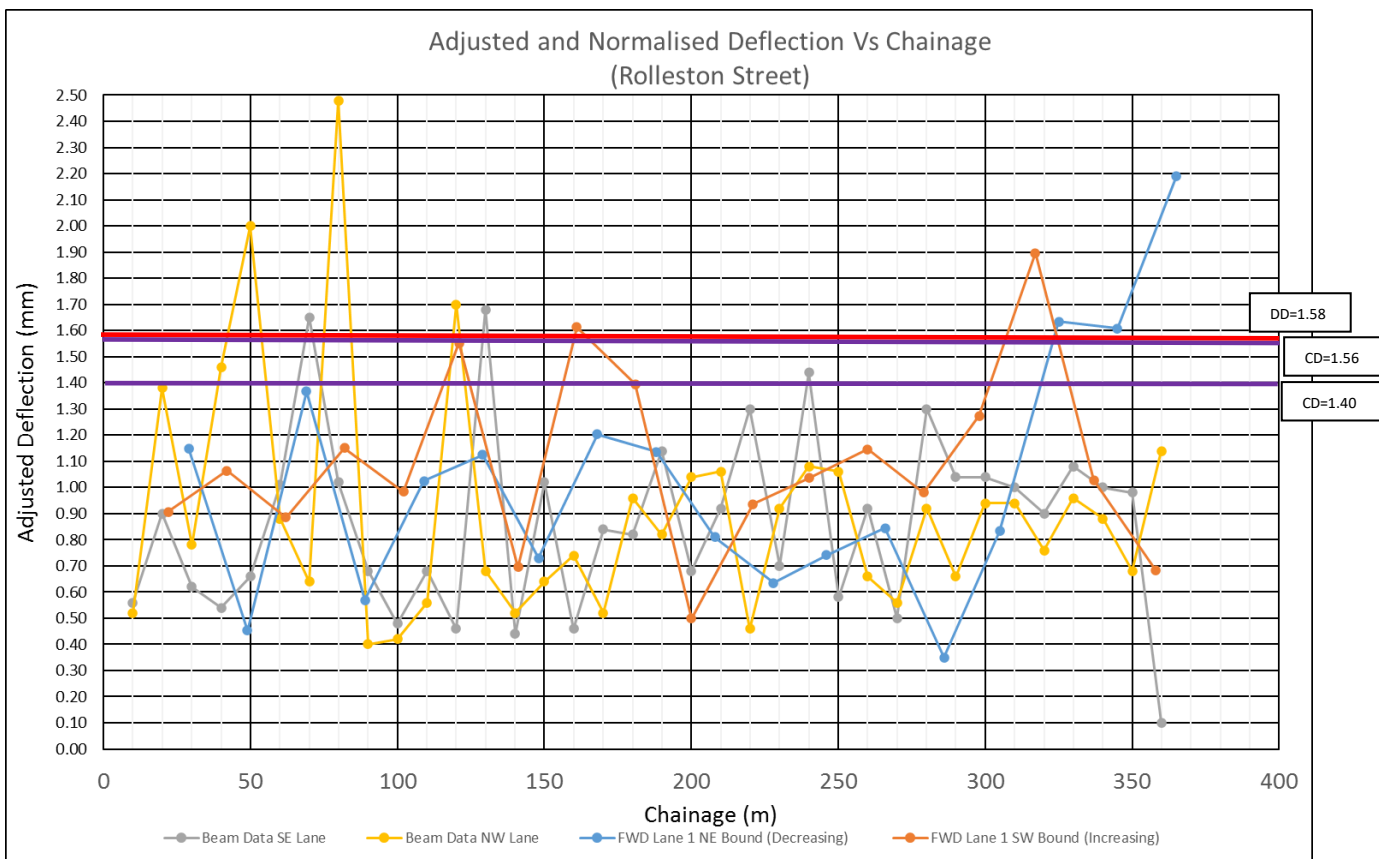
Figure 3.1 Normalised and Standardised Deflection Data

Based on the analysis of the provided data it has been determined that the characteristic deflection values from both the FWD and Benkelman beam data sets are less than the tolerable (design) deflection value for both the cases with and without additional construction traffic (1.58 mm and 1.64 mm respectively). Therefore, it is concluded that the majority of the road pavement has sufficient strength to accommodate the predicted design traffic loading including the additional construction traffic. It is noted however that in some areas that individual deflection results were greater than the deflection values which may indicate localised areas of pavement weakness that may exhibit unacceptable deformation or distress within the nominated assessment period. However as previously noted this assessment is on the presumption that the road pavement is adequately maintained and remains waterproof throughout.

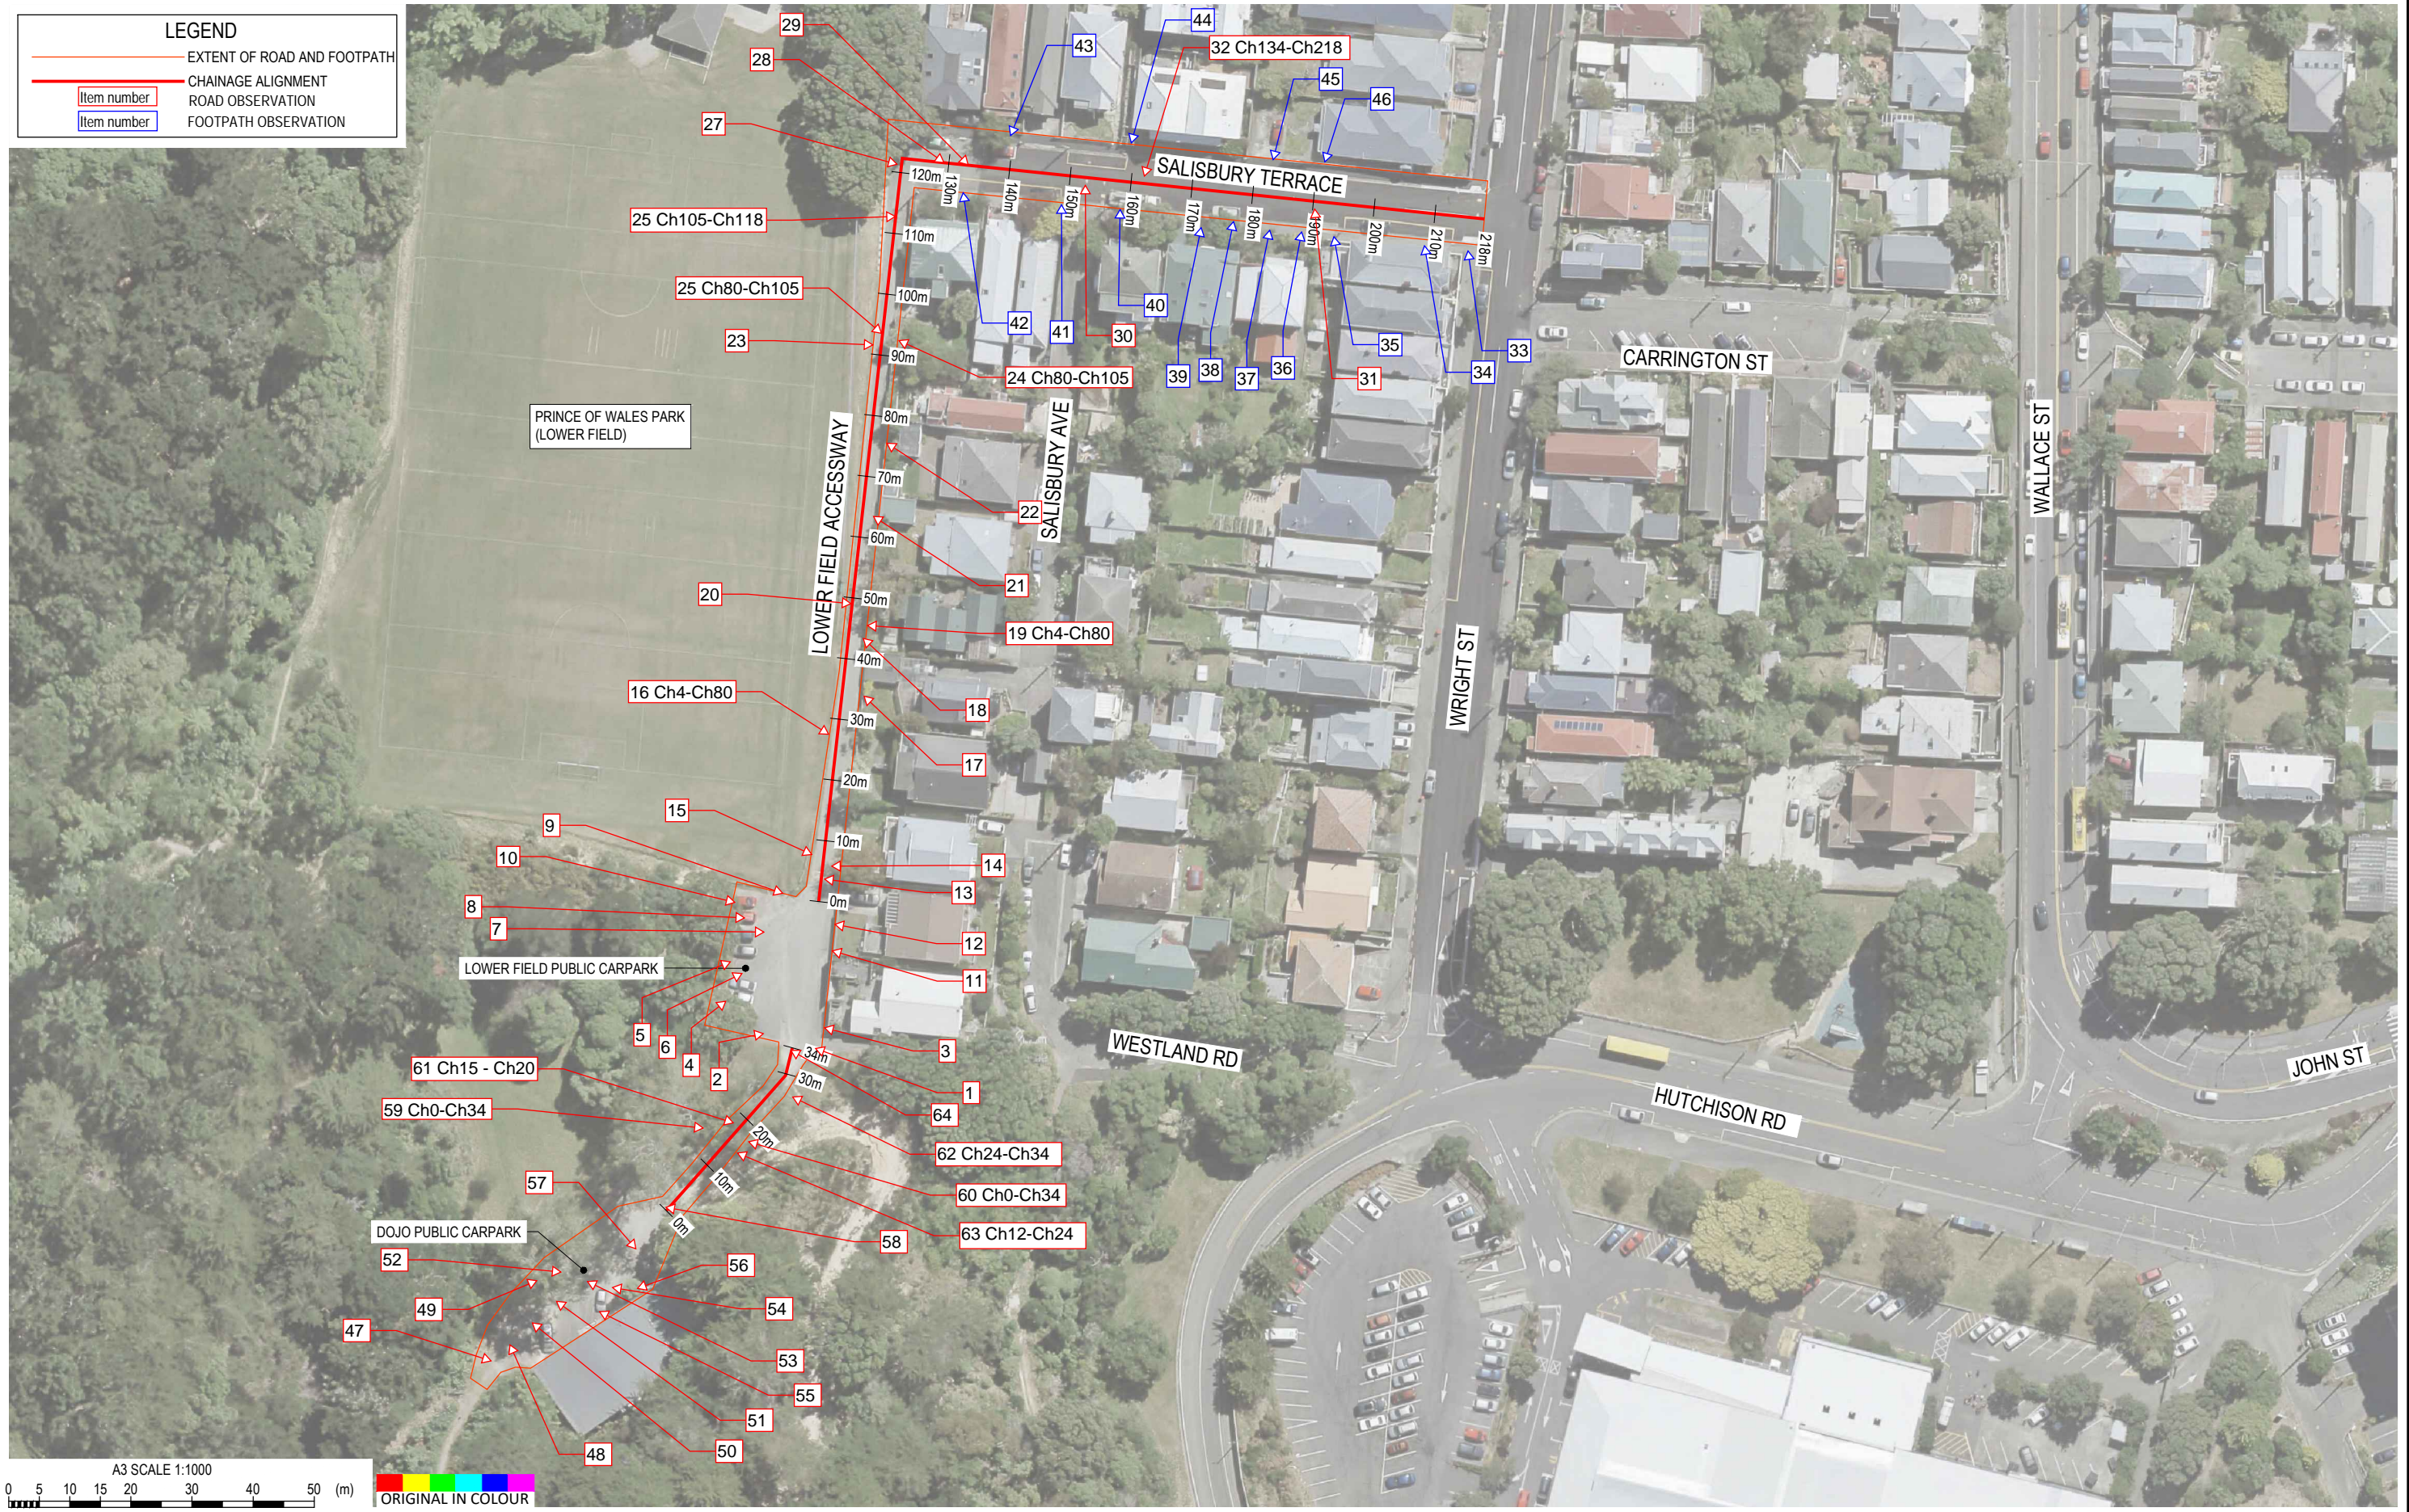
CLIENT	HEB CONSTRUCTION		
PROJECT	OMĀRORO RESERVOIR PRE-CONSTRUCTION PAVEMENT SURVEY		
TITLE	SALISBURY TERRACE SURVEY PLAN		
SCALE (A3)	1:1000	FIG No.	FIGURE 1
REV			2

The lower field public access way, lower field carpark, dojo carpark and carpark link driveway pavements are variable condition, with 44 observations noted for the approximately 230 m length of road (refer to electronically attached video). However, extensive damage and areas showing signs of structural failure of the pavement is evident along the accessway and in isolated locations within both the lower field and dojo carparks (Ch0 – Ch34 and Ch0 – Ch130, Figure 1, Appendix A with observation details in Appendix B). Areas of notable pavement defects been listed below:

- Item 9 – Cluster of cracks and potholes at carpark/field accessway;
- Item 12 to 15 – Edge cracks, deformation, isolated crocodile cracking along 76 m of road/field bank interface. Isolated areas of structural failure;
- Item 23 to 26 – Cluster of longitudinal cracks, extensive crocodile cracks, potholes and patch repairs along 33 m length of road indicating widespread structural failure of the pavement in wheel tracks;
- Item 51 – Cluster of potholes, crocodile cracking, local depressions and patch repairs;
- Item 56 – Deep, large pothole in parking wheel track;
- Item 57 – Cluster of potholes with minor unravelling and crocodile cracking, and patch repairs; and
- Item 61-63 – Clusters of potholes, local depressions, edge breaks repairs, unravelling crocodile cracking and patch/pothole repairs.

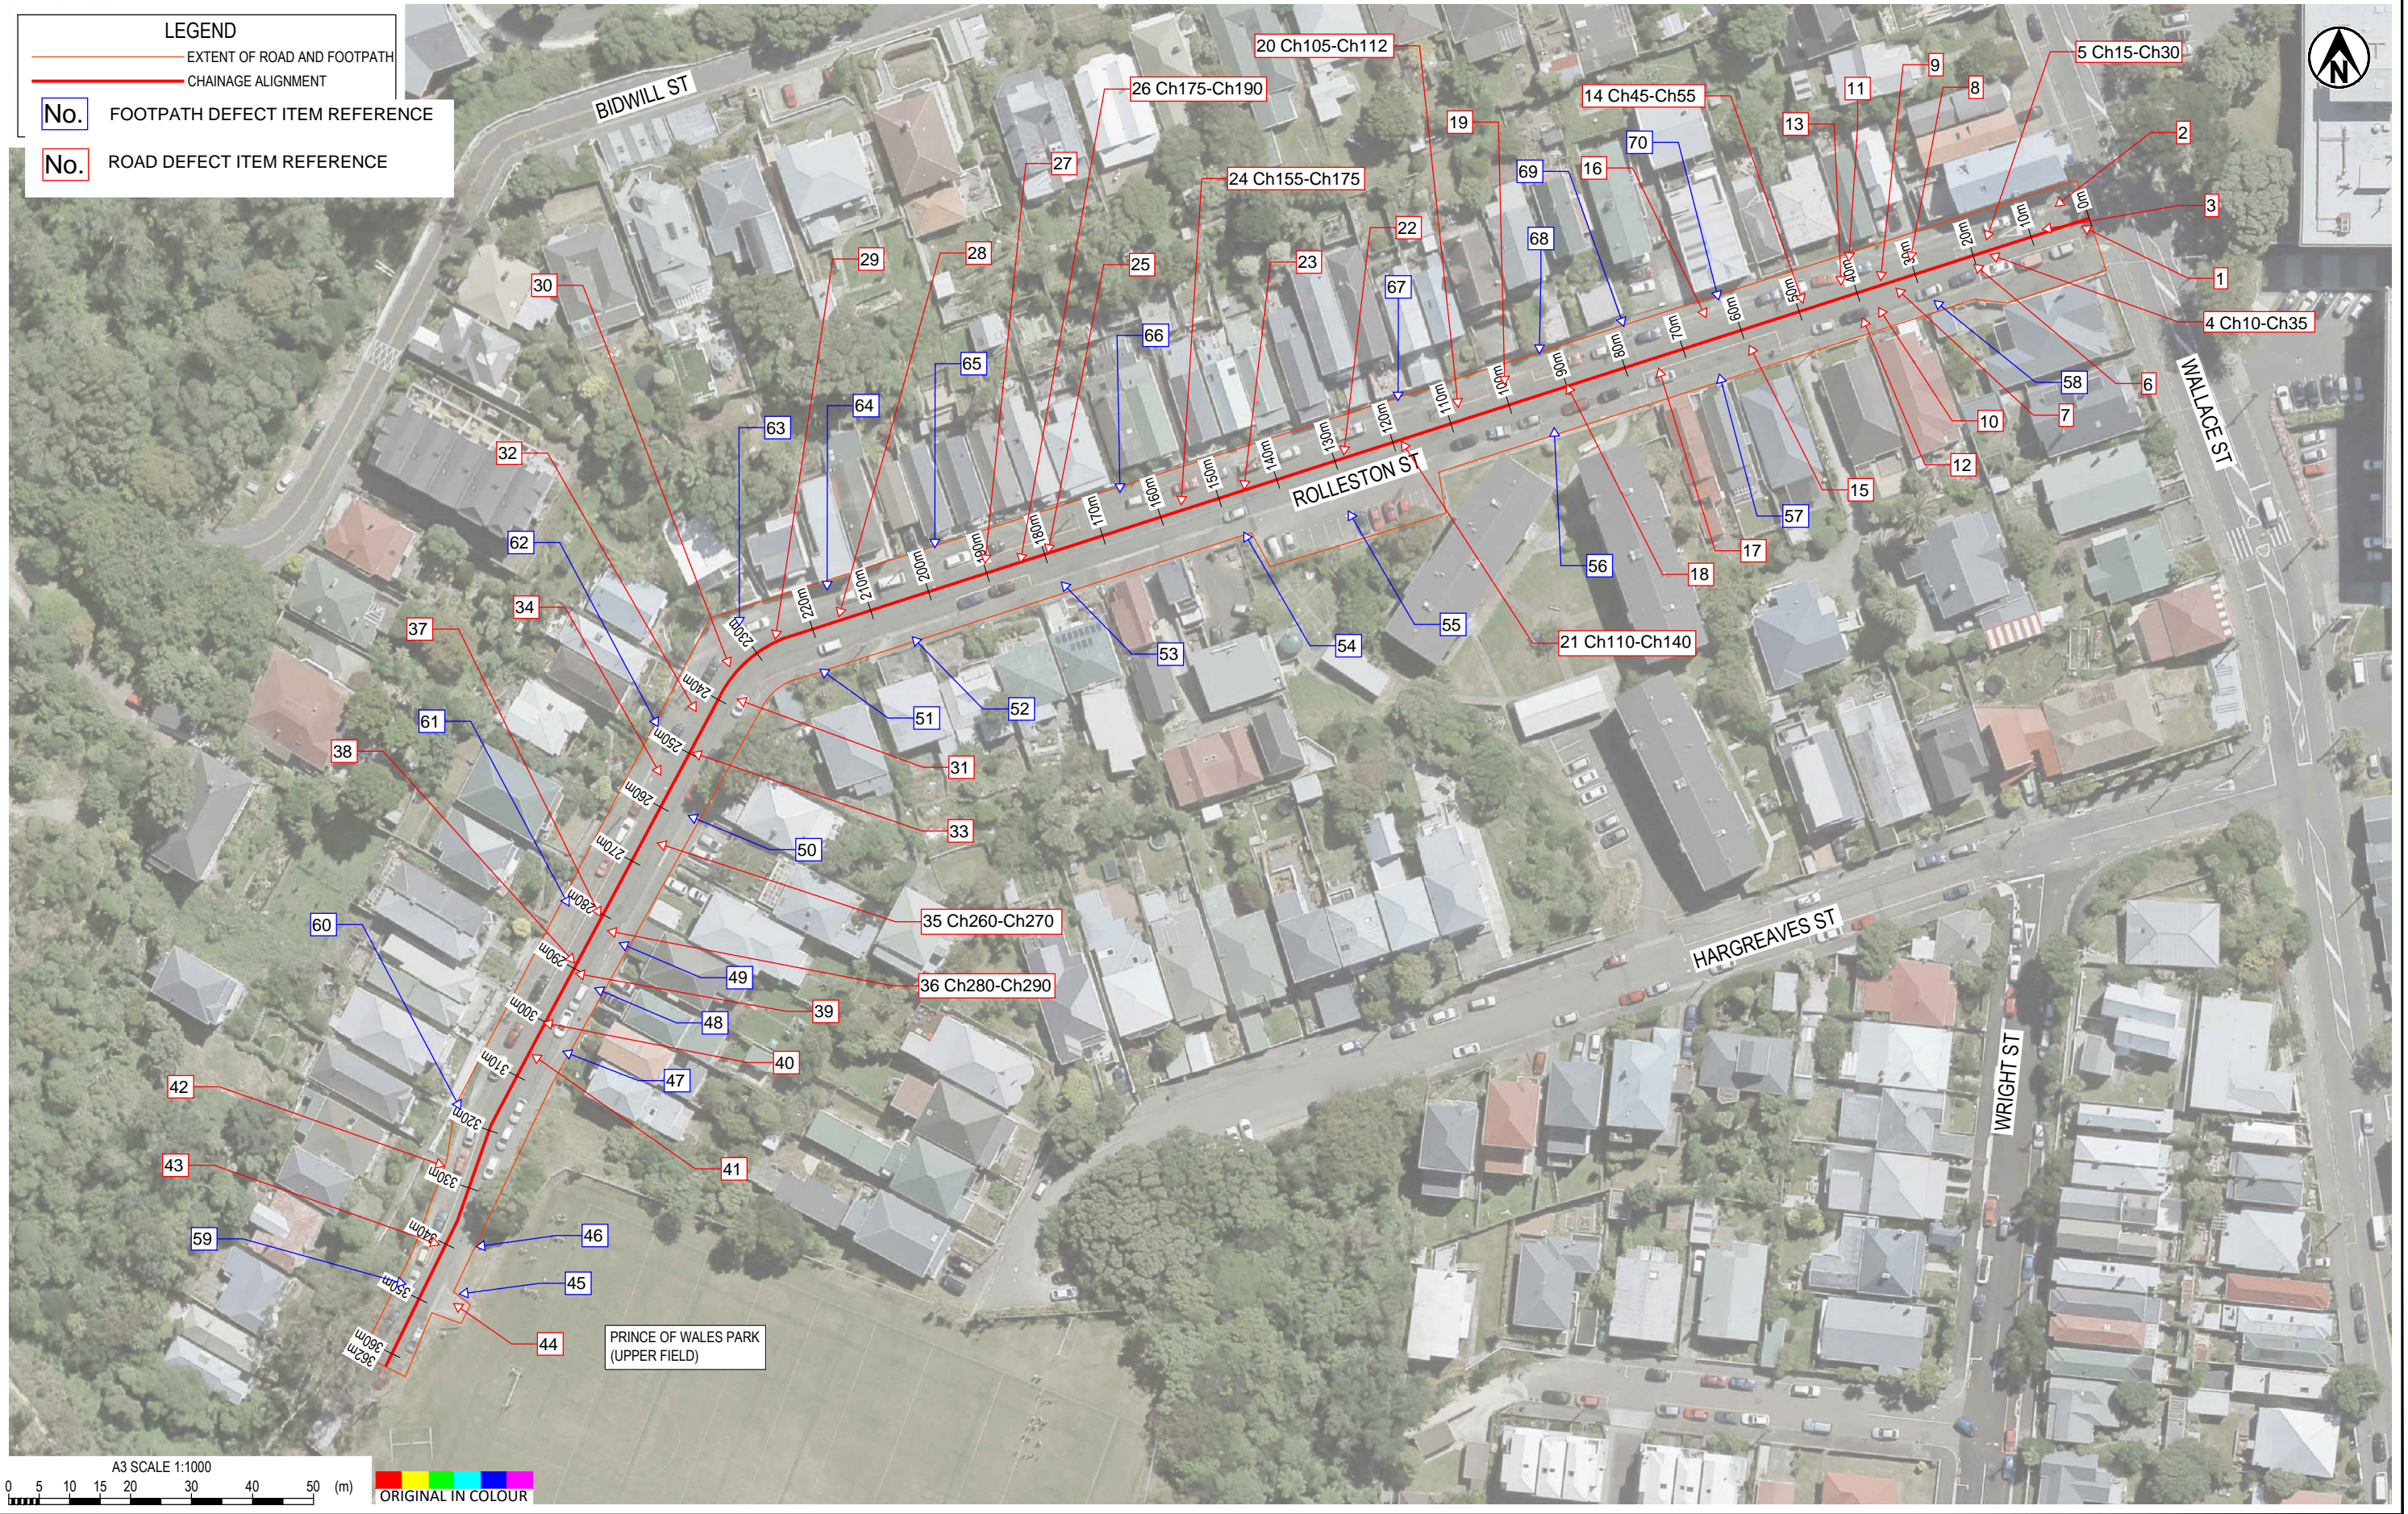
CLIENT	HEB CONSTRUCTION	
PROJECT	OMĀRORO RESERVOIR PRE-CONSTRUCTION PAVEMENT SURVEY	
TITLE	ROLLESTON STREET SURVEY PLAN	
SCALE (A3)	1:1000	FIG No. FIGURE 2
REV	1

The road surface is chipseal with asphalt cement (AC) footpaths and concrete kerbs and channels. The general chipseal surface is in reasonable condition (refer to electronically attached video). Some 44 observations were recorded along the 362 m length of road, with a further 26 observations noted along both footpaths. Most observations relate to the presence of service trenches, in various levels of condition due to intermittent upgrading of wastewater, water, fibre and electrical services. However, isolated areas of notable pavement defects were also observed, which have been listed below (refer to Figure 2, Appendix A for location and Appendix B for observation details):

- Item 5 – 20 mm rutting for 15 m length in wheel track;
- Item 14 – 25 mm rutting for 10 m length, a cluster of services with cracking, and a local depression;
- Items 16 & 17 – Cluster of cracks and depressions around service trenches;
- Item 33 – Joint cracks and a consolidation of a service trench;
- Item 35 – Cluster of edge/longitudinal cracks and a local depression;
- Item 38 – longitudinal cracks, consolidation and edge cracks around service trench;
- Item 40 & 42 - Cracks on road surface, edge and service joints; and
- Item 41 – Crocodile cracking on road surface indicating potential structural failure.

- Item 52 – Surface cracks;
- Item 55 – Extensive crocodile cracks and structural failure along the 30 m extent of the property development;
- Item 60 – potholes and edge break along kerb edge;
- Item 62 – Cracks around service trenches;
- Item 63 – Cluster of potholes and cracks;
- Item 68 – Cracks at the edge of a drive; and
- Item 69 – Cluster of potholes and cracks between a garage and drive out indicating structural failure of entire footpath width.

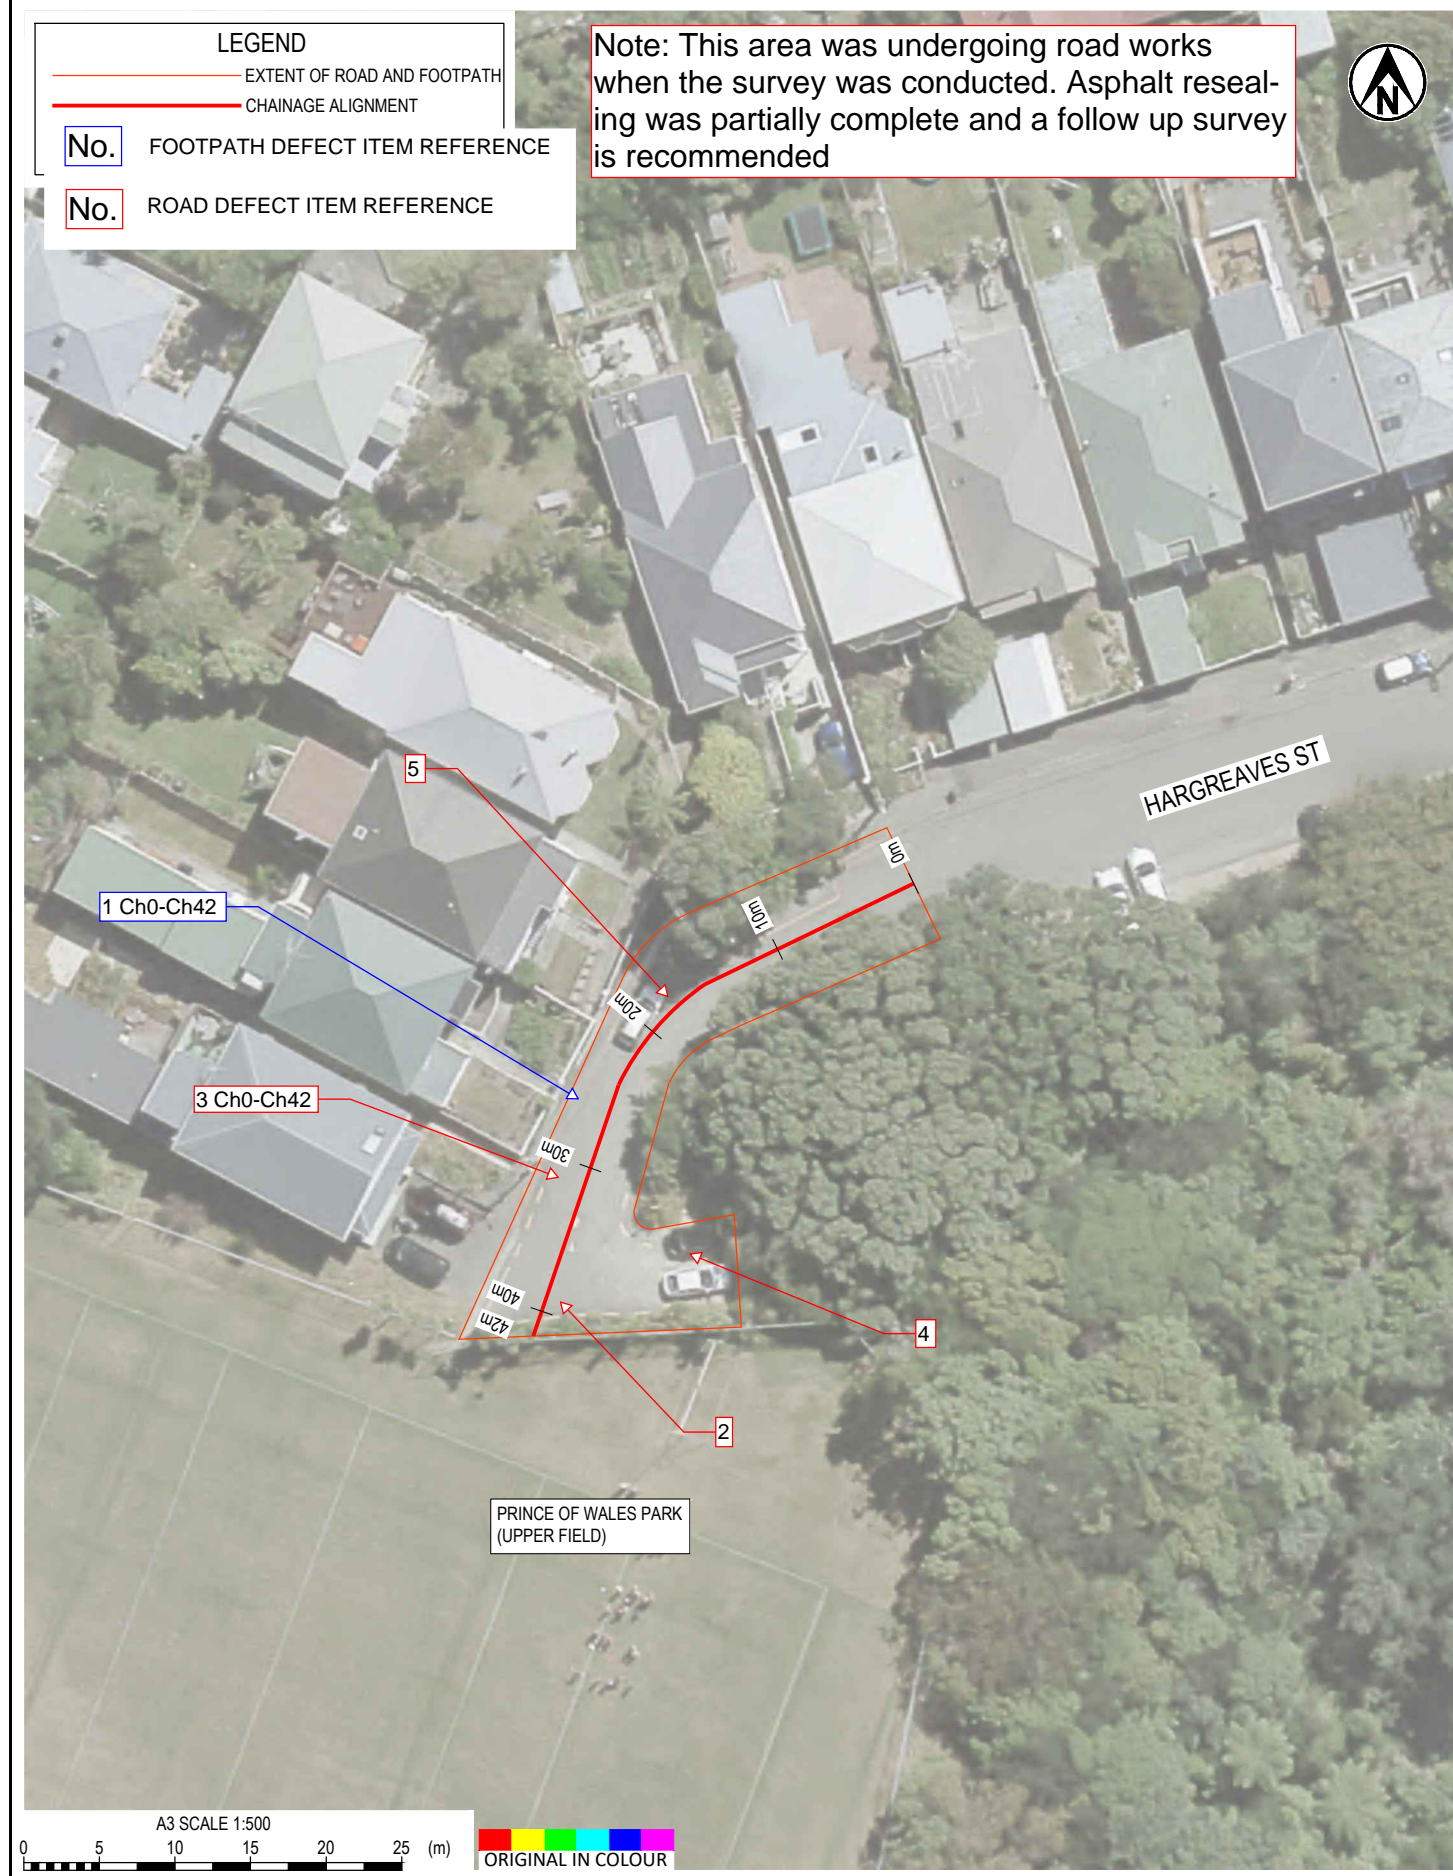
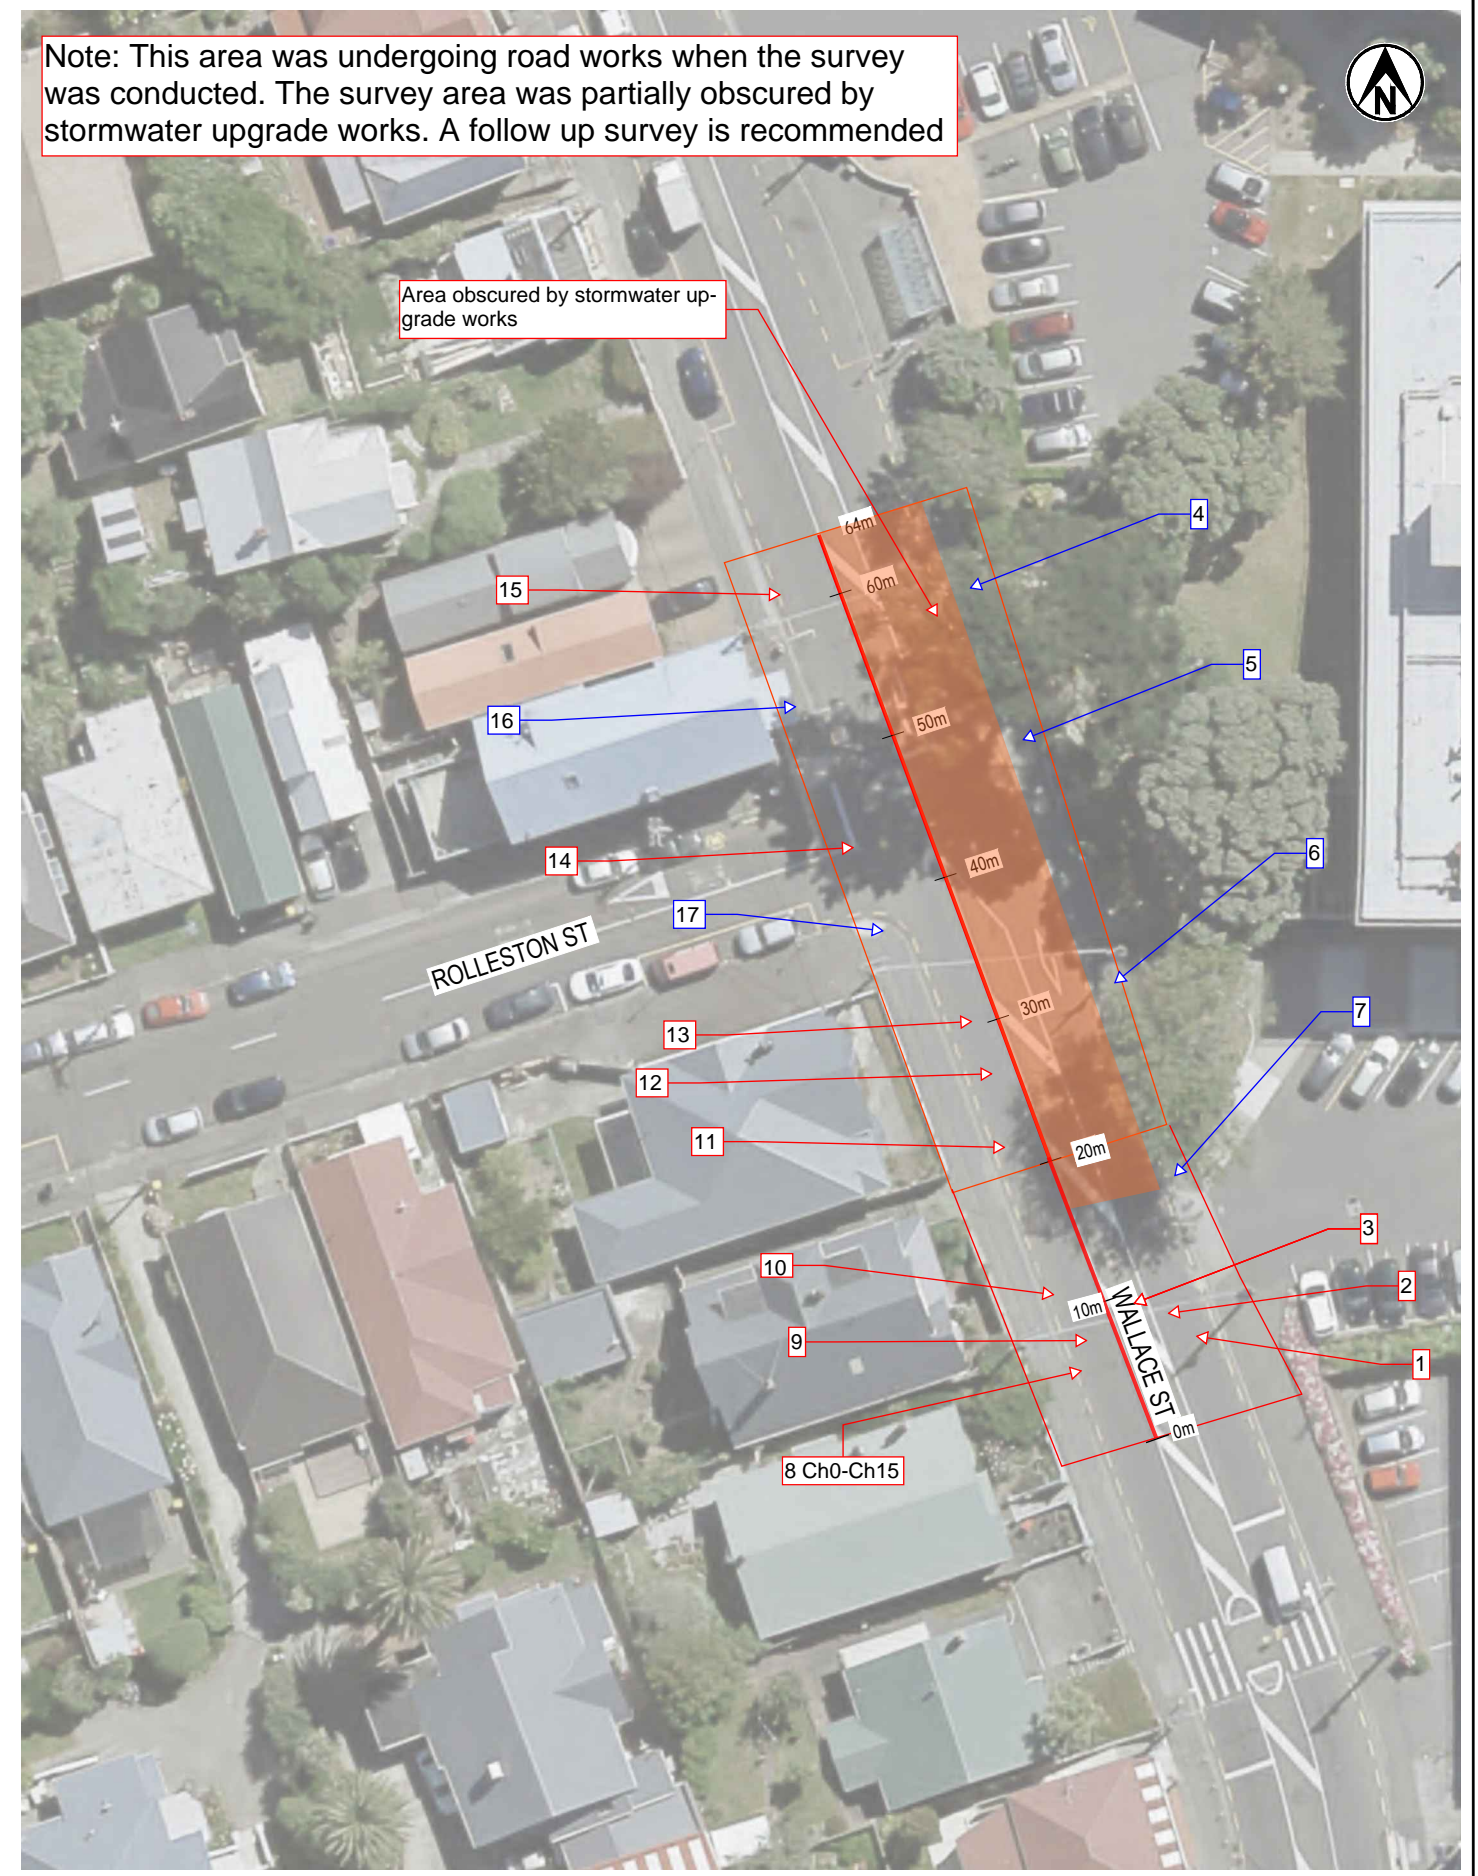
- Item 8 – Longitudinal cracks in the vehicle wheel paths for 15 m length;
- Item 11 - Longitudinal cracks in between vehicle wheel paths;
- Item 14 – Edge cracks visible on AC; and
- Item 15 – Crocodile cracking and depression around an asphalt patch repair, likely indicating isolated structural failure.

Note: This area was undergoing road works when the survey was conducted. Asphalt resealing was partially complete and a follow up survey is recommended

Note: This area was undergoing road works when the survey was conducted. The survey area was partially obscured by stormwater upgrade works. A follow up survey is recommended

Construction works in the road corridors on Wallace and Hargreaves Streets partially obscured the survey extent. The road and footpath surfaces at both locations are expected to be resealed upon completion of these works and we recommended that a follow up survey is carried out to confirm pavement condition on completion of these works.
