11 October 2023

File No: WGN200229

Explanation regarding the discharges of undisinfectd wastewater due to UV System turning off at Porirua Wastewater Treatment Plant

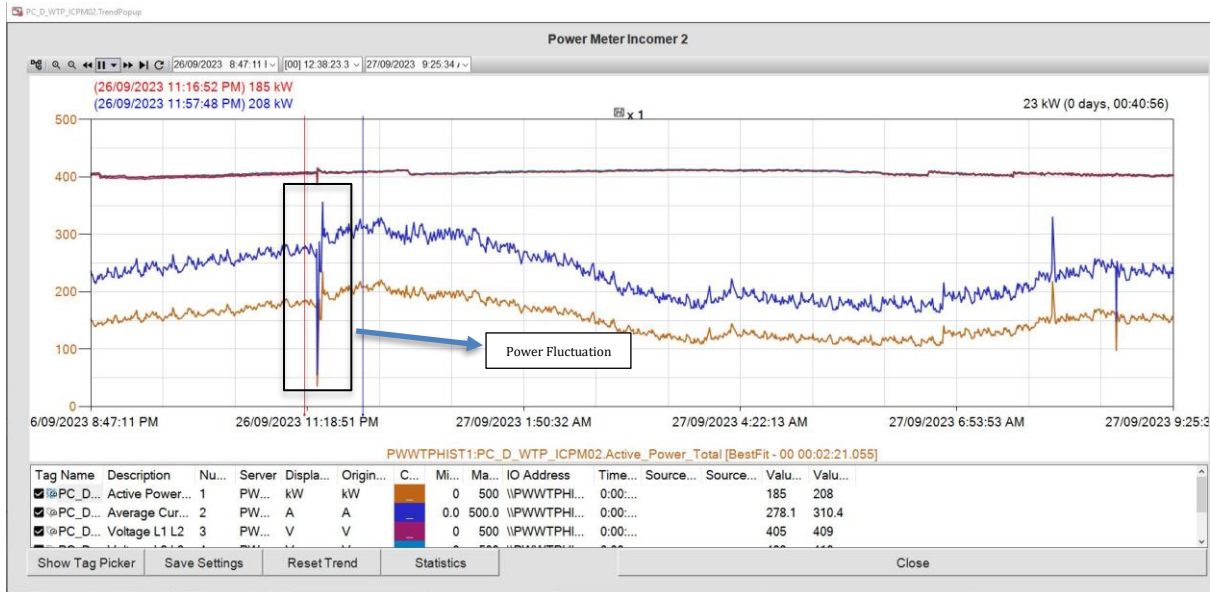
A power fluctuation (rather than a power surge as initially reported) from the electricity network supplying the Porirua WWTP caused the UV system to turn off at 23:22hrs on 26 September 2023. The power trend at the site is shown in the graphic below shows the power fluctuation. The power trend is shown on amber line while the electrical current trend is shown in blue.

Unfortunately, the alarm paging system for the site failed to send an alarm and therefore the duty operator (remote) was not aware of the incident.

When the operator arrived at the site on 27 September morning by 7:30am, the fault was identified and the system was immediately reset. The UV system operation was re-established by 7:46hrs. The UV system was off for 8h 24min in total.

1. Investigating a more robust alarm system process for Porirua WWTP.
2. Investigate the nature of the power fluctuation and determine if there's any improvement that can be undertaken to make the UV system more resilient to power fluctuations. A Back-up Power Supply Project for the UV system is already underway.

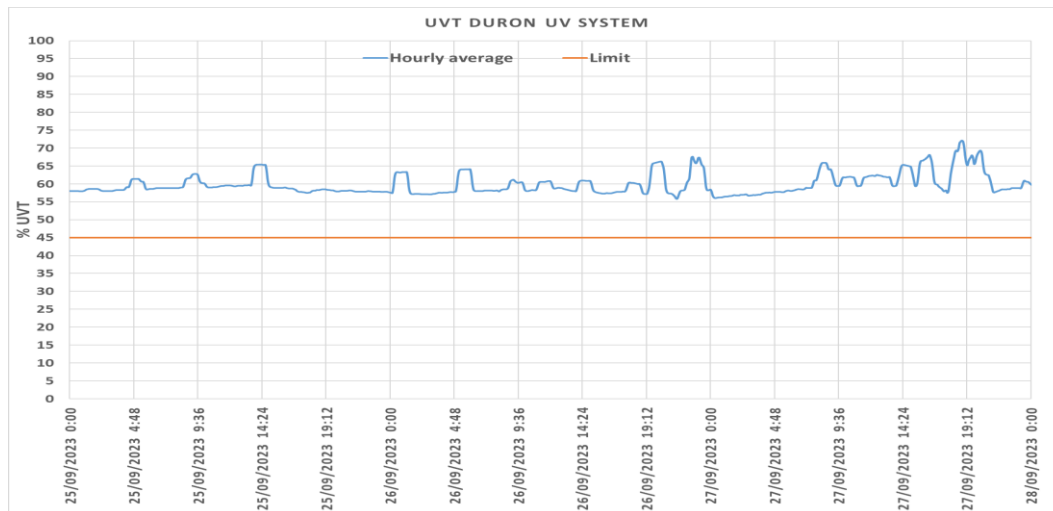
The UV transmissivity of the treated wastewater remained above 55% as shown in the graph below. The consent requires to have the effluent UVT measurement to be at least 45%.

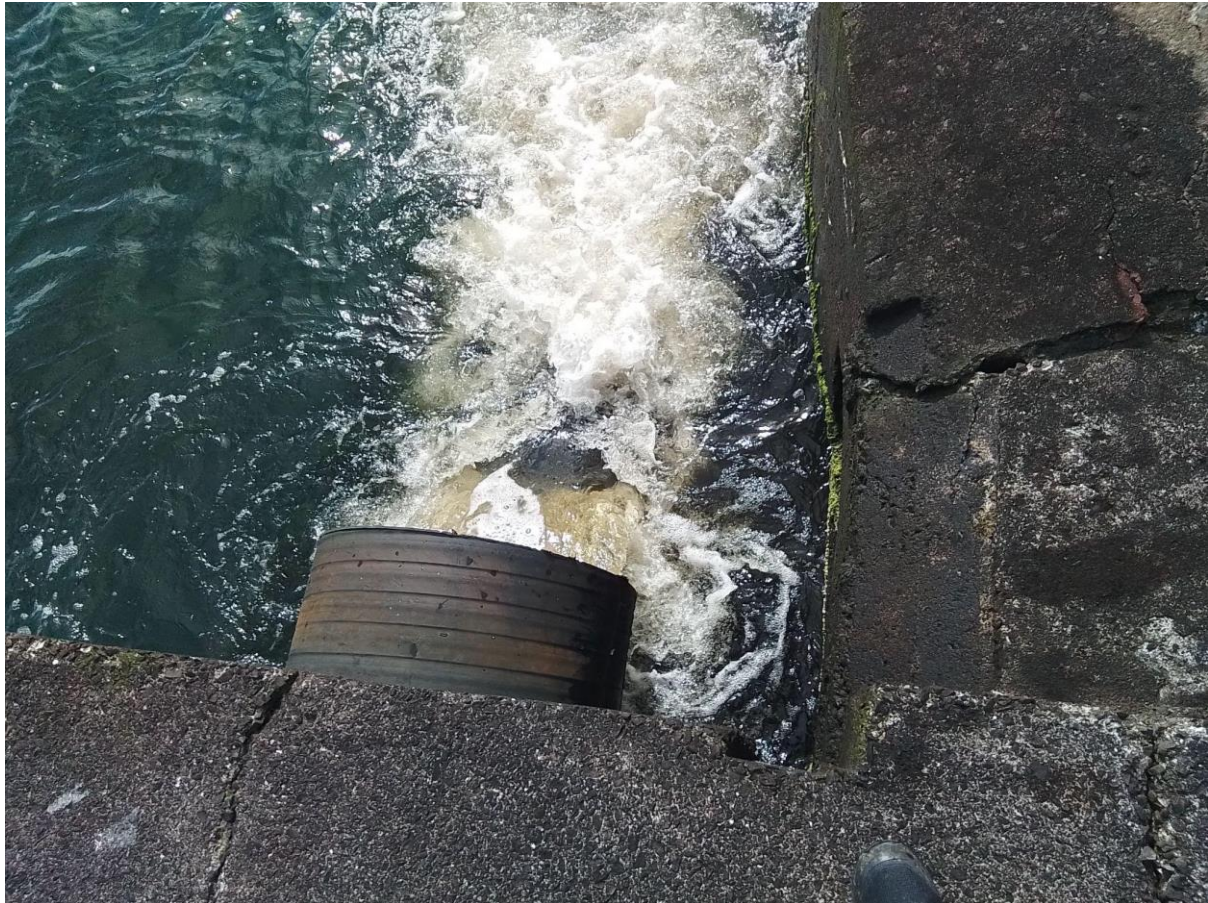
The discharge was still compliant with condition 13 of the resource consent WGN200229[36816] as there should be no change in the appearance, odour or physicochemical characteristics of the treated wastewater. A photo taken on the Rukutane outfall on the 27th September showed no visible observable effect on the wastewater discharge and the nearby water.

Photo 1: Rukutane Outfall – Dated 27 September 2023
