Moa Point Wastewater Treatment Plant Flood Event

SCHEMATIC VIEW. NOT TO SCALE

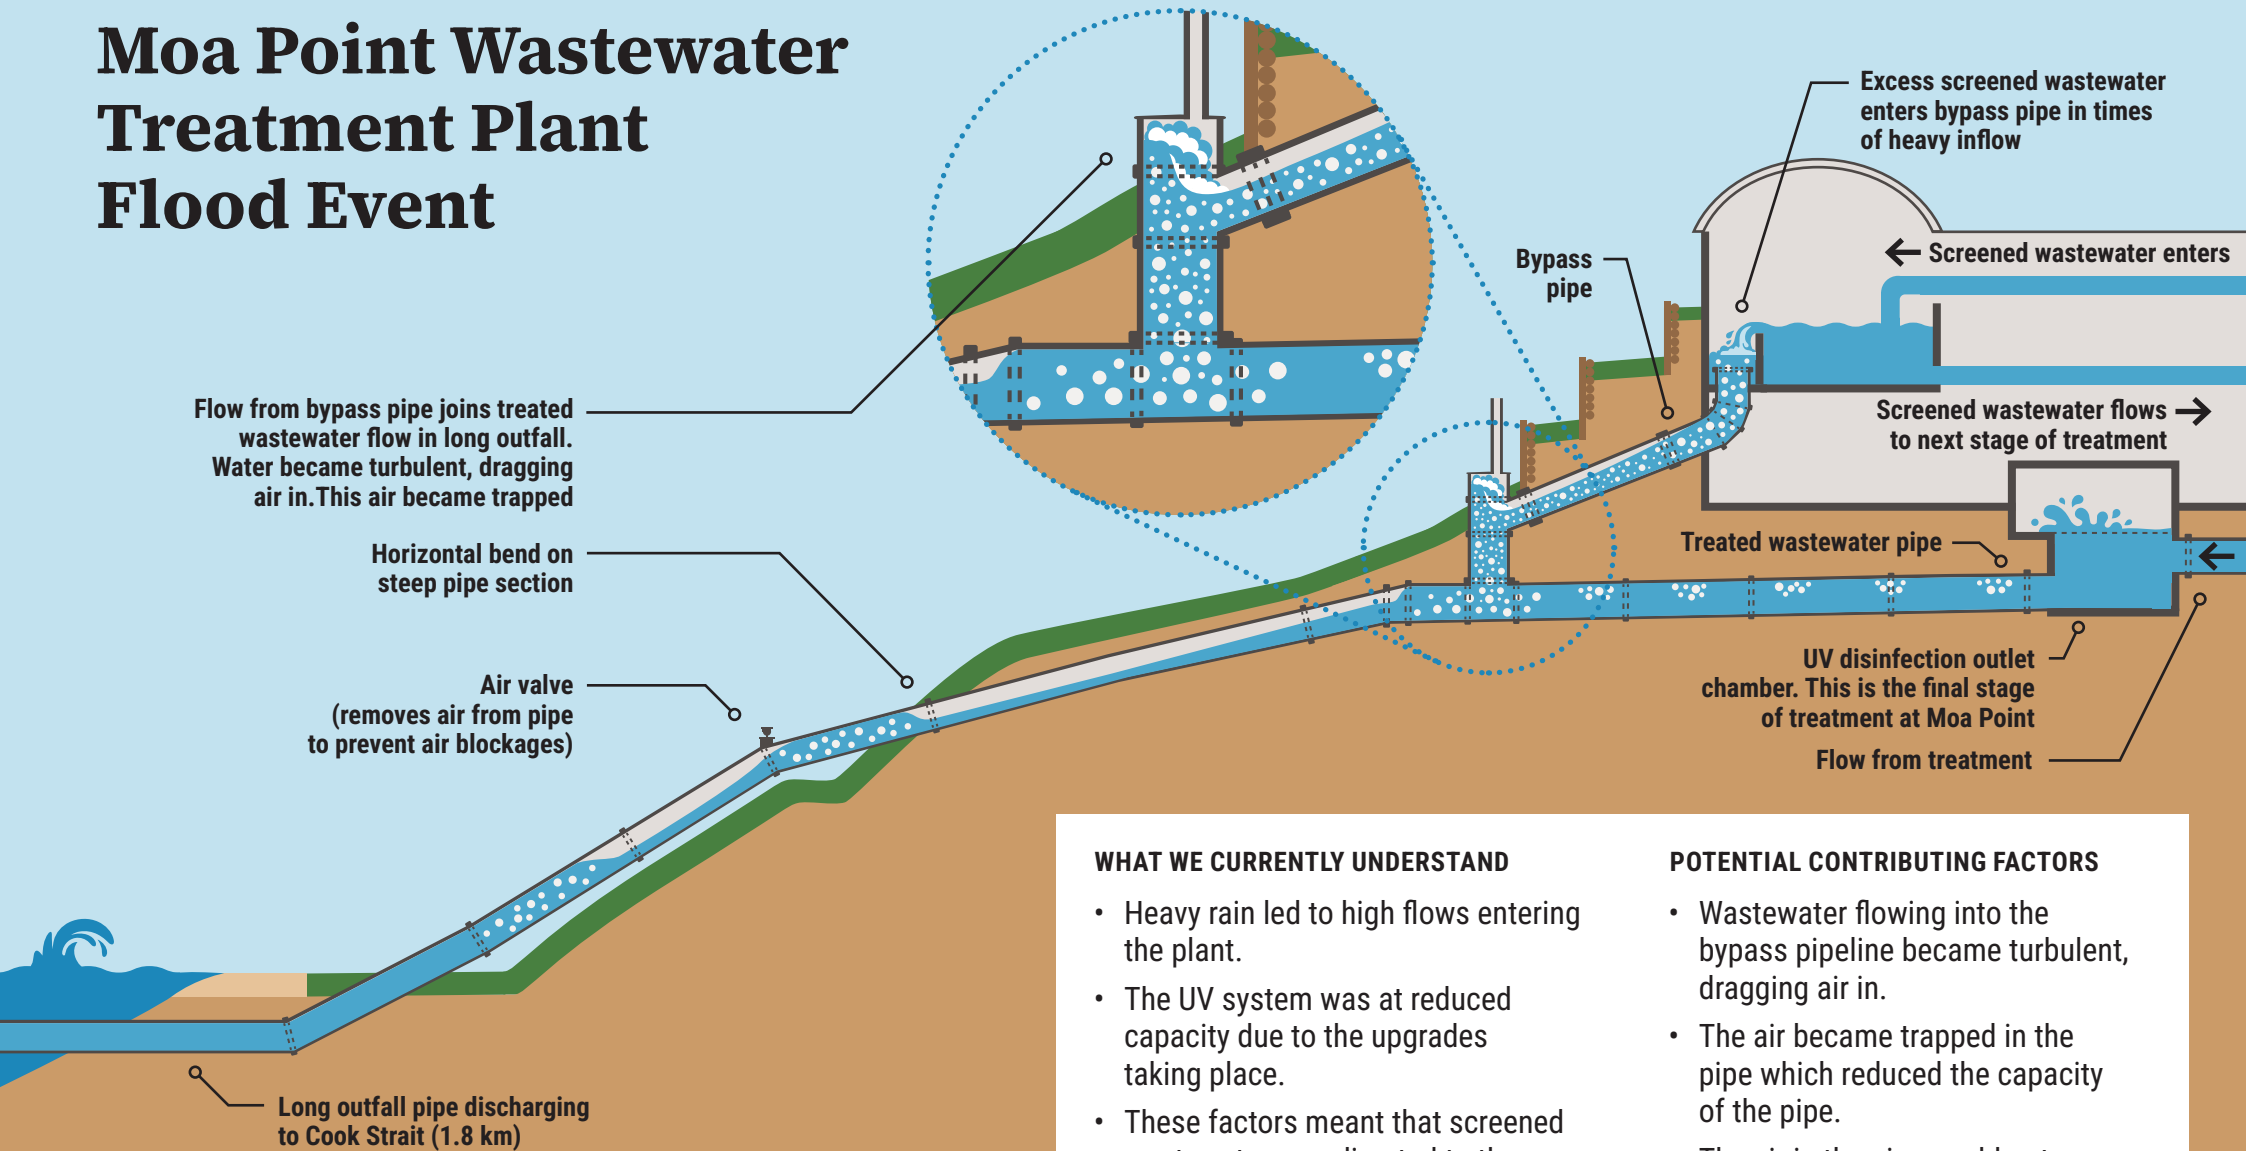
Long Outfall: 1200 to 1400 mm (diameter varies)
Bypass Pipe: 900 mm diameter

- Heavy rain led to high flows entering the plant.
- The UV system was at reduced capacity due to the upgrades taking place.
- These factors meant that screened wastewater was diverted to the bypass pipe, as designed.
- The fully treated wastewater did not flow through the UV channels to the long outfall as per normal, and treated wastewater flooded the plant.

- Wastewater flowing into the bypass pipeline became turbulent, dragging air in.
- The air became trapped in the pipe which reduced the capacity of the pipe.
- The air in the pipe could not vent effectively.
- Other contributing factors may be present in the long outfall. These are also being investigated.
