Moa Pt WWTP

Damage Assessment Report – Stage 2

Prepared for s7(2)(a) – Privacy
Prepared by Beca Limited

17 April 2026

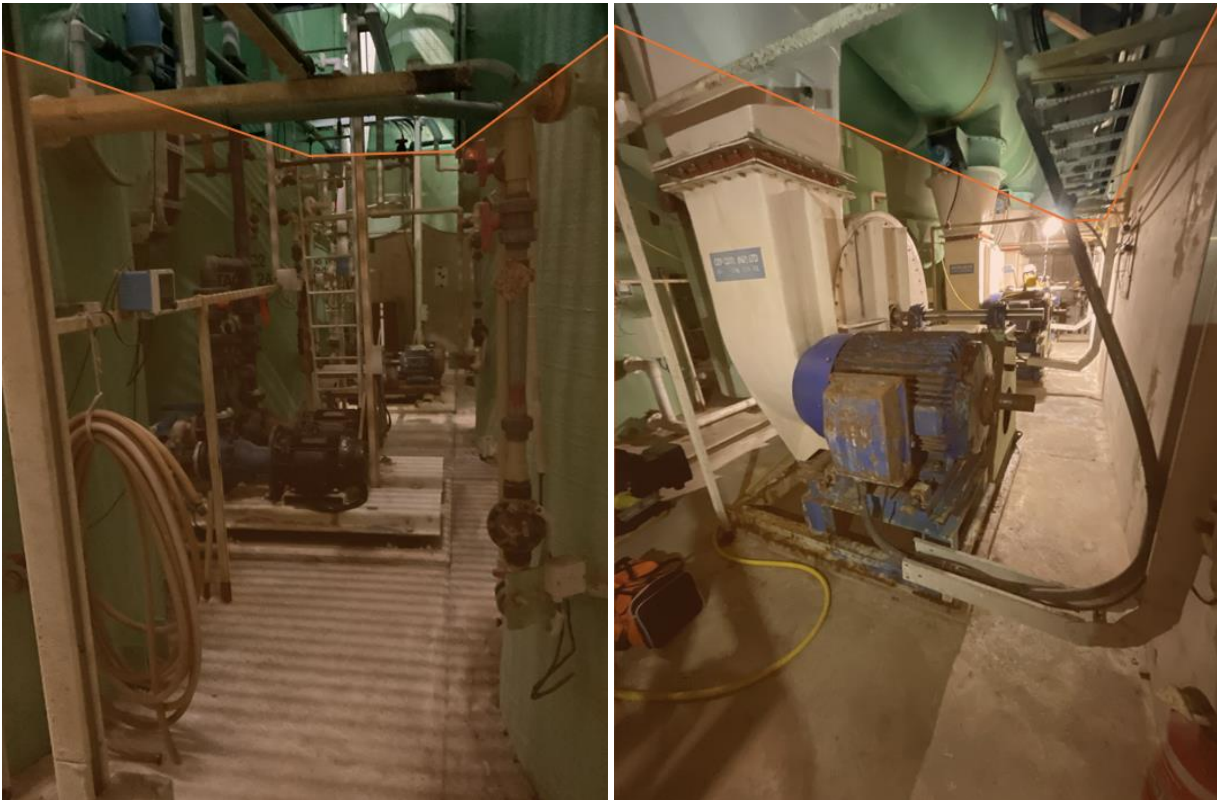
Beca was advised that this location was submerged to a level of 2.5m above floor level. This impact is shown indicatively below in Figure 4.

Figure 4: Odour Control Room indication of the approximate level to which assets were submerged (Scrubber recirculation pumps, (L), Scrubber extraction fans (R))

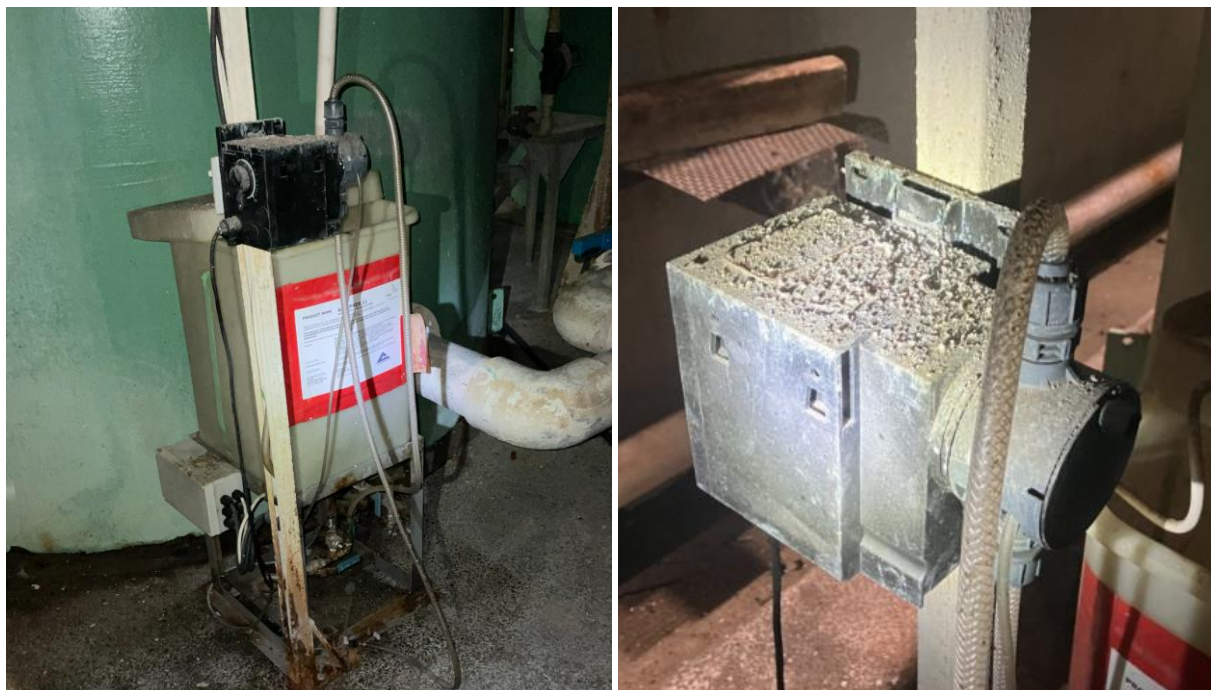
The anti-scalant dosing pump was observed to have been fully submerged during the flooding event and is not expected to be functional without assessment or intervention.

Figure 5: Anti Scalant Dosing System (L) and Anti Scalant Dosing Pump (R)

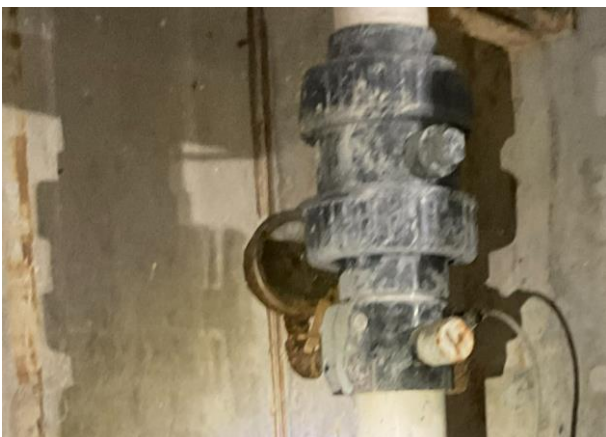
- E-00295367: Observed to have been fully submerged.
- E-00295368 and E-00295369: Observed to be in poor condition prior to the flooding event.
- E-00295108: Not observed; no comment provided.

Figure 7: Neutralisation system pressure indicator in poor condition

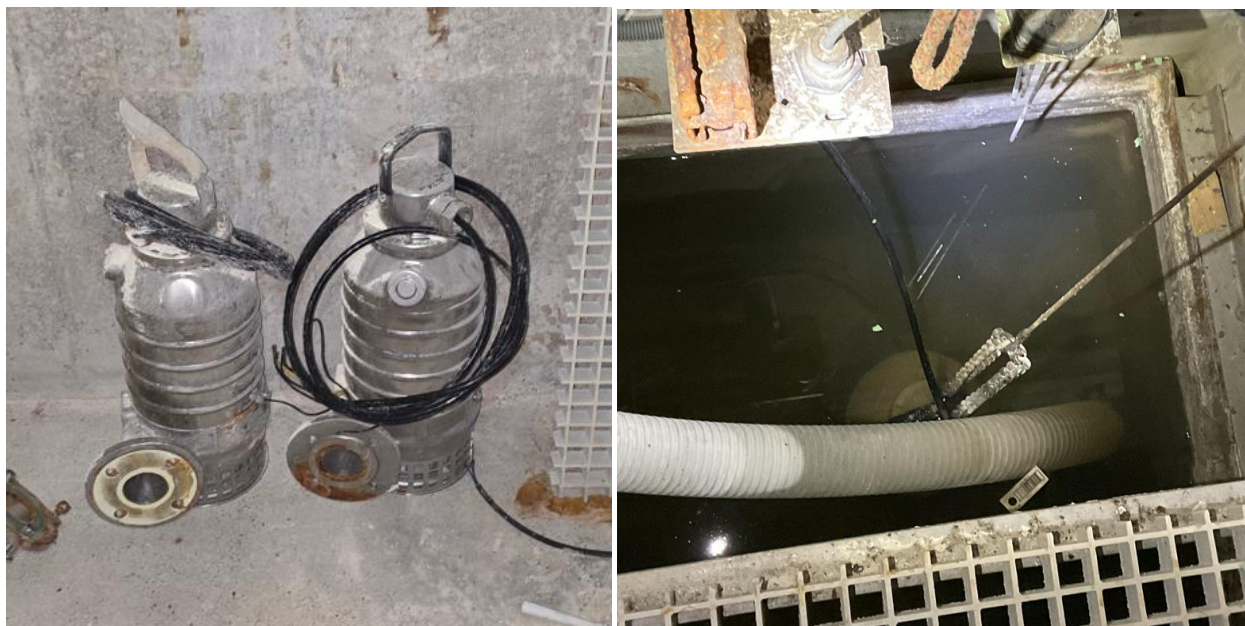
One pump was installed within the pump well and two pumps were observed to be decommissioned at the time of inspection. Site personnel advised that the pumps were reportedly operating during the flooding event and subsequently ceased operation; however, this information could not be independently verified at the time of assessment. As such, operational status during the event and the cause of failure cannot be confirmed based on observations alone.

Figure 8: Neutralisation Discharge Pumps (L) and installed Neutralisation Discharge Pump in the well (R)

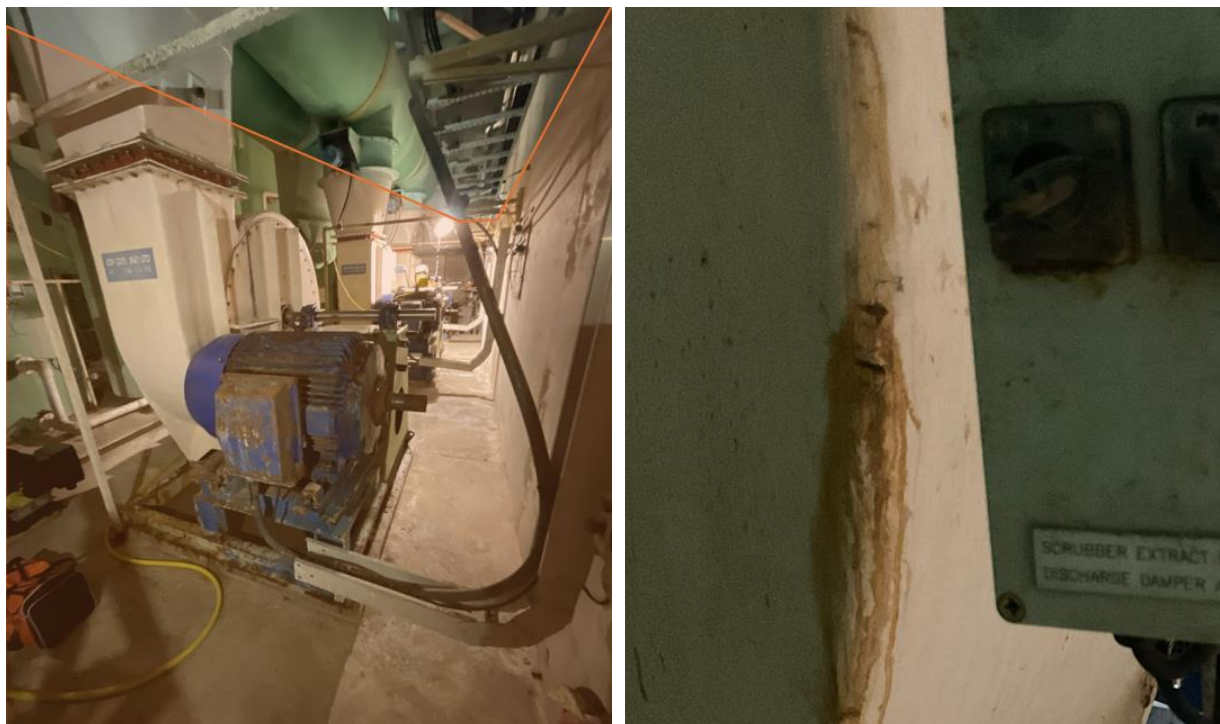
It is noted that water ingress can occur into electrical cables through exposed terminations or damaged insulation and may migrate internally along the cable length. Sections of cable tray were observed to be installed close to the high-water level, indicating potential moisture exposure to supported cabling.

Figure 10: Odour control extraction fans indicative level of submergence (L) and Scrubber Extraction Fan 2 housing damage where ingress is likely to occur (R)

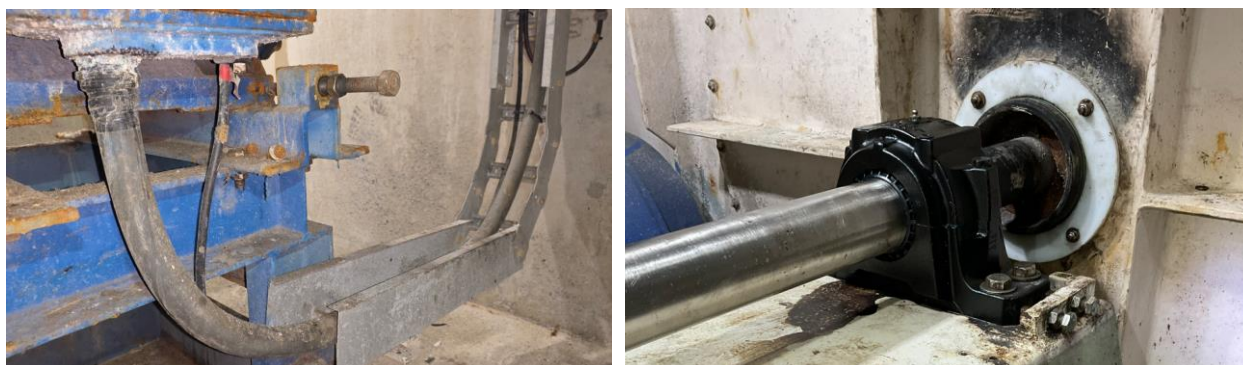
Figure 11: Scrubber Extraction Fan Motor Cables and Terminal Box (L) and Scrubber Extraction Fan 2 Bearing (R)

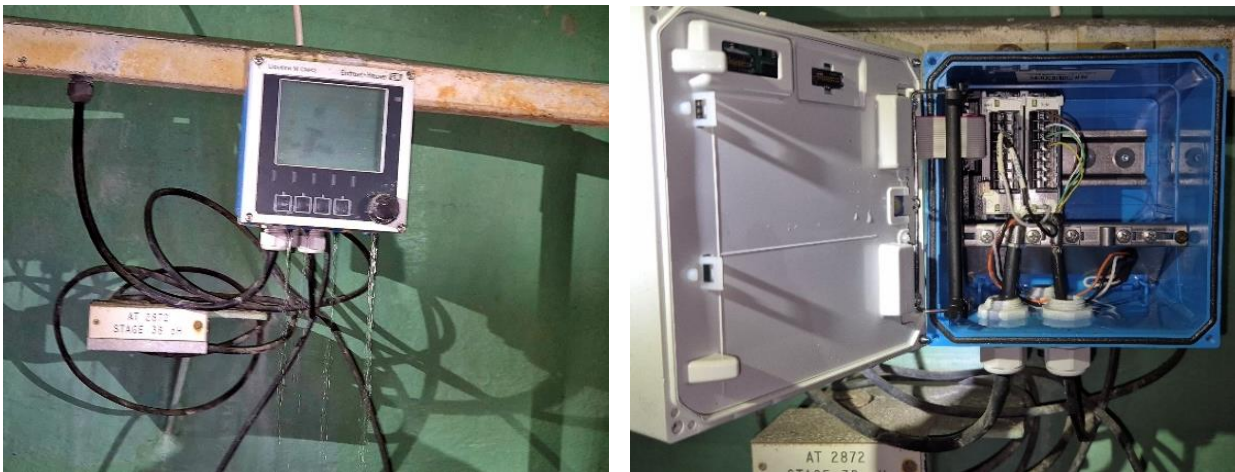
It is also noted that several assets could not be positively identified due to missing or detached asset tags. As a result, confirmation of exposure condition and asset identification for these items could not be undertaken at the time of inspection.

Figure 12: Scrubber analyser transmitter (L and R)

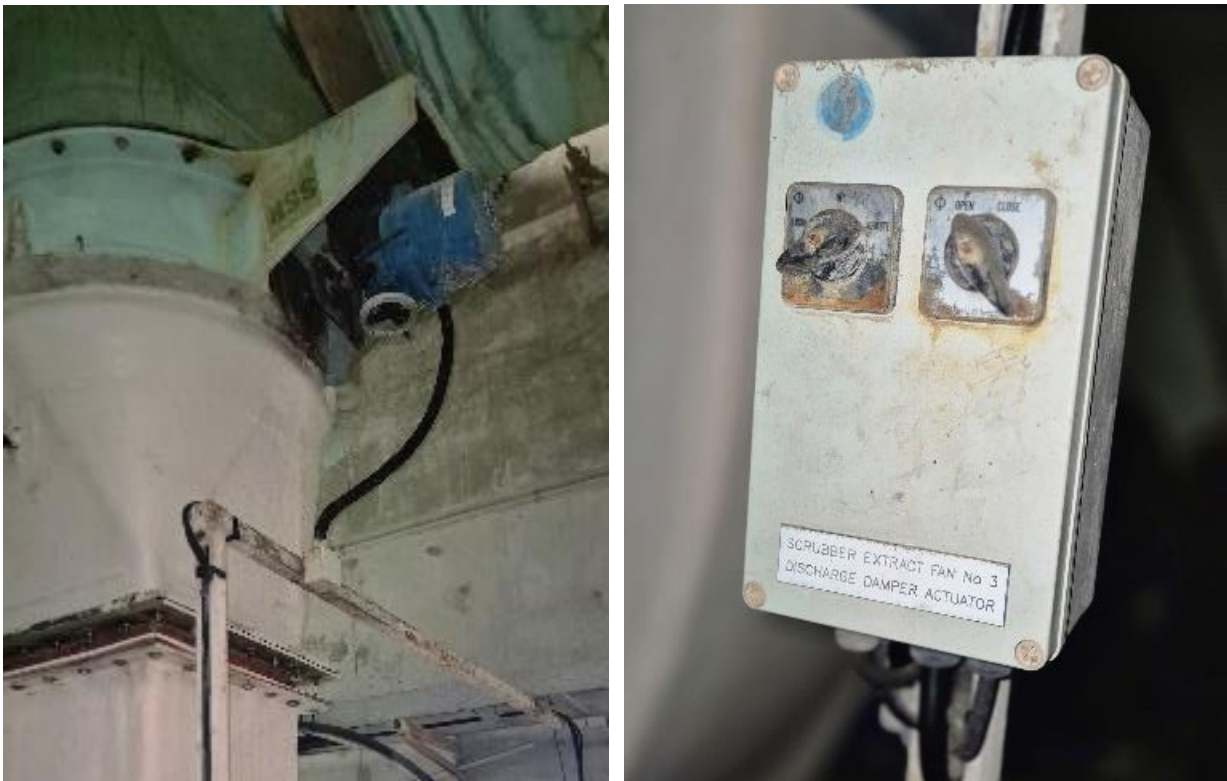
The dampers were not readily accessible at the time of inspection; accordingly, close visual inspection of internal components and operating mechanisms could not be undertaken, and condition could not be confirmed based on observation alone.

Figure 13: Actuated odour control damper (L) and local control station (R)

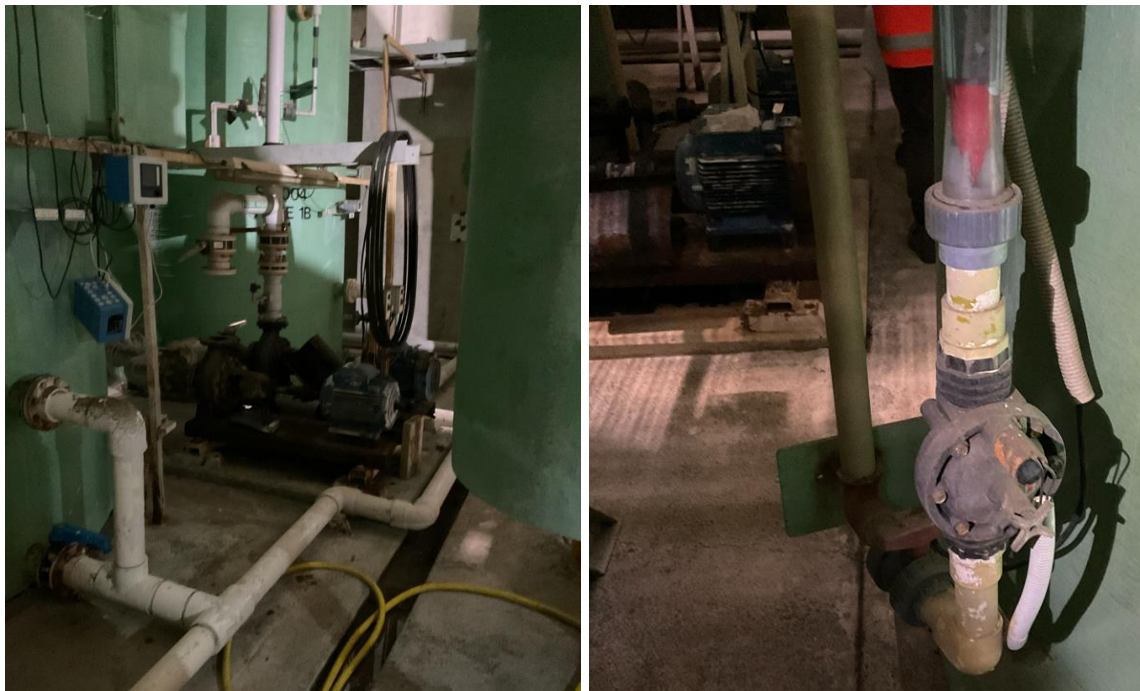
Given the extent of submergence, both the solenoid valves and associated junction boxes are considered to have been exposed to floodwater, with an increased likelihood of internal water ingress. As a result, operational condition and ongoing reliability cannot be confirmed based on visual inspection alone.

Figure 15: Odour scrubber piping and valves (L and R)

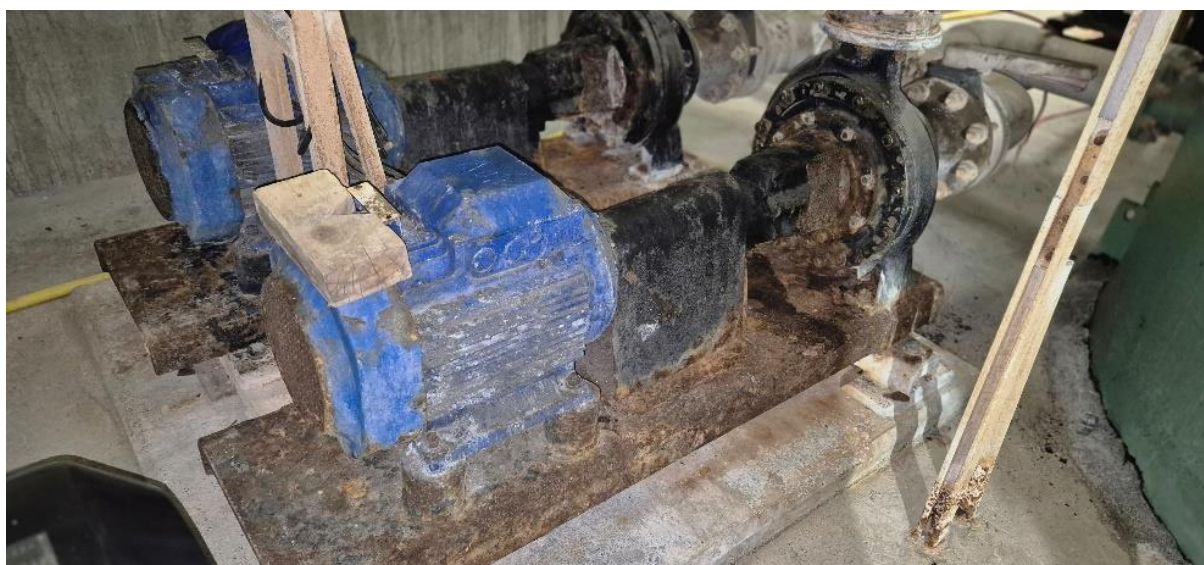
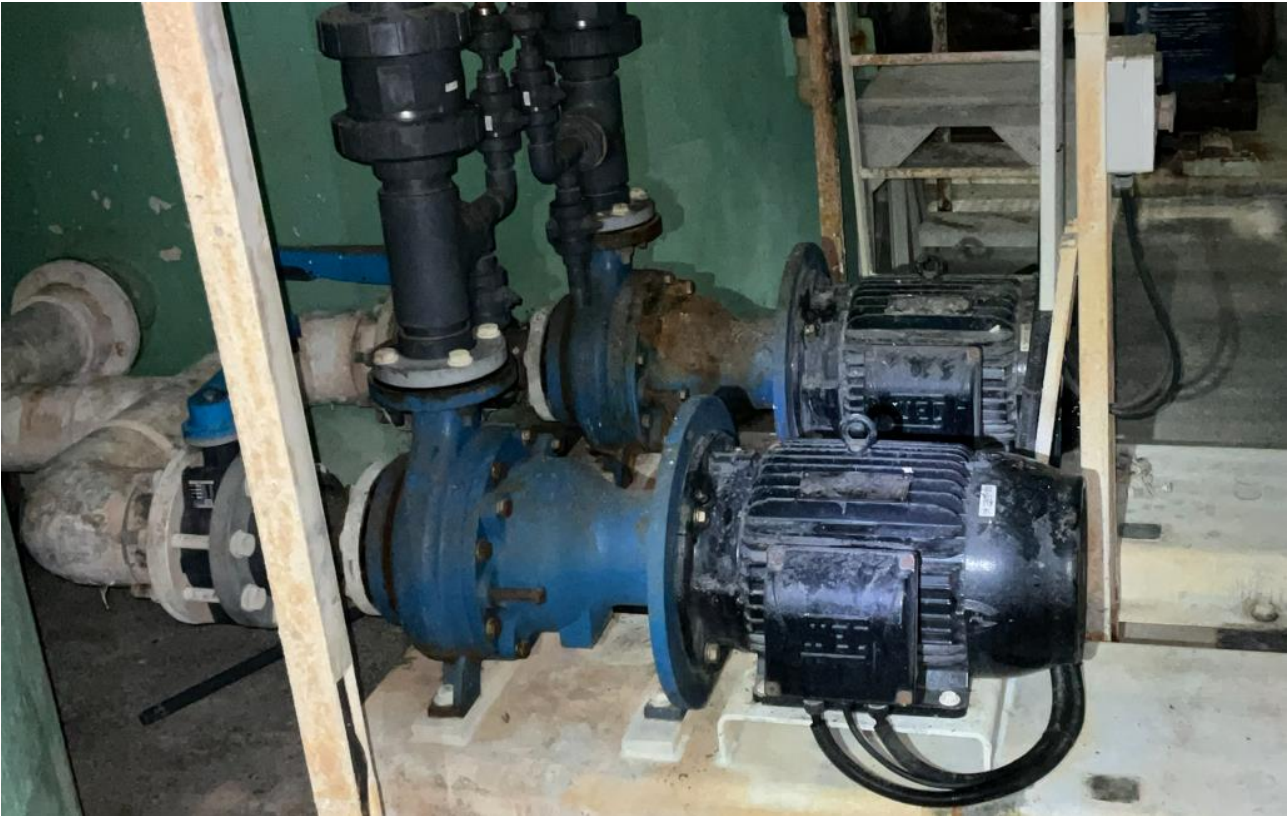
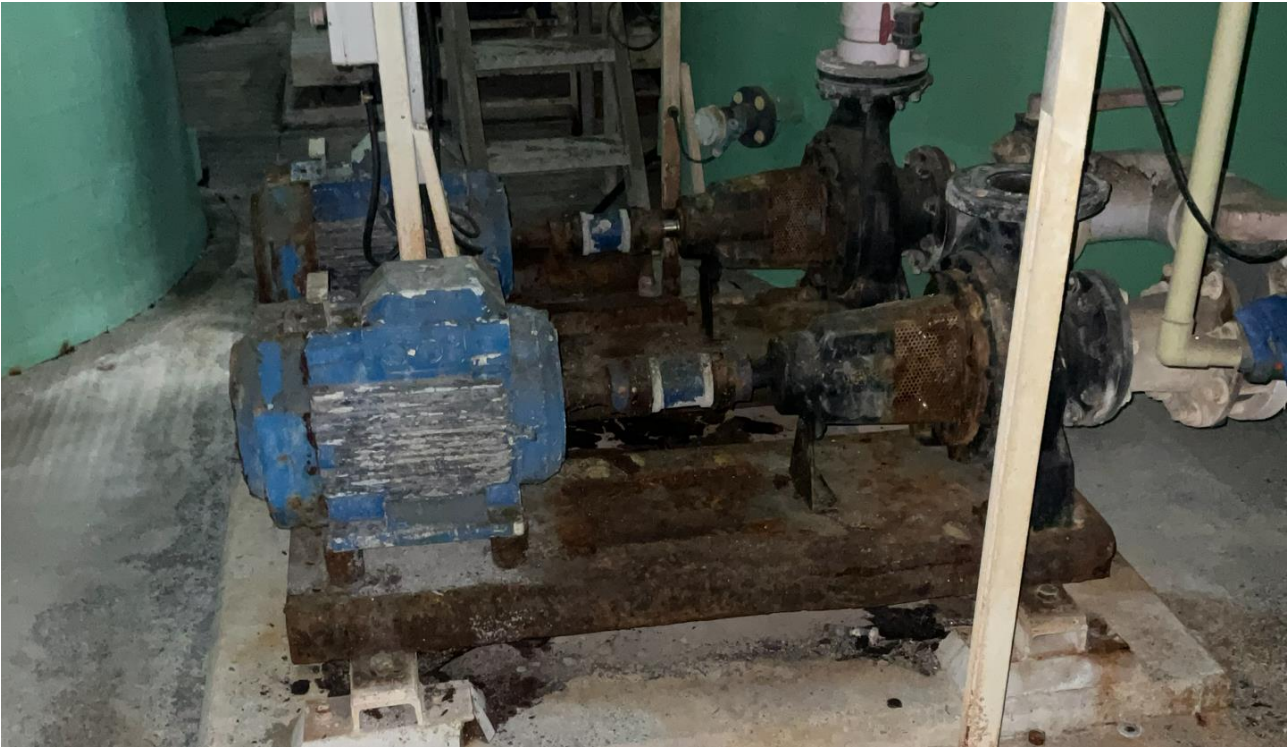
Given the extent of exposure, both the pump motors and associated local controls are considered to have been subjected to floodwater, with an increased likelihood of internal water ingress. As a result, operational condition and continued serviceability cannot be confirmed based on visual inspection alone.

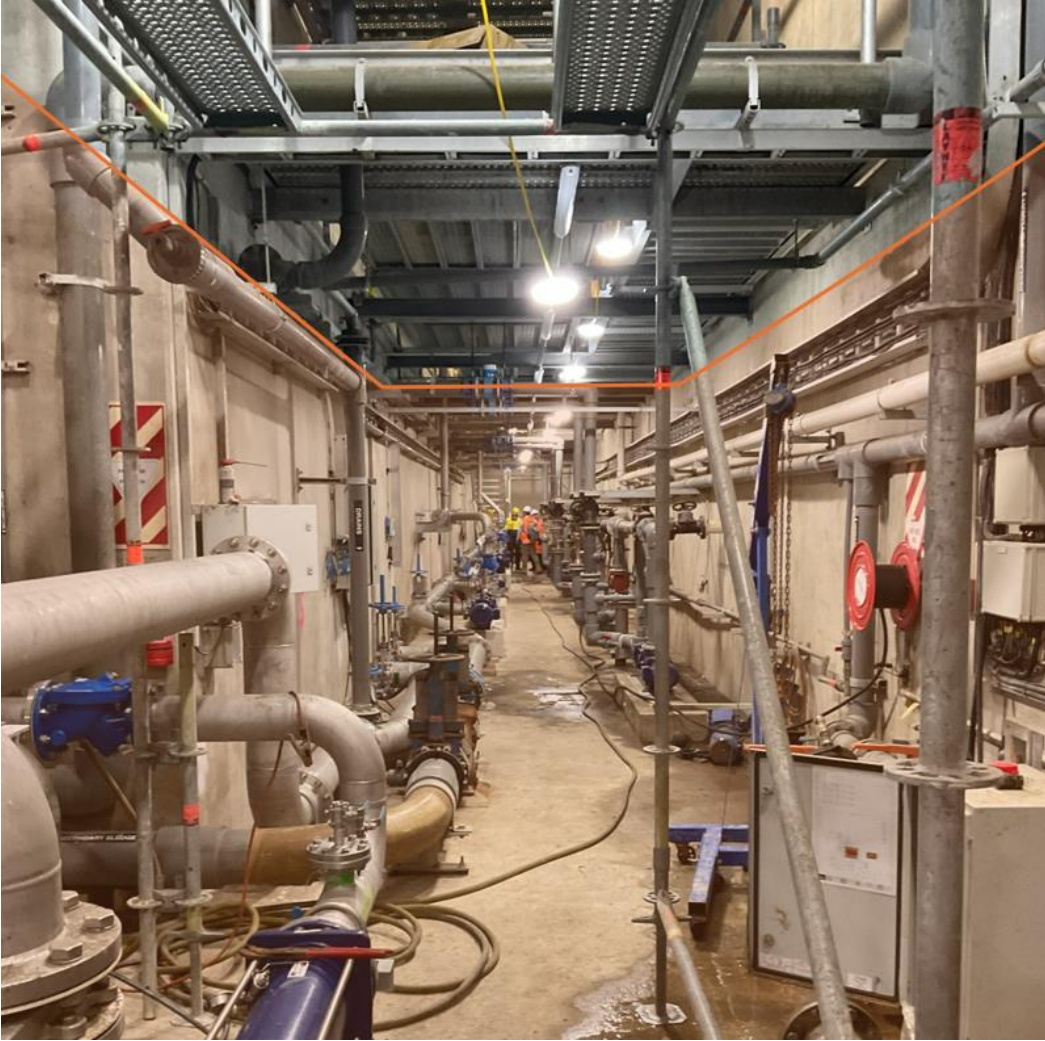
Beca was advised that the Primary Sludge Pumps Technical Gallery was submerged to a level of 3.0m above floor level. This impact is shown indicatively below in Figure 23.

Figure 23: Primary Sludge Pumps Technical Gallery indication of the approximate level to which assets were submerged

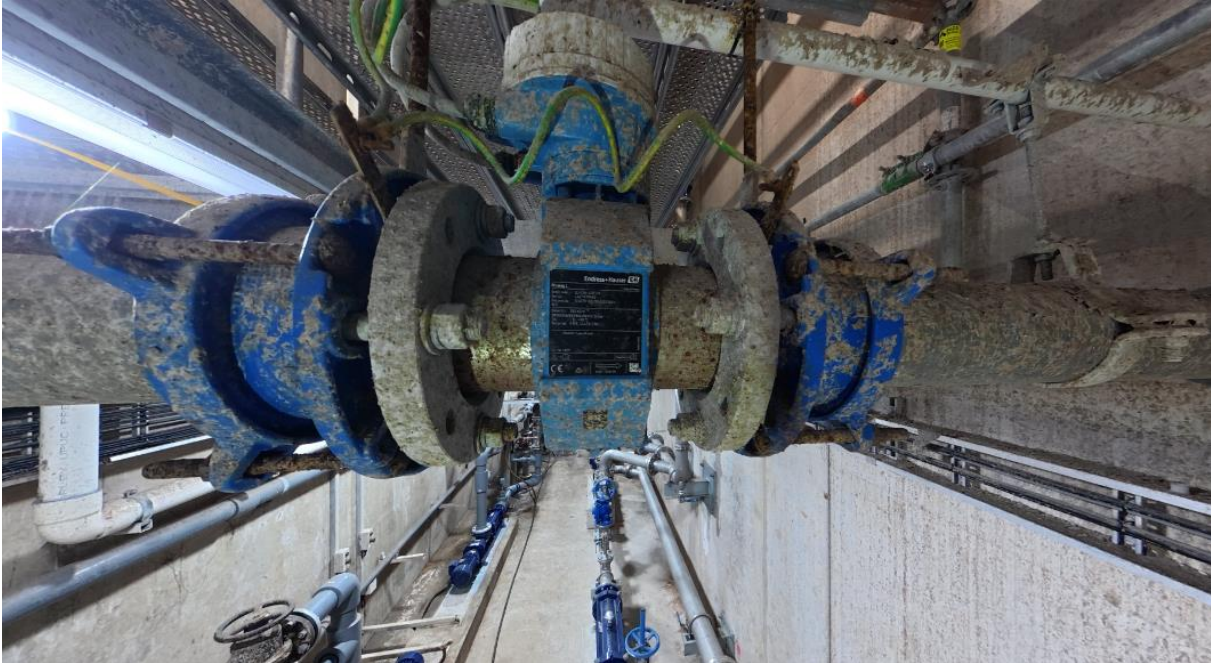
The flow transmitters are powered via a remote I/O panel located in the sludge gallery. This panel was observed to show signs consistent with water ingress, indicating potential exposure to floodwater.

Figure 25: Primary sludge flow meter and flow transmitter.

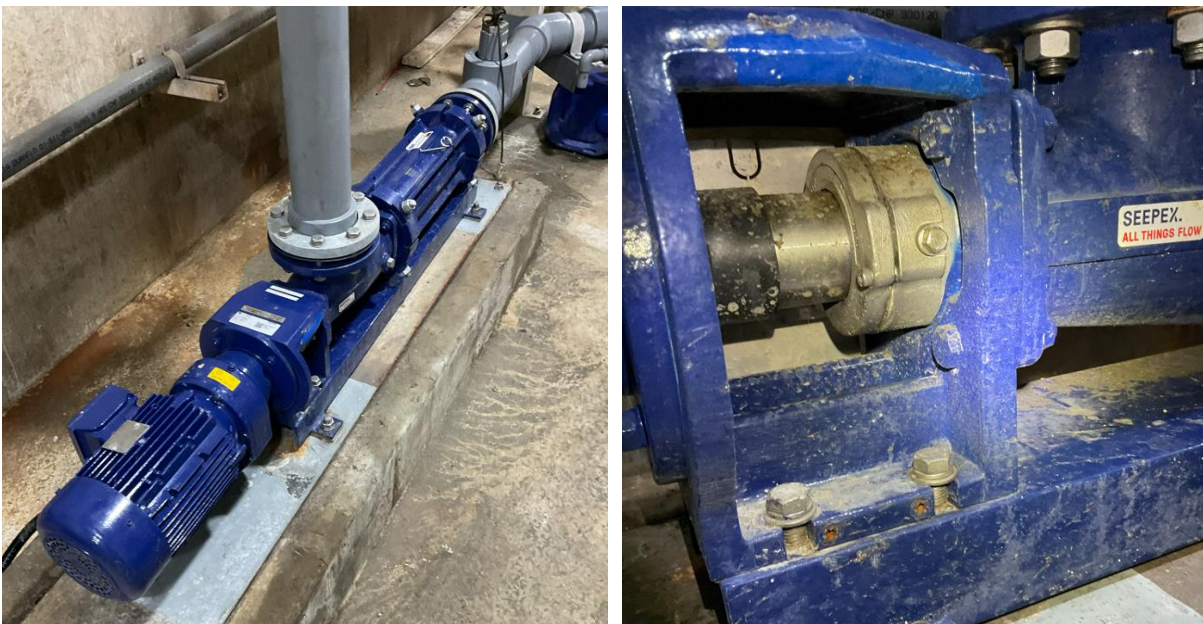
Based on the above, the operational condition and continued serviceability of the motors, associated controls, and ancillary equipment cannot be confirmed through visual inspection alone.

Figure 27: Primary Sludge Pump 6 (L) and pump shaft and seal (R)

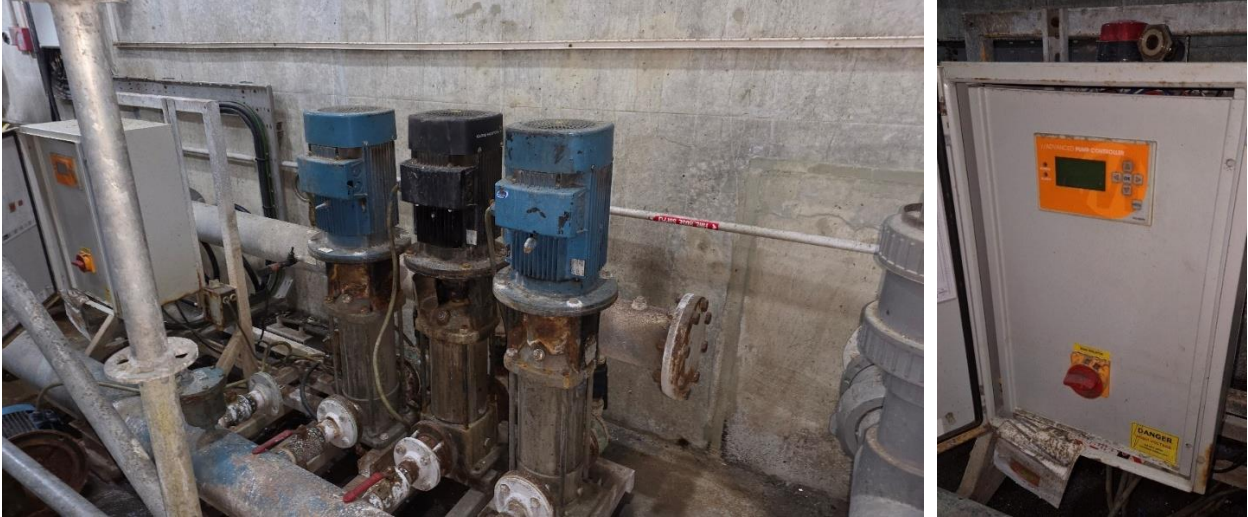
Based on the observed and inferred exposure conditions, the operational condition and continued serviceability of the electronic pump controller, motors, and associated equipment cannot be confirmed through visual inspection alone.

Figure 34: RE Wash Water pumpset (L) and controller (R)

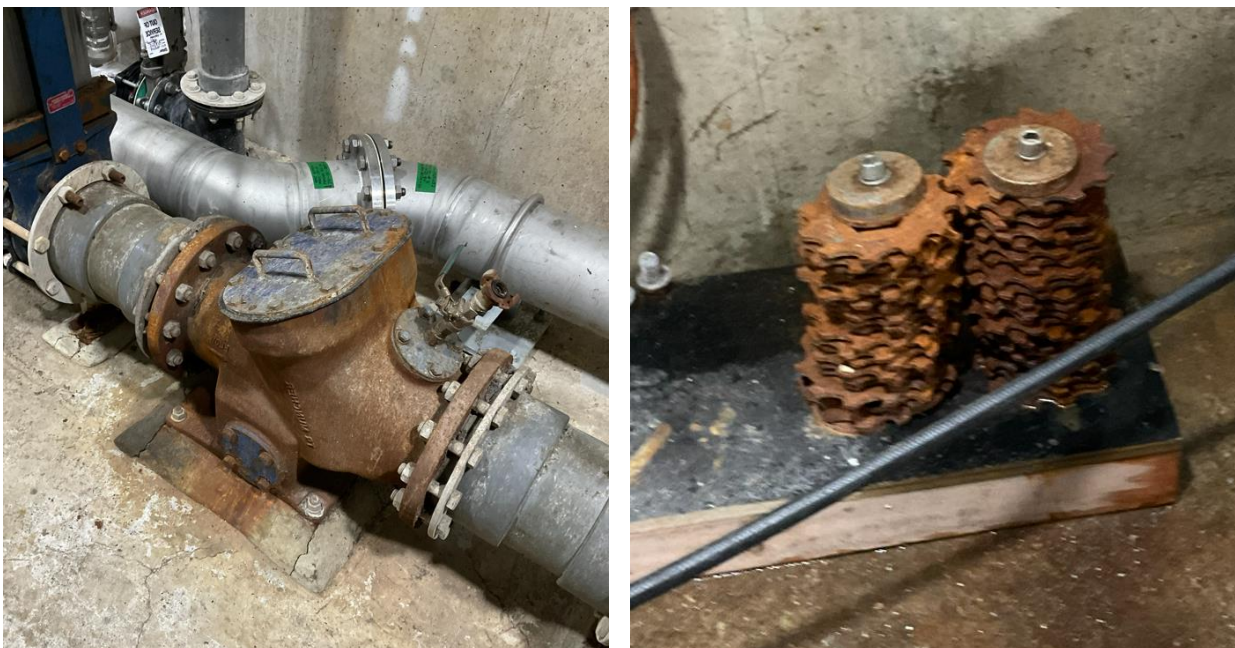
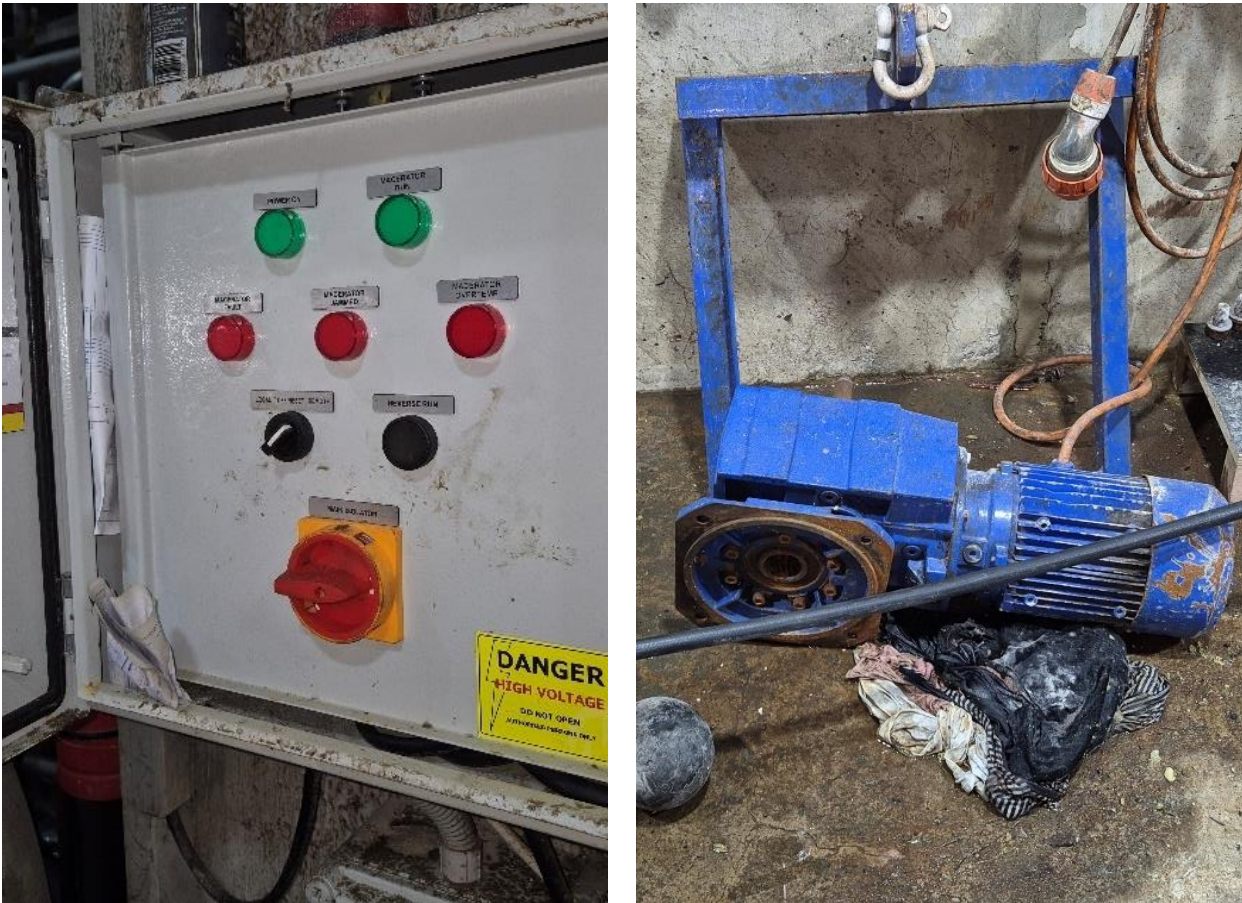
Based on the extent of submergence and visible ingress indicators, the operational condition and continued serviceability of the local control panel, terminal boxes, flexible power connection, and associated equipment cannot be confirmed through visual inspection alone.

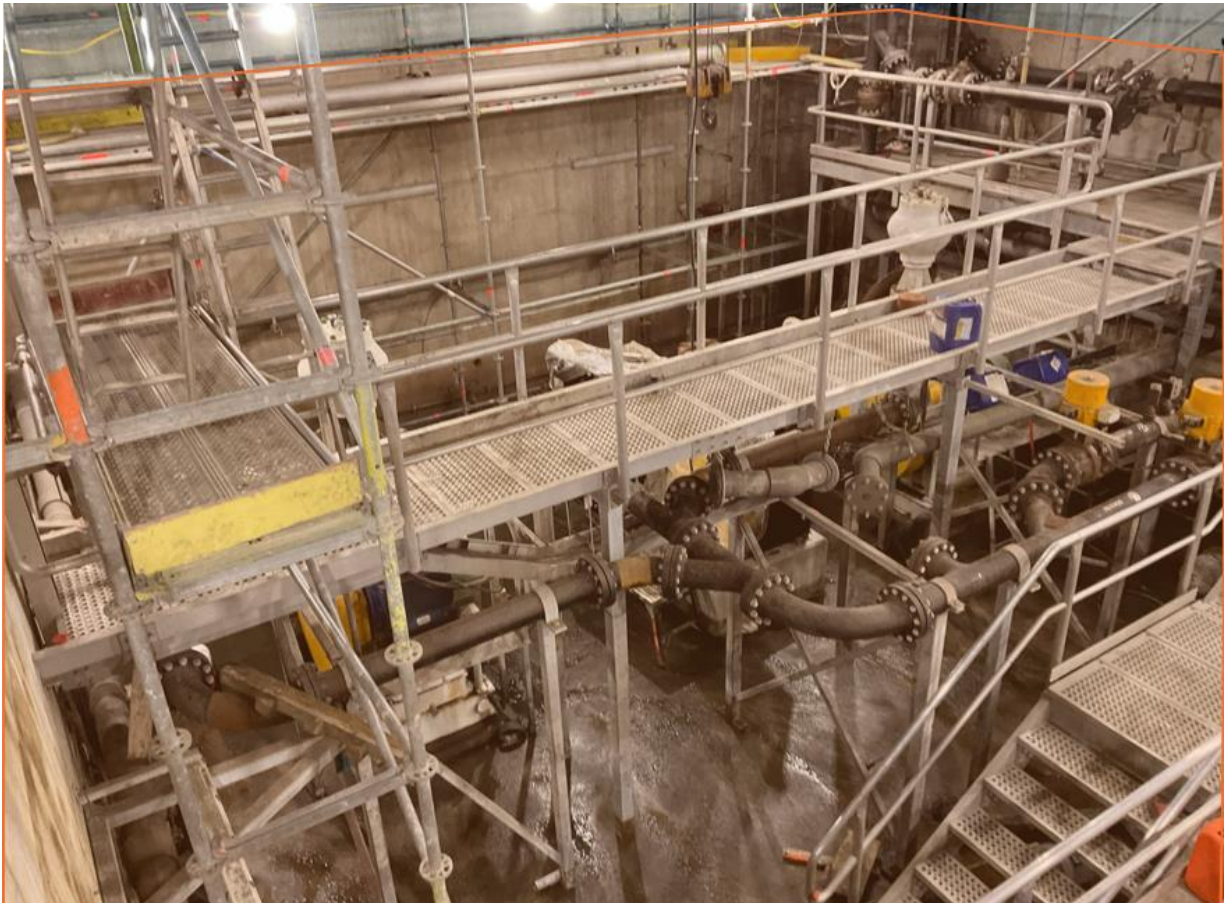
Beca was advised that this location was submerged to a level of 6.0m above floor level. This impact is shown indicatively below in Figure 42.

Figure 42: Sludge Transport Pumps Chamber indication of the approximate level to which assets were submerged

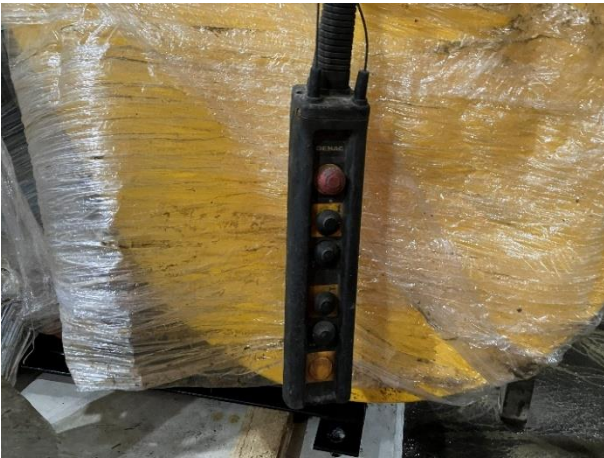
The sludge gallery hoist motor was observed to be installed well above the recorded flood water level and is not considered to have been directly exposed to floodwater. However, the associated remote-control equipment was identified as having been fully submerged during the flooding event.

Figure 43: Sludge gallery hoist remote control

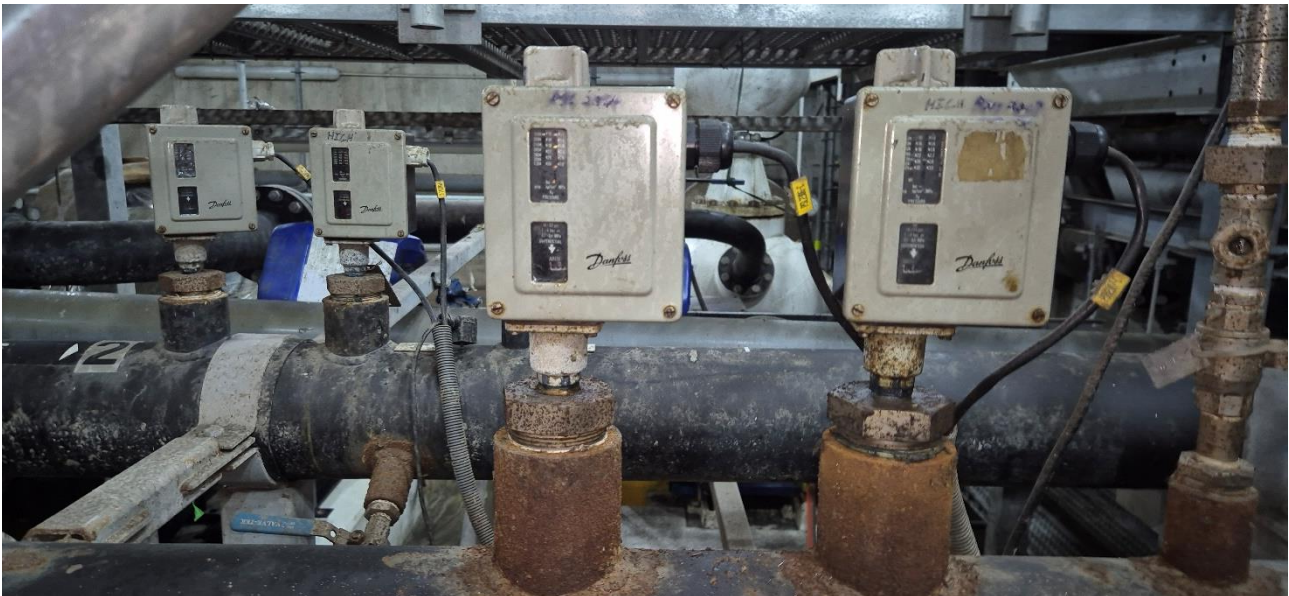
Based on the observed condition, the operational status and continued serviceability of these pressure switches cannot be confirmed through visual inspection alone.

Figure 44: Sludge transport pressure switches and gauges

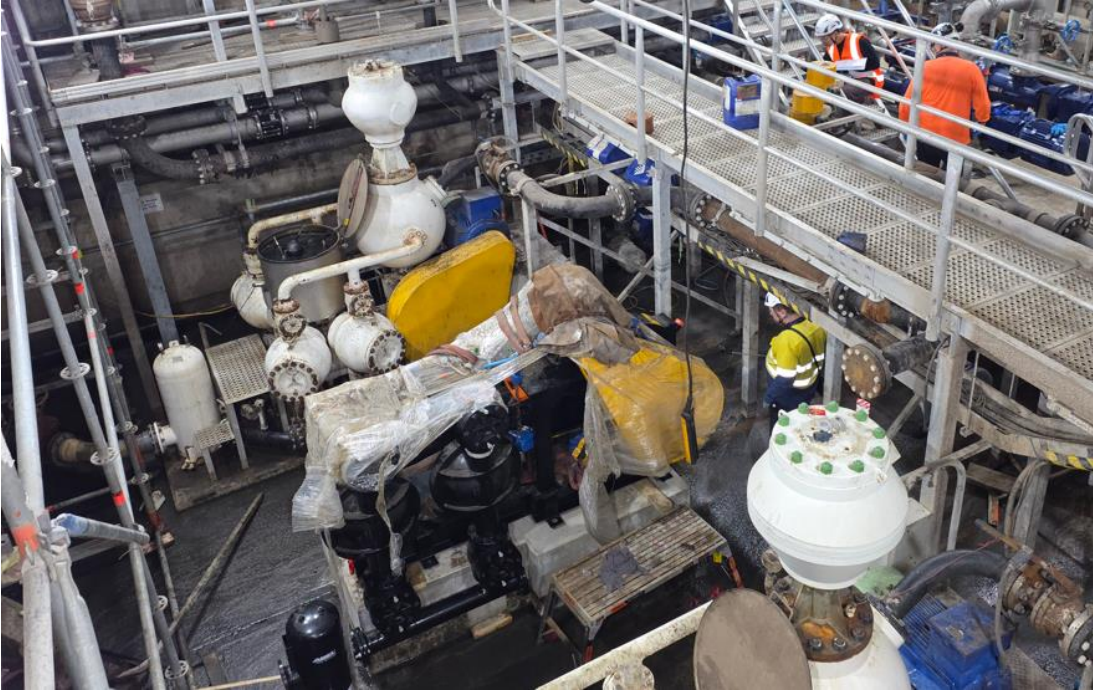
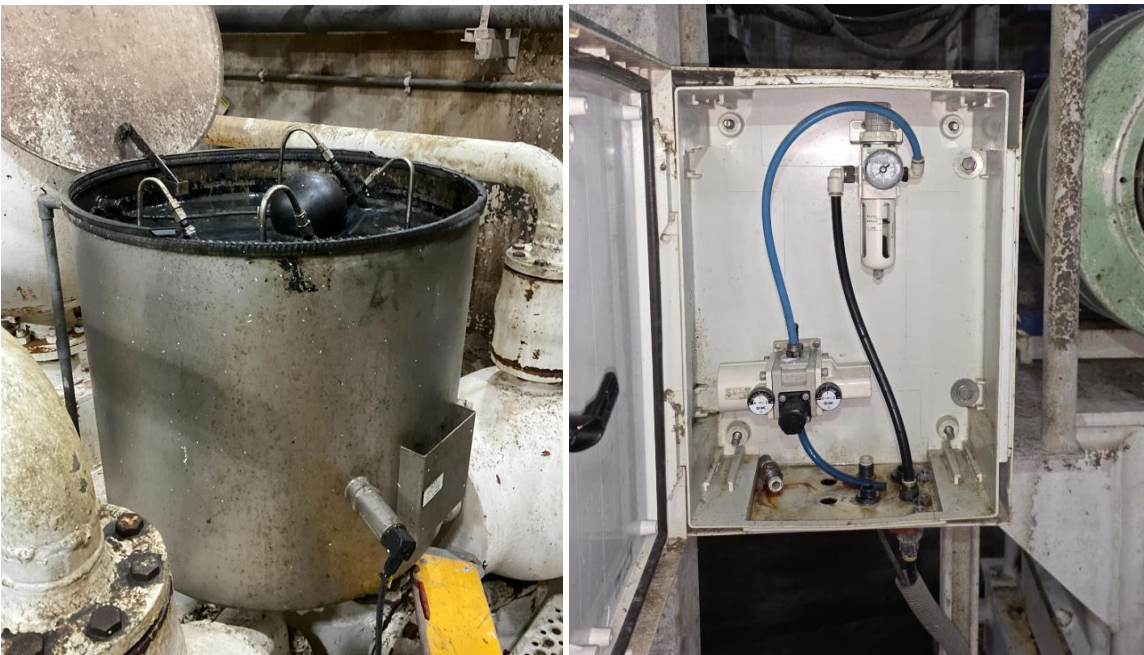
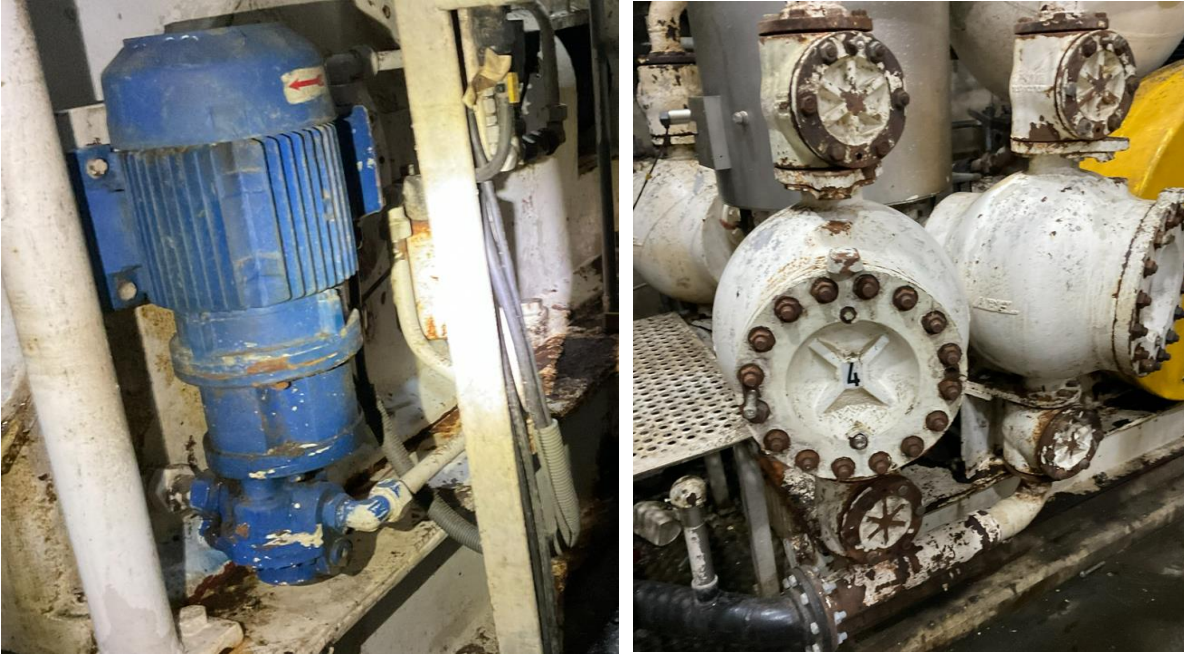
Based on their location within the inundation area, all associated electrical components, including, but not limited to, motors, cabling, instruments, controls, and junction boxes, are considered to have been exposed to floodwater. As a result, the operational condition and continued serviceability of these components cannot be confirmed through visual inspection alone.

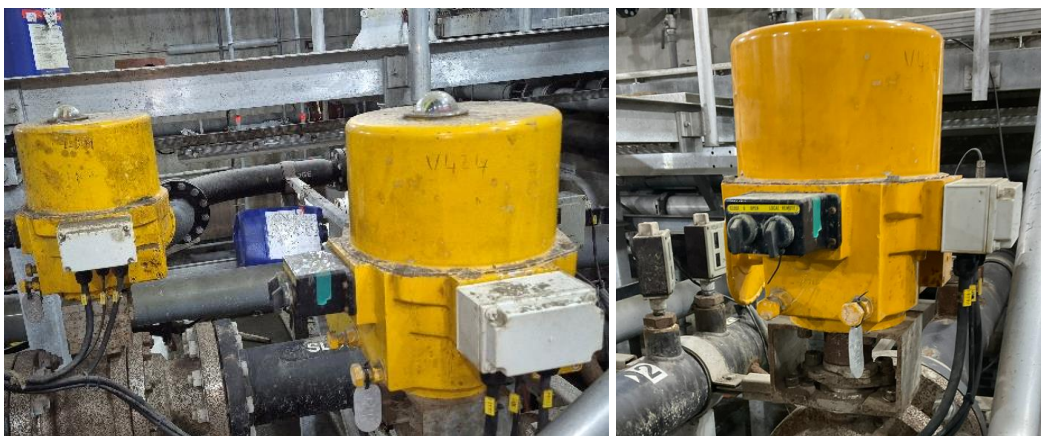
Based on the above observations, the condition and continued serviceability of submerged equipment and associated controls cannot be confirmed through visual inspection alone.

Figure 50: Sludge Pipeline Actuated Valves

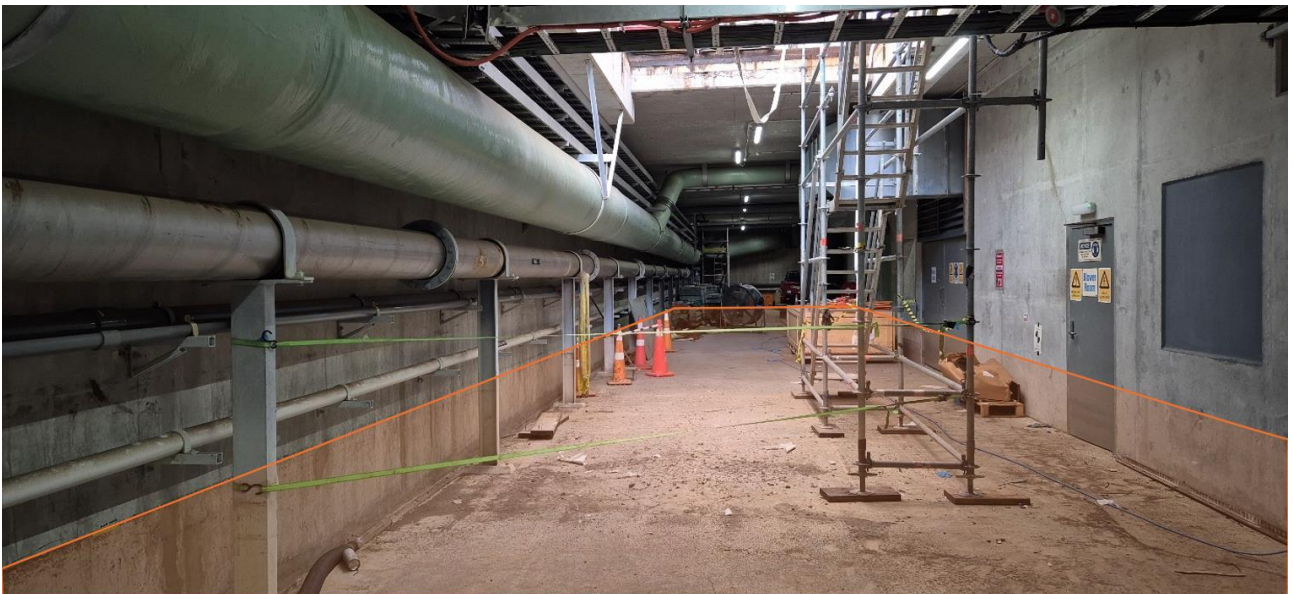
Beca was advised that this location was submerged to a level of 0.65m above floor level. This impact is shown indicatively below in Figure 52.

Figure 52: Service Gallery indication of the approximate level to which assets were submerged

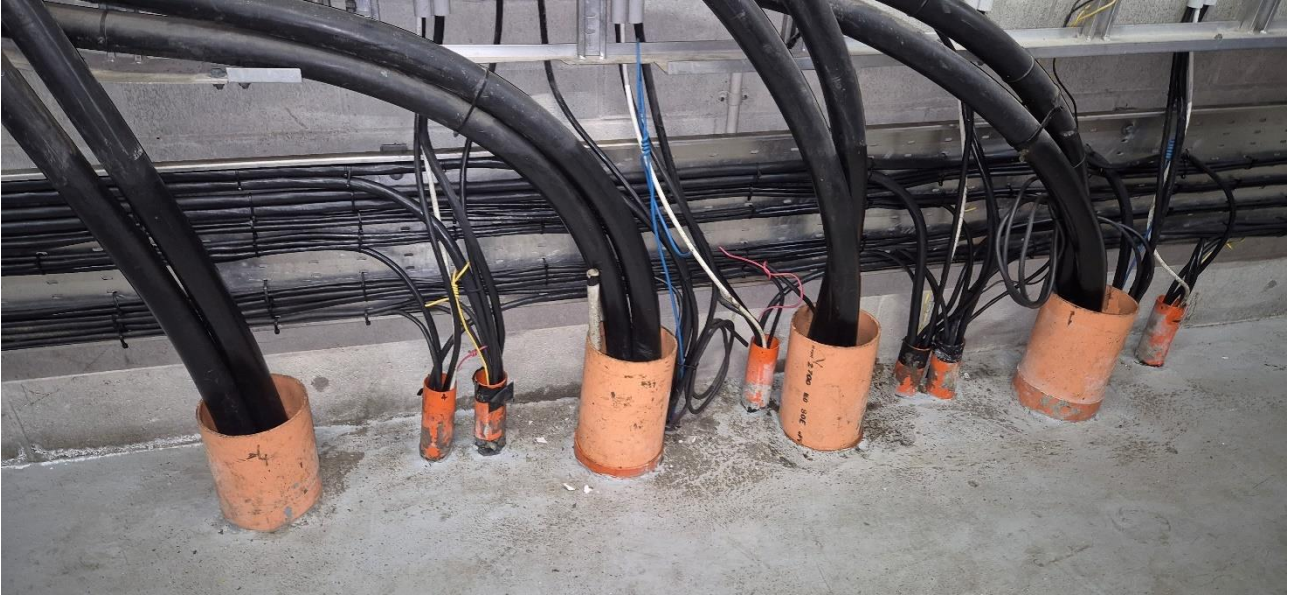
Figure 65: Blower motor cables, power cables and control cables through ducting in floor to individual blowers
