Moa Pt WWTP

Damage Assessment Report – Stage 2

Prepared for s7(2)(a) – Privacy
Prepared by Beca Limited

17 April 2026

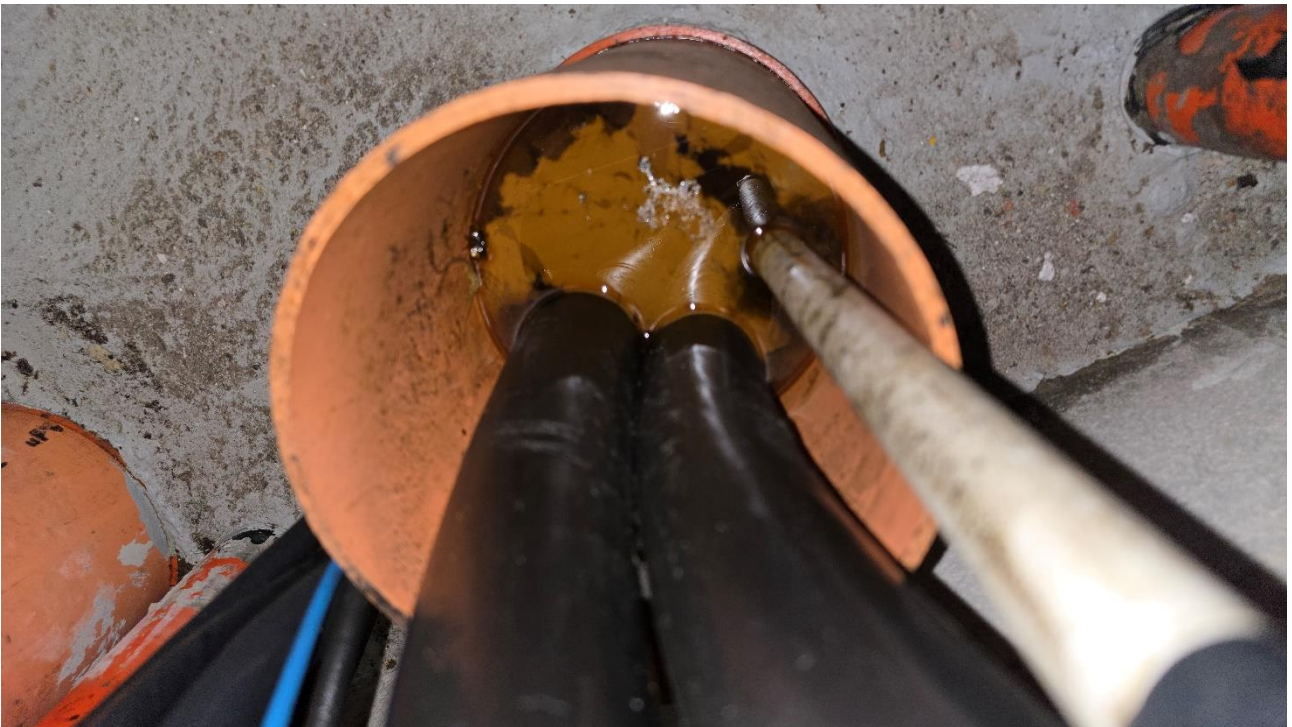
Figure 66: Blower motor cables ducting with liquid still inside.

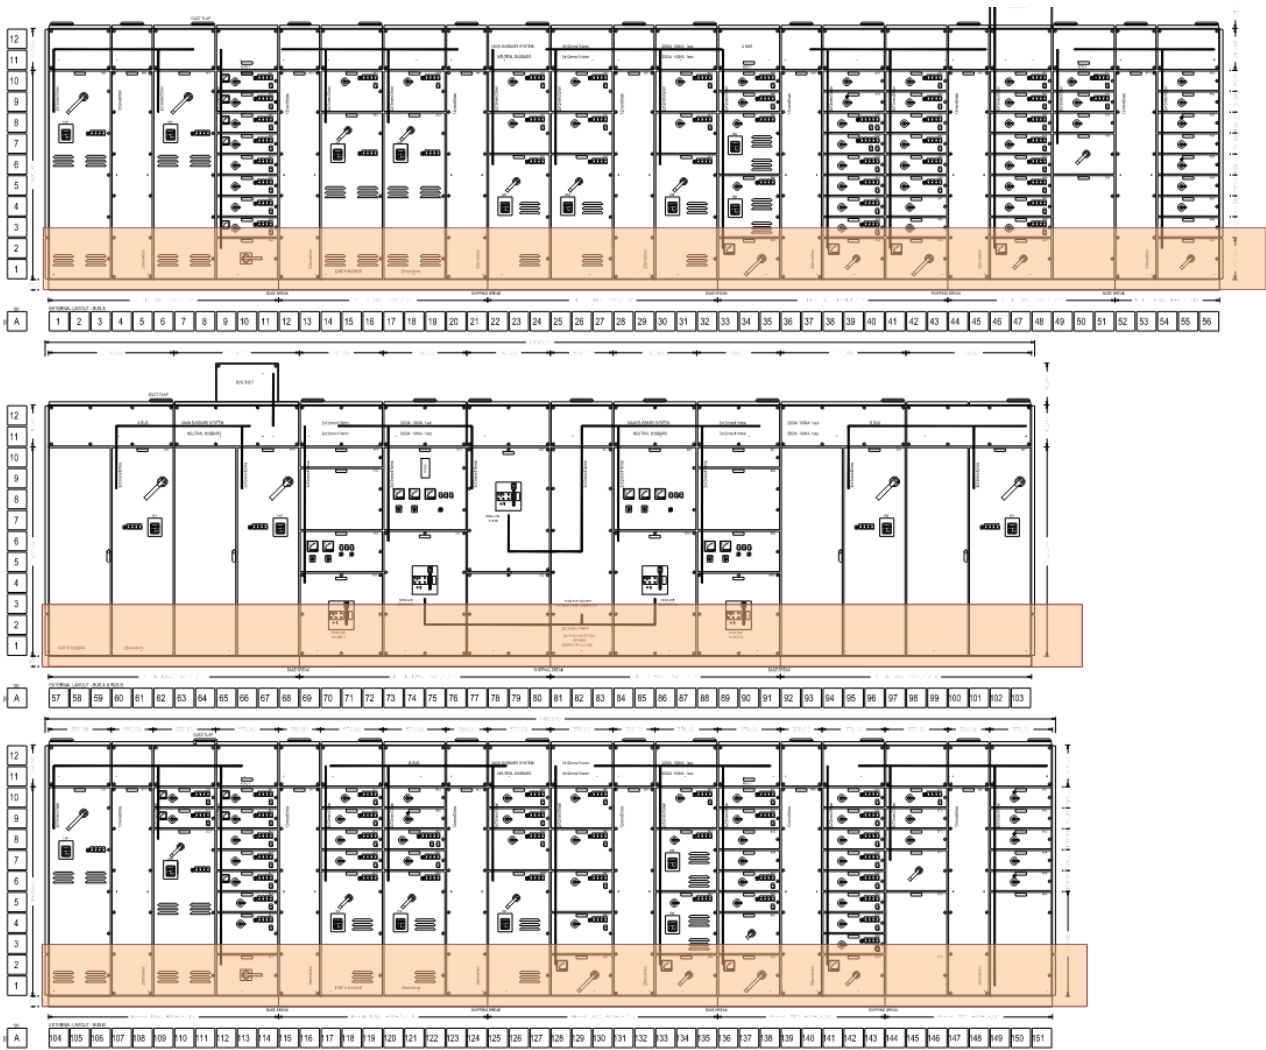
Beca was advised that this location was submerged to a level of 0.55m above floor level. This impact is shown indicatively below in Figure 70.

Figure 70: Indication of the approximate level to which MCCs were submerged

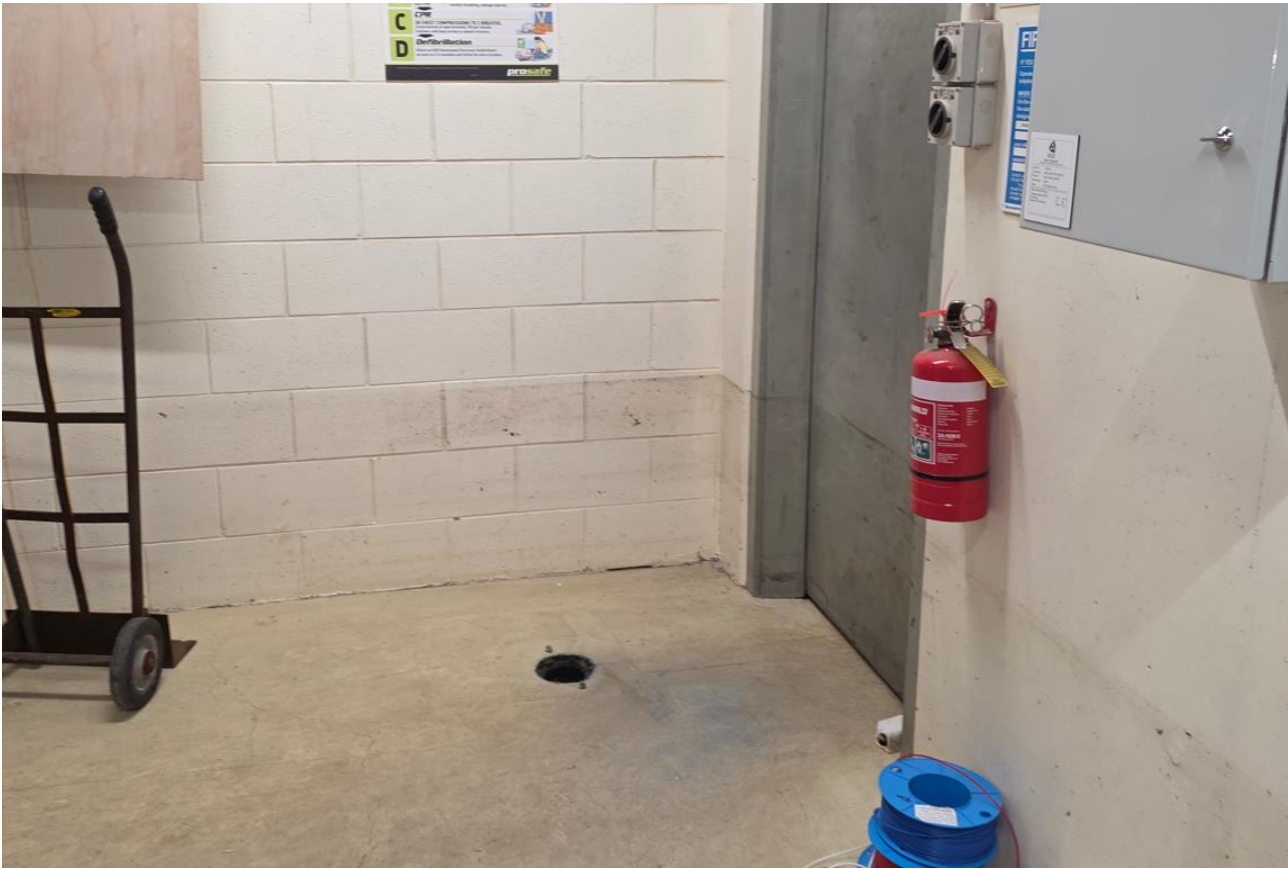
Figure 71: Waterline mark in Switch Room

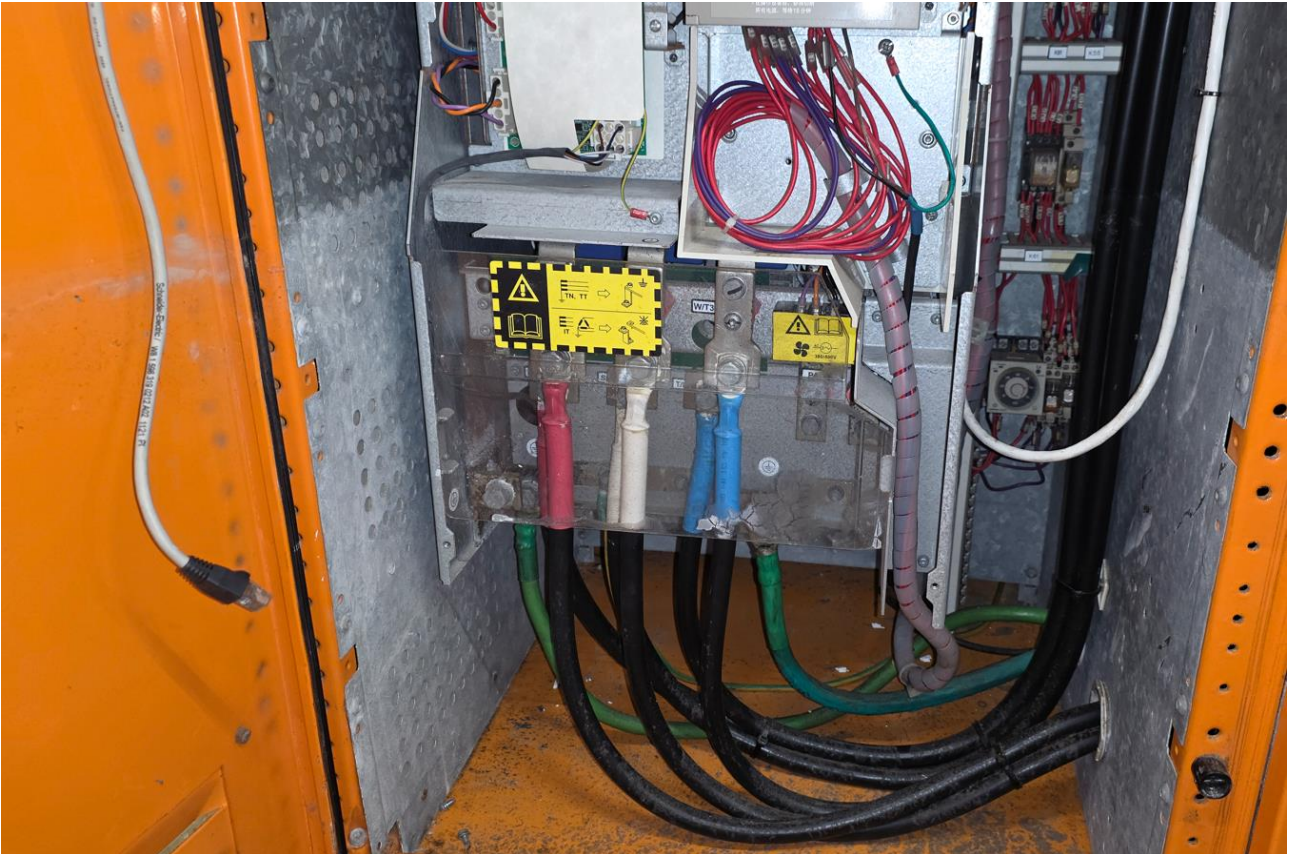
Figure 72: Scrubber Extraction Fan 1 VSD terminals and waterline mark

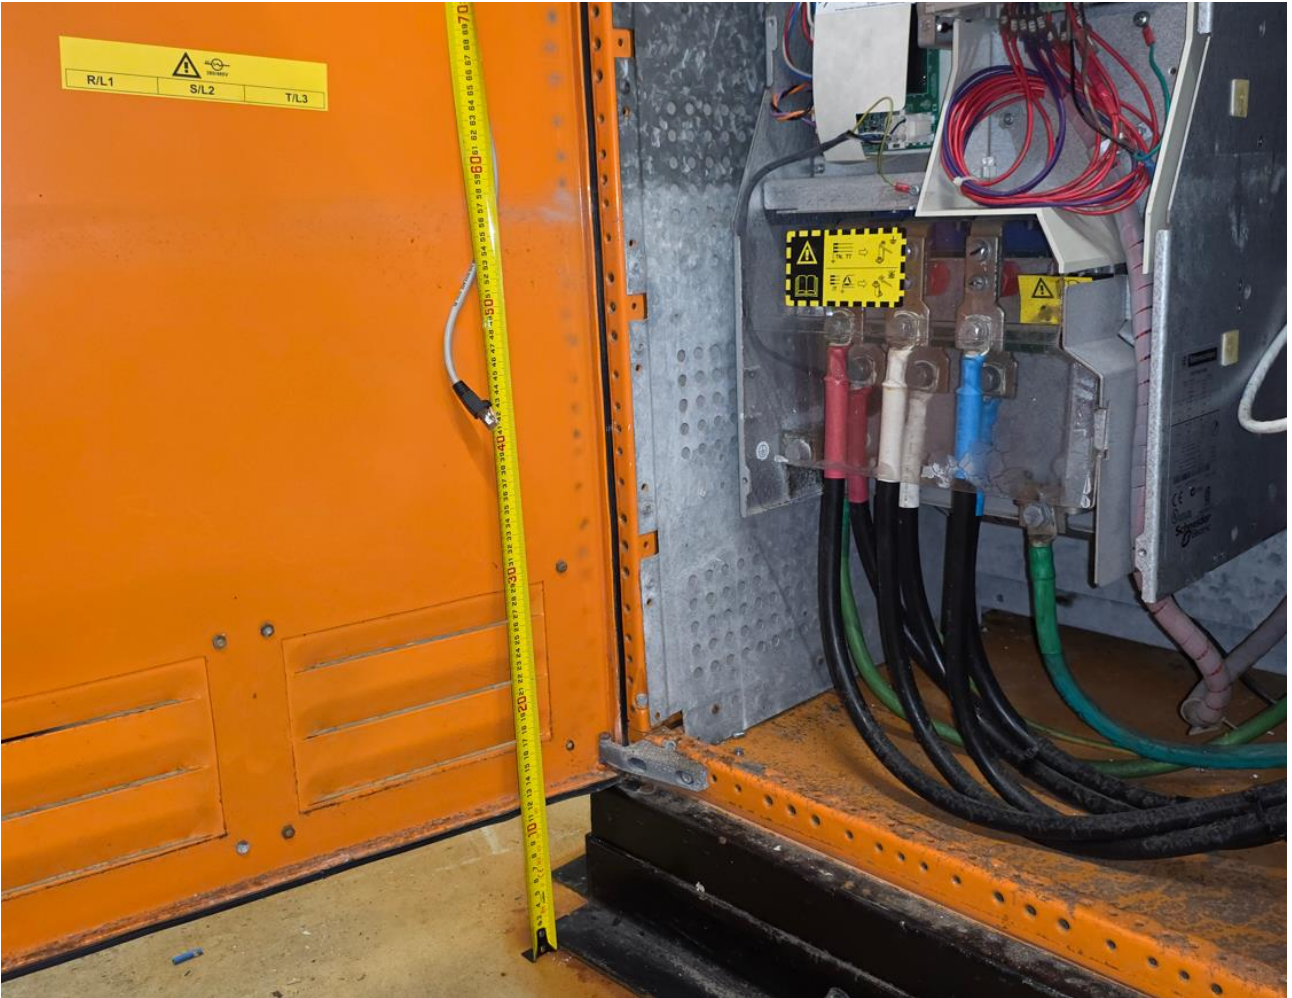
Figure 74: Waterline height and VSD terminals

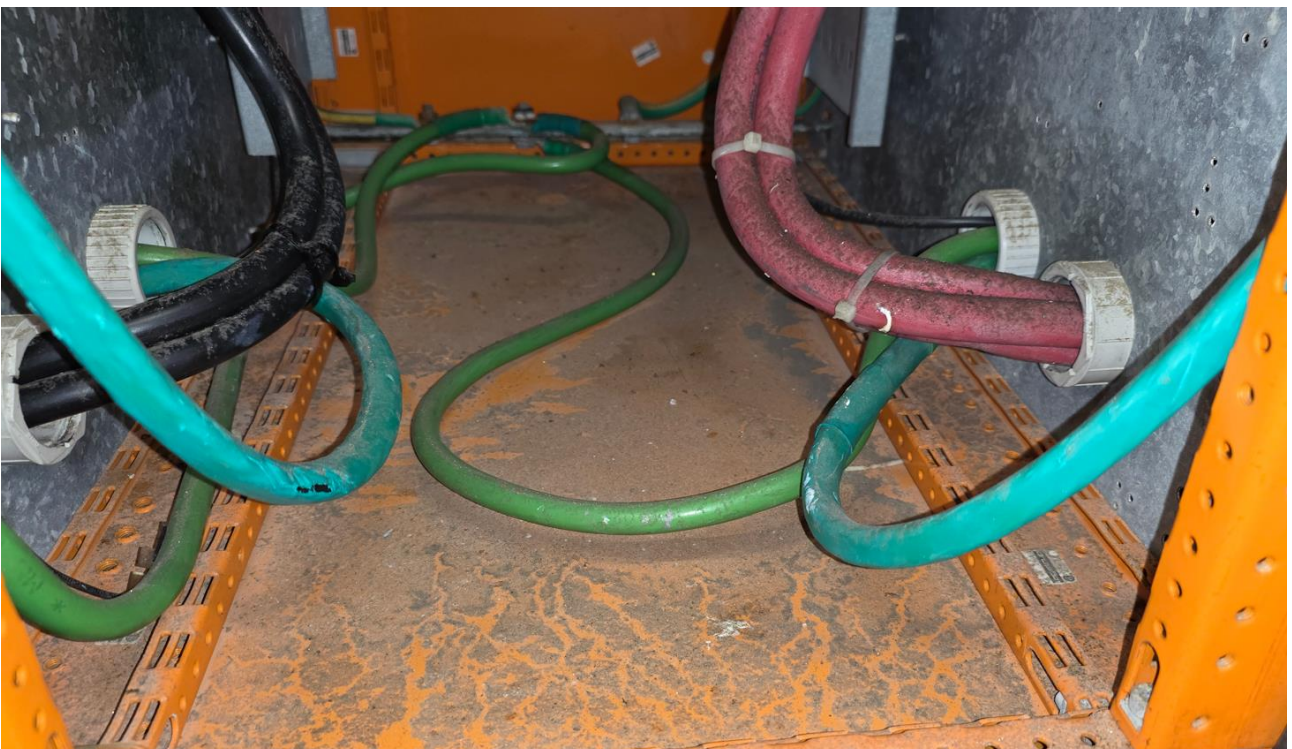
Figure 75: Affected cable showing evidence of submergence in water

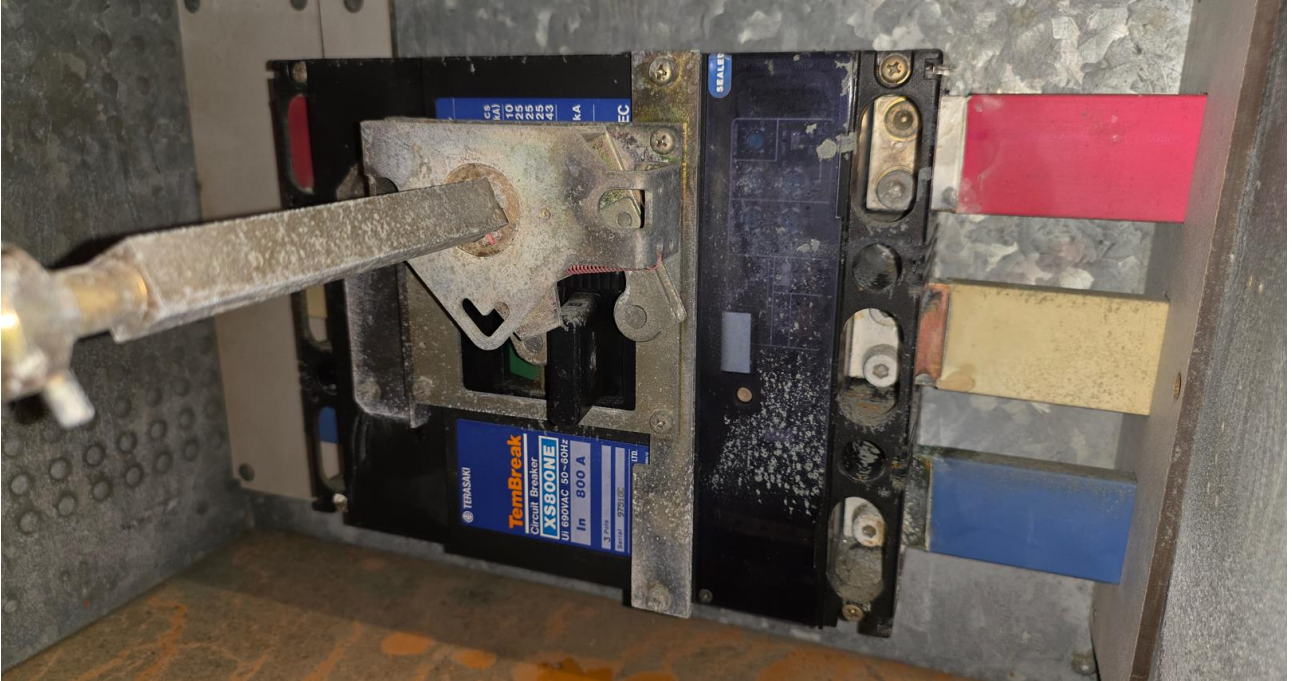
Figure 76: Affected MCC Cells, Isolators

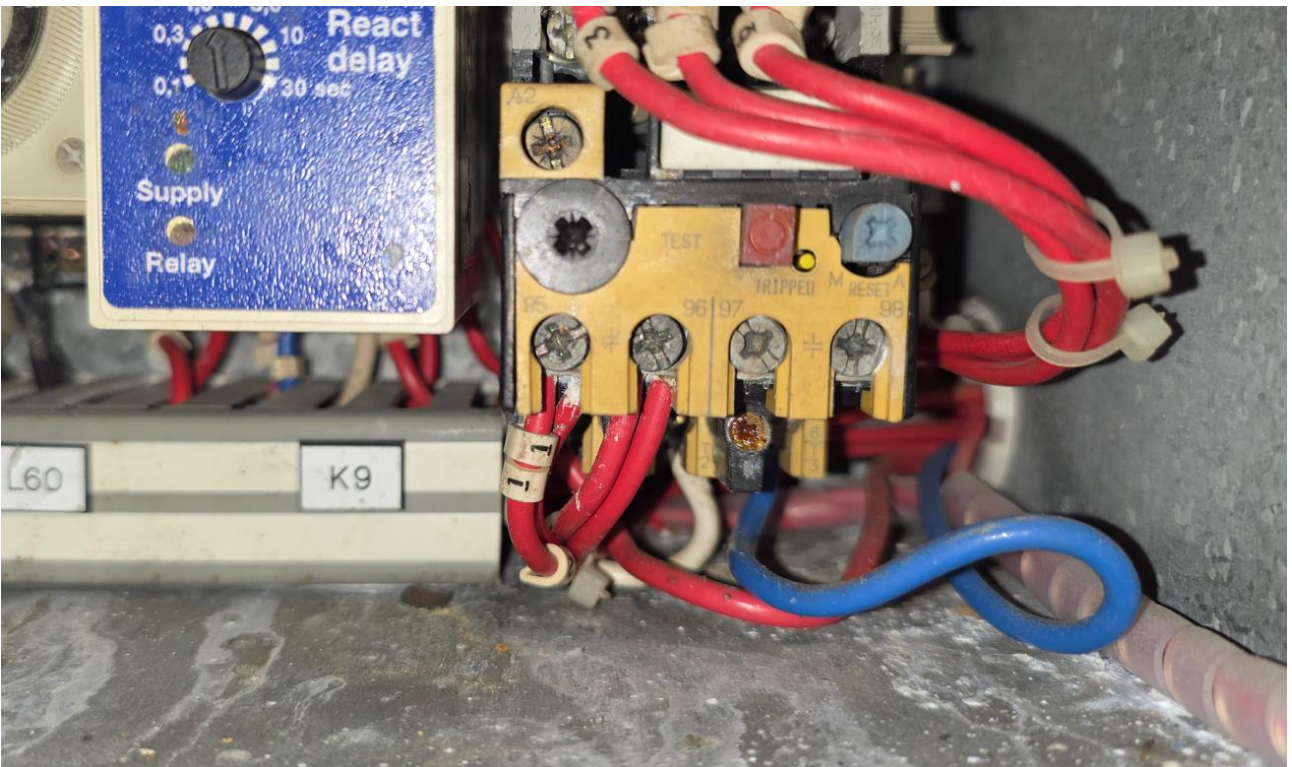
Figure 77: Partial electronics submerged with fresh rust visible

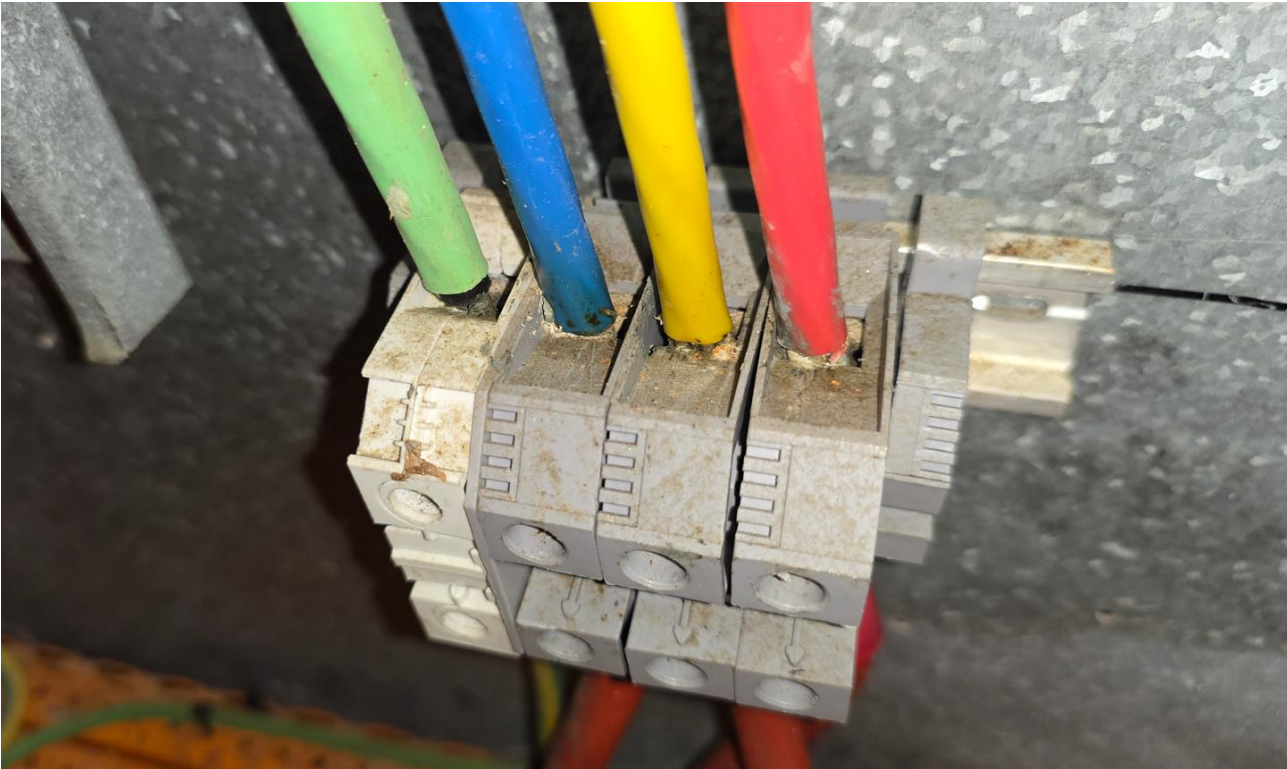
Figure 78: Affected terminals and cables

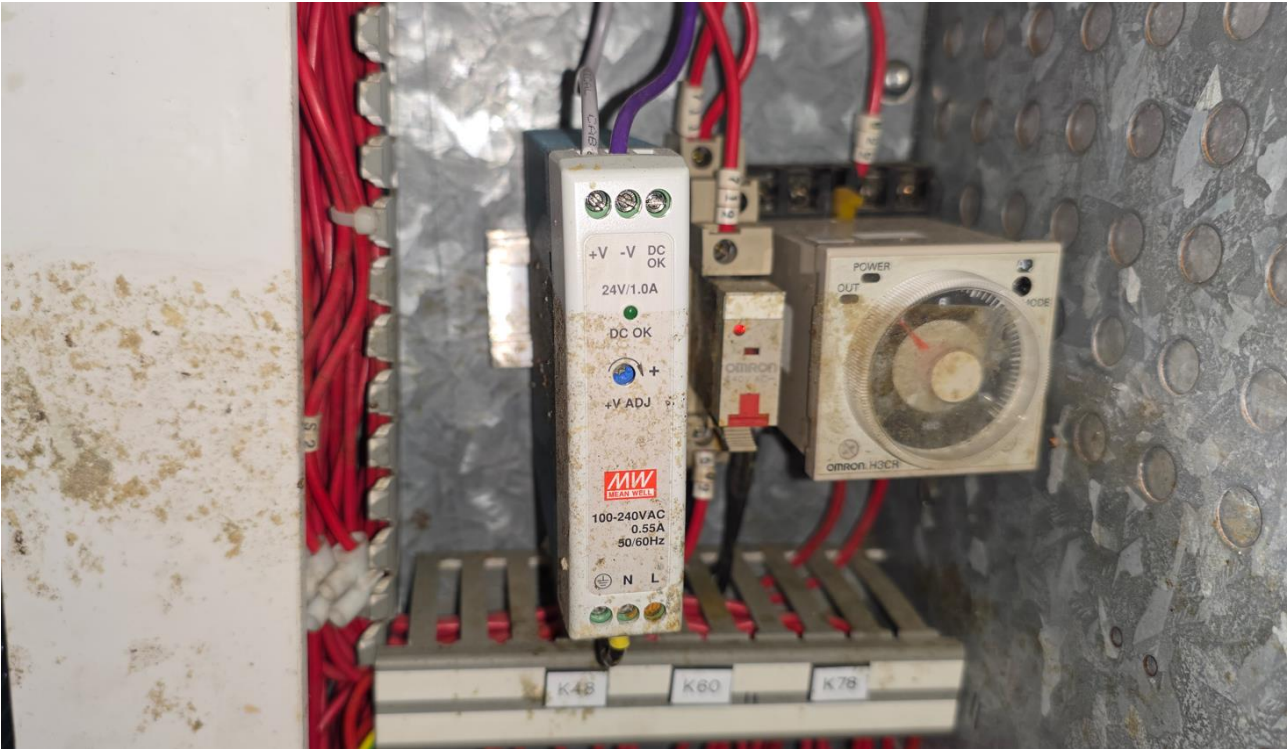
Figure 79: Electronics partially submerged

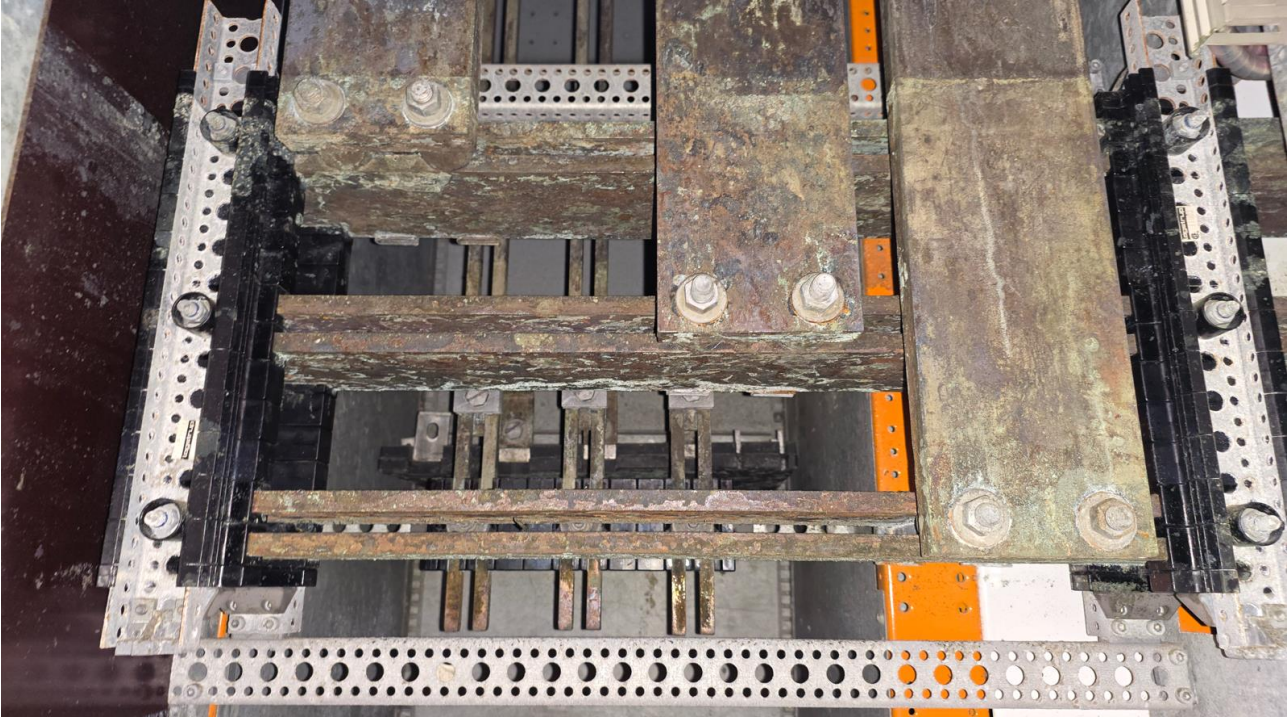
Figure 80: Partially submerged busbars

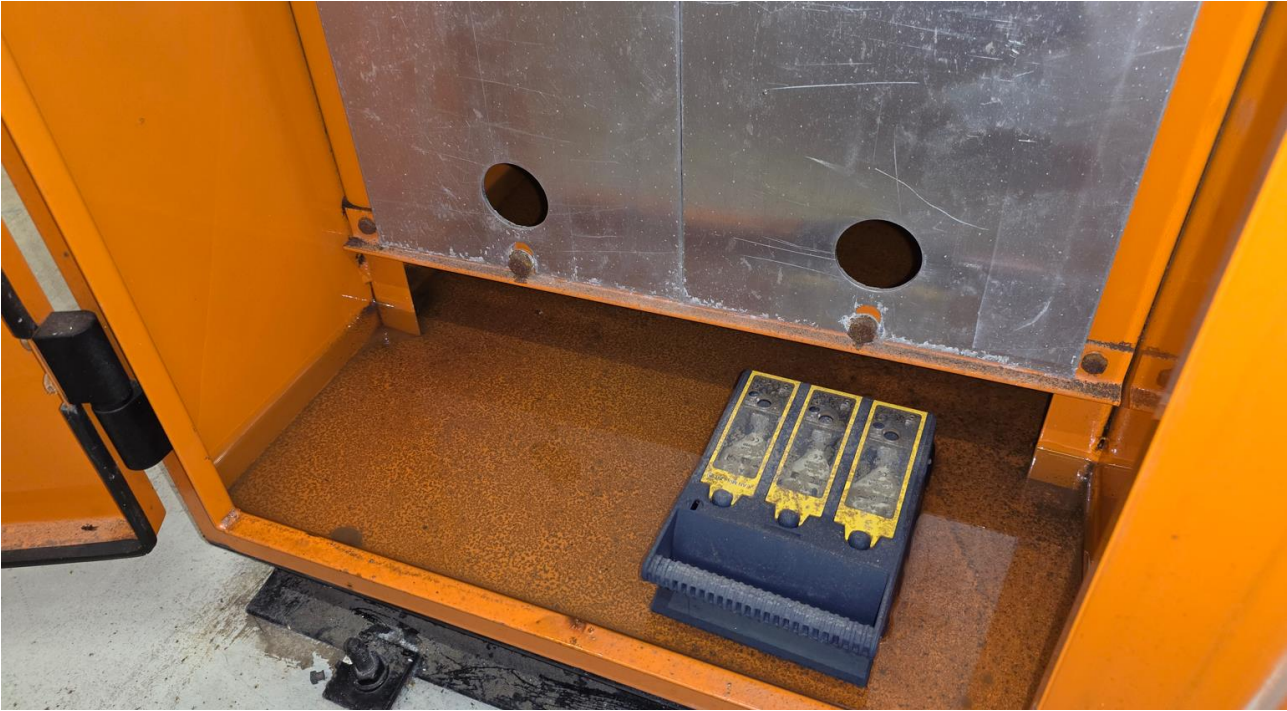
Figure 81: Residual wastewater in Power Factor Correction panels

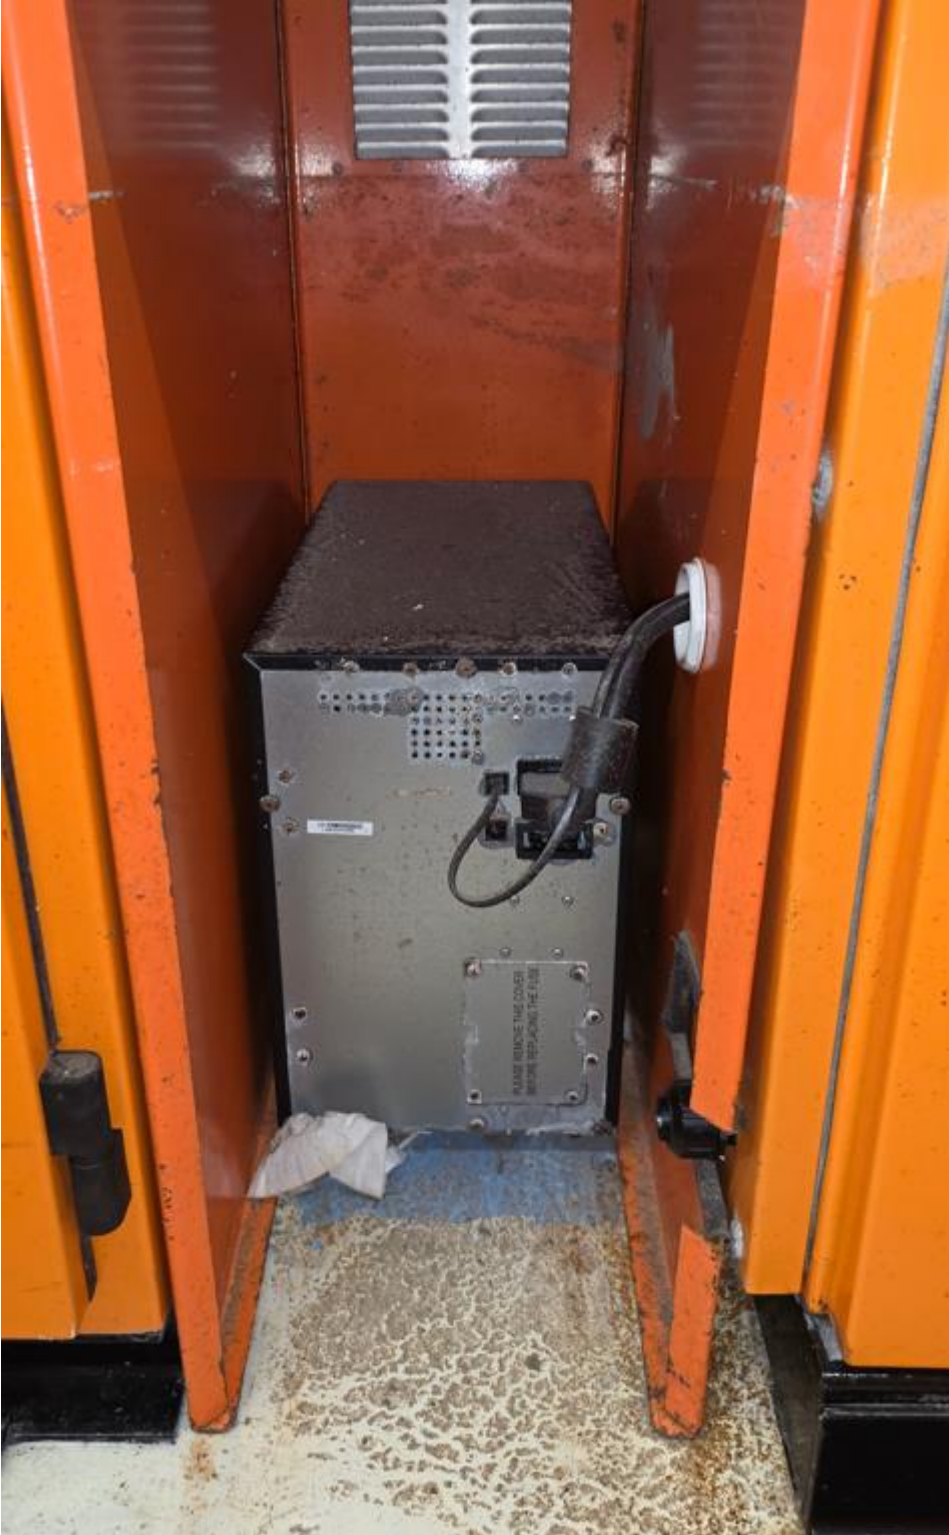
Figure 82: Fully submerged power supply

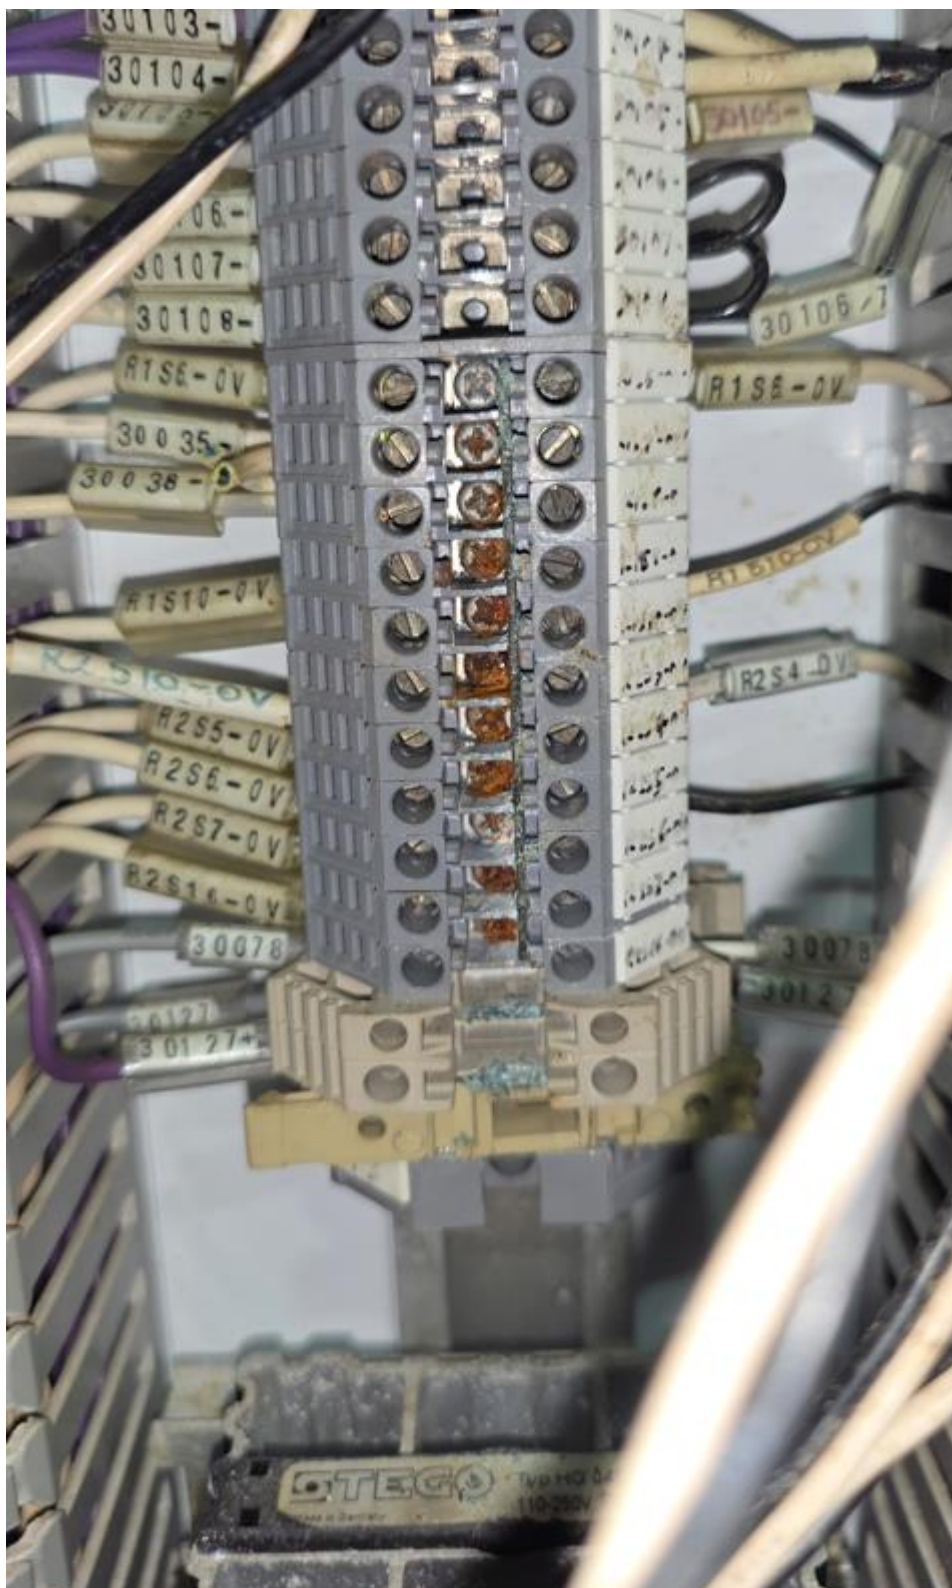
Figure 83: Submerged terminals in PLC panel

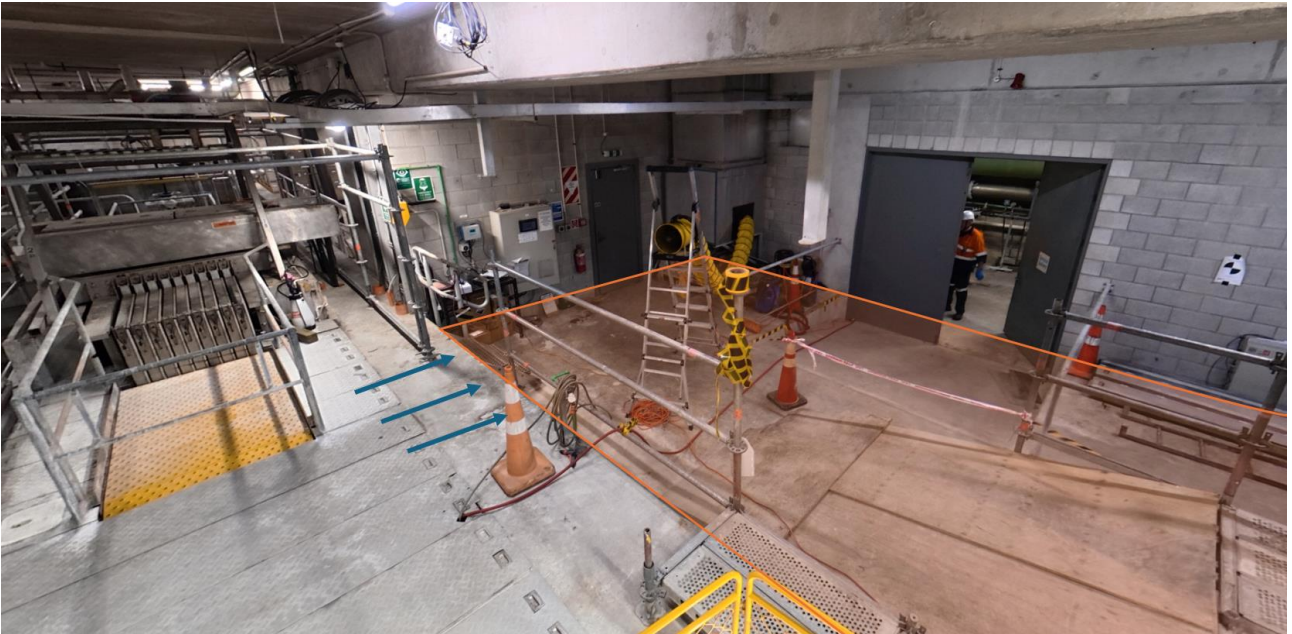
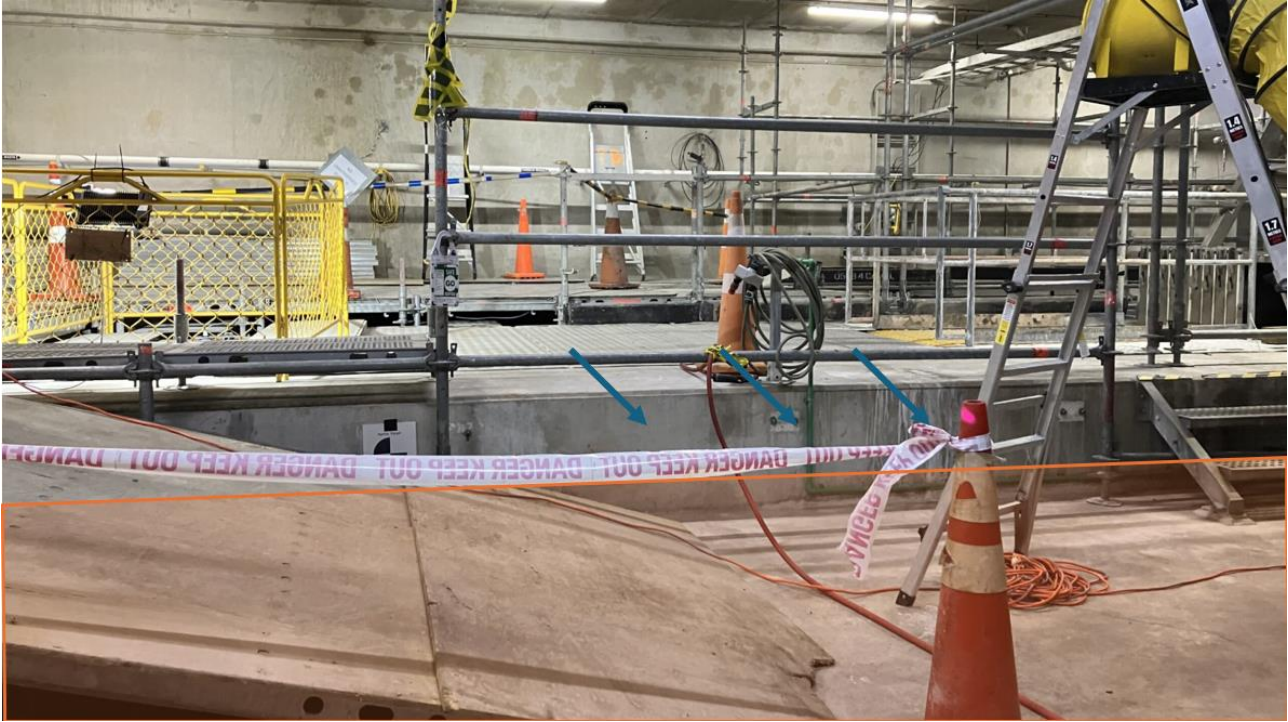
Beca was advised that this location was submerged to a level of 0.6 m above floor level at the doors and with water flow originating from the UV channels. This impact is shown indicatively below in Figure 89 and Figure 90.
