*Waterloo Wellfield*  
*Water Quality Contamination*  
*Investigations*

**August 2017**

This report documents the result of our multiple reviews, technical assessments, analysis of incident reports, and advice from independent experts relating to the changes in water quality within the Waterloo Wellfield.

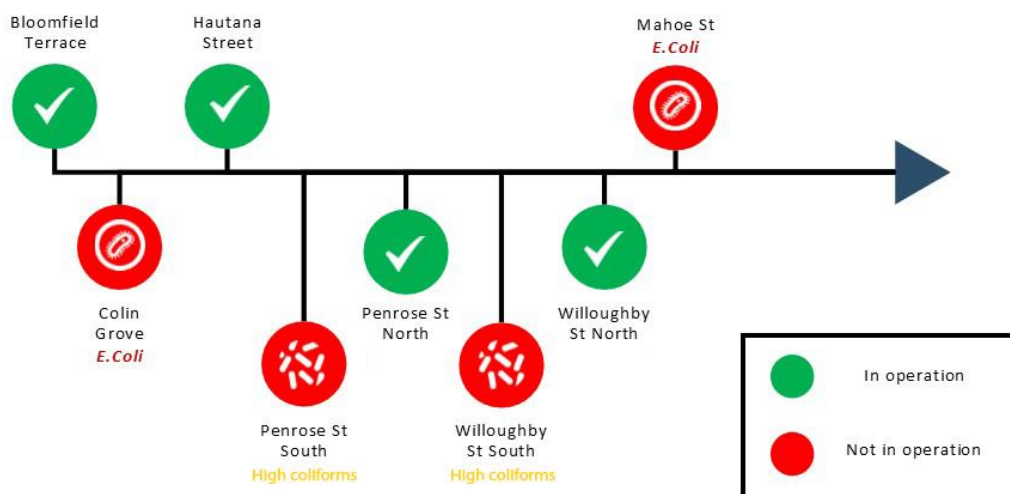
From April 2017, we continued to sample water supplied from the Waterloo Wellfield, with increasing total coliforms at the Willoughby Street South bore being particularly noticeable. As this increasing coliform trend continued during early May 2017, we decided to take this bore offline in late May as a precaution. A similar trend was subsequently detected at Penrose Street South bore, and we also took this bore offline in mid-June 2017. We have also detected positive total coliform results from the Buick Street water fountain in Petone, which draws water directly from the Waiwhetu Aquifer. **Figure 5** below sets out the current operational status of Waterloo Wellfield bores.

**Figure 5** Current operational status of the Waterloo Wellfield Bores (as at July 2017)

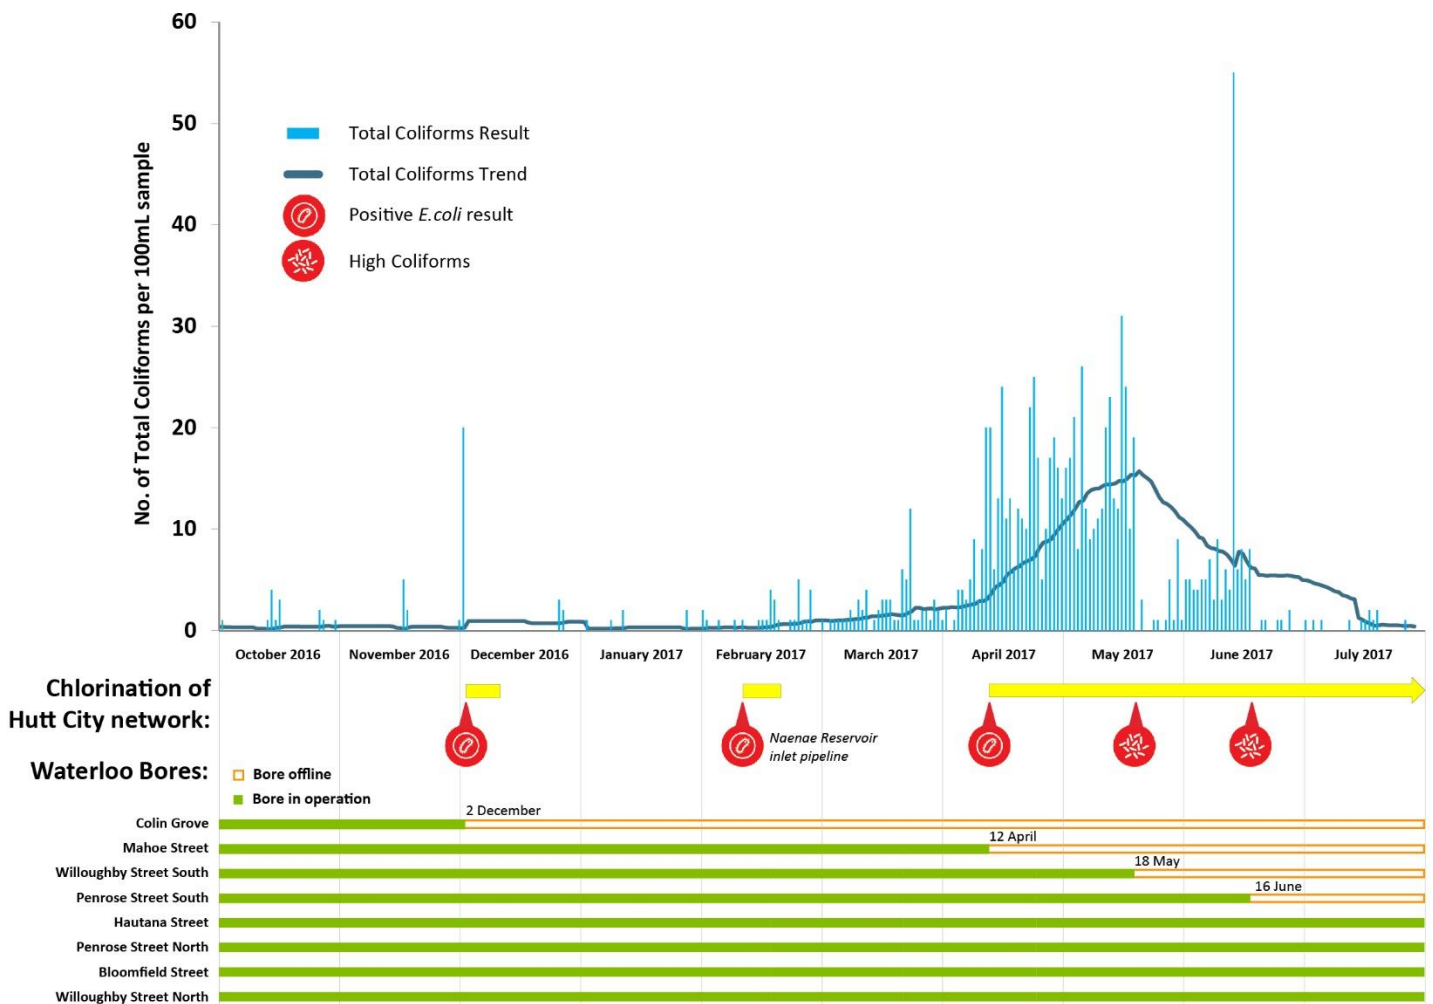
As noted previously, since Colin Grove bore *E. coli* test result on 1 December 2016, we have recorded two further positive *E. coli* results from the water drawn from the Waiwhetu Aquifer. As set out in **Figure 6**, total coliforms in this water have also been increasing since October 2016. The upward trend has been particularly noticeable since February 2017, and is continuing despite progressively taking four of the eight bores in the Waterloo Wellfield offline due to either positive *E. coli* test results or high total coliform test results.

**Figure 6** *E. coli* and total coliform recordings – October 2016 to July 2017

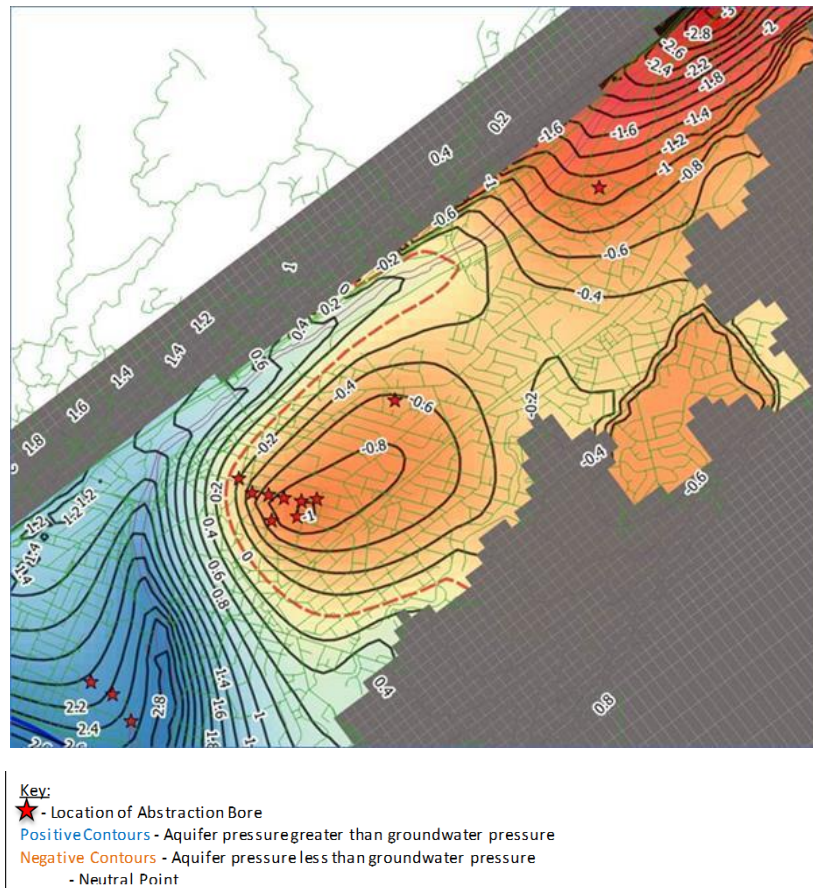
Further study of the zone of influence<sup>25</sup> for the localised drawdown effects was recommended by PDP and Earth in Mind. We subsequently undertook hydraulic modelling, which indicated that the downward hydraulic gradient is larger than first thought and potentially extends well beyond the Waterloo Wellfield. **Figure 7** sets out an indicative plan to help explain the potential extent of the negative vertical hydraulic gradients caused by pumping at the Waterloo Wellfield further.

**Figure 7 Potential extent of negative hydraulic gradients in Lower Hutt (north is up)**

Both PDP and Earth in Mind also recommended that we consider installing pressure gauges and multi-level hydrostatic monitoring wells to further aid with the understanding of downward hydraulic gradients when the bores are pumping. It is noted that GWRC is installing multi-level monitoring wells at locations around the Waterloo Wellfield as part of the second stage of its Waiwhetu Aquifer Science Study. These wells will include equipment to measure the vertical hydraulic gradients as well as being capable of taking water quality samples from different depths. Following completion of the study, and if considered necessary, we will install pressure gauges.

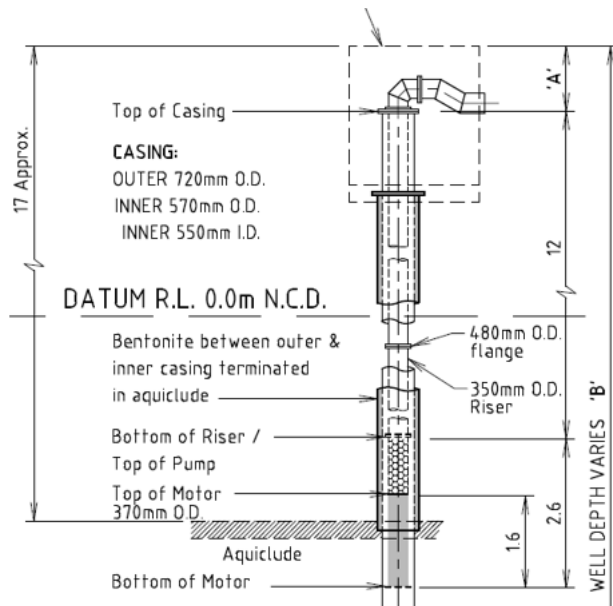
**Figure 8 Bentonite location in the well casings (Extract of 1980 well design from drawing A3-10161-BS)**

The outer casing of the well terminates at the aquitard, with a smaller well and associated casing drilled through the aquitard and into the Waiwhetu Aquifer. The void between the two casings is then filled with bentonite in order to prevent water tracking between the two well casings, and to plug any fissures that may develop between the aquitard and the casing of the well.

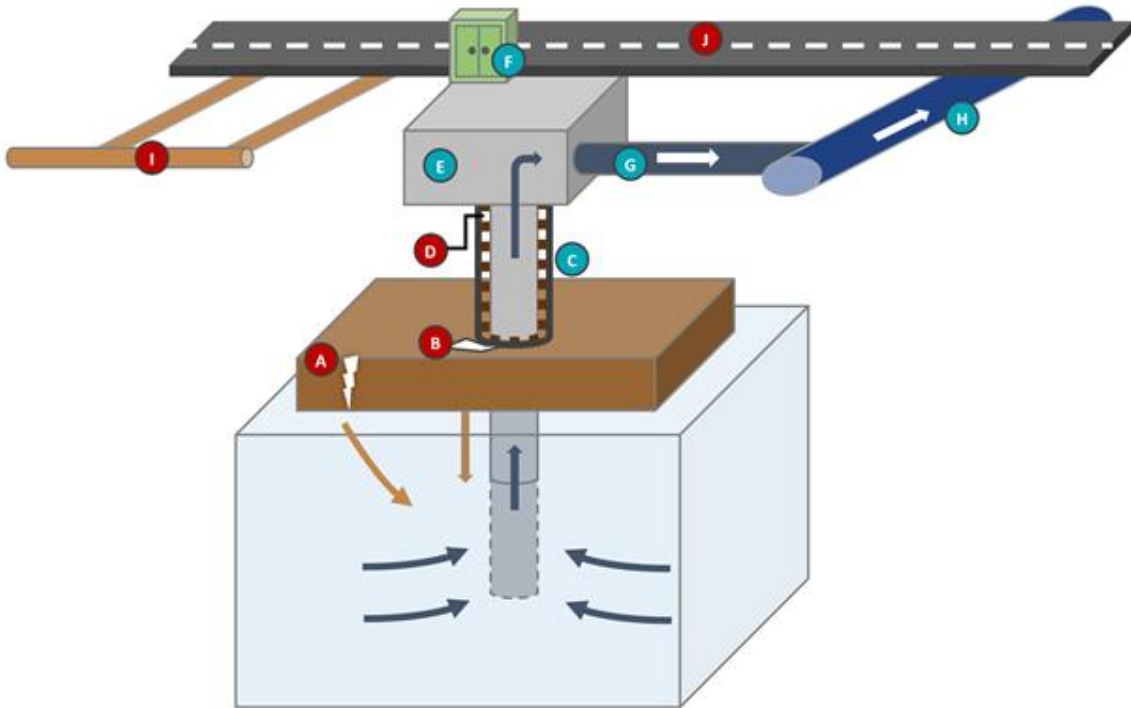
**Figure 9** and **Table 2** summarise the possible sources of contamination risk from a bore perspective. The most likely sources of contamination are as follows:

- The possible existence of discrete pathways for water to travel into the aquitard
- The possible existence of discrete pathways in the aquitard near the well casing
- The bentonite in the well casing is not flowing efficiently and filling voids
- Buried services leaking contamination into groundwater
- The above ground urban environment is affecting the performance of the well equipment.

**Figure 9** Location of possible wellhead contamination risks
