Moa Point Wastewater Treatment Plant

Annual Resource Consents Report 2020/2021

Document Title: Moa Point Wastewater Treatment Plant Annual Resource Consents
2020/2021

Document generated on: 22nd February 2021
Document title: Moa Point Wastewater Ocean Outfall Pipeline & Seabed Annual Inspection
Document no.: UCL – 2021.02 – WWPT Outfall Pipeline – IR001
Document release: Released for Client review and comment – 12th March 2021

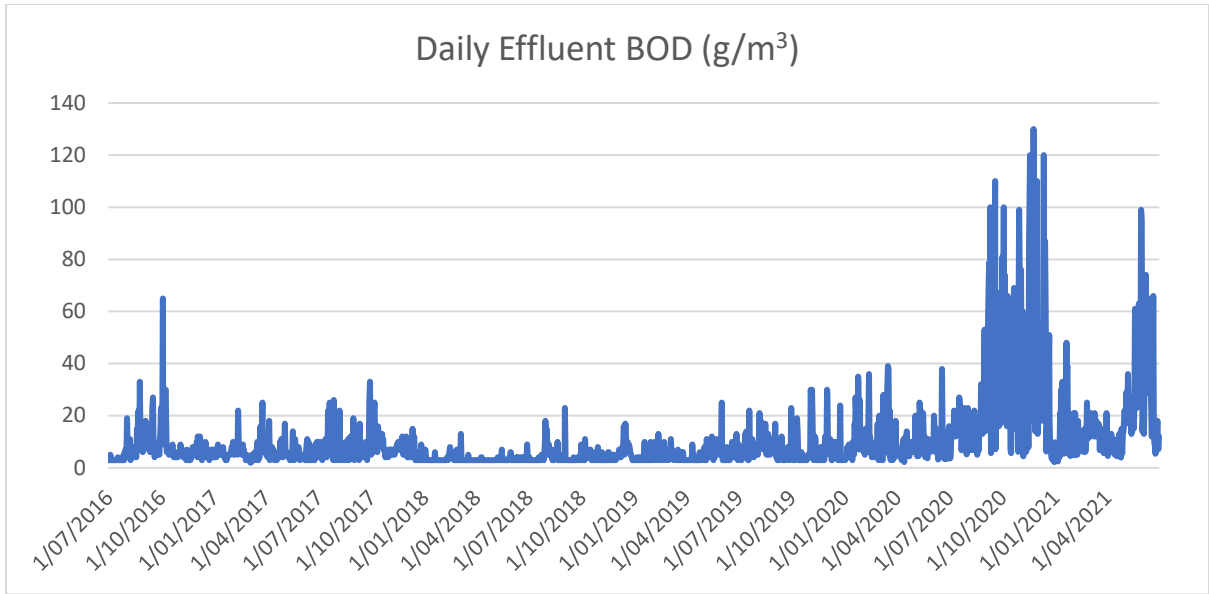
Figure 6: Daily Effluent cBOD₅ Results

In figure 6, it can be noted that the daily effluent BOD₅ had an increase in daily values since August to December 2020 which was due to mechanical issues in the clarifiers. One of the clarifiers was repaired in 23rd December which dramatically improved the plant's effluent quality. In May 2021, the plant's effluent quality started to deteriorate again. Veolia's investigation report stated that the failures in the clarifiers and mechanical failures in the sludge dewatering plant have caused the issue.

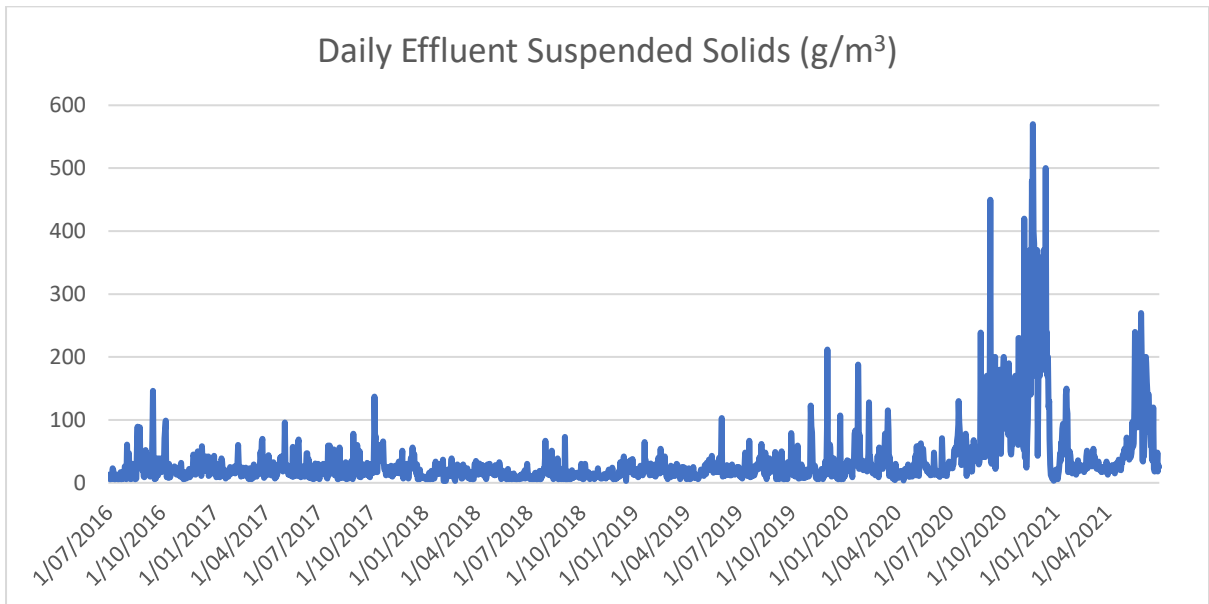
Figure 7: Daily Effluent Suspended Solids Results

In figure 7, it can be noted that the daily effluent suspended solids had an increase in daily values since August to December 2020 which is due to mechanical issues in the clarifiers. One of the clarifiers was repaired in 23rd December which dramatically improved the plant’s effluent quality. In May 2021, the plant’s effluent quality started to deteriorate again. Veolia’s investigation report stated that the failures in the clarifiers and mechanical failures in the sludge dewatering plant have caused the issue.

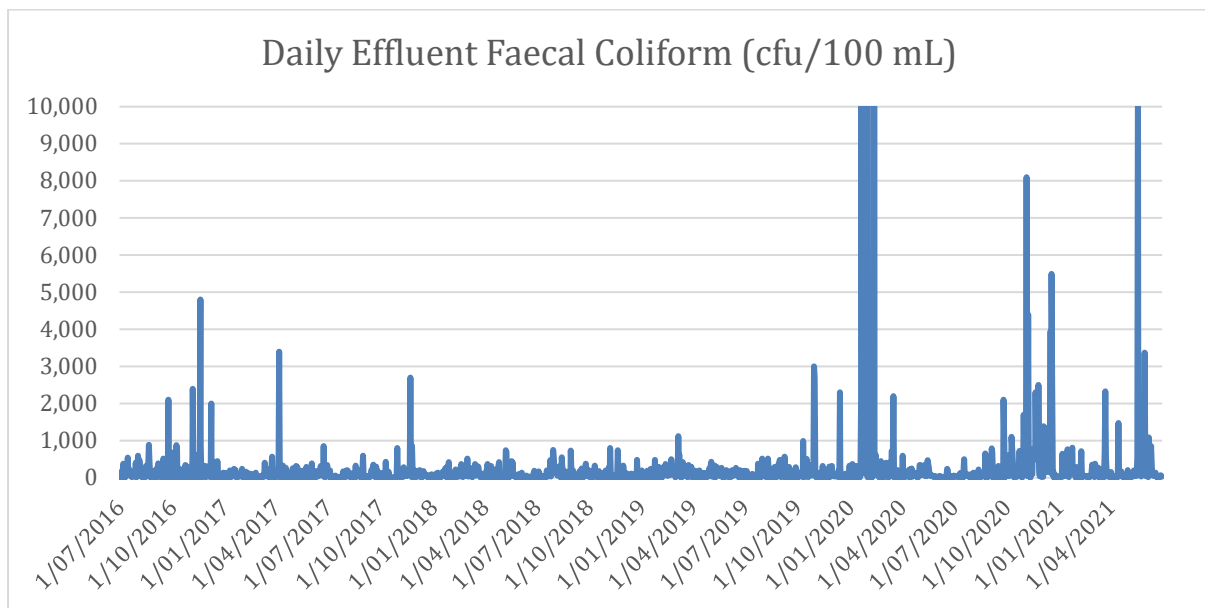
Figure 8: Daily Effluent Faecal Coliform Results

In figure 8, it can be noted that the daily effluent faecal coliforms had spikes in January and February 2020 due to sludge pipeline failure. It then experienced an increase in daily values since August to December 2020 which is due to mechanical issues in the clarifiers. One of the clarifiers was repaired in 23rd December which dramatically improved the plant's effluent quality. In May 2021, the plant's effluent quality started to deteriorate again. Veolia's investigation report stated that the failures in the clarifiers and mechanical failures in the sludge dewatering plant have caused the issue.

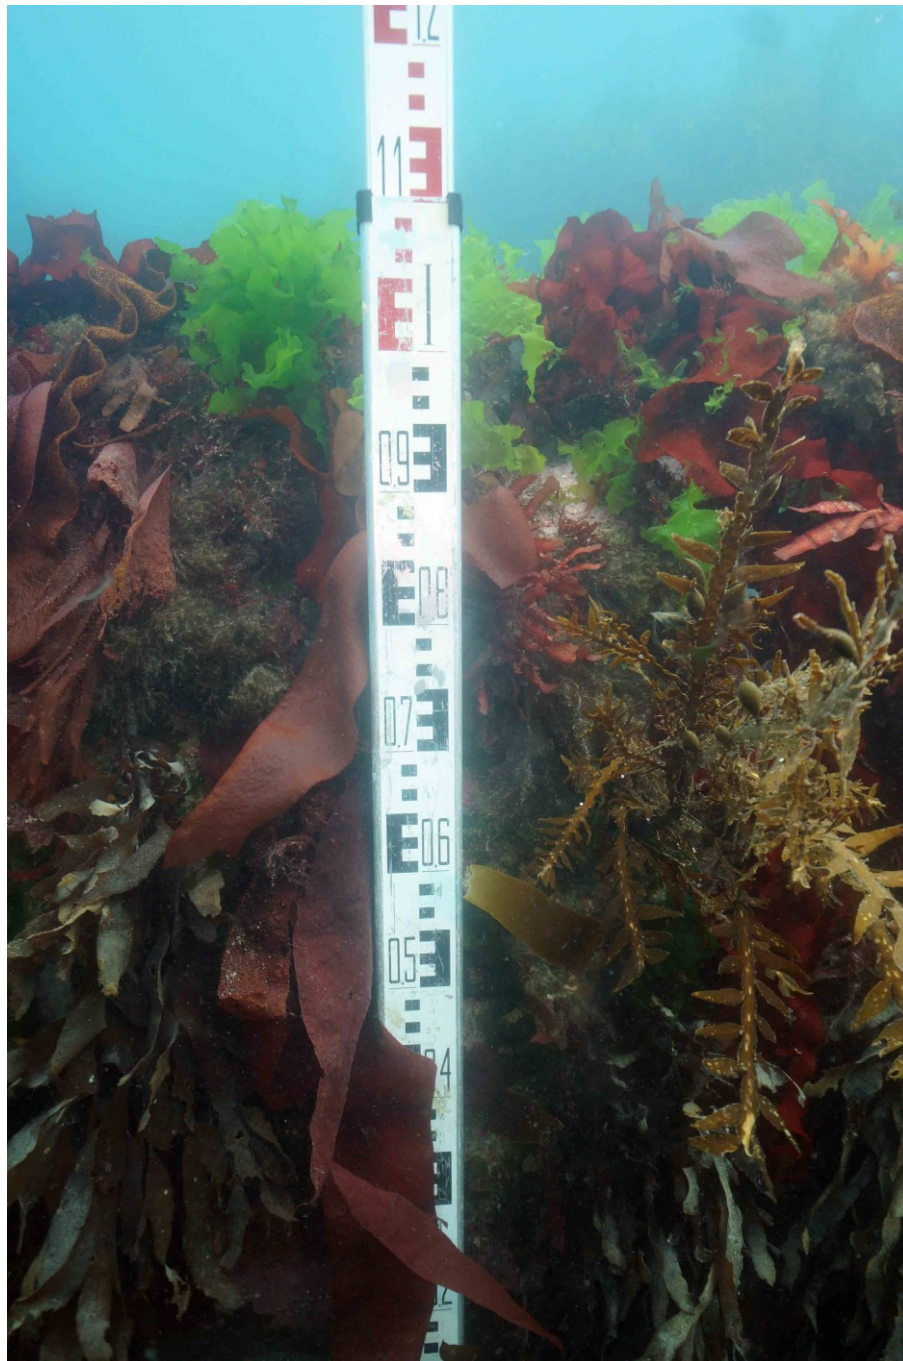
The inshore exposed pipeline section (position 'C') commences 44.0 metres below the MHWL at a depth of 3.0M, and extends approximately 80.0 metres to a depth of 7.0M.

Over the past year (between 2020 to 2021 Inspections) sea conditions have tended to remain relatively moderate; with less frequency of strong Southerly wind and severe sea wave and swell conditions. These moderate type conditions resulting in a lesser volume of sand and fine gravel deposits been eroded from adjacent the pipeline, and an increased establishment of marine growth in the shallows.

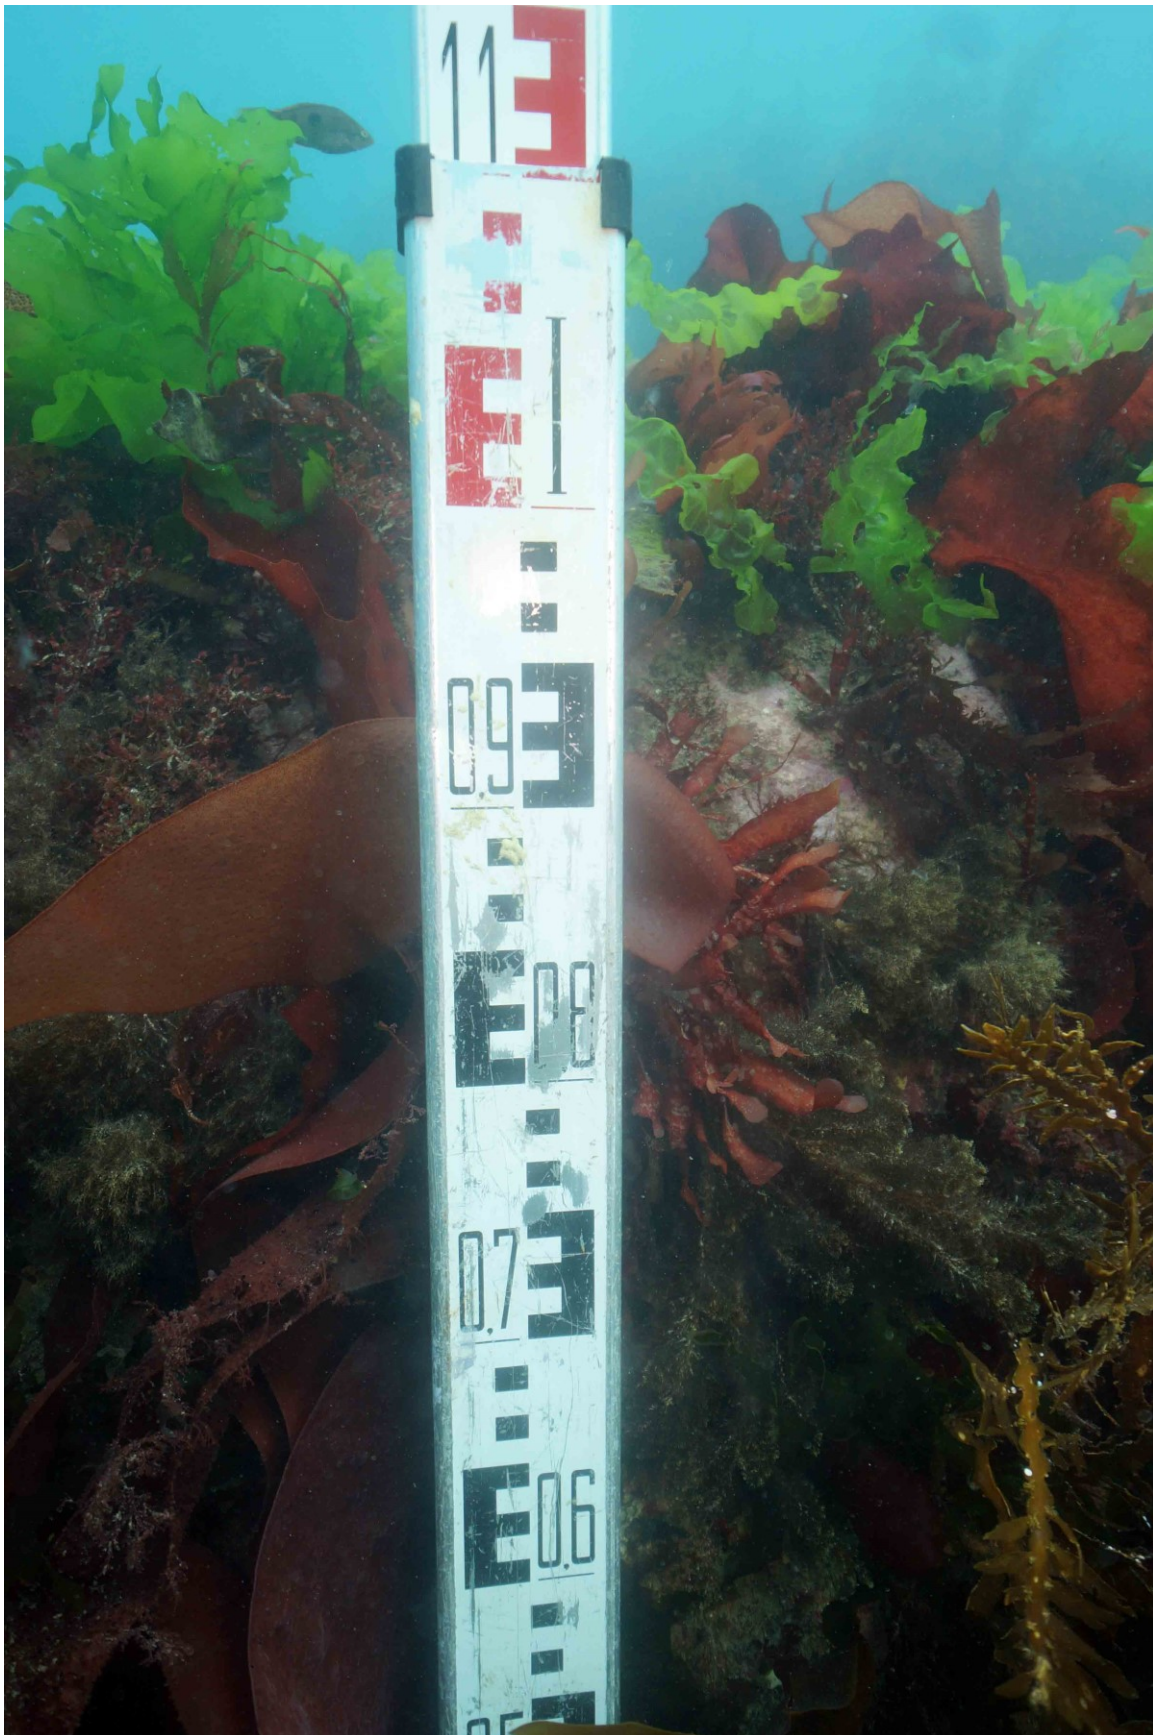
Figure 13: Maximum scour depth was measured between check positions 50.0 – 60.0 metres: [980mm](#)

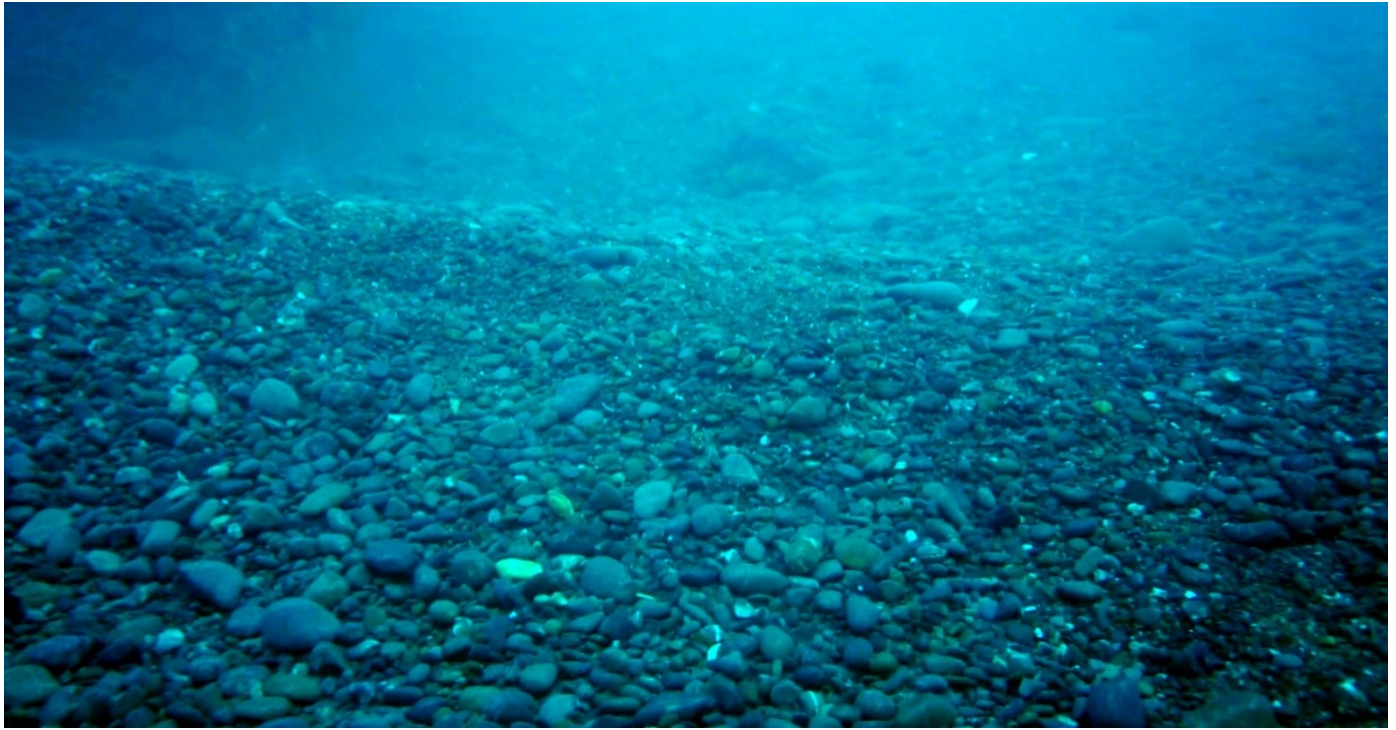
Figure 15: Typical seabed composition – offshore route – Position E

The result of the underwater tow inspection being; no areas for concern observed.

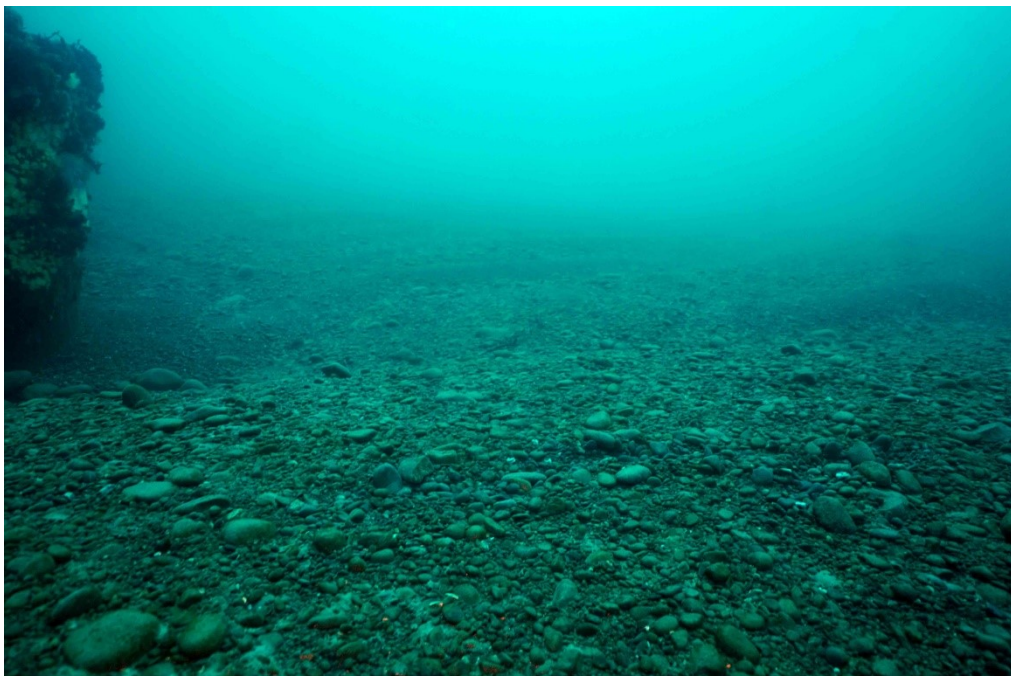
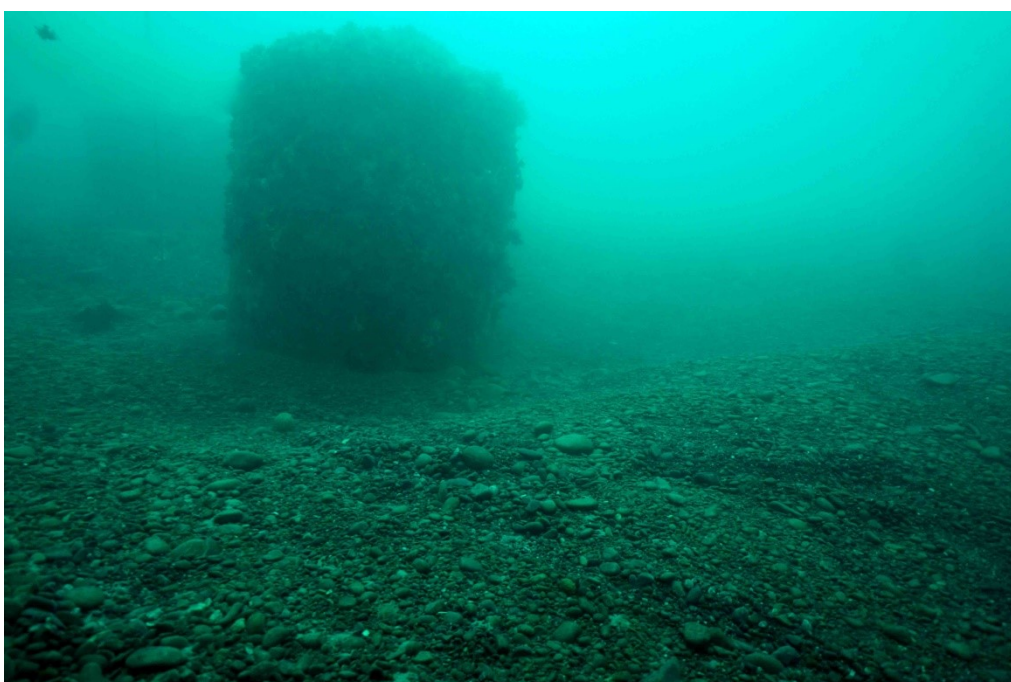
With reference to the construction drawings it should be noted that at the current recorded scour depths some of the bed erosion stabilisation matting should be exposed; however none was observed.

Figures 18 & 19: At diffusers where greatest scour depths were measured, examination was completed for any evidence of exposed erosion control mats; however no sighting of any such material was made

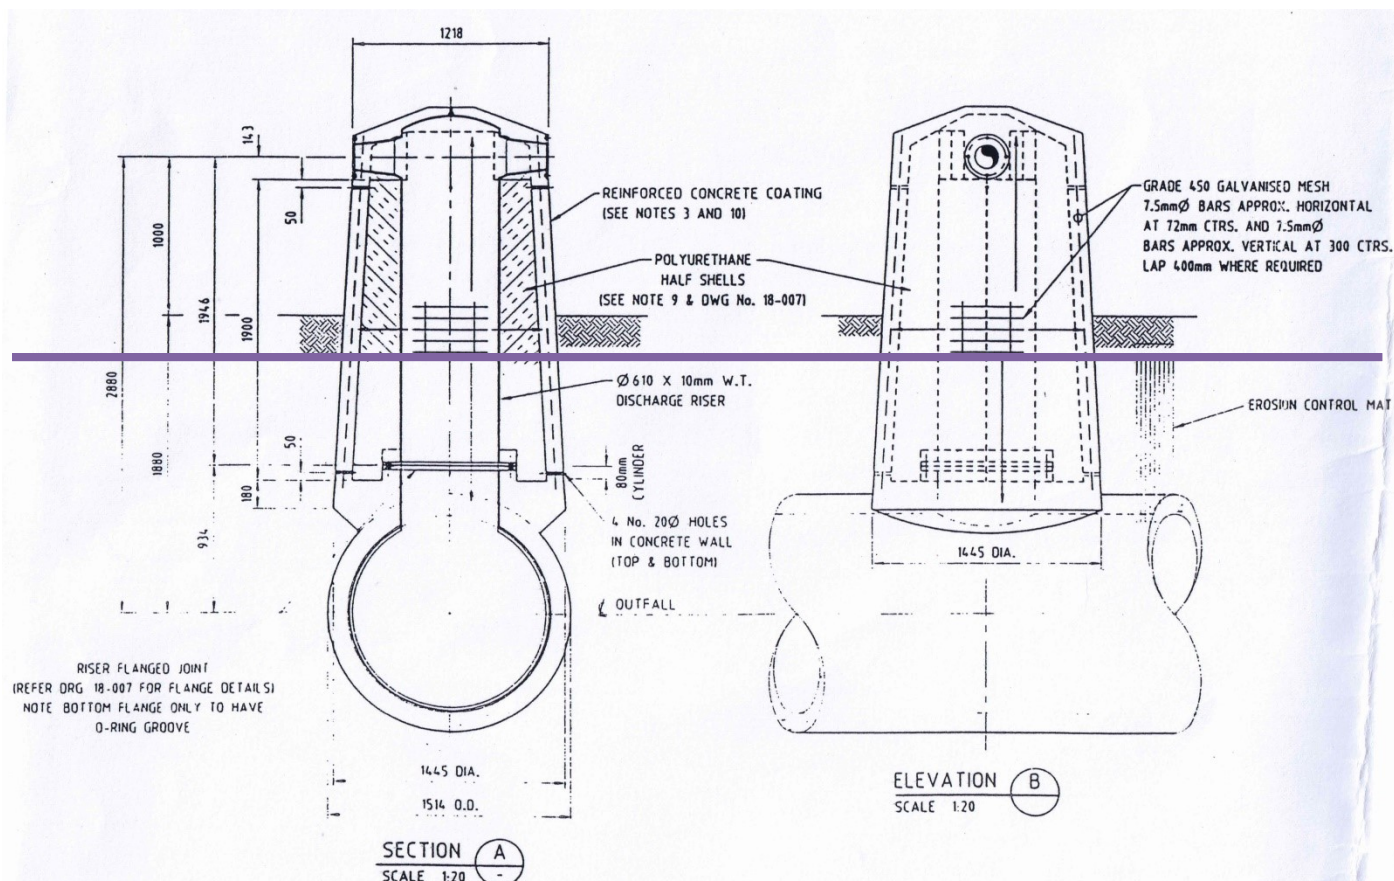
Figure 20: Diffuser detail

No evidence was observed of any damage or deterioration to any of the 18 diffuser assemblies. Seafloor deposits of rocks, coarse gravels and sand form undulating, peaks and depressions typically of +/- 400mm in west – east (shoreline) orientation around the diffuser positions.

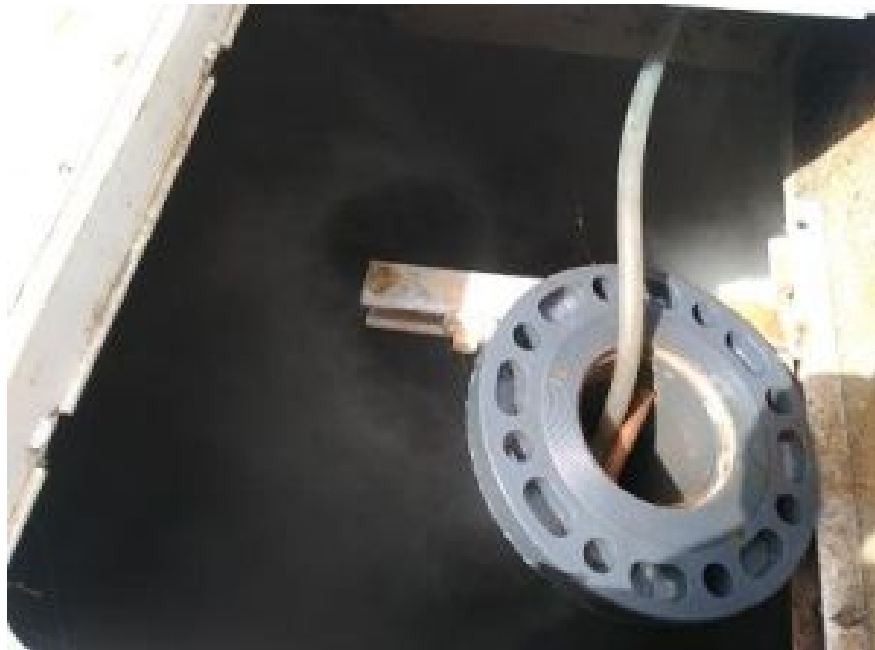
Smoke escaping from the inspection hatch once the temporary cover is removed.
