## Wellington Water – Seaview Odour Investigation Study

# Odour Assessment

**Document Title:** WWL - Seaview Odour Investigation Study

**Date of issue:** 9 June 2023

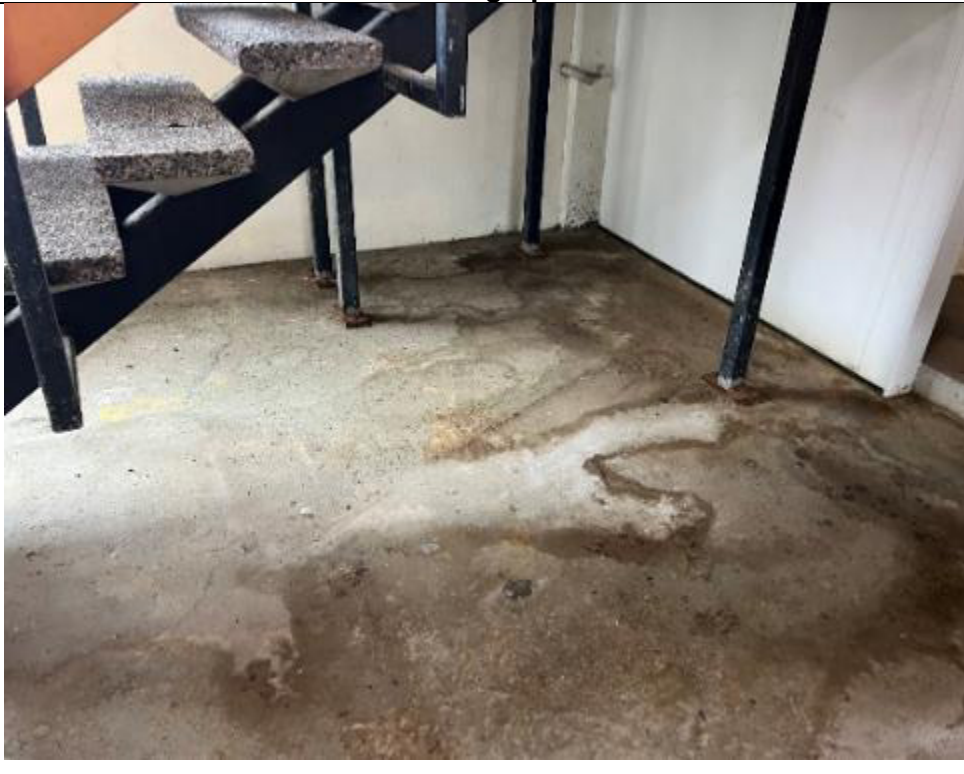
Location	Comments	Photograph
<p><b>Milliscreen Building</b></p>	<p><b>General Observation</b> - Corrosion at various places near floor level in the lower level of the plant – Indicative of H<sub>2</sub>S pooling in low-lying areas (as it is heavier than air) and resulting in increased corrosion.</p> <p>Relatively high levels of H<sub>2</sub>S are required to result in corrosion of metal structures, acknowledging that the building is ~40 years old.</p> <p>A H<sub>2</sub>S concentration of 6 ppb was observed in the building at the time of the site visit. However, the corrosion would indicate that levels of H<sub>2</sub>S in this building have been elevated in the past.</p>

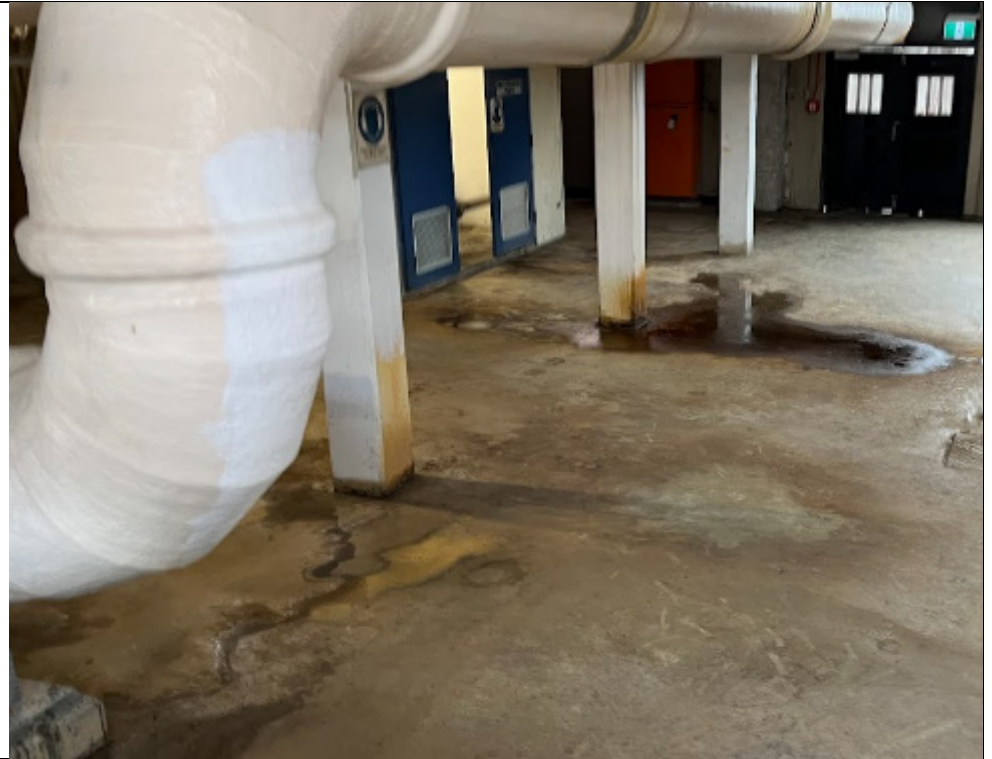
**Milliscreen Building**

Also noted were a number of water leaks potentially resulting in wastewater on floors and slip drains.

Wastewater odour was observed during the site visit at relatively low intensities, with the odour masking agent providing a more obvious odour.

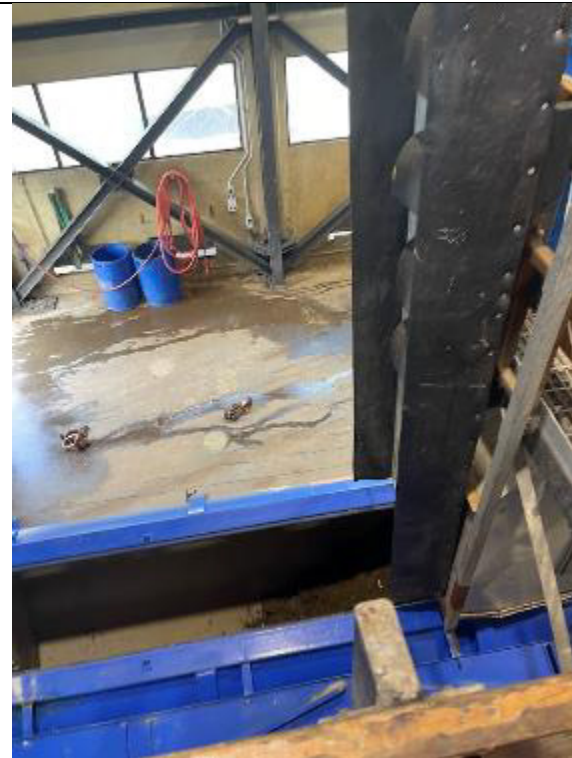
**Milliscreen Building**

Screenings bin open – Minor odour source.

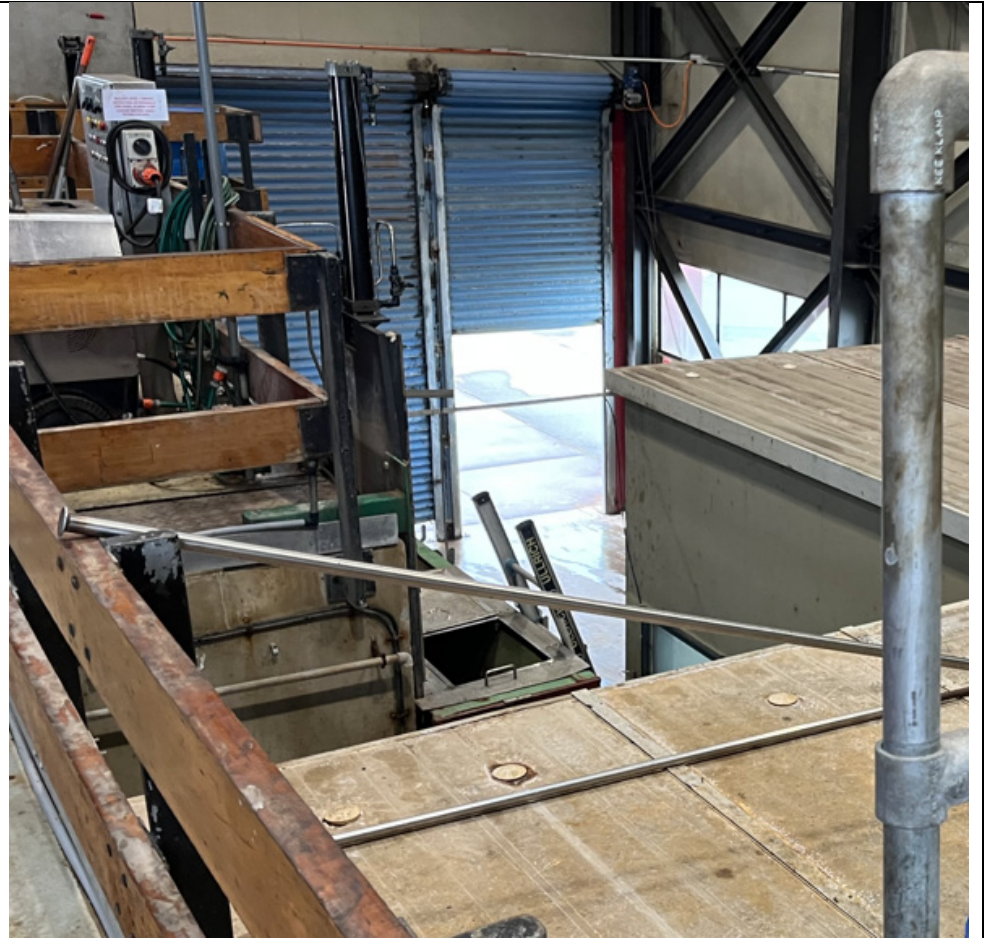
**Milliscreen Building**

Inspection port left open – Minor odour source.

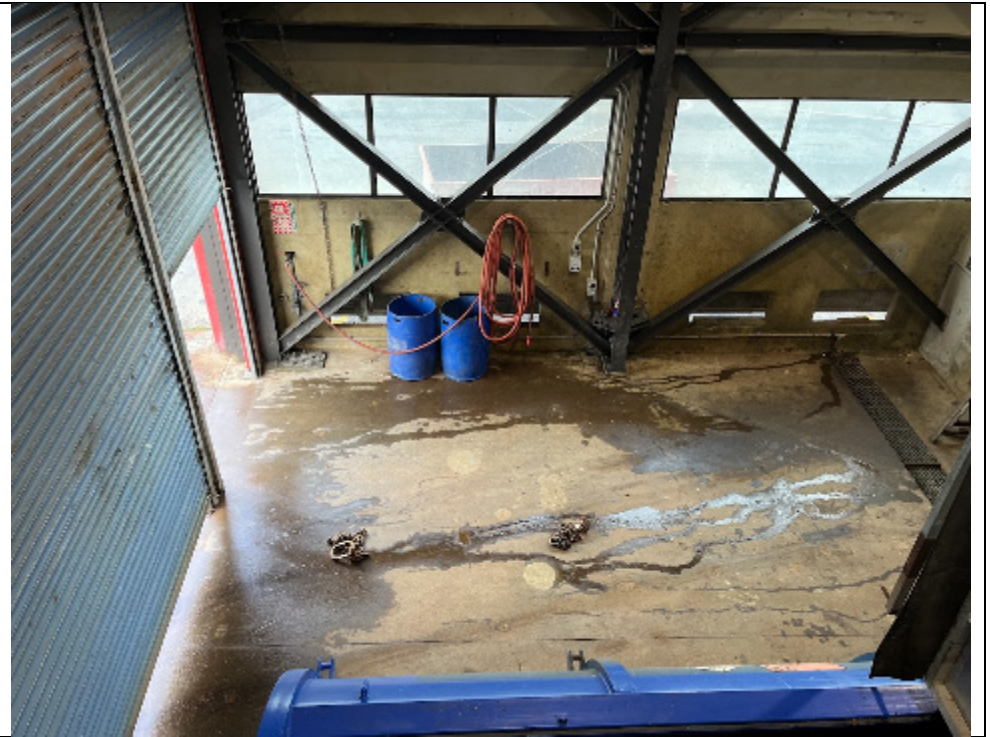
**Milliscreen Building**

Plant door open – Minor fugitive odour source.

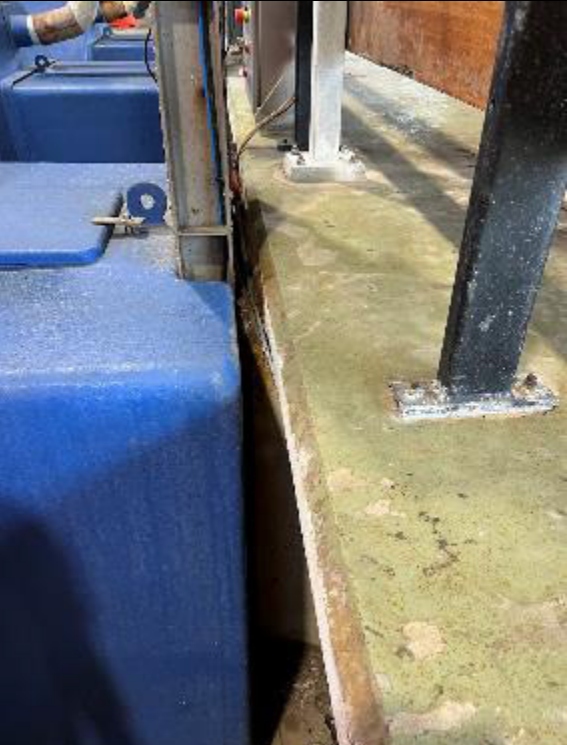
<b>Milliscreen Building</b>	<p>Minor source of odour – Odour observed coming from a seal at the back of the milliscreens – corrosion evident on nearby metalwork.</p> <p>The STNZ report states that screens are in poor condition, and the cleaning jets are no longer operational, potentially resulting in higher odour levels within the drums.</p> <p>STNZ recommended blocking roof vents and installing additional ventilation/odour treatment.</p> <p>Not observed during the site visit, but mill screens are opened for cleaning on a daily basis which could generate elevated odour.</p>

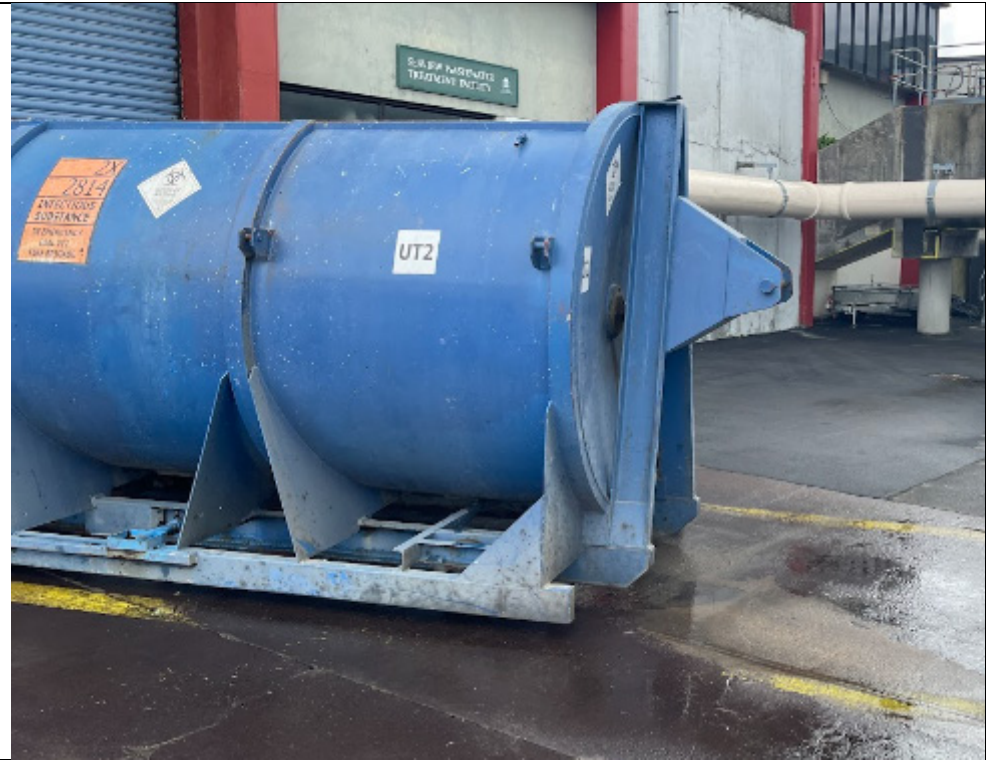
**Milliscreen Building**

**General Observation – Bin closed/sealed.**

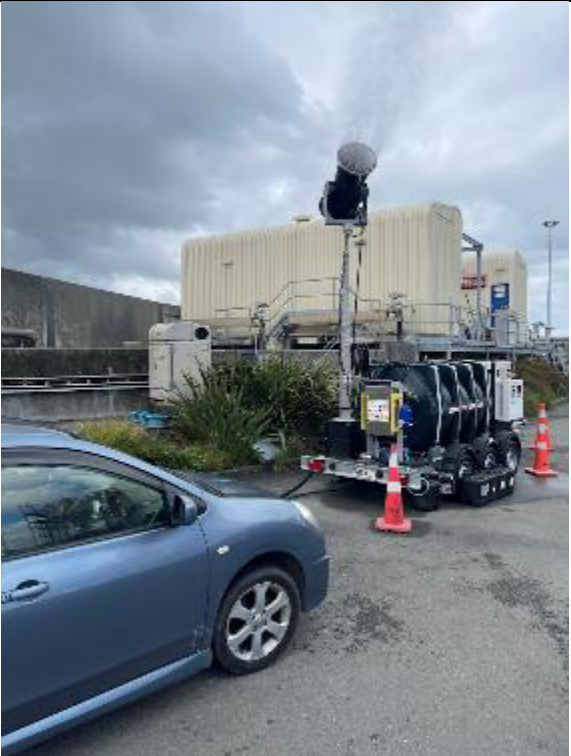
<p><b>Odour Cannon</b></p>	<p><b>General Observation</b> – Very low levels of odour were observed around this part of the plant.</p> <p>This odour cannon has a limited effective range. For the odour cannon to be effective, it needs to be positioned adjacent to/downwind of an odour source.</p> <p>AQCNZ considers that this odour cannon in its current location will likely have a very limited/negligible effectiveness at reducing/masking off-site odour.</p> <p>AQCNZ recommends that the cannon be redeployed to areas where odour has been identified as being a significant source, the biofilter, for example.</p>

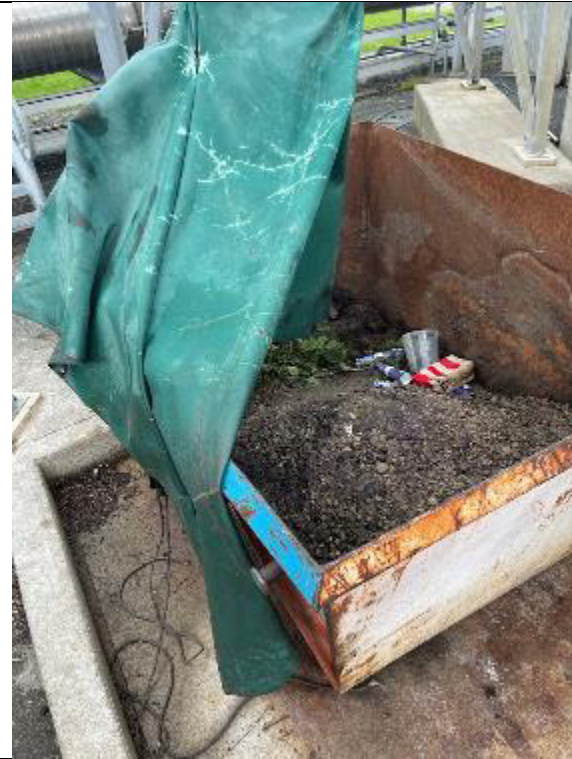
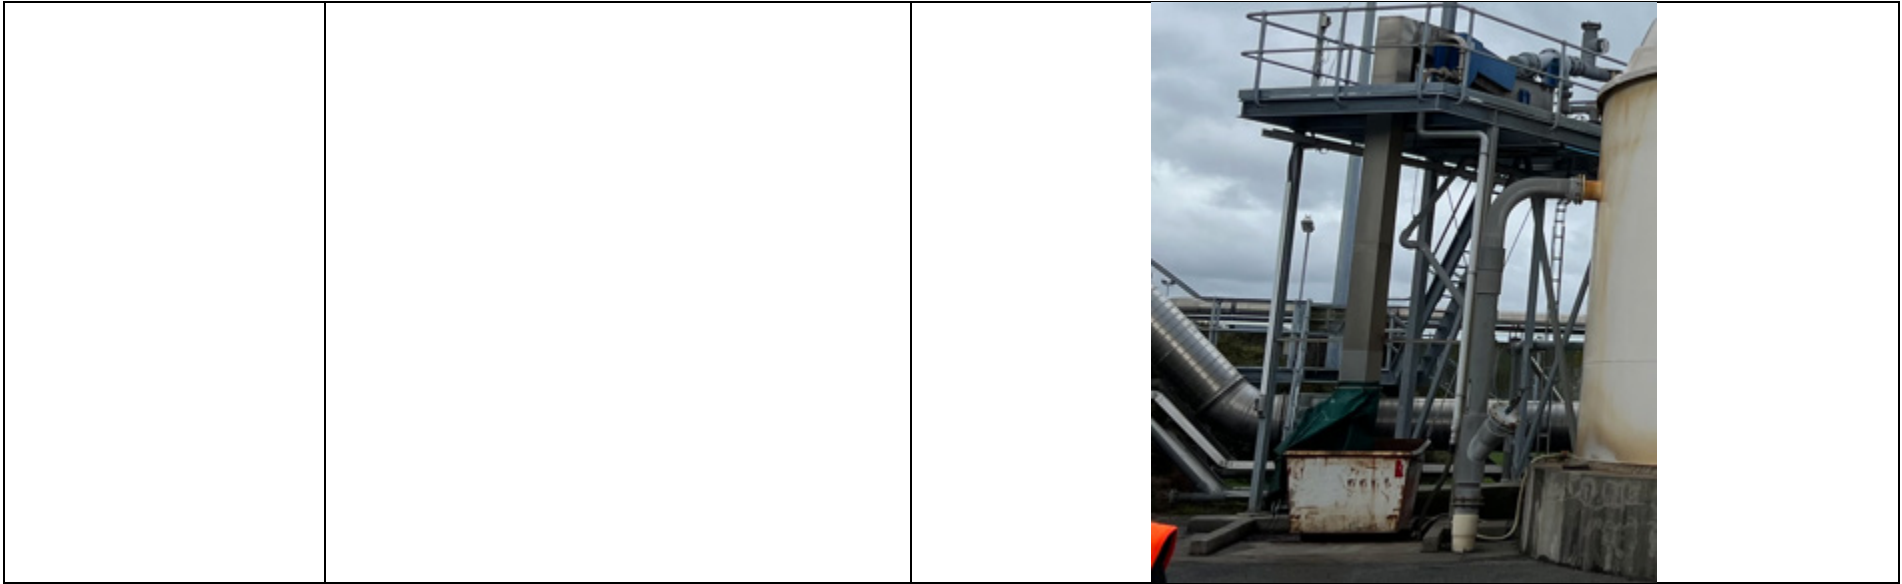
**Grit Bin**

A minor source of odour - cover not in place. It appeared to be a minor source of odour (i.e. very low-level odour).

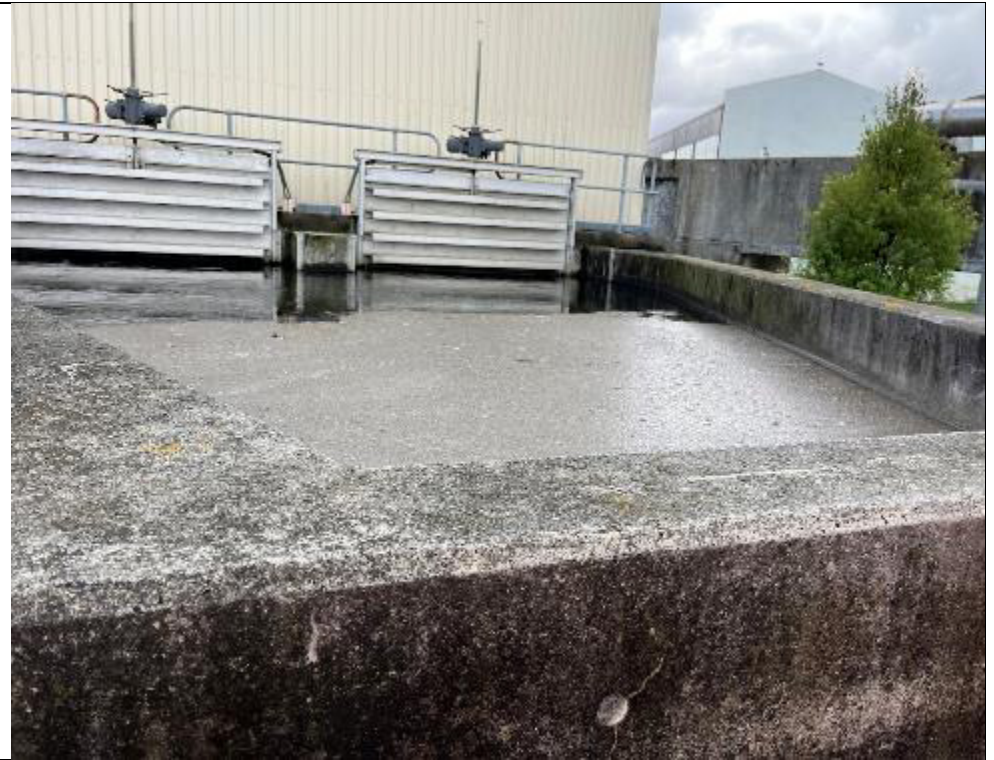
**UV Inlet Channel**

A minor source of odour – low-intensity odour from contamination – Very unlikely to be the source of off-site odour complaints.

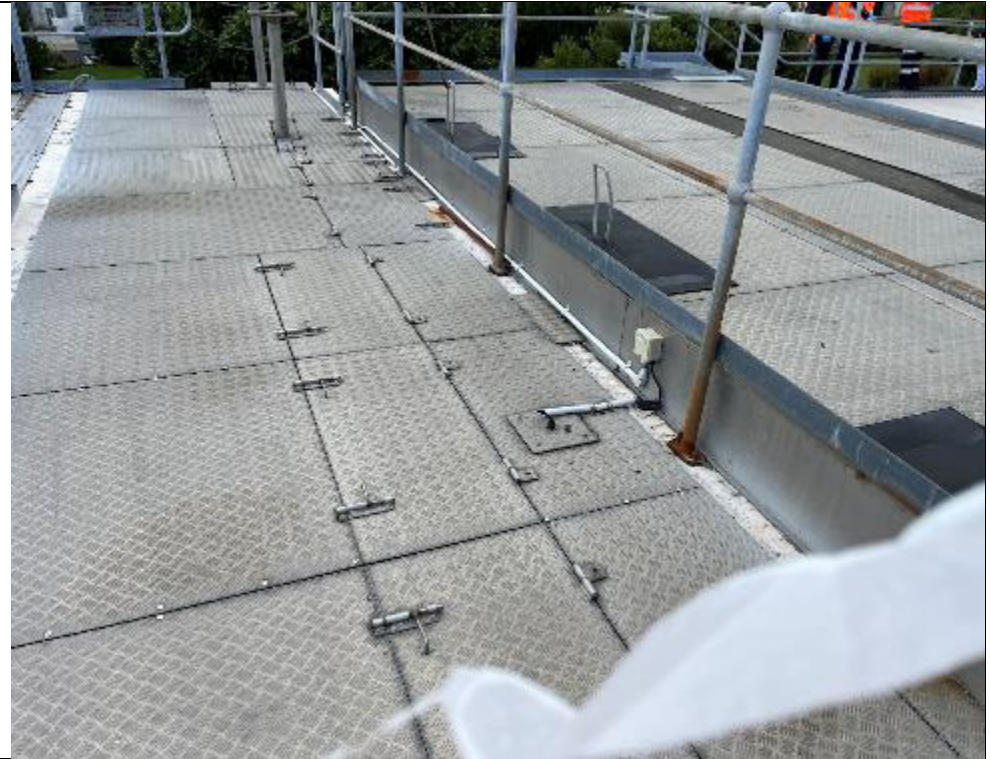
**Primary Sedimentation Tank (PST)**

Minor to Moderate source of odour – Corrosion on steel structures around covers indicates leaks/lack of negative pressure in the PST headspace.

There was also evidence of the seals along the edges of the PST corrugated iron covering missing/deteriorated. Again corrosion of metal structures around these leaks indicated fugitive odour discharges and a lack of a negative pressure environment within the PST.

13 ppb of H<sub>2</sub>S was observed on top of the PST.

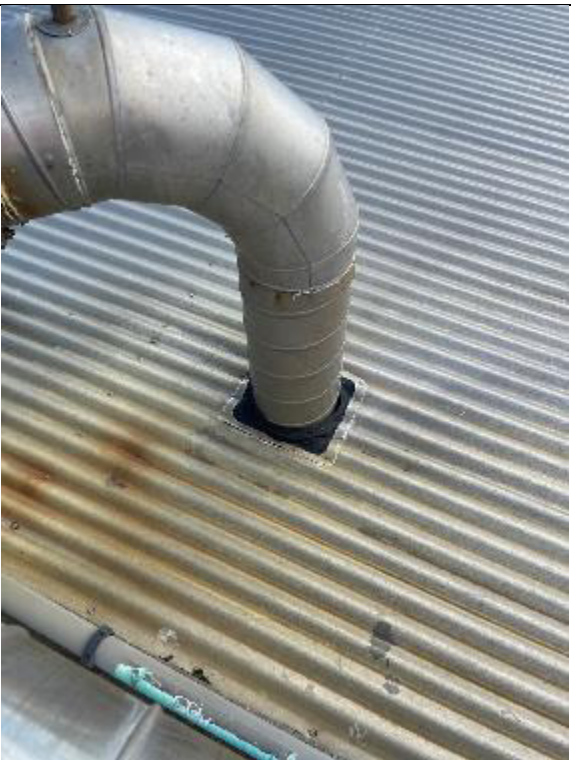
<p><b>PST</b></p>	<p>Minor source of odour – leaking around the flange on PST.</p>

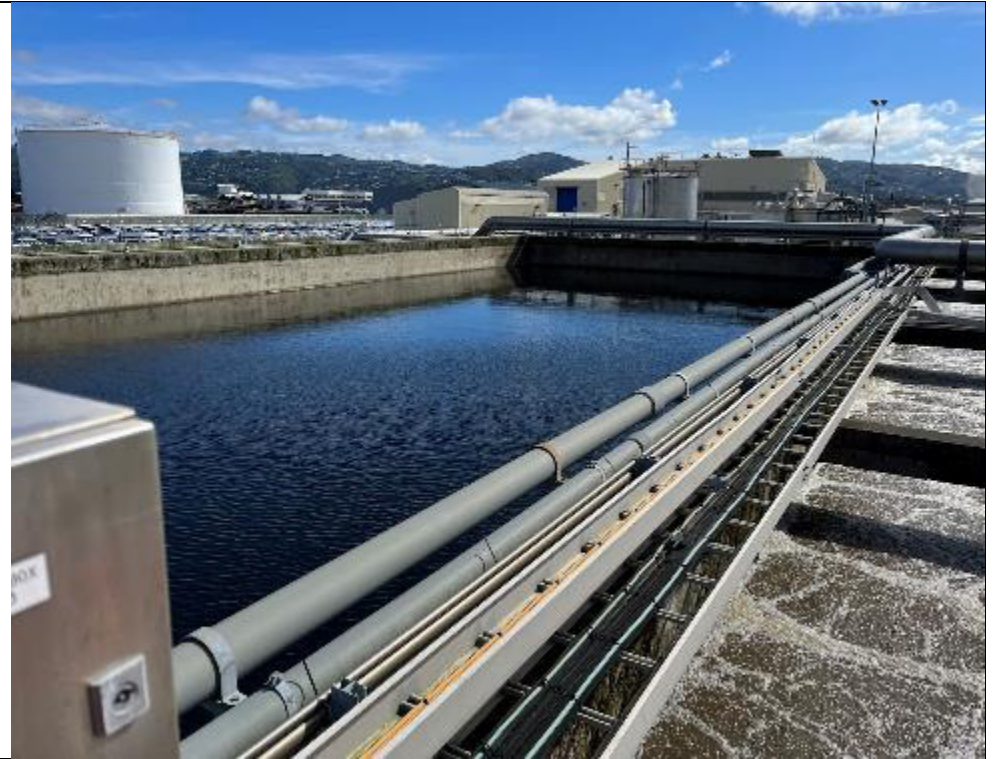
**Storage Basin**

During the site visit, it was discussed whether or not any sludge was left at the base of this basin when emptied. If so, then the sludge could turn anaerobic and result in odour discharges when empty.

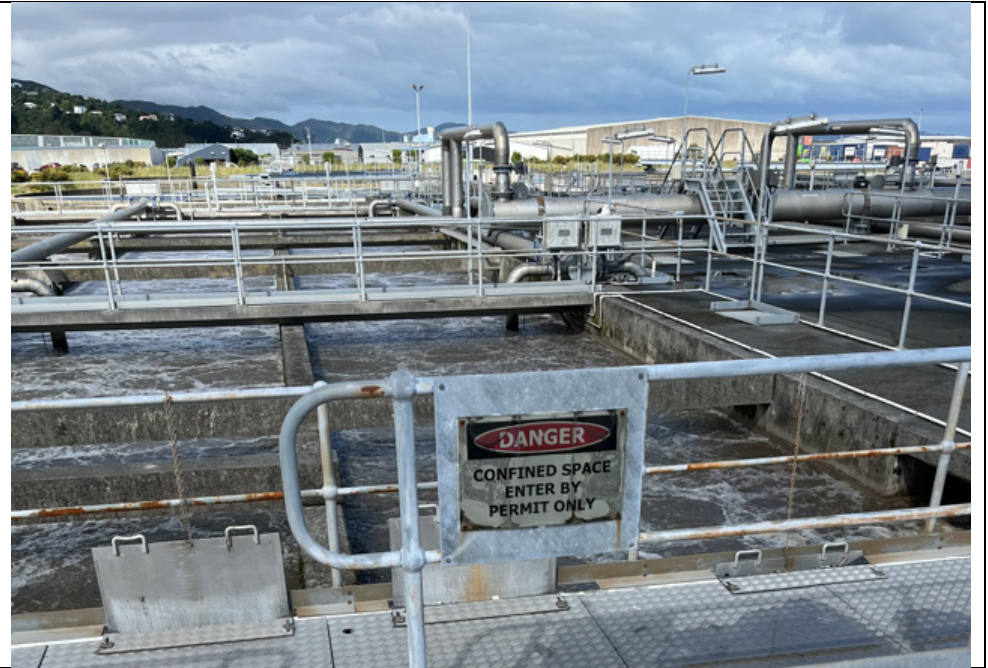
**Aerobic tanks**

Minor odour source – the odour observed from these tanks has an odour character described as ‘fresh wastewater’.

This type of odour has been observed during odour scouting beyond the site boundary but is considered to be of a lower offensiveness than other odour discharges from the site (i.e. putrid/acrid odour from the biofilter, rotten egg-like odour from high-level H<sub>2</sub>S discharges).

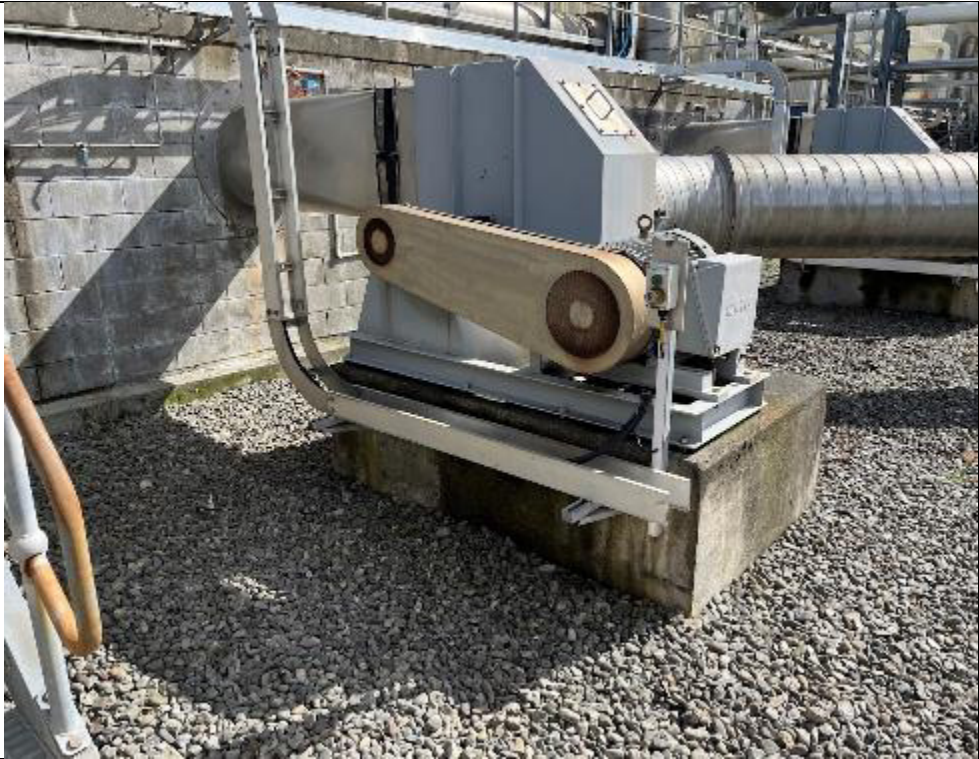
**Biofilter**

Moderate source of odour - Rubber seal around fans split/leaking on both fans.

AQCNZ understands that this has now been repaired.

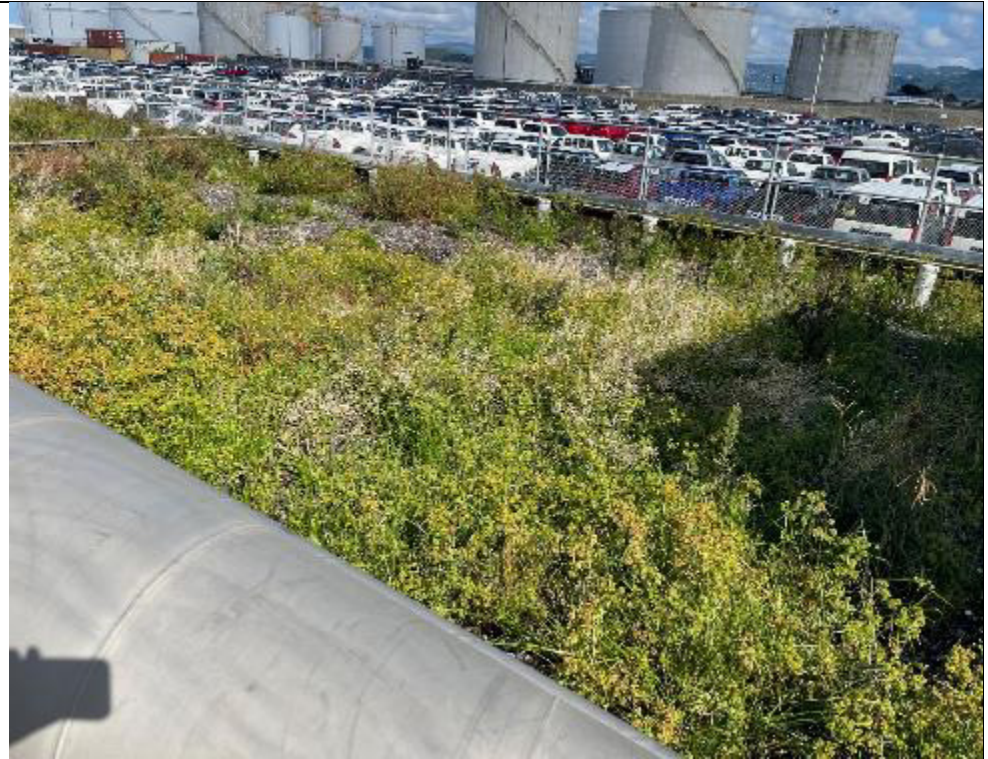
**Biofilter**

A significant source of odour:

- Media is likely to be at end of life.
- Significant short-circuiting of gas flow was observed during the site visit – particularly around edges of the biofilter
- highly odorous on top of the biofilter – odour character appeared to be most consistent with those from the dryer. However, it is likely that odour from all point source extraction sources is being emitted from the biofilter with limited treatment.
- No vegetation should be present on the biofilter – this creates preferential pathways and removes moisture from the biofilter.

Uneven distribution of air through the media bed and degraded media is resulting in excessive odour discharges from the biofilter.

AQCNZ understands that the biofilter media was replaced approximately five years ago. AQCNZ considers it good practice to replace biofilter media once every five years. Therefore, it is recommended that the media be replaced.

As there is obvious short-circuiting of the media along the walls of the biofilter, it is recommended that during the media replacement, a wall return/fin is installed around the inner perimeter of the biofilter cells (see Figure 13 for an example). This return is designed to divert air from the wall back into the main body of the media. Further guidance on the design parameters for such a return is outlined in the EPA Victoria *Biofilter Design and Maintenance* publication 1880 May 2021.

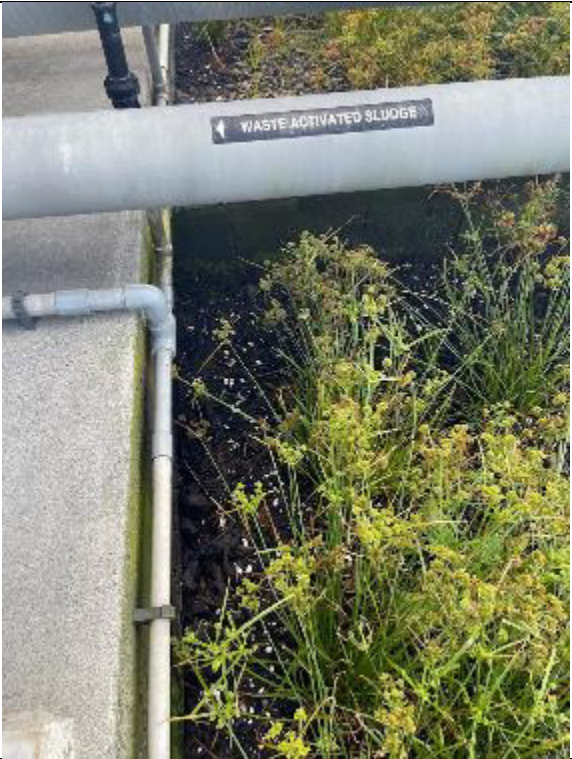
**Biofilter**

Example of short-circuiting around edges of the biofilter.

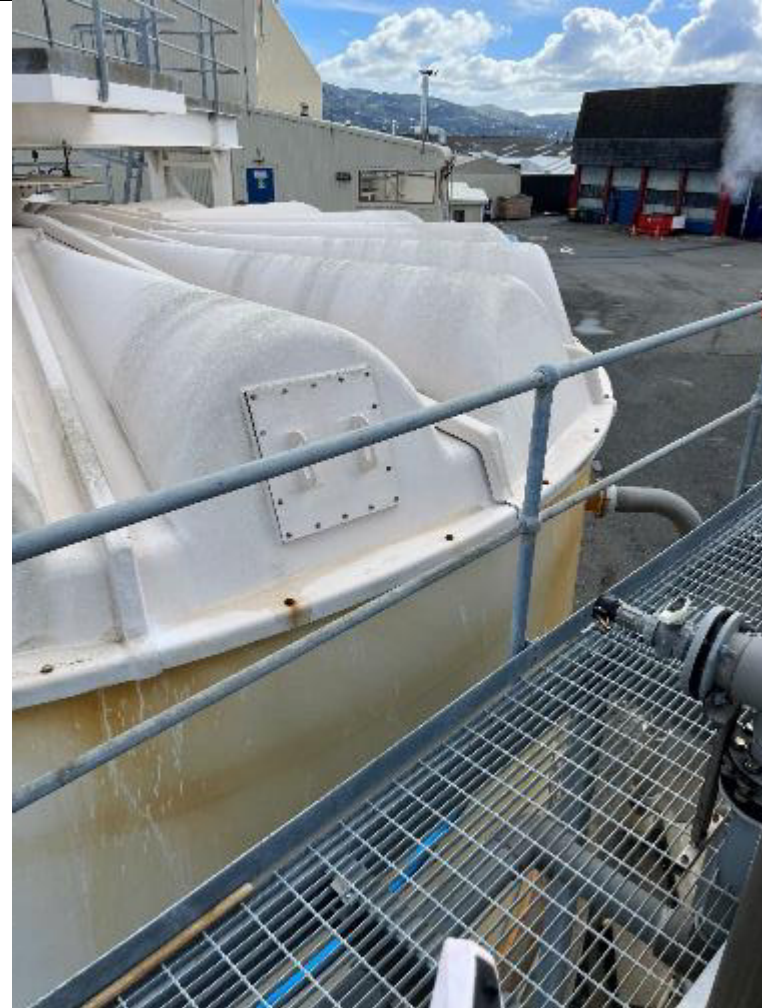
**Gravity Thickener**

Minor source of odour – leaking around the flange on top of gravity thickener. Strong H<sub>2</sub>S like odour was briefly observed along walkway near top of tank.

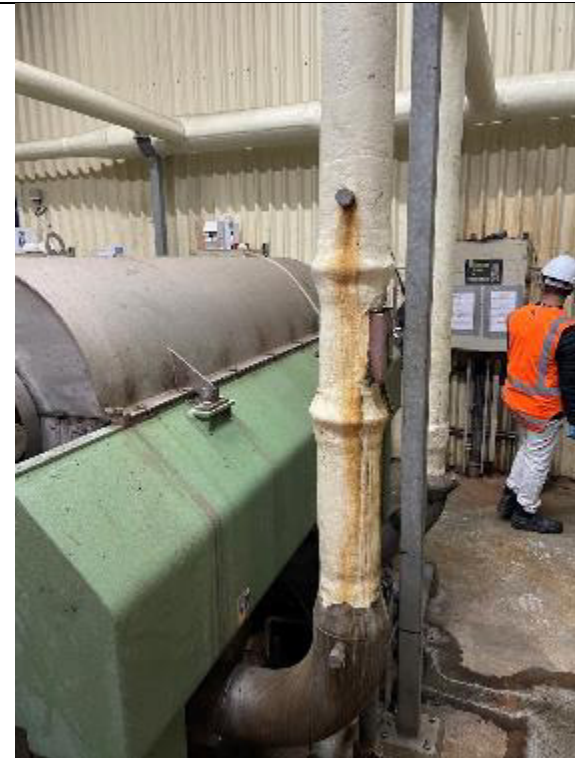
**Centrifuge room**

A minor source of odour – low level odour observed in centrifuge room – H<sub>2</sub>S concentration of 12 ppb.

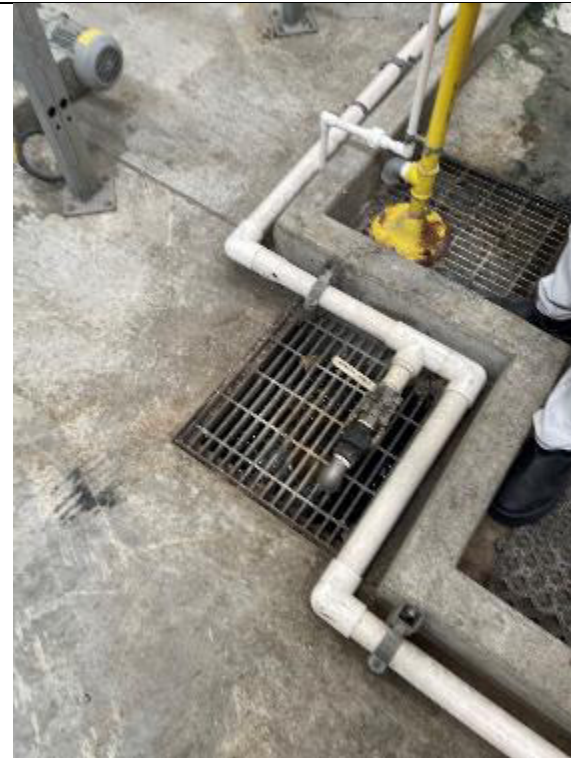
**Polymer Room**

Polymer Room – very strong unusual strong odour observed. Odour source was traced back to a floor sump – see picture. This appeared to relate to the dryer process.

Potentially related to the biofilter leachate drainage system.

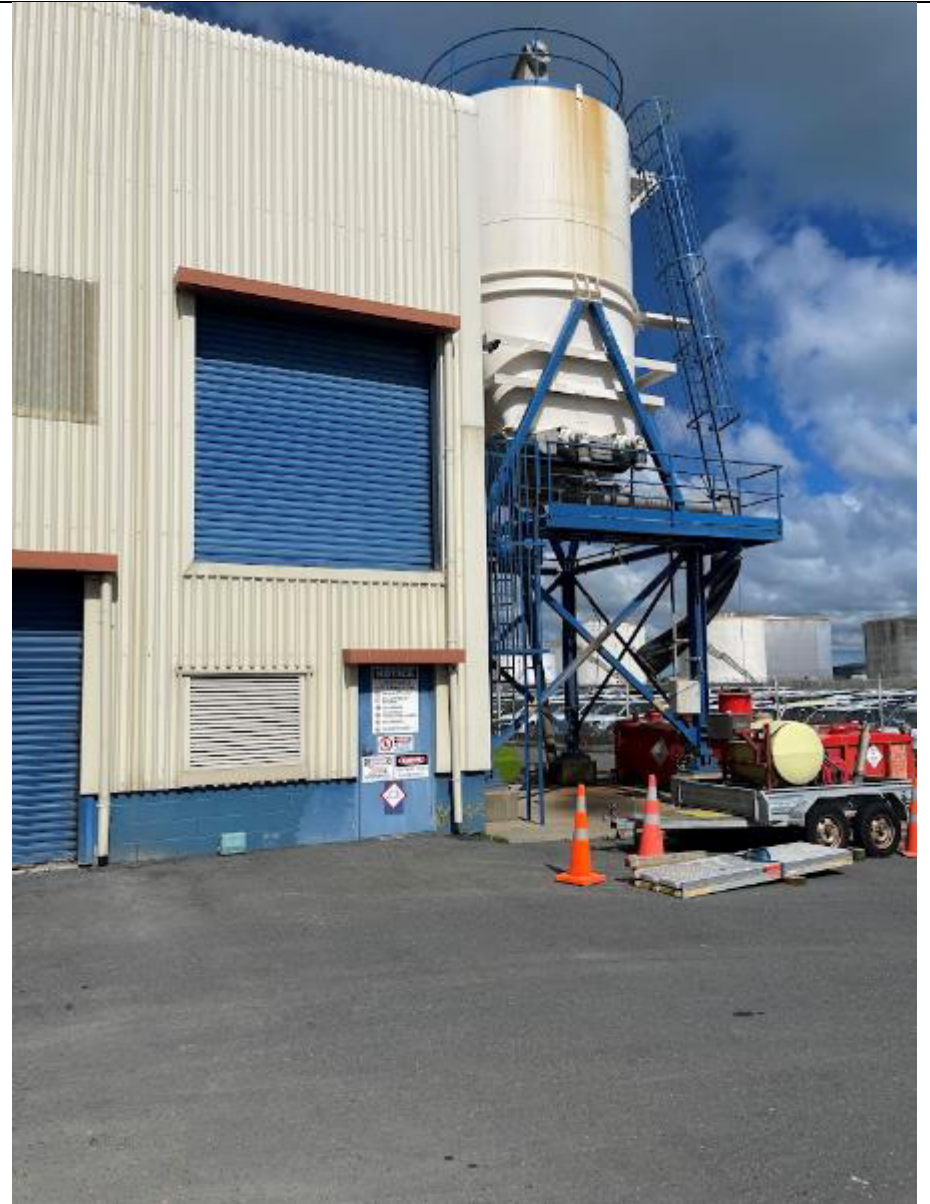
## Dryer Building

### Possible source of odour

- One roof fan was not operational.
- STNZ air flow checks appeared to be within expected values.
- Building under slight negative pressure 5-10 Pa.
- STNZ noted gaps around cyclones and roof – potential pathway for odour.
- STNZ recommended sealing these gaps + roof fans and having additional extraction to a biofilter.

The latest observation from WWL is that the odour observed at the biofilter that smelt like the drier could be observed at the northern gate. Potentially suggesting that the biofilter could be the cause of some of the recent complaints attributed to the dryer building.

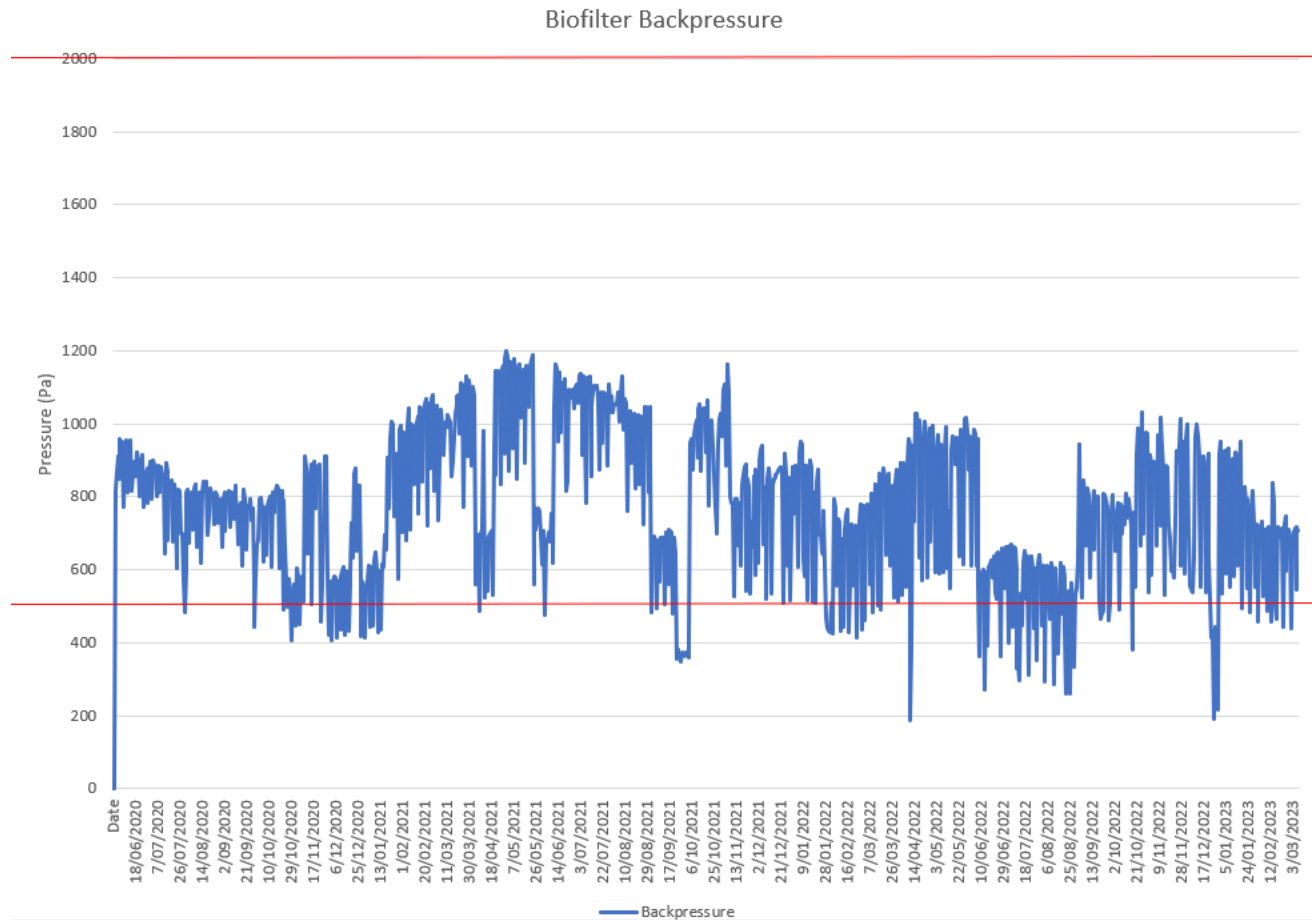
Figure 10: Biofilter Backpressure

A graph of daily measured backpressure is presented in Figure 10. The recommended backpressure design range is between 500 and 2,000 Pa (represented by red lines in Figure 10). The measured backpressure is at the bottom end of this range and, at times, falls below the range. This is indicative of short-circuiting, as has been observed during the site visit.

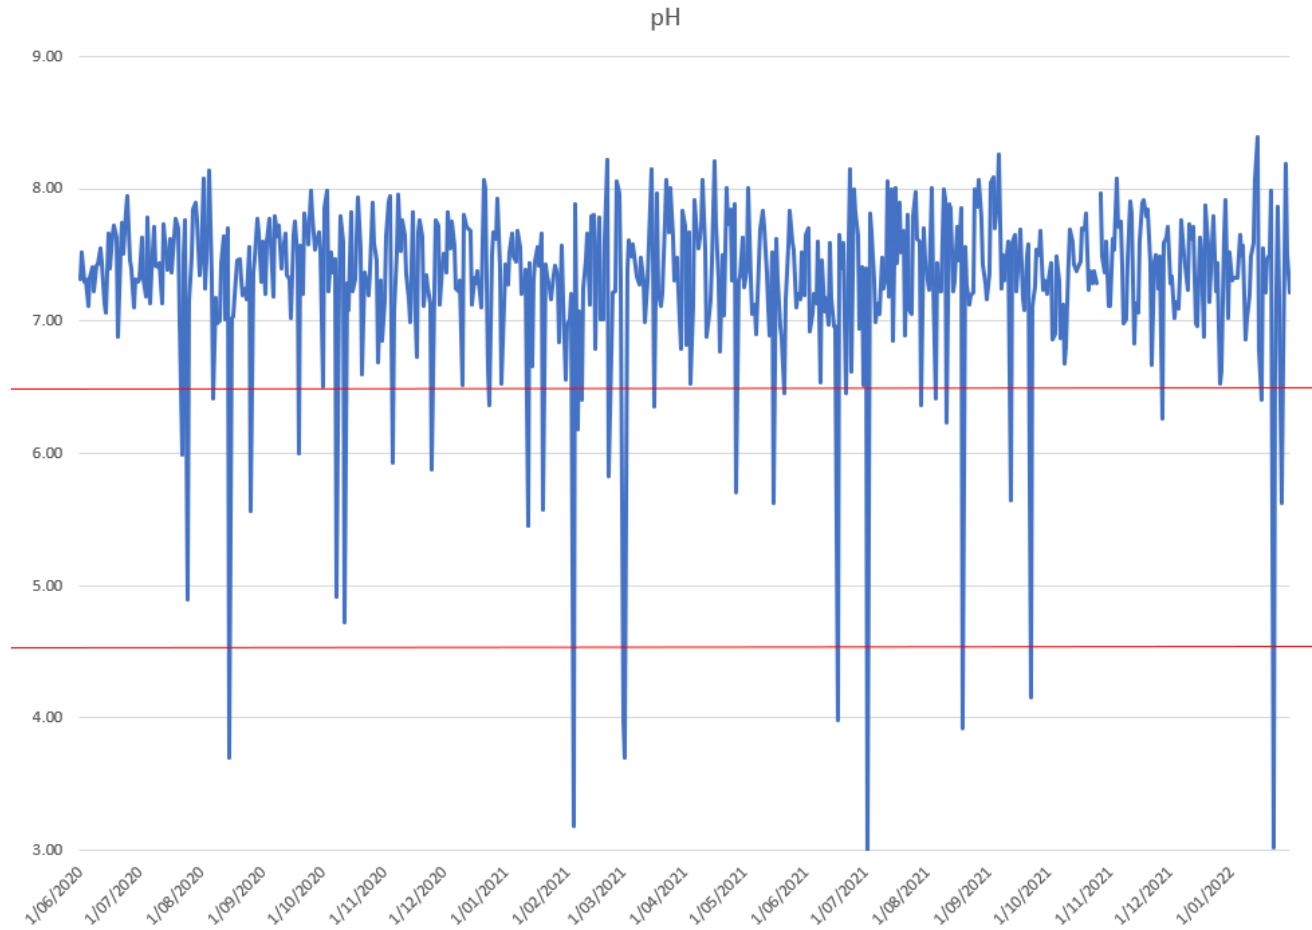
Figure 11: Biofilter pH

A graph of daily measured pH is presented in Figure 11. The recommended pH range is between 4.5 and 6.5 (represented by red lines in Figure 11). The measured pH is mostly above this range averaging around 7.5. This may also be a result of short-circuiting as the foul air is not being directed evenly through the biofilter media resulting in more neutral pH of the media.

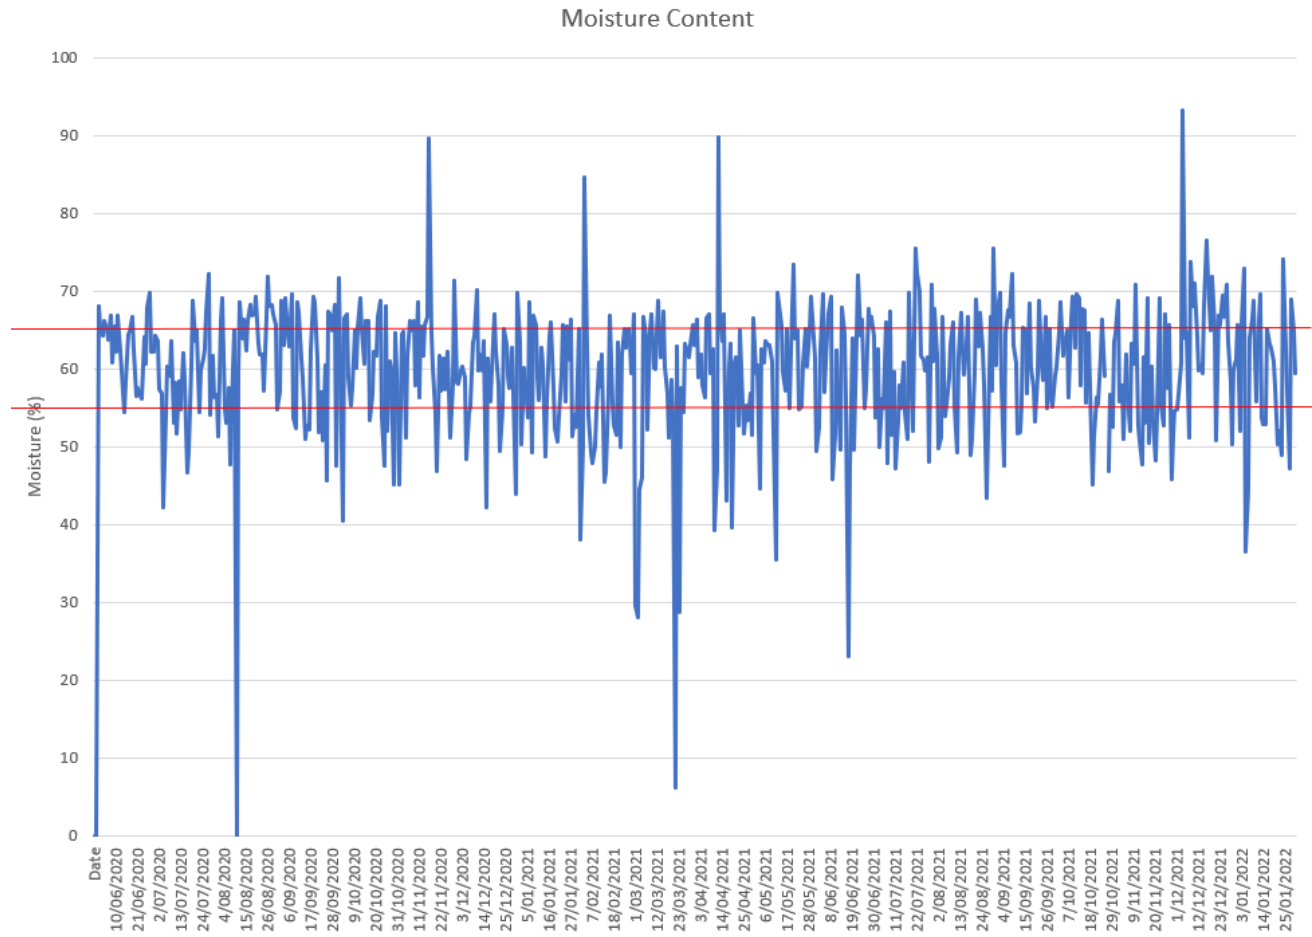
Figure 12: Biofilter moisture

A graph of daily measured moisture is presented in Figure 12. The recommended backpressure design range is between 55% and 65% (represented by red lines in Figure 12). The measured moisture is generally between the recommended this range. This is indicative of good irrigation management.
