CATHODIC PROTECTION SYSTEM ASSESSMENT MOA POINT WASTE WATER OUTFALL PIPELINE

WELLINGTON WATER LIMITED MOA POINT WWT PLANT

DOCUMENT NUMBER: CCE-R-2403-0393-0100A

DATE: 21 March 2024

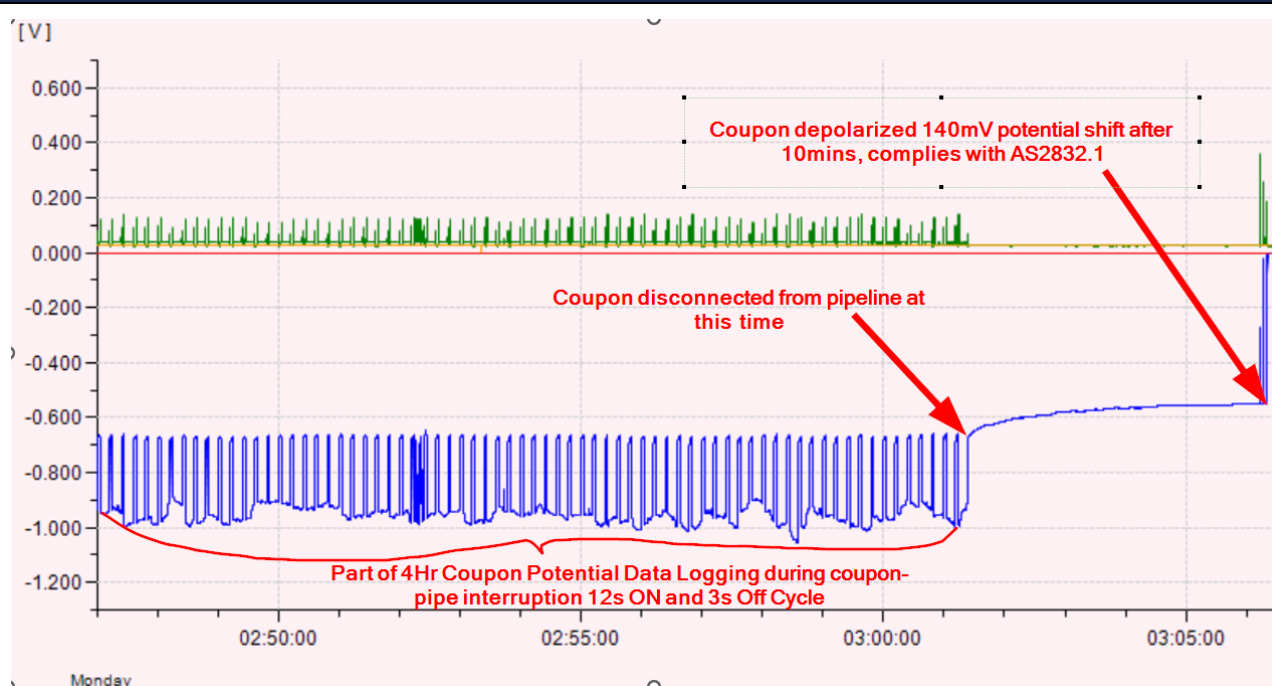
Figure 2, Datalogging of Temporary Coupon Potentials (Depolarization)

After 4 hours the coupon appeared to have attained the same potential as the pipeline in this vicinity, indicated by only slight changes in both ON and Instant OFF potential measurements. The coupon was then disconnected from the pipeline to allow a depolarization test: Within 10 minutes the potential of the coupon had changed from -687 to -547, a difference of 140 mV, indicating that the pipeline is protected against corrosion in this vicinity by the 100-mV criterion of the Australian Standard AS 2832.1:2015 and AS 2832.5:2008.

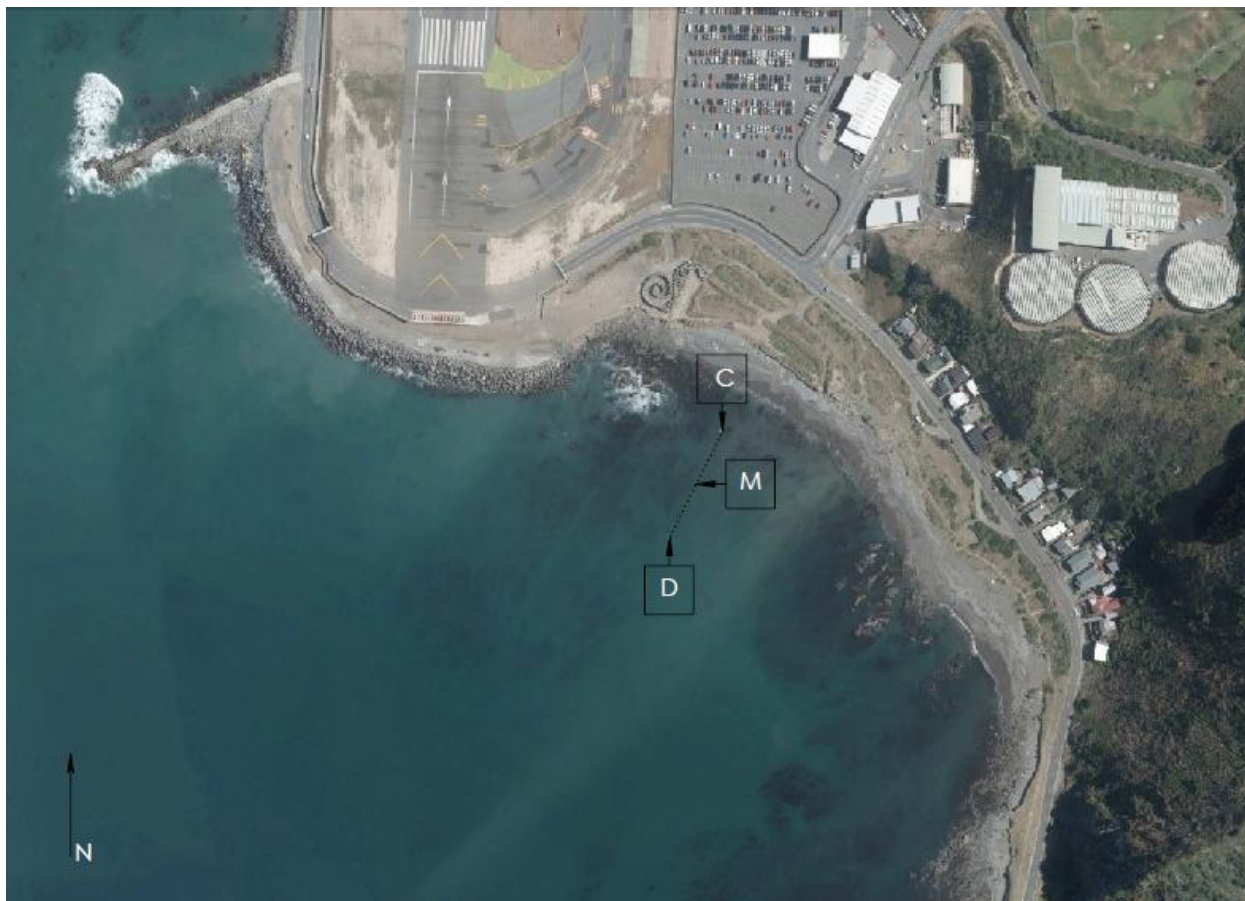
Figure 3: Shallow Water Section – Exposed Pipeline between positions C & D

SCOUR DEPTH DATA				
Position [m]		2024		
		West (mm)	East (mm)	Comment
C	00.0	100	100	
	10.0	100	150	
	20.0	300	300	
	30.0	450	450	
M	40.0	600	650	
	50.0	800	850	
	60.0	900	1000	
	70.0	850	1050	
	80.0	700	800	
D	90.0	200	200

The occurrence of scour being predominately due to the cyclic effect of repetitive southerly sea states, resulting in sand and light gravel deposit migration within the shallows and along the shoreline.

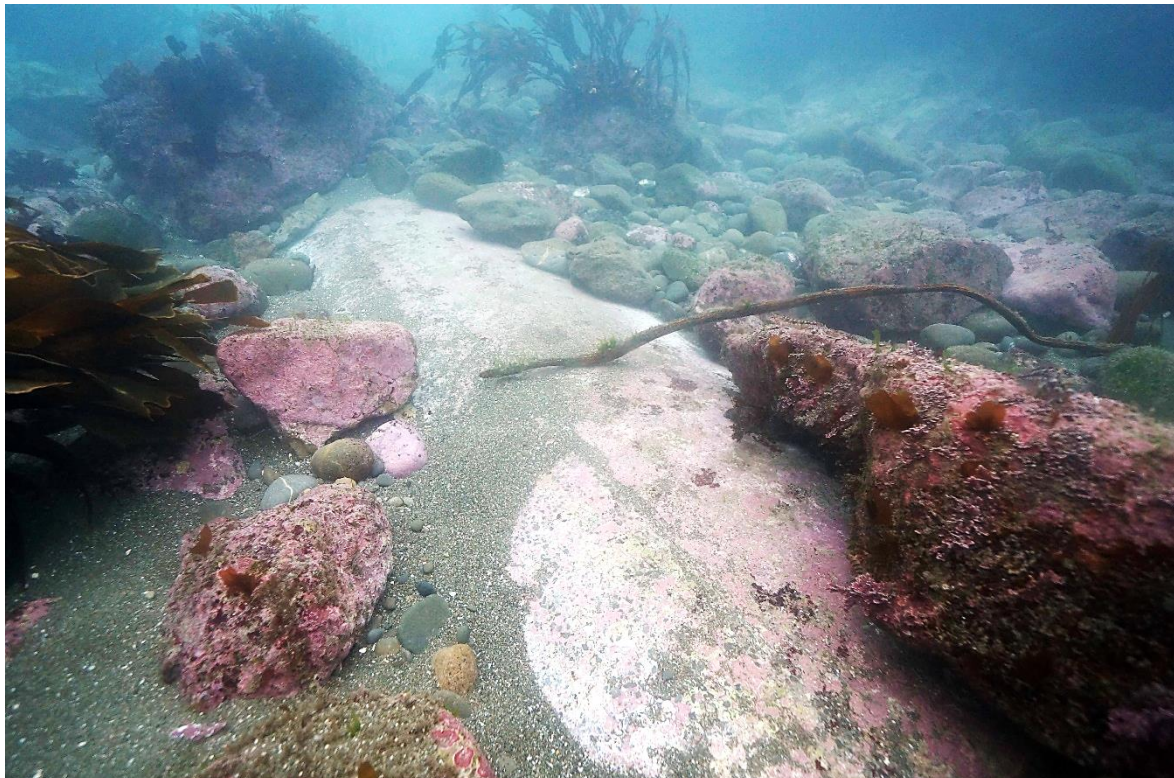
Figure 4: Zone C – shoreward position at which pipe exposure commences

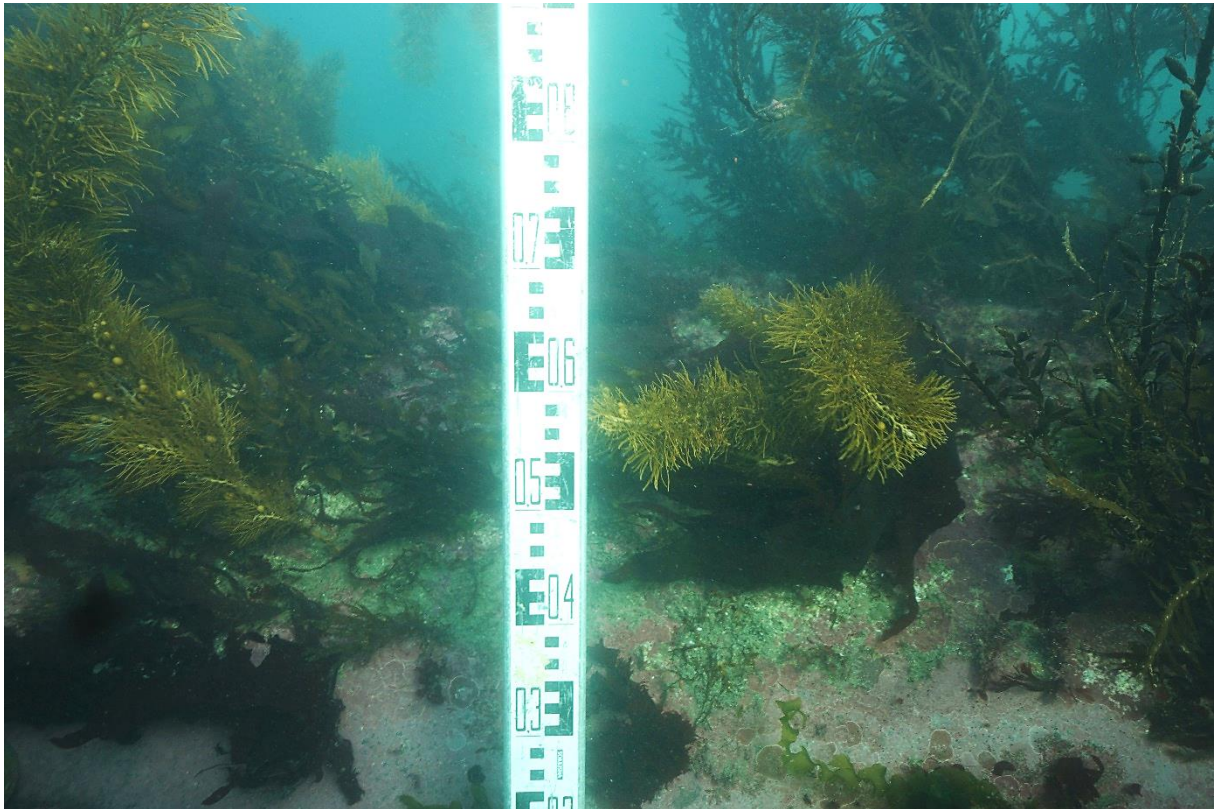
Figure 5: Position M – shoreward end of zone M to D

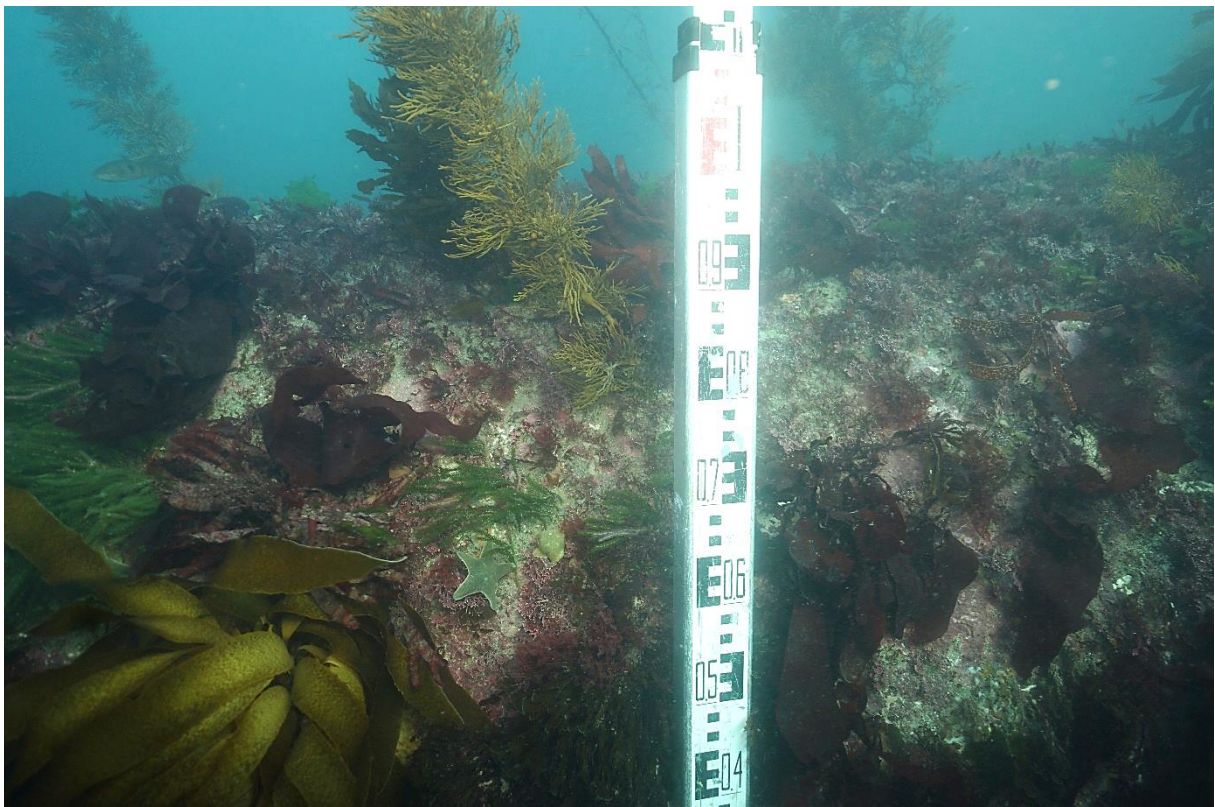
Figure 6: Zone M to D – 60m position

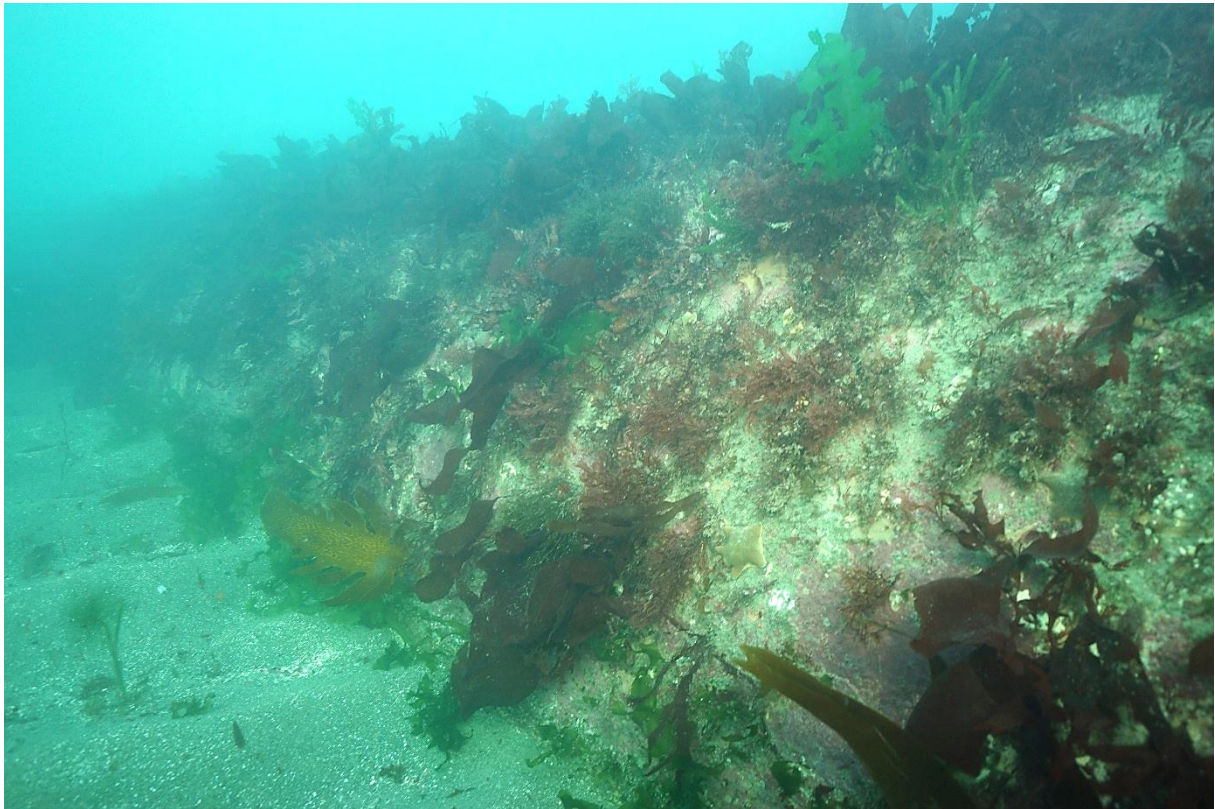
Figure 7: Zone M to D – 80m position

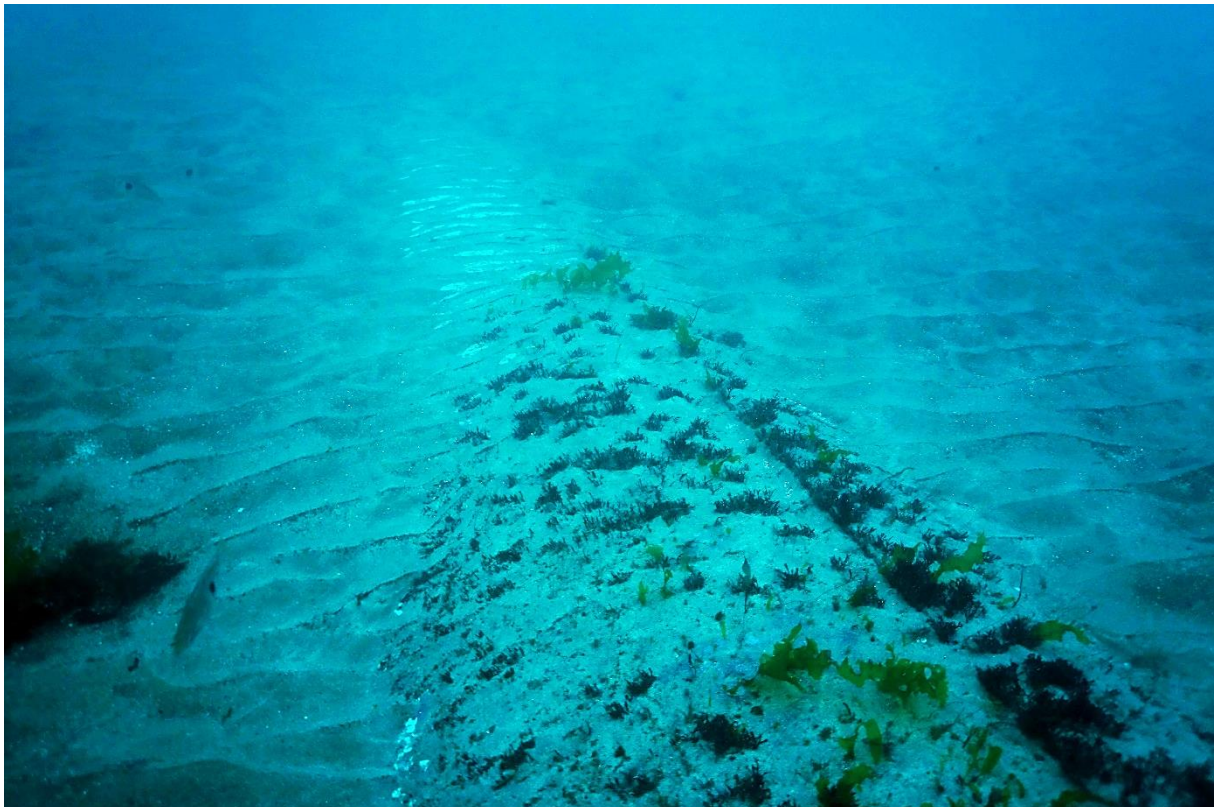
Figure 8: Position D – seaward position of pipeline departure back below seabed

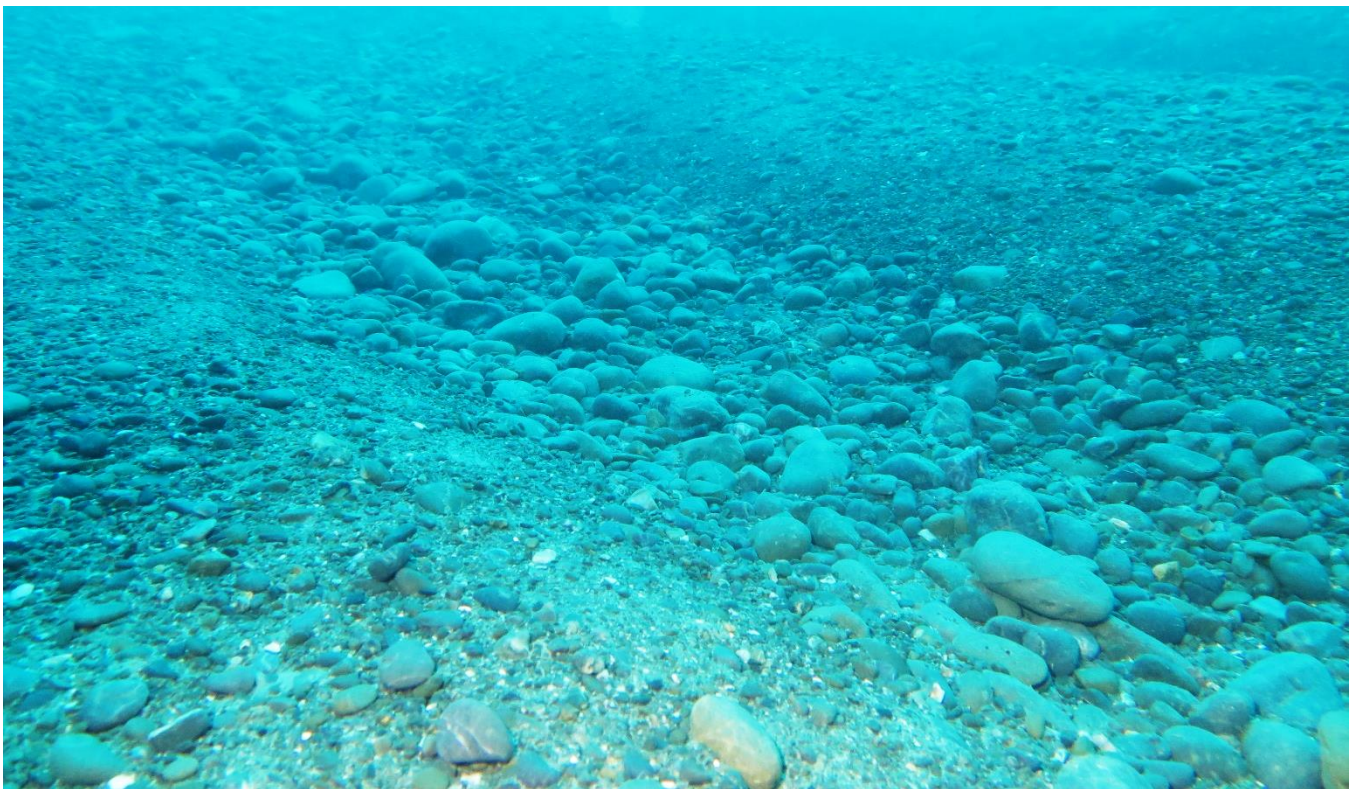
The result of the underwater inspection of the pipeline route being; no areas of concern observed.

Figure 10: Typical seafloor profile and aggregate composition at seaward end of pipeline route. Approaching closer to position 'D' the aggregate sizing reduces, primarily to small gravel and coarse sand. Then returns to a combination of rocky outcrops, small to large boulders, and coarse gravels through the shallower shoreline surf zone.

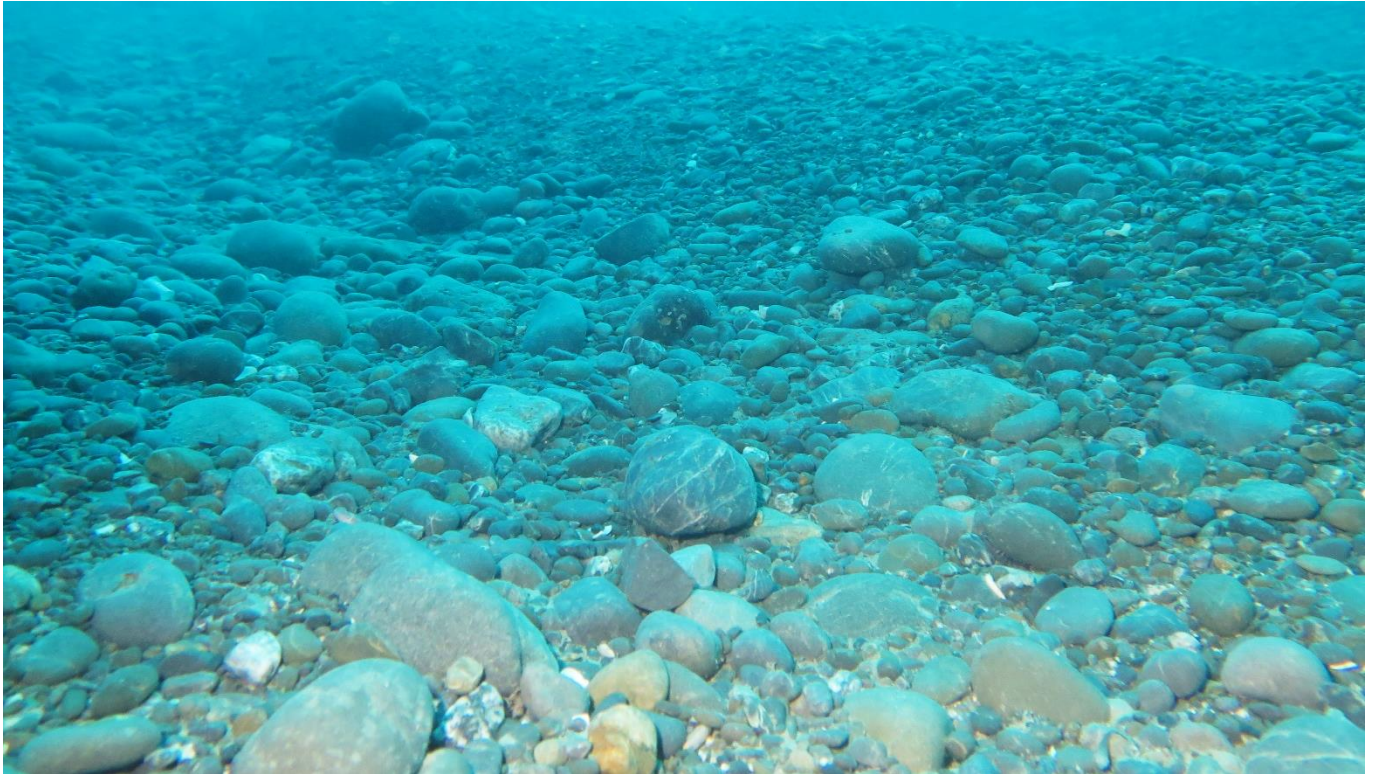
No evidence was observed of any damage or deterioration to any of the 18 diffuser assemblies. About the diffuser positions, seafloor deposits of rocks, coarse gravels and sand form undulating peaks and depressions traversing the seafloor in west / east orientation, typically of +/- 300mm in height and mirroring wave direction.

Figure 12: Typical seafloor profile and aggregate composition around the Diffuser section

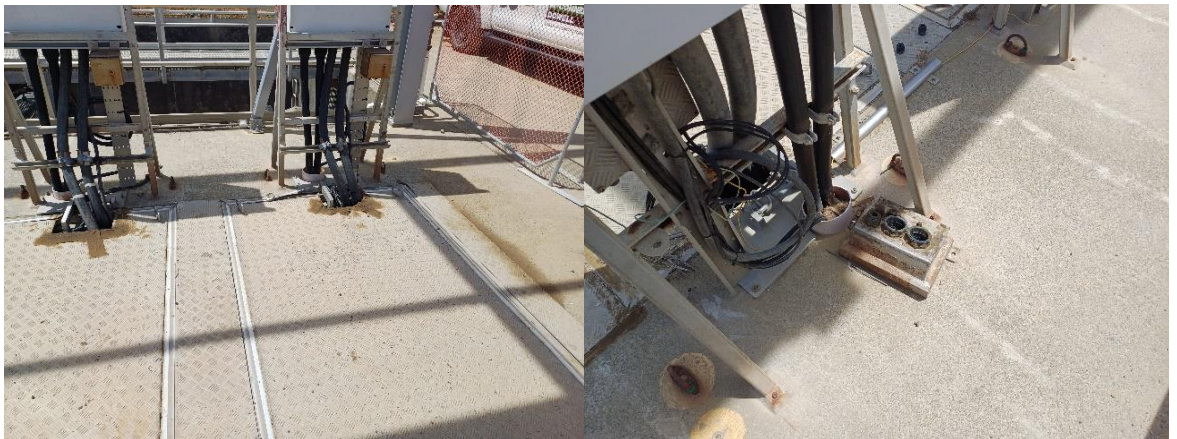
After approximately 30-minutes, a site walk around was conducted to assess the physical containment aspects of the odour control system. As the IPS is in the process of being decommissioned and incorporated into the new sludge minimise plant, limited preventative maintenance has been performed and as a result all the seals around the pumps power supplies were missing and in poor condition after a recent overhaul of the pumps and wet wells (see Figure 3).

■ **Figure 3: Moa Pt IPS Seals, 26 January 2024**

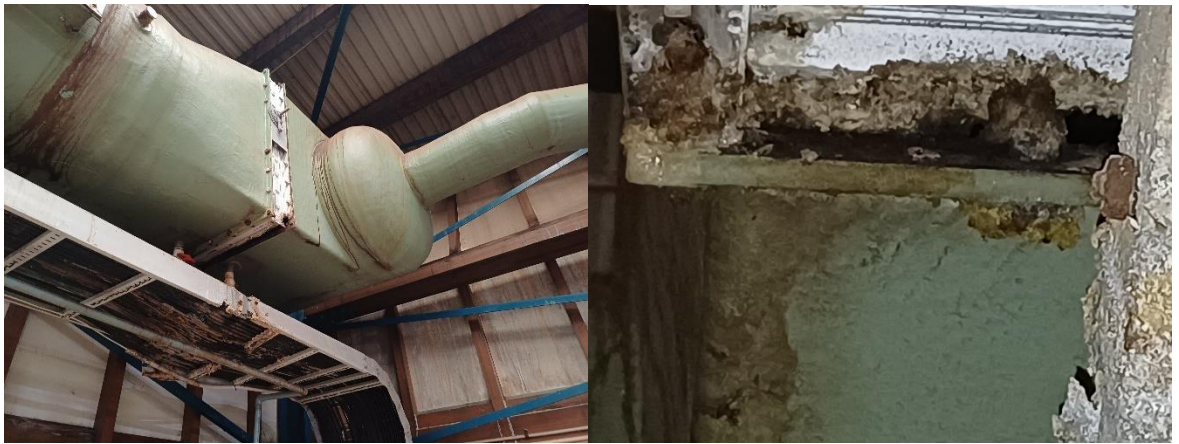
Examination of the odour control duct found the primary treatment room flow control baffle to be severely degraded with large holes evident (see Figure 5). The extremely poor condition of this baffle has potentially reduced the effective ventilation rate of the primary treatment room. Hence, *it is recommended that the primary treatment flow control baffle be replaced and associated ducting repaired.*

■ **Figure 5: Primary Treatment Room Baffle, 26 January 2024**

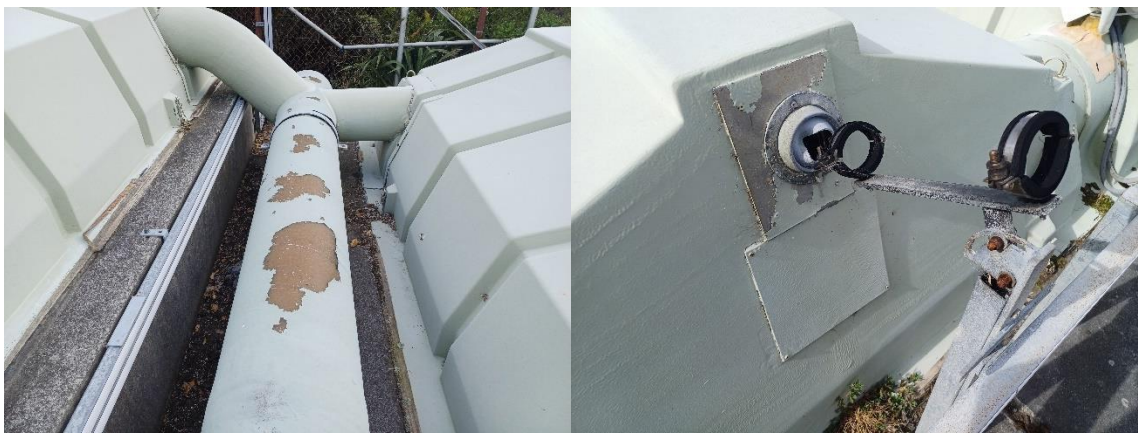
The visual assessment of the MBBRs, RATs and SCRTs odour containment system found the fibre glass enclosures, ducting and associated seals to be weathered with flaking paint, cracked rubber and numerous gaps (see Figures 9 and 10). Furthermore, the tape used on repairs was also degraded and the overall conditions of the cover seals was poor. While smoke testing showed the system was being maintained under negative pressure, the poor condition of the seals and repairs acts to increase the risk of fugitive odour emissions. Therefore, *it is recommended that the secondary treatment containment system be upgraded to rectify the poor condition of the seal and observed leaks.*

■ **Figure 9: Secondary Treatment Enclosure Weather Paint and Holes, 26 January 2024**

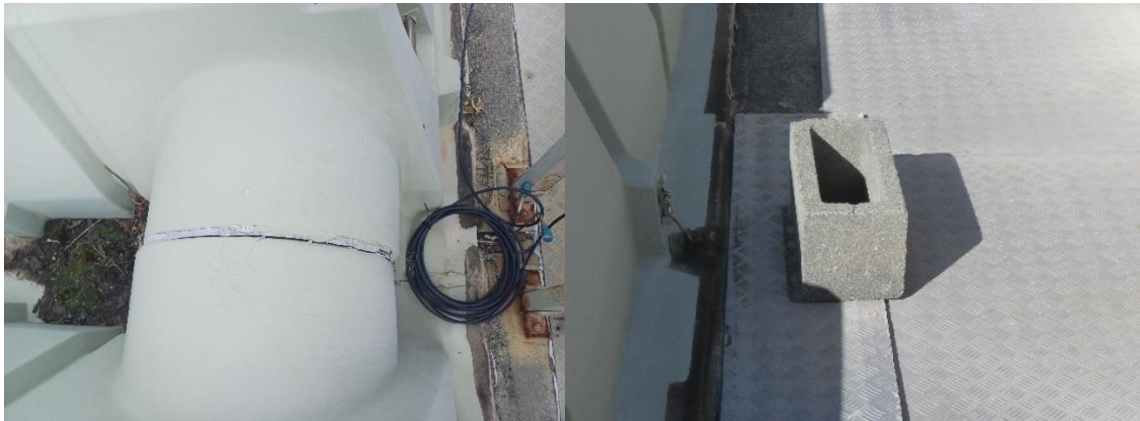
■ **Figure 10: Secondary Treatment Enclosure Seals, 26 January 2024**

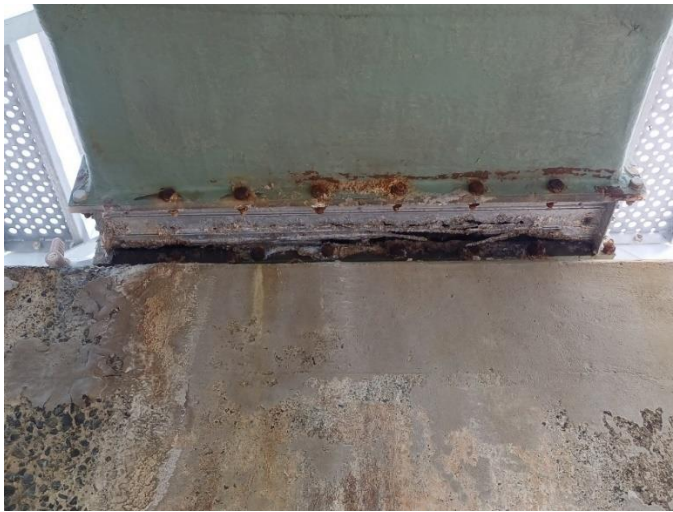
The flow control baffle for the MBBR tanks was found to be highly degraded with significant gaps and holes visible as depicted in Figure 11. The flow control baffle for the RATs and SCRTs extraction ducting was also degraded with substantial rust and the drain line was semi-detached (see Figure 12). Hence, *it is recommended the MBBR and RATs and SCRTs flow control baffles be repaired or replaced.*

■ **Figure 11: MBBR Flow Control Baffle, 26 January 2024**

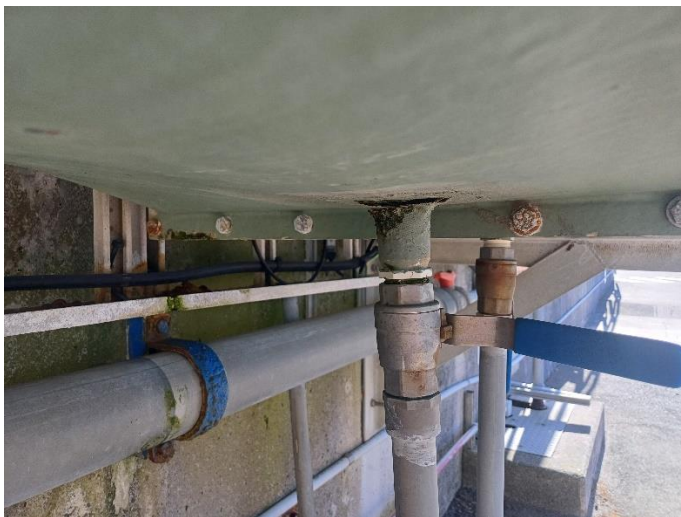
■ **Figure 12: Rats & SCRTs Flow Control Baffle, 26 January 2024**
