<b>Document Title</b>	UCL – QMS – IMS – Moa Point Waterwater Outfall Pipeline – Annual Inspection
<b>Document No.</b>	QMS – Item: Inspection – Moa Point Pipeline – March 2025 – Rev. 0
<b>Date Developed</b>	February 2025
<b>Last Review Date</b>	March 2025
<b>Date of Client Issue</b>	13 <sup>th</sup> May 2025

## MOA POINT WASTEWATER OUTFALL PIPELINE – ANNUAL INSPECTION

March 2025

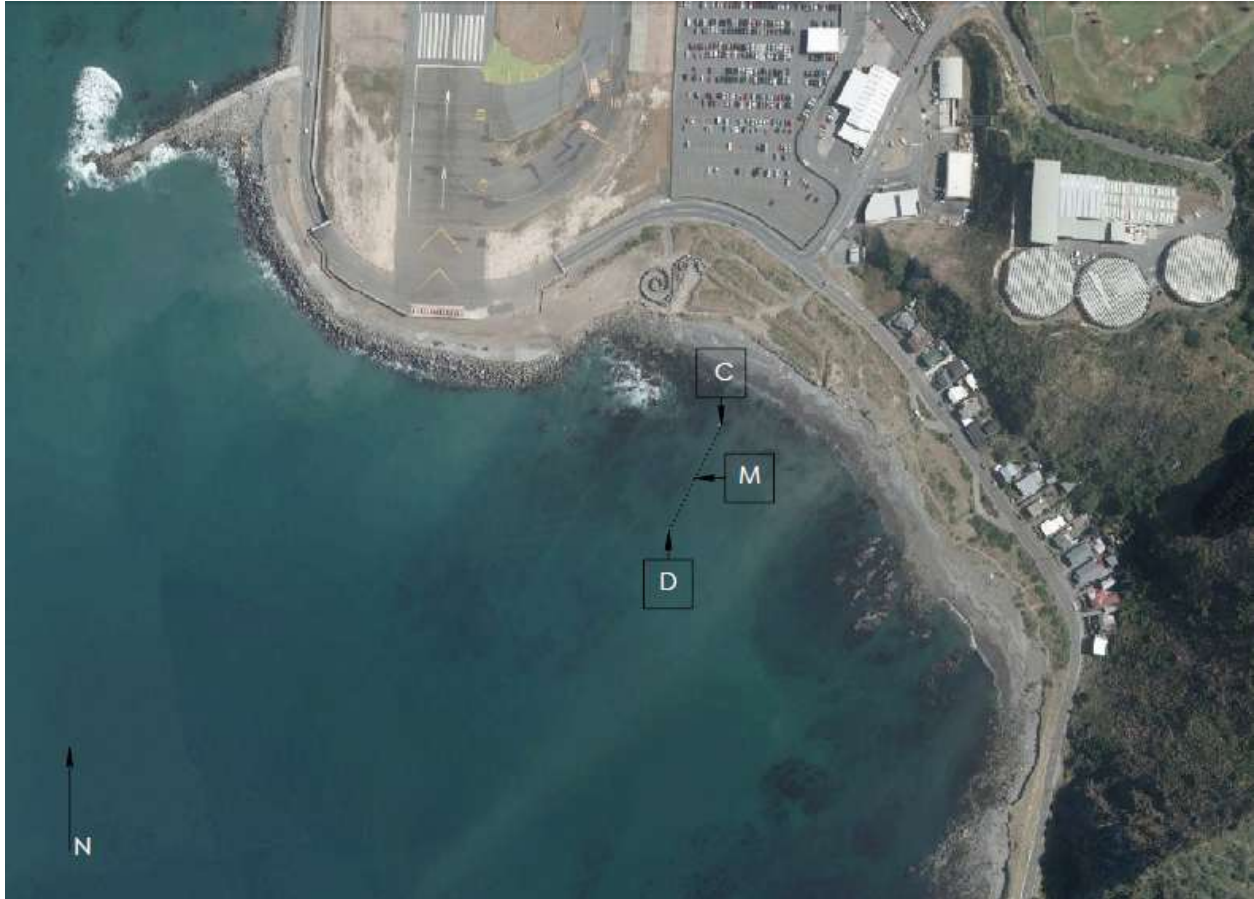
Figure 3: Shallow Water Section – Exposed Pipeline between positions C & D

SCOUR DEPTH DATA			
Position [m]	2025		
	West (mm)	East (mm)	Comment
<b>C</b> 00.0	150	150	
10.0	150	150	
20.0	300	300	
30.0	450	500	
<b>M</b> 40.0	600	650	
50.0	800	800	
60.0	900	950	
70.0	950	1050	
80.0	750	800	
<b>D</b> 90.0	150	150

While neither the length of exposed pipe nor the maximum scour depth have increased, the average scour depth over the length was found to be greater.

Over the period between the 2024 to 2025 annual inspections, exposed pipe length has remained constant, and maximum scour depth adjacent to the pipeline remains stable; however, the average scour depth within the 'M' to 'D' positional zone has increased over the period.

The occurrence of scour being predominately due to the cyclic effect of repetitive southerly sea states, resulting in sand and light gravel deposit migration within the shallows and along the shoreline.

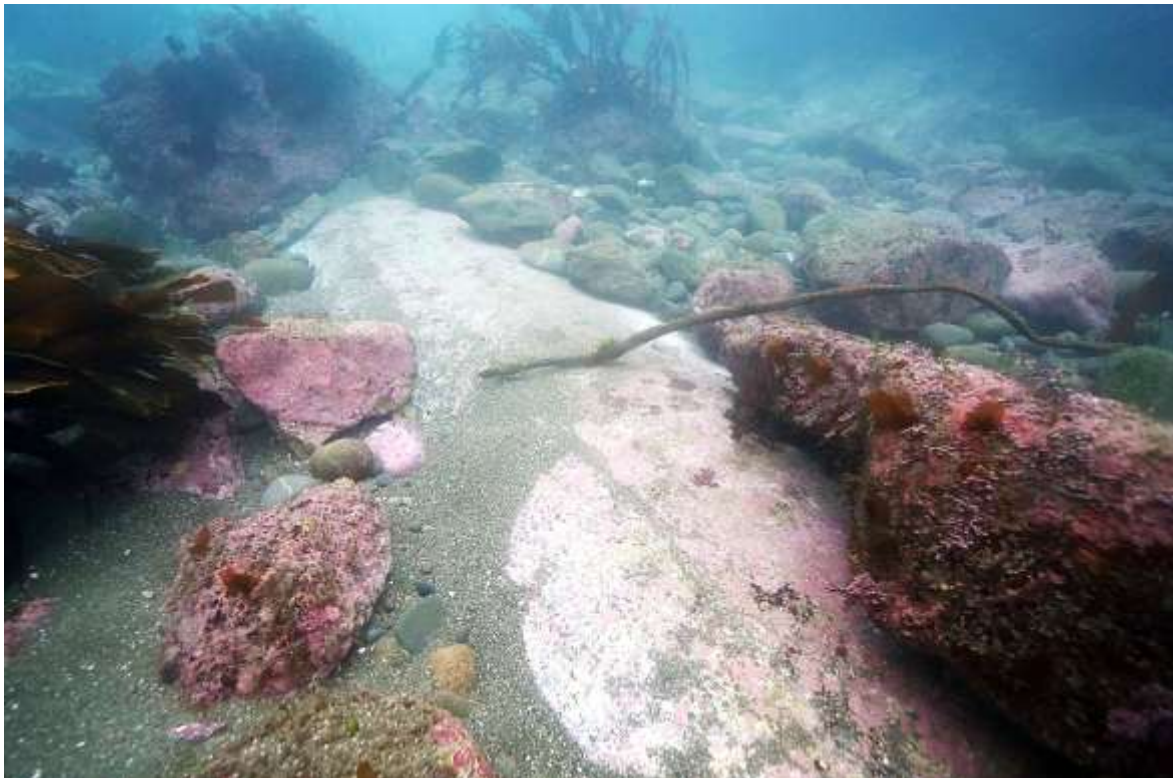
Figure 4: Zone C – shoreward position at which pipe exposure commences

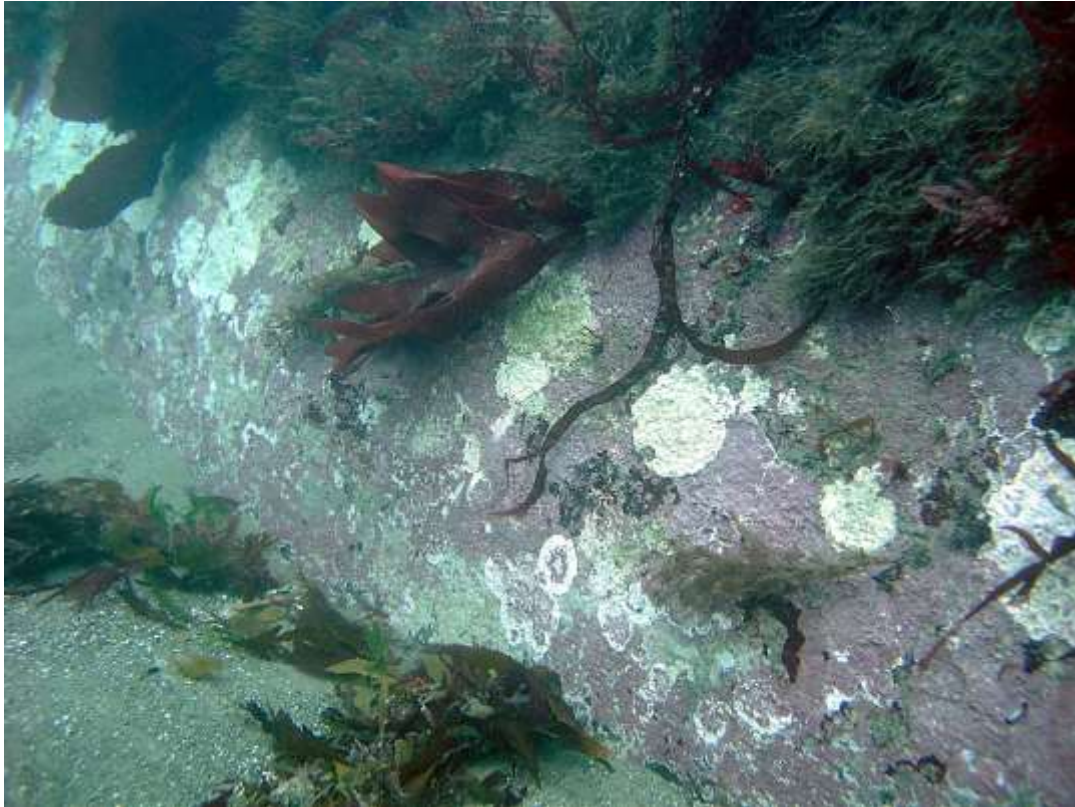
Figure 5: Position M – shoreward end of zone M to D

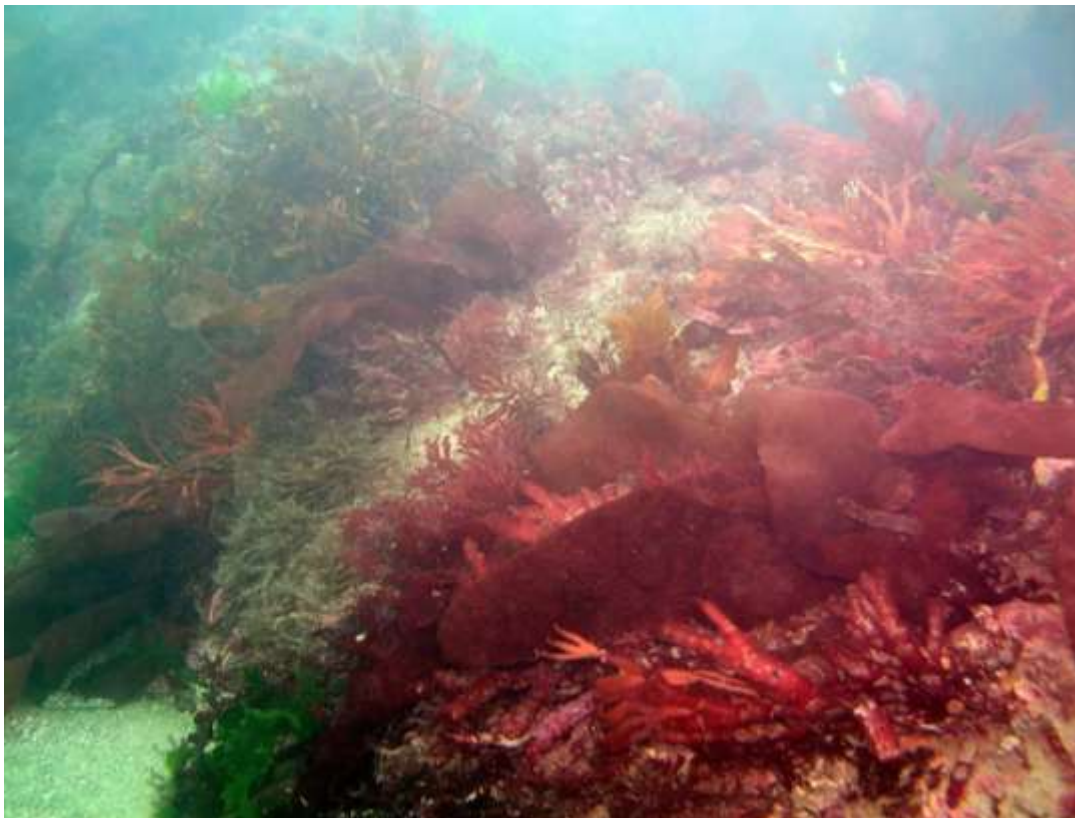
Figure 6: Zone M to D – 60m position

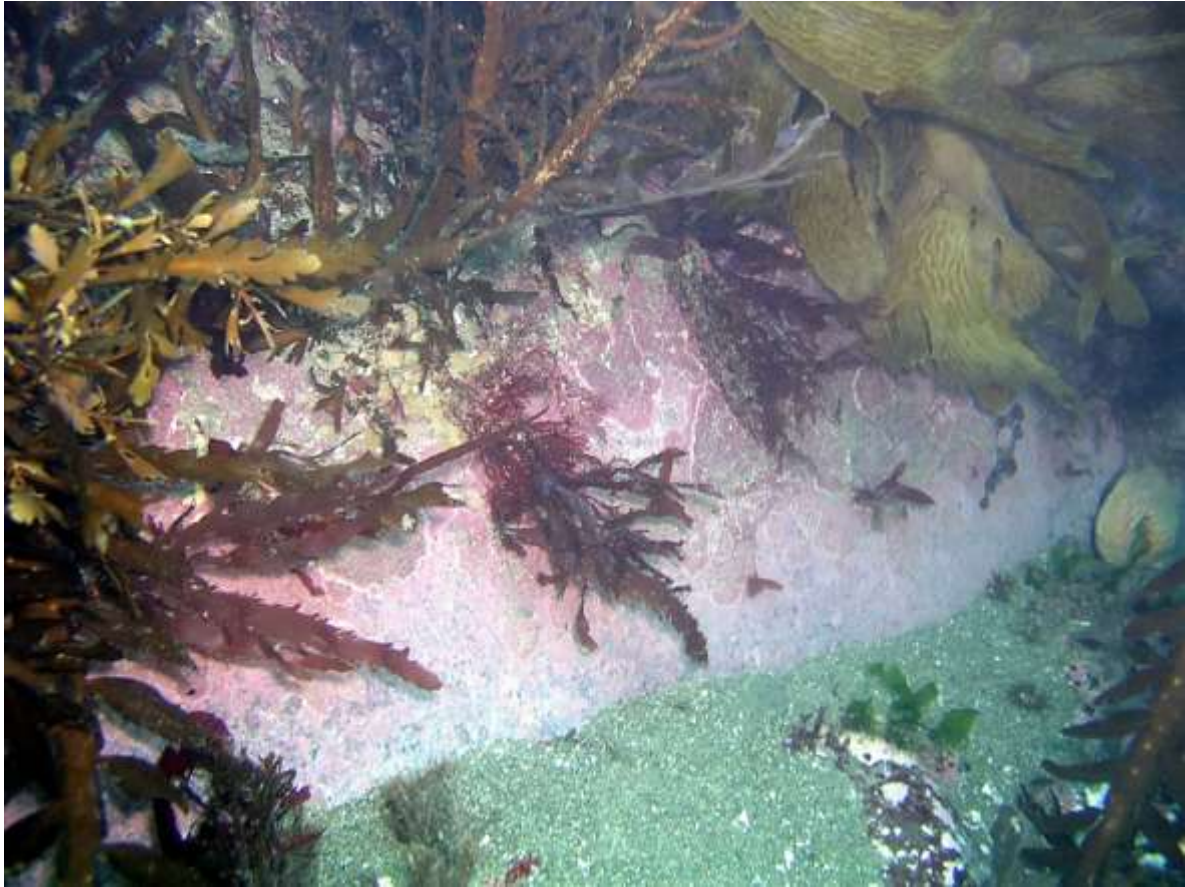
Figure 7: Zone M to D – 80m position

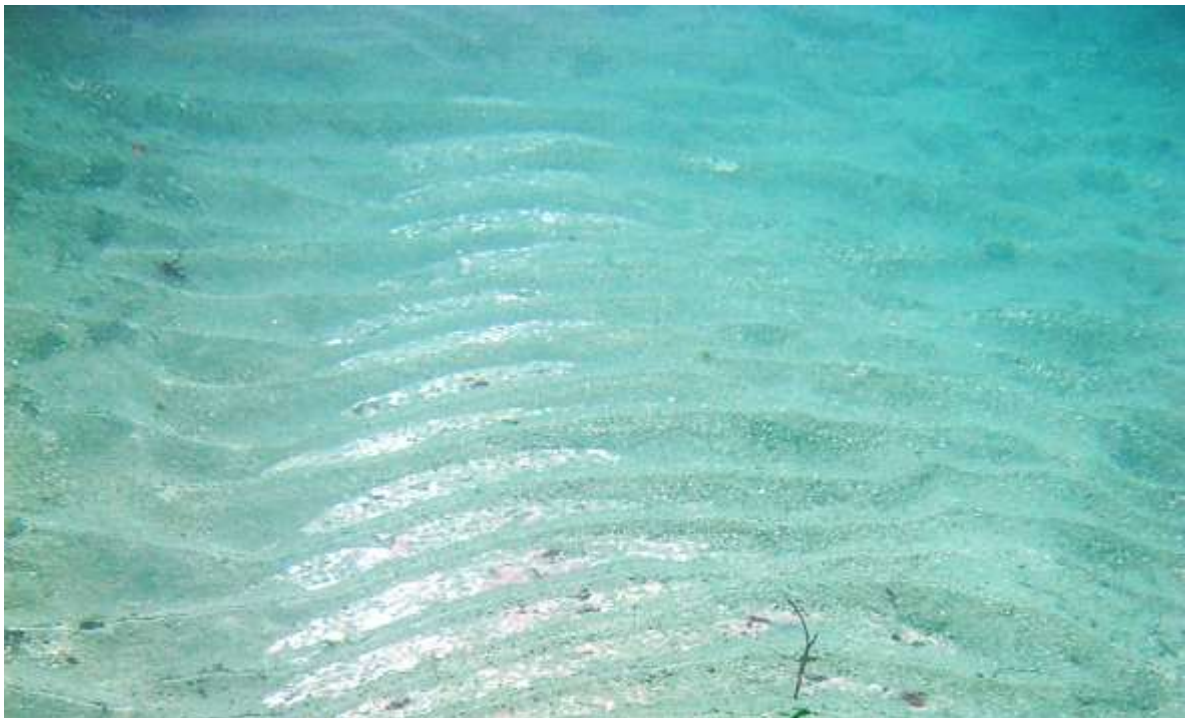
Figure 8: Position D – seaward position of pipeline departure back below seabed

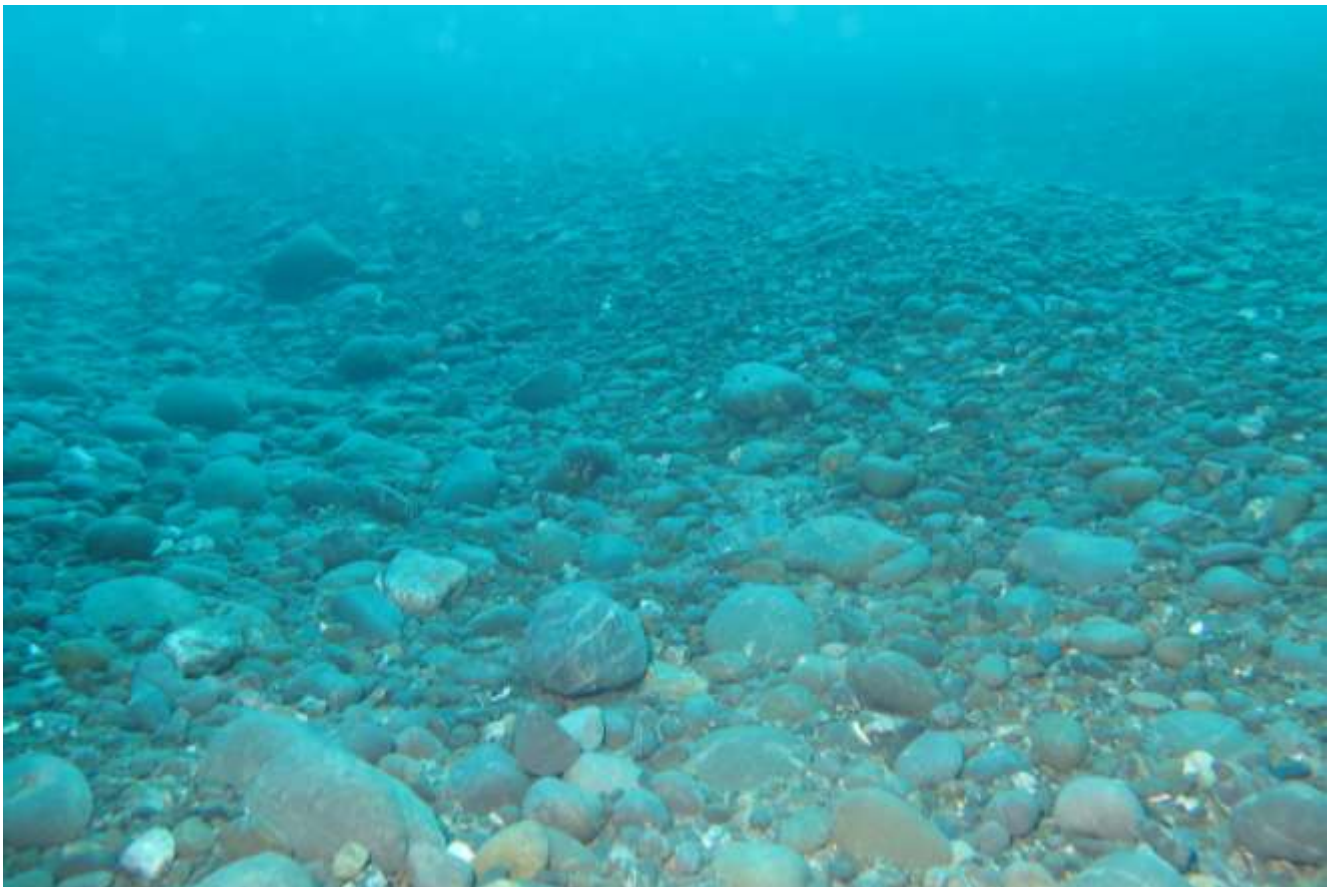
The result of the underwater inspection of the pipeline route being; no areas of concern observed.

Figure 10: Typical seafloor profile and aggregate composition at seaward end of pipeline route. Approaching closer to position 'D' the aggregate sizing reduces, primarily to small gravel and coarse sand. Then returns to a combination of rocky outcrops, small to large boulders, and coarse gravels through the shallower shoreline surf zone.

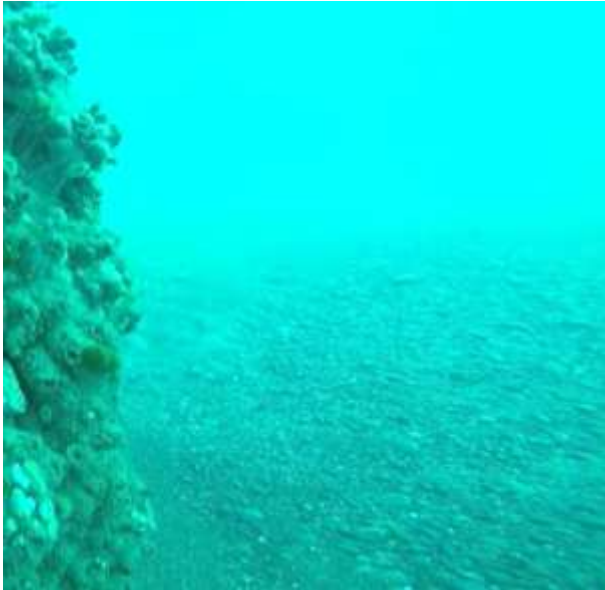
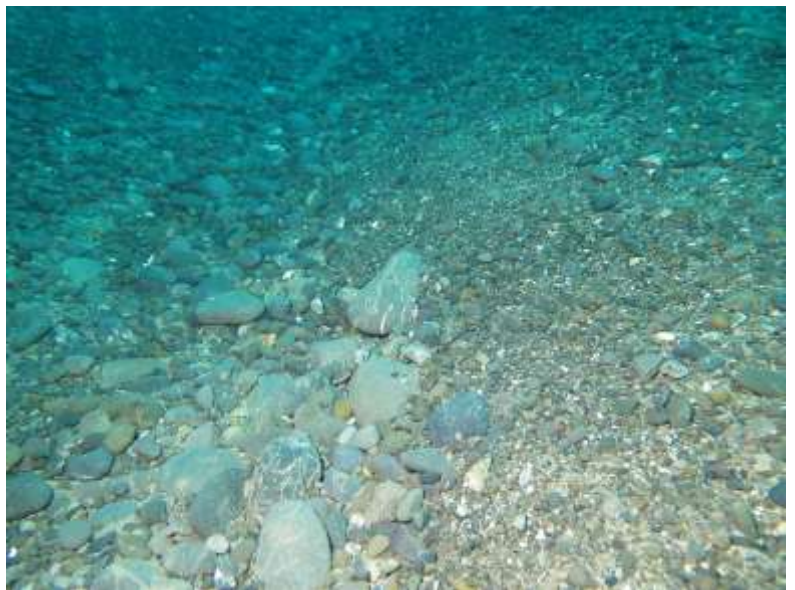
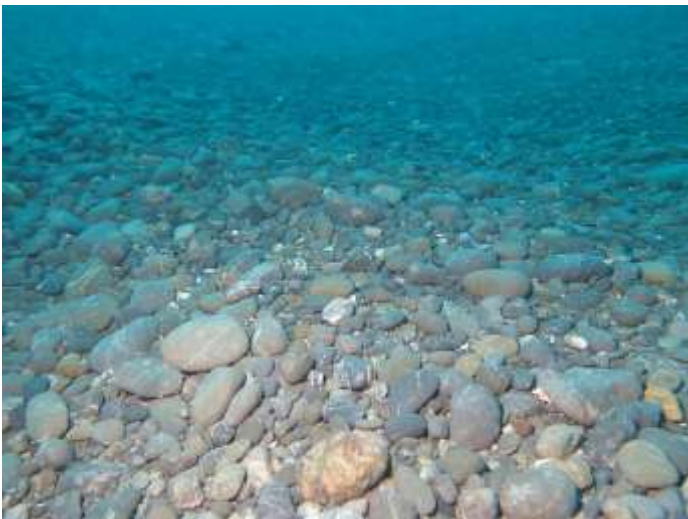
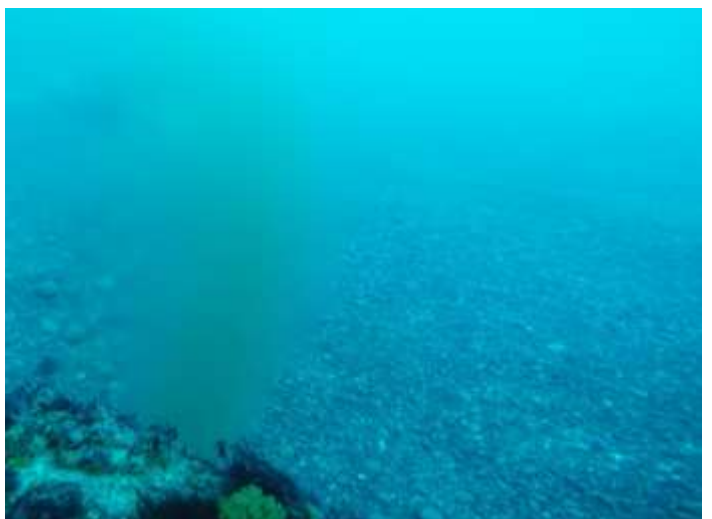
Figures 13, 14, 15, &16:

No evidence was observed of any damage or deterioration to any of the 18 diffuser assemblies. About the diffuser positions, seafloor deposits of rocks, coarse gravels and sand form undulating peaks and depressions traversing the seafloor in west / east orientation, typically of +/- 300mm in height and mirroring wave direction.

Typical seafloor profile and aggregate composition around the Diffusers 1, 11, 12, 18 (as per photo order)

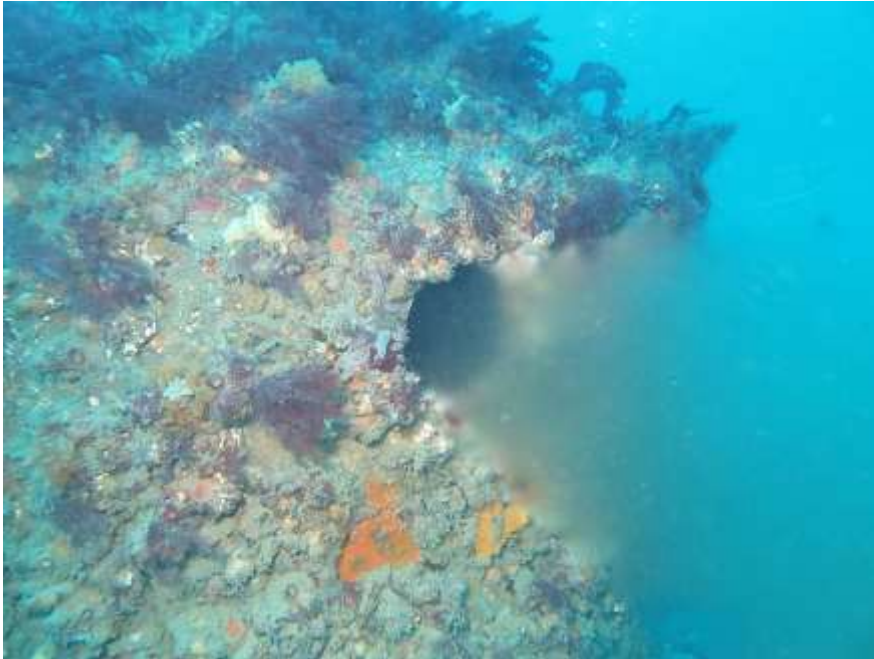
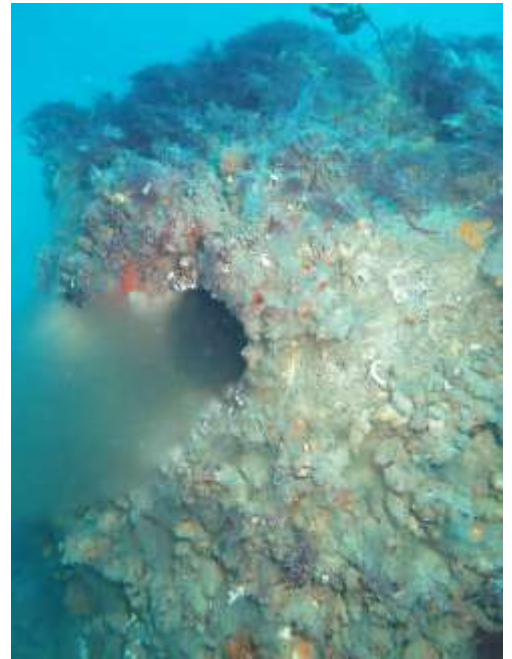
Figures 17 & 18: Diffusers in operation

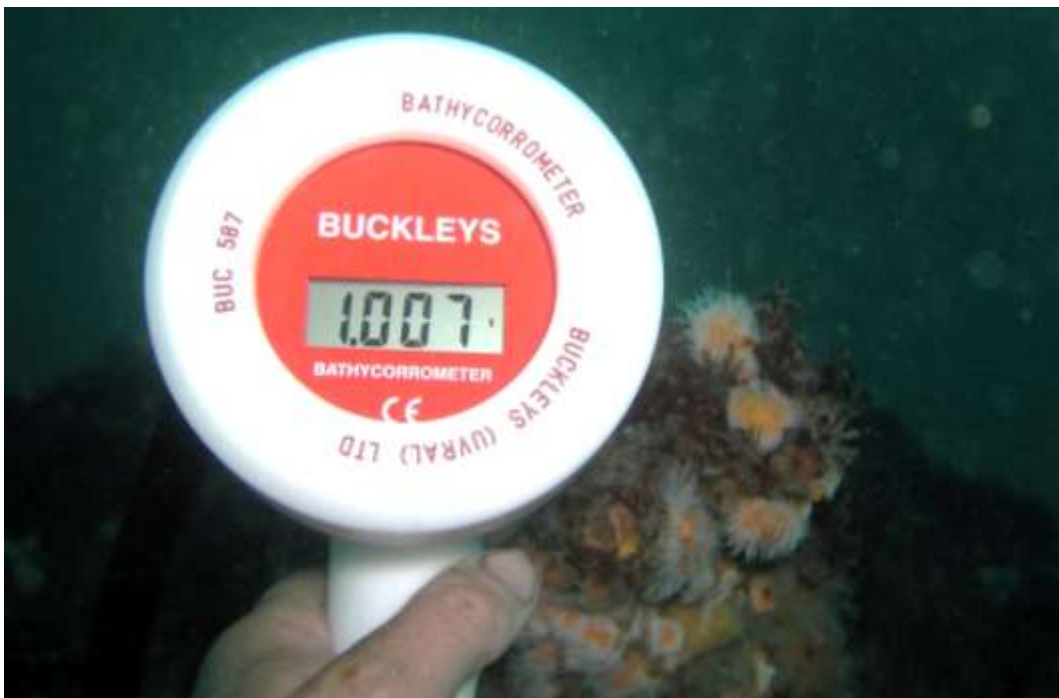
Figure 22: Cathodic Potential reading taken at Diffuser # 1

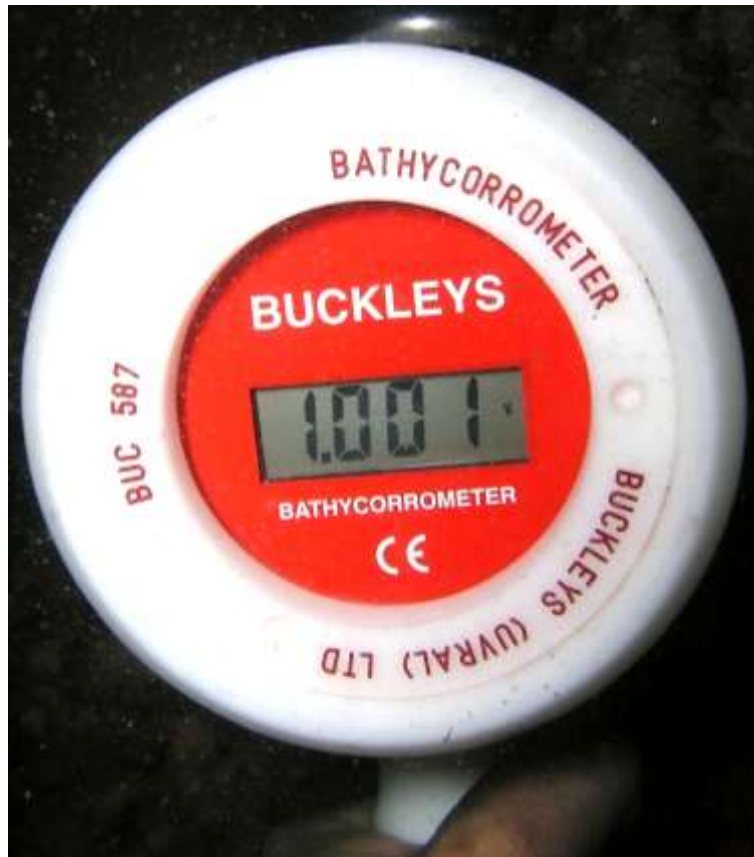
Figure 23: Cathodic Potential reading taken at Diffuser # 3

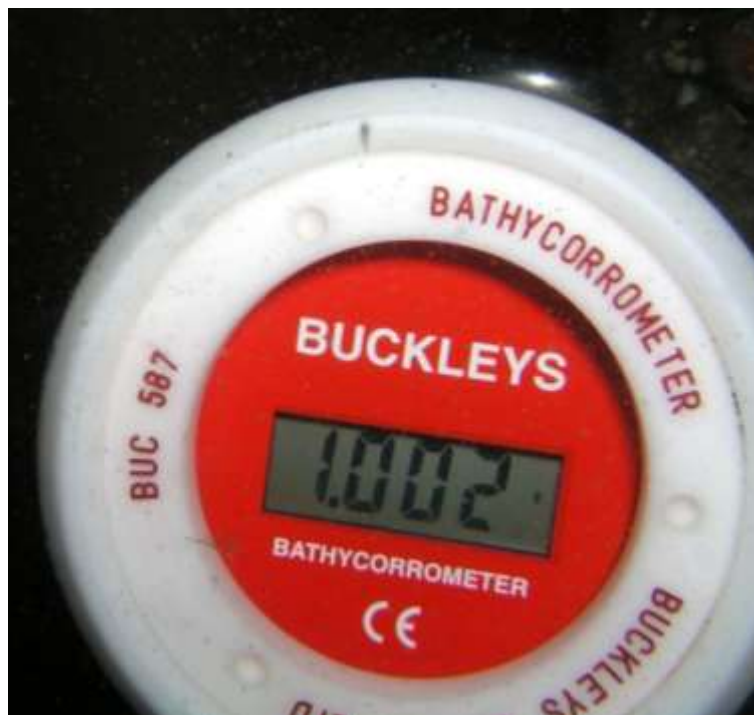
Figure 24: Cathodic Potential reading taken at Diffuser # 7

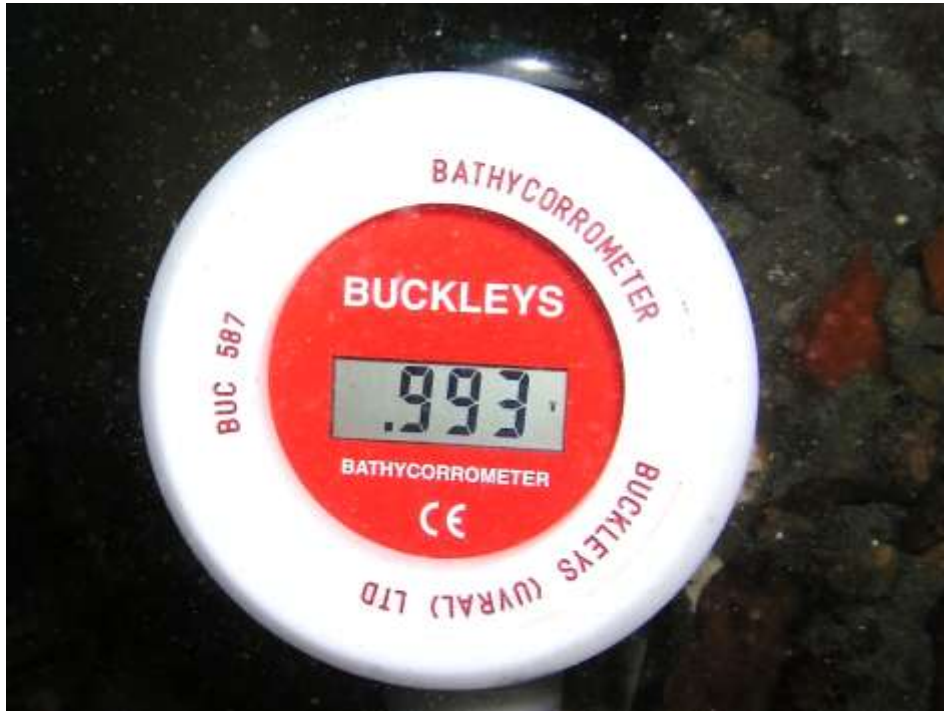
Figure 25: Cathodic Potential reading taken at Diffuser # 11

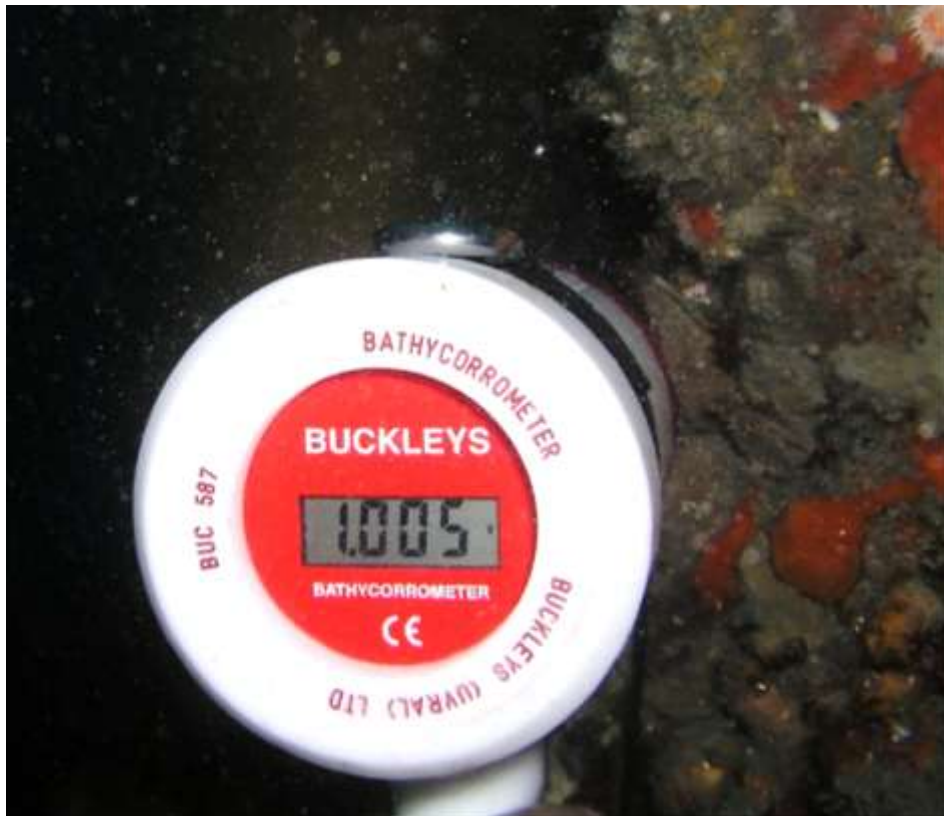
Figure 26: Cathodic Potential reading taken at Diffuser # 17
