Veolia Water Services (ANZ) Pty Ltd

MOA POINT WASTEWATER TREATMENT PLANT –
ANNUAL SMOKE TESTING, NOVEMBER 2024

February 2025

Source Testing New Zealand Ltd
PO Box 32 017
Maungaraki
Lower Hutt 5010
Tel: 0275 533 210
Fax: 04 569 4446

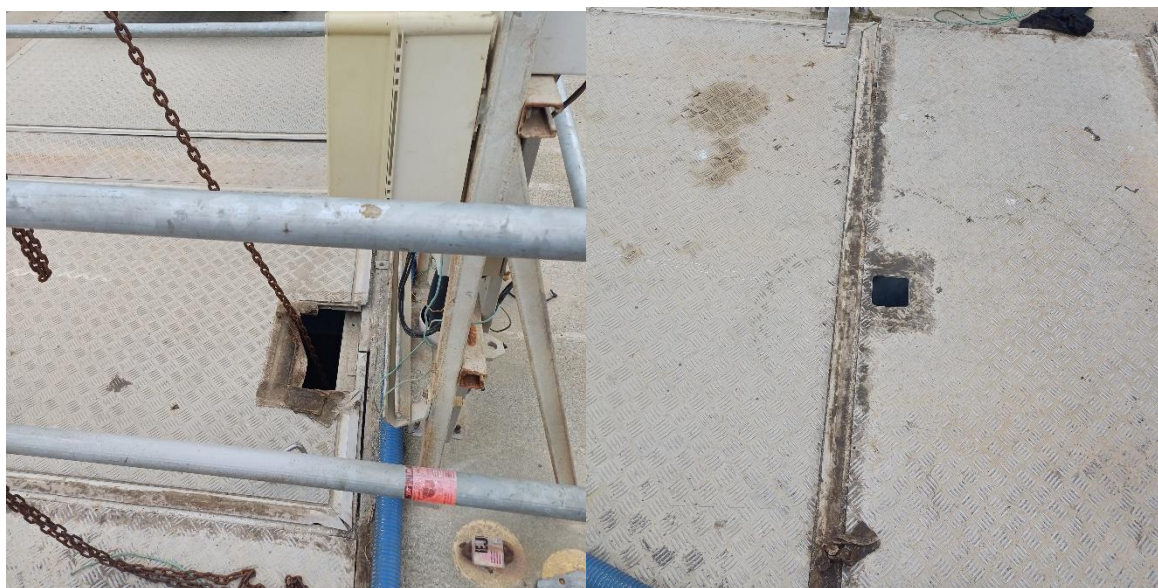
■ **Figure 1: Moa Pt IPS Seals, 23 November 2024**

The ongoing construction and upgrades to the IPS has resulted in most of the seals being either completely removed or in such a poor condition that the covers are no longer able to contain the foul air within the inlet works (see Figure 1). Furthermore, the condition of the seals has degraded further since the last assessment in January 2024 when there were no visible emissions, as multiple leaks were observed emitting from the gaps between covers, cable flanges and other unsealed access ports.

In summary, the work on the IPS has resulted in the odour extraction system no longer being able to maintain a negative pressure within the system, allowing foul air to be released leading to the light moderate sewage odour on site. Unfortunately, this will be an ongoing issue until the IPS is fully contained within the structure of the SMF.

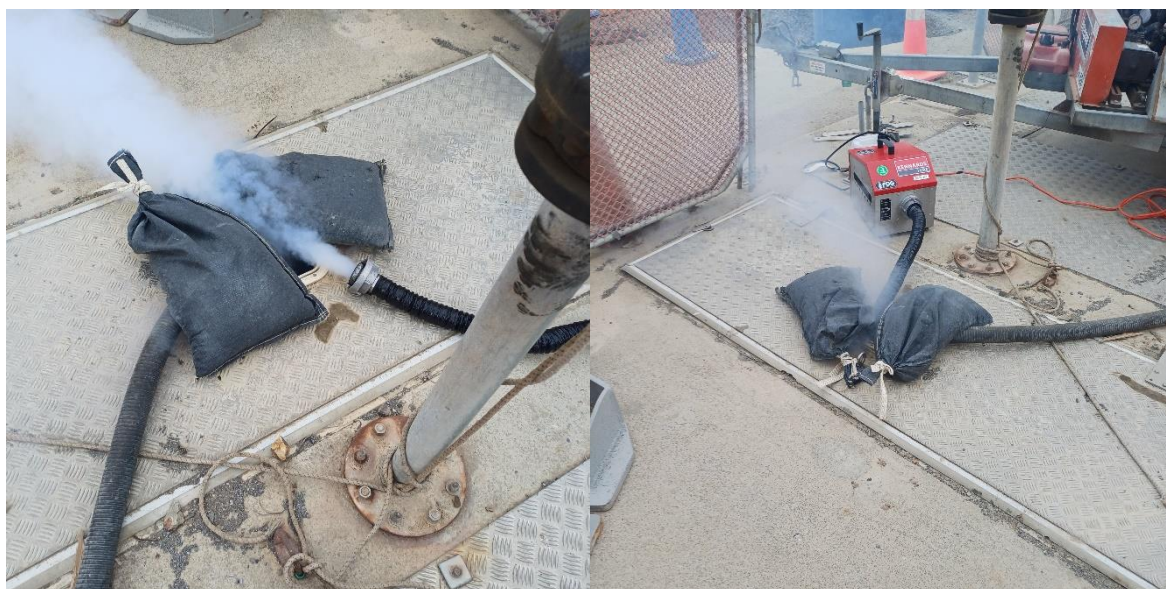
■ **Figure 2: Moa Pt IPS Smoke Machine, 23 November 2024**

Smoke testing of the Moa Pt IPS was performed on a Saturday to minimise the amount of activity on the wet wells and was performed by inserting an industrial smoke machine into an inspection hatch above of one of the wet well to fill the chamber for approximately 30-minutes (see Figure 2). During previous smoke testing, visible emissions from the IPS scrubber were normally observed within a few minutes, however, the for the current assessment this took over 20 minutes.

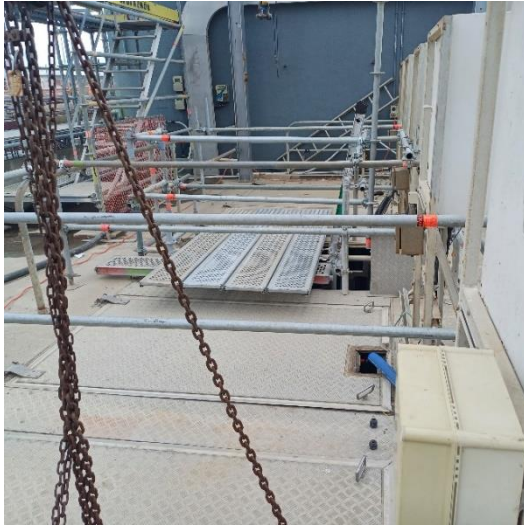
■ **Figure 3: Moa Pt IPS Wet Well Access Scaffolding, 23 November 2024**

The current work at the IPS required scaffolding to access the wet wells which prevented the covers from being closed for the assessment (see Figure 3). During the week however, the covers will often be open and ventilated as was the case on 23 December 2024 (see Figure 4) when STNZ was on site for other testing. There is currently a light raw sewage odour routinely detected on site which is most likely due to with the open covers and active ventilation of the wet wells.

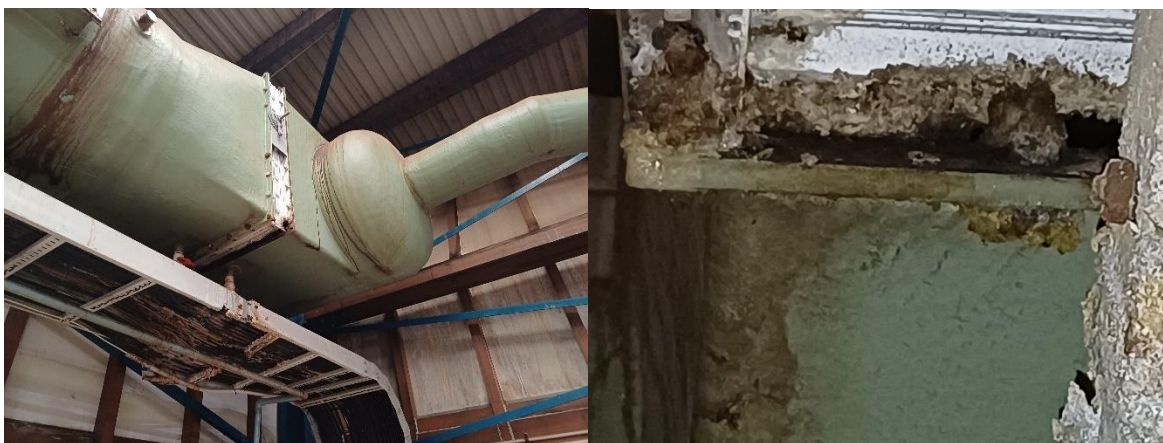
■ **Figure 5: Primary Treatment Room Baffle, 23 November 2024**

The primary treatment room is actively ventilated via a ceiling level duct above the outlet of the process channels. The extraction ducting from the primary treatment room combines with duct from the covered inlet channels immediately prior to exiting the building. At this junction a flow control baffle enables the extraction rates to be adjusted, however, the baffle is so severely degraded that it is no longer fit for purpose and will be adversely affect the building ventilation rates (see Figure 5). Hence,

The combination of the damaged baffle and the dirty grills will act to limit the effective ventilation of extraction primary treatment room as air will preferentially be drawn from the immediate vicinity of the baffle, reducing the extraction rate for the remainder of the building, furthermore, the ventilation of the covered inlet channels will also be adversely affected.

It is recommended that the primary treatment flow control baffle be replaced and the associated ducting repaired.

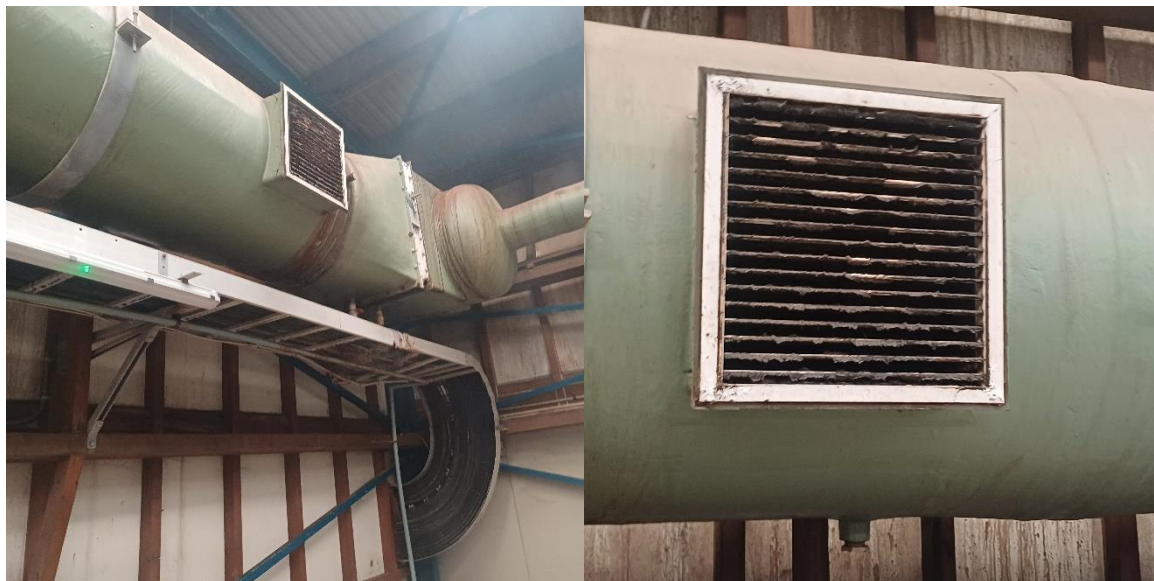
■ **Figure 6: Primary Treatment Room Extraction Grills, 23 November 2024**

The extraction ducting has six ventilation grills to capture foul from the process and are currently covered in a thick coating that will be acting to restrict the flow (see Figure 6). Hence,

It is recommended that the primary treatment extraction grill undergo a deep clean remove the excessive fouling.

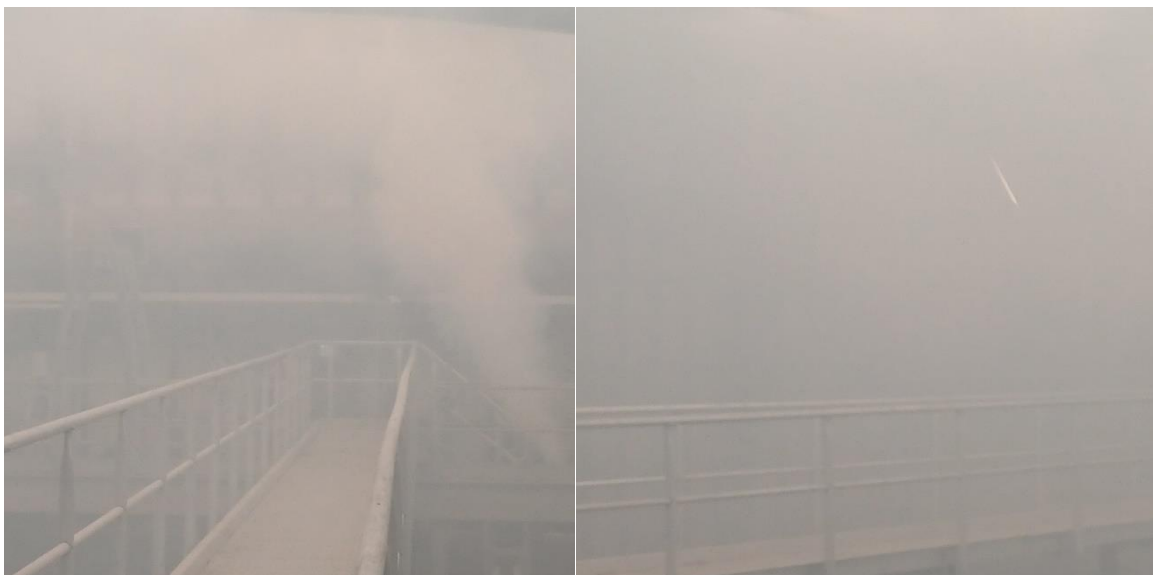
■ **Figure 7: Moa Pt Primary Tanks, 23 November 2024**

Smoke testing of the Moa Pt WTP primary treatment room was performed by placing an industrial smoke machine at the inlet end of the primary treatment room (see Figure 7) and allowing the space to fill for approximately 45-minutes. Once the building was full of smoke, the exterior of the building, including the roof, was visually assessed to identify any leaks which could indicate potential sources of fugitive odour emissions.

On 23 November 2024, no visible smoke was observed emitting from the exterior of the building indicating that despite the issues with the extraction ducting, the building was being maintained under negative pressure thereby minimising the potential for fugitive odour emissions.

In addition to identifying any potential leak, the smoke testing also provides an indication of the buildings ventilation rate by determining the time taken to clear 95 % of the smoke, which for the current assessment was approximately 40-minutes and indicates a ventilation rate of 1.5-room changes per hour. Engineering guidelines for this type of process are in the range 3 to 5 room changes per hour, up to 10 room changes in cases where workers are required to routinely enter the area.

In January 2024, the estimated ventilation rate was 2-room changes per hour, while in November 2022 it was 3- room changes per hour with the decline indicating the performance of the extraction system is deteriorating and is no longer suitable for routine access. Hence,

It is recommended that the primary treatment odour control extraction ducting be repaired to ensure adequate ventilation for operators to routinely work in the area.

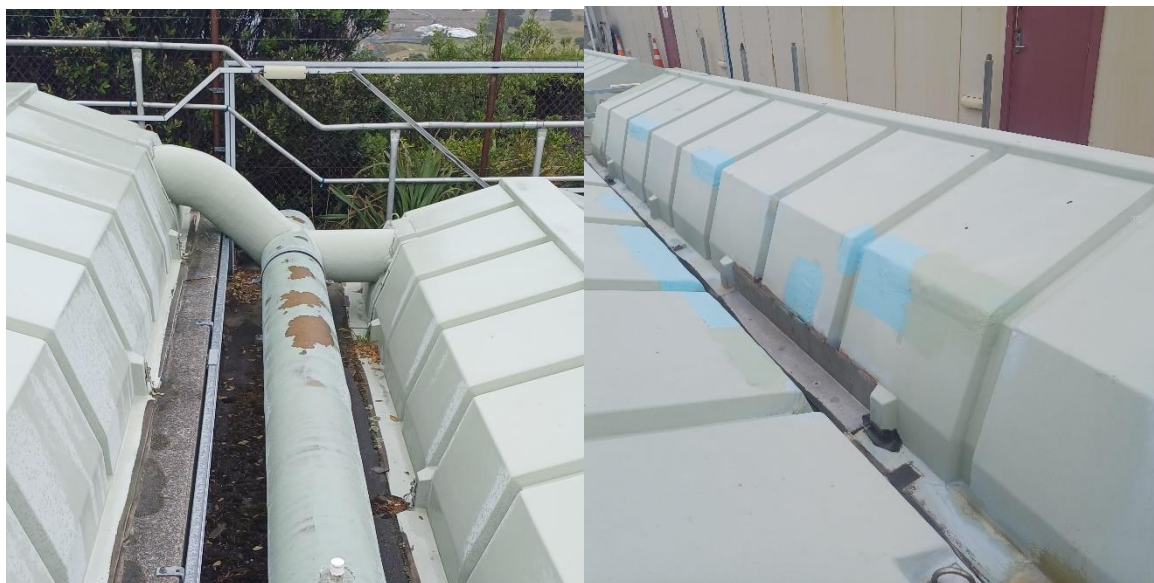
■ **Figure 8: Secondary Treatment Covers & Ducting Weathering, 23 November 2024**

The visual assessment of the secondary treatment odour containment system found the fibre glass enclosures and ducting to be weathered and showing its age (see Figure 8) but were generally still fit for purpose.

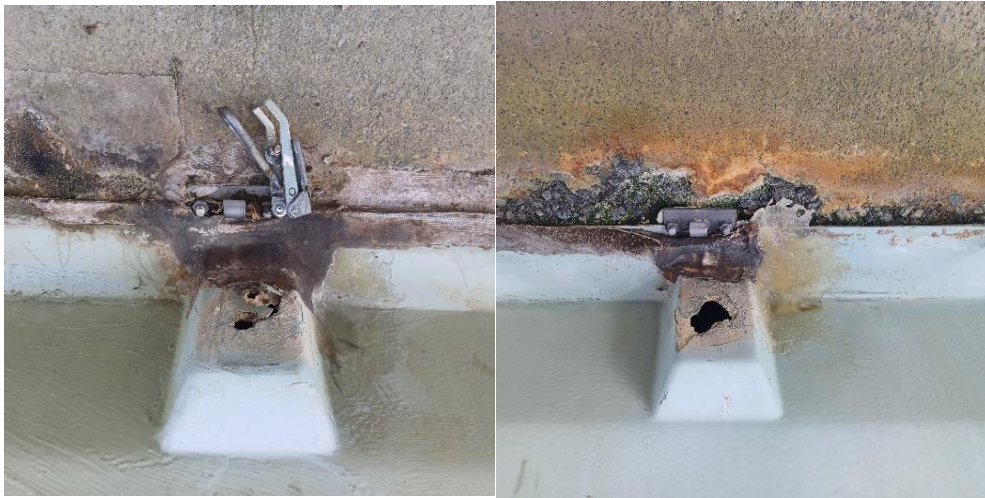
■ **Figure 9: MBBR Latches, 23 November 2024**

In mid-2023, the northern MBBR tank was refurbished which required the covers to be removed which caused some minor damage to the structure, in particular the latches and seals as depicted in Figures 9 and 10 respectively. Hence,

It is recommended that the all the seals and latches of the MBBR tanks covers be repaired to prevent potential fugitive odour emissions.

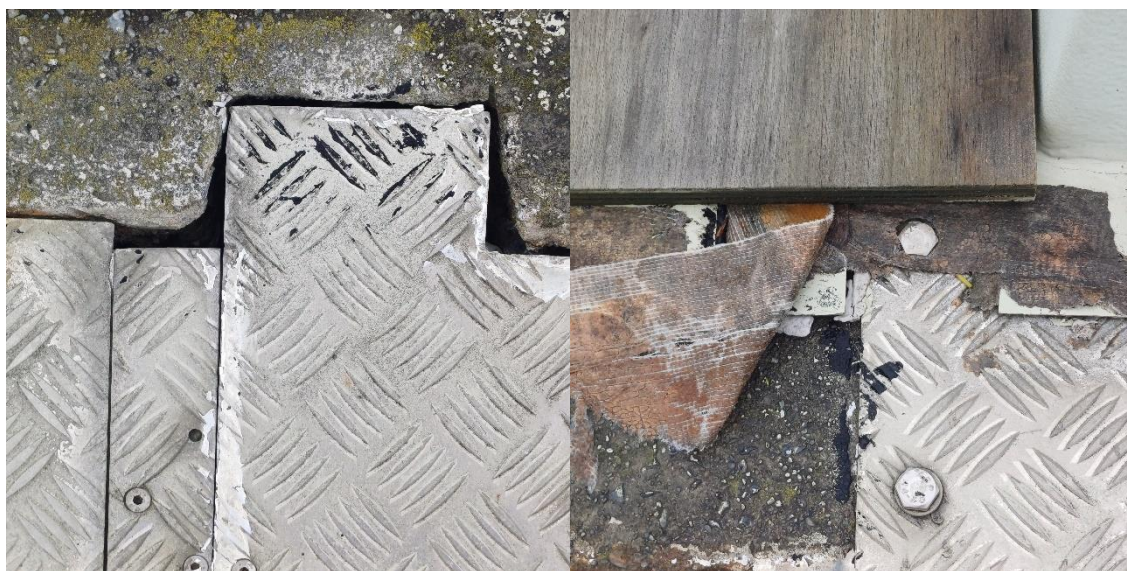
■ **Figure 11: Secondary Treatment Seals, 23 November 2024**

Inspection of the remaining covers found a large portion of the seals for the covers and floor plates to be in a poor condition with the potential for fugitive odour emissions (see Figure 11). One area of particular concern were the seals for the floor plates located by the stairs from the northern MBBR to RAT where the seals were in particularly poor condition and there was a discernible odour sewage odour present on the day of the assessment and has routinely been detected by STNZ. Hence,

It is recommended that high priority be given to the repair of the floor plate seals in the vicinity of the transition from the northern MBBRs to the RATs

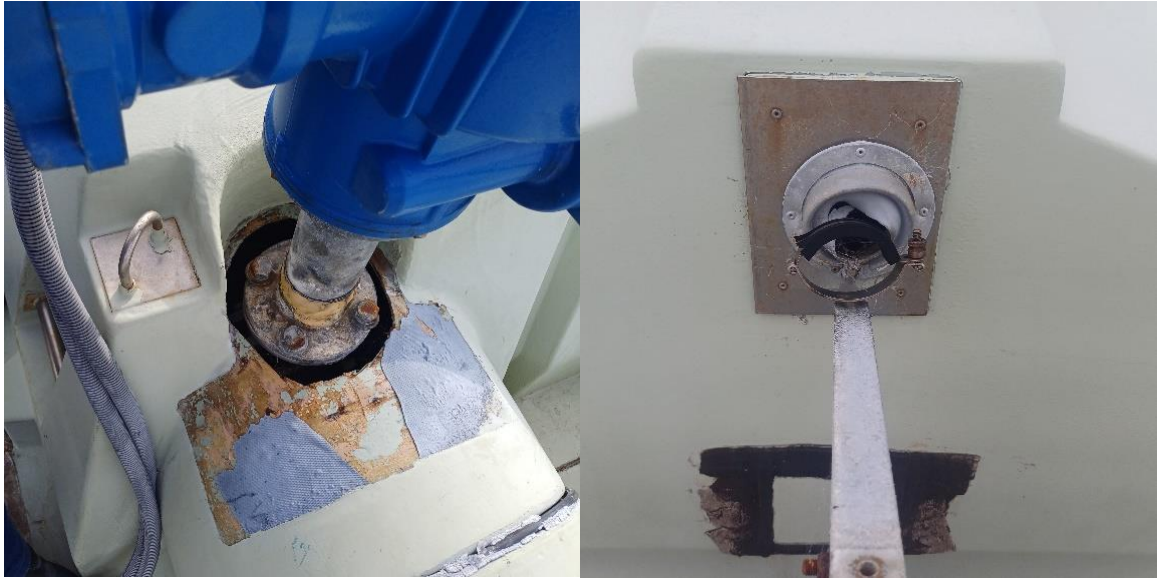
■ **Figure 12: Unsealed Access Hole, 23 November 2024**

Several of the access ports identified in the January 2024 assessment needing repair have been fixed, however, there were still some significant gaps such as those depicted in Figure 12. Hence,

It is recommended that all access ports be suitably sealed.

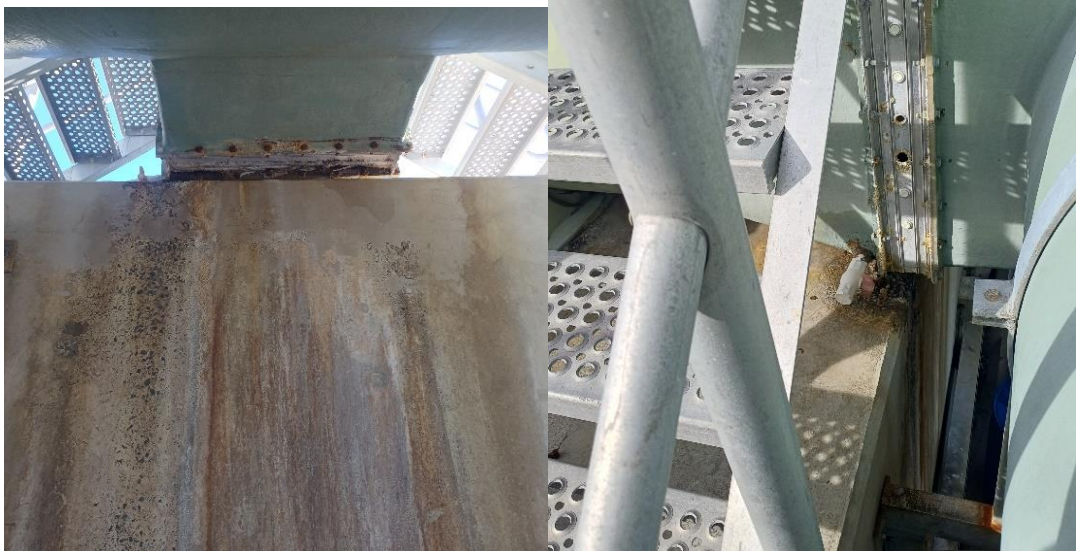
■ **Figure 13: MBBR Flow Control Baffle, 23 November 2024**

The flow control baffle located at the junction of the primary extraction duct and the MBBR covers was highly degraded with the connection almost completely rusted off (see Figure 13) which will be adversely affecting the extraction from not only the MBBRs but also the primary treatment and covered inlet channels as air will preferentially be drawn in from the leaks in the baffle.

It is recommended the MBBR and RATs/ SCRTs flow control baffles be repaired or replaced.

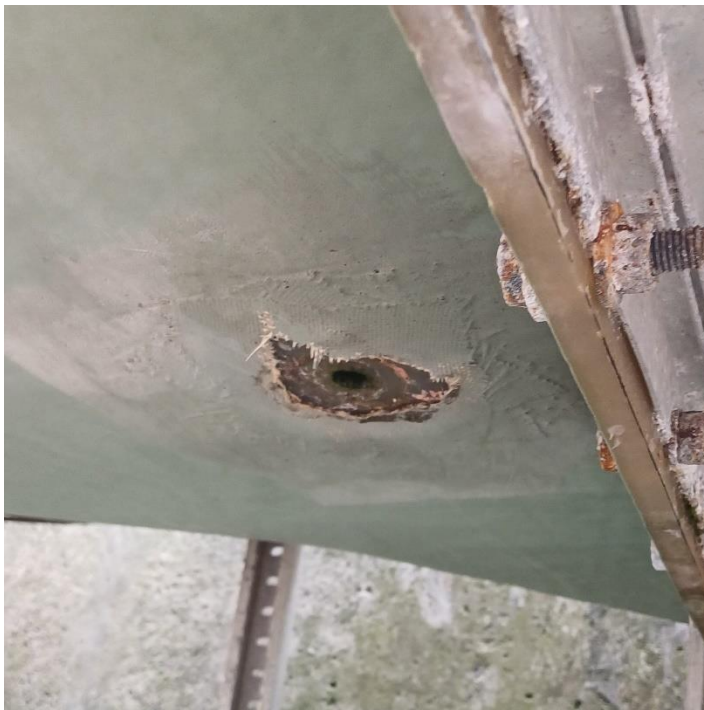
■ **Figure 14: RAT and SCRT Flow Control Baffle, 23 November 2024**

The flow control baffle for the RATs and SCRTs extraction ducting was also degraded with substantial rust and the drain line has completely detached since the last assessment (see Figure 14). Hence,

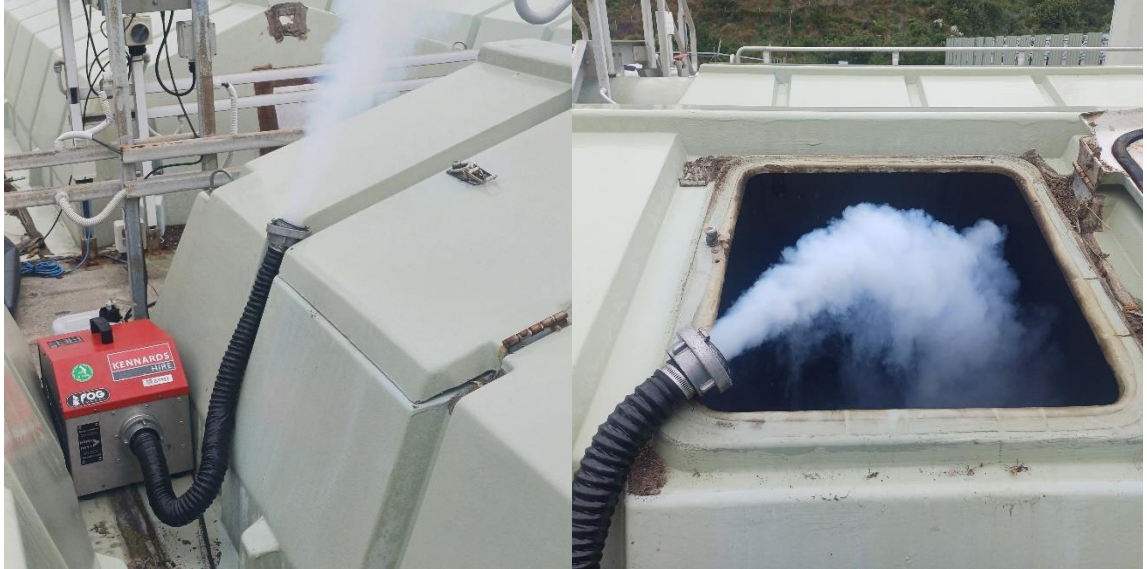
■ **Figure 15: MBBR Tanks Smoke Test, 23 November 2024**

The smoke testing of the MBBR tanks on 23 November 2024 was conducted by inserting the smoke machine into an access hatch of the MBBR tanks (see Figure 15) and allowed to fill the chambers for approximately 30-minutes. During previous assessments of the MBBRs, light but still visible smoke was generally observed exiting the main scrubber stack. However, on this occasion there was no visible discharge which was likely a combination of low ventilation rates and the difficulties in viewing the smoke in overcast conditions.

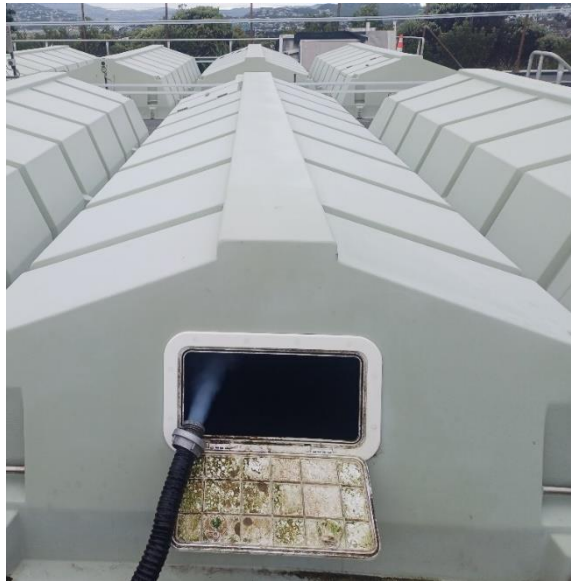
Figure 16: RATs Smoke Test, 23 November 2024

The process was subsequently repeated for the RAT's and SCRTs with the outlet of the smoke machine inserted into a hatch (see Figures 16 and 17) and after approximately 30-minutes there was no smoke observed indicating that despite the condition of the seals, the odour control system was providing sufficient extraction to minimise the potential for fugitive odour emissions.
