# Moa Point Wastewater Treatment Plant

Annual Resource Consents Report 2021/2022

**Document Title:** Moa Point Wastewater Treatment Plant Annual Resource Consents 2021/2022

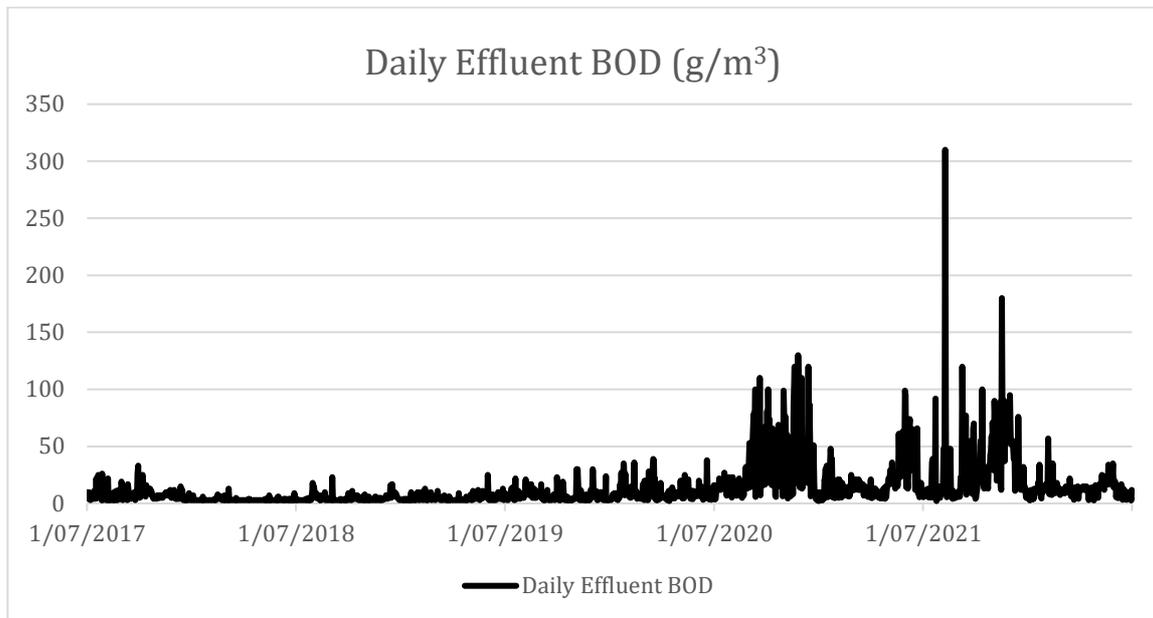
There were exceedances in the effluent BOD results in the past two financial years which can be majorly attributed to a series of asset failures in the treatment plant. The daily results are now returning to be below consent limits since the end of FY2021/2022.

**Figure 6: Daily Effluent BOD Results**

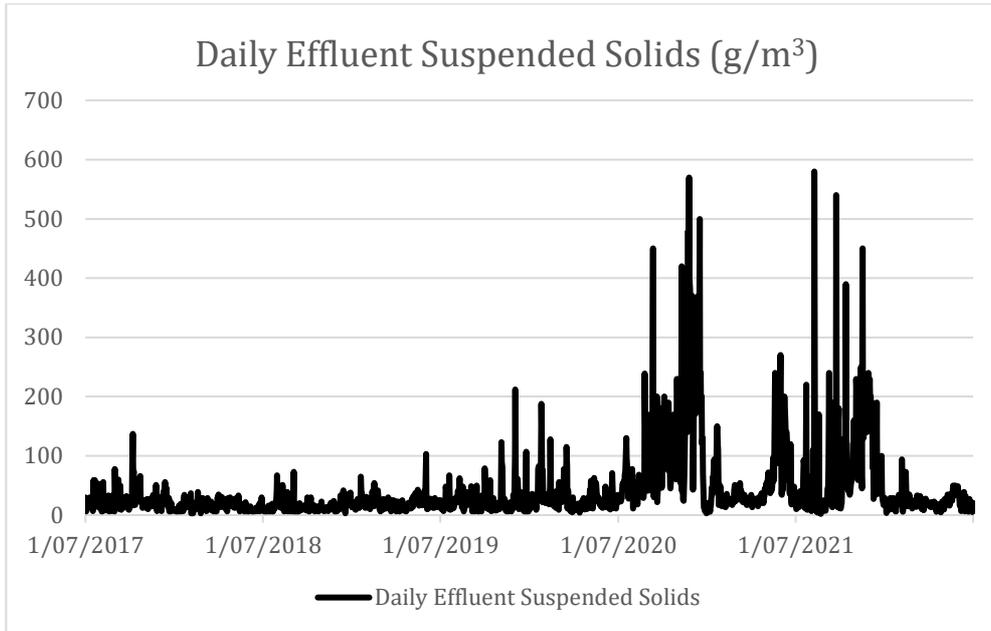
There were exceedances in the effluent suspended solids results in the past two financial years which can be majorly attributed to a series of asset failures in the treatment plant. The daily results are now returning to be below consent limits since the end of FY2021/2022.

Figure 7: Daily Effluent Suspended Solids Results

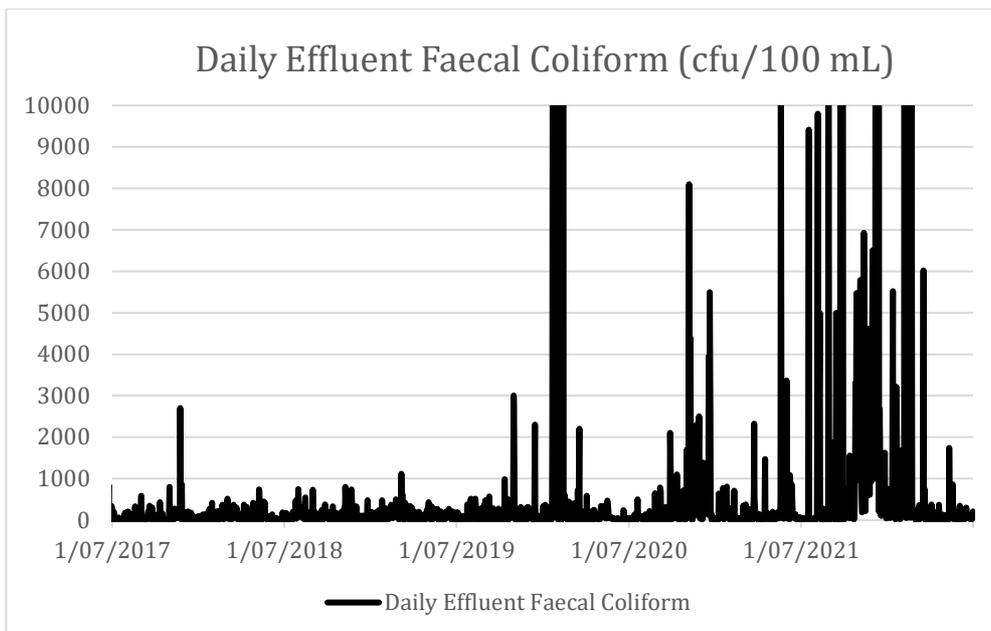
There were exceedances in the effluent faecal coliform results in the past two financial years which can be majorly attributed to a series of asset failures at the treatment plant. The daily results are now returning to be below consent limits since the end of FY2021/2022.

Figure 8: Daily Effluent Faecal Coliform Results

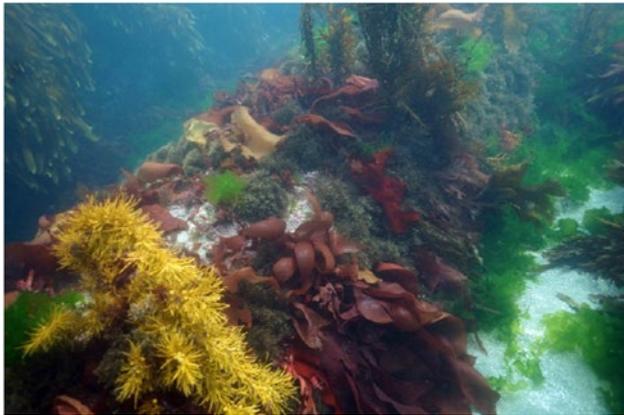
**Plate 3:** View of the pipeline 30m from shore, Feb 2021

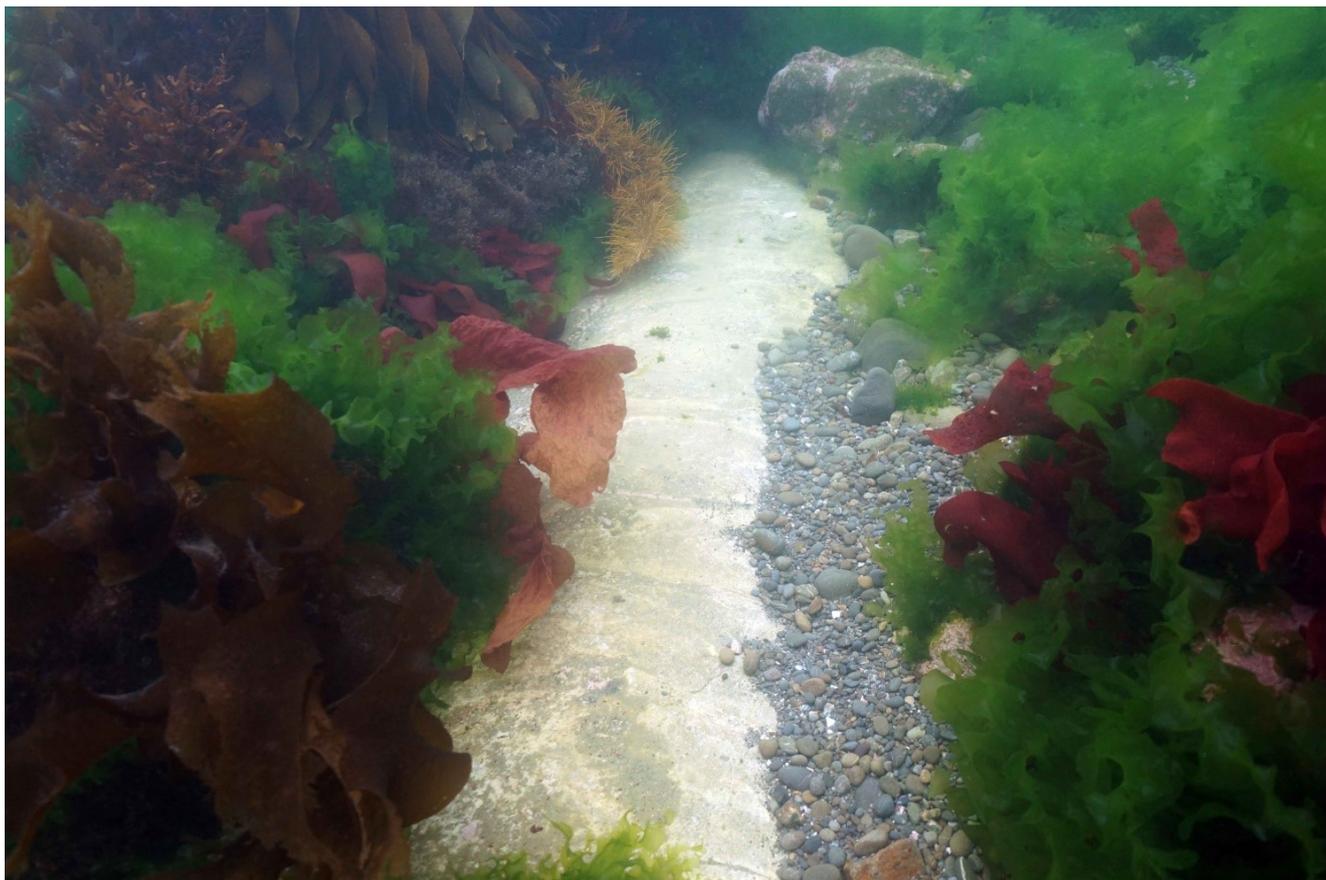
Although the exposed length of pipeline has increased slightly since commissioning; exposure progression has remained relatively slow; with exposure length only increasing minimally over the 2021 to 2022 inspection period. Over this same period scour adjacent to the pipeline has remained stable, with only increases of scour depth as measured at the several designated monitoring positions. This being largely due to the cyclic effect imposed from repetitive Southerly conditions on sand and light gravel deposit migration within the shallows.

Figure 3: Shoreward of the 00.0 metres monitoring mark, a further 03.0 metres of pipeline has been exposed

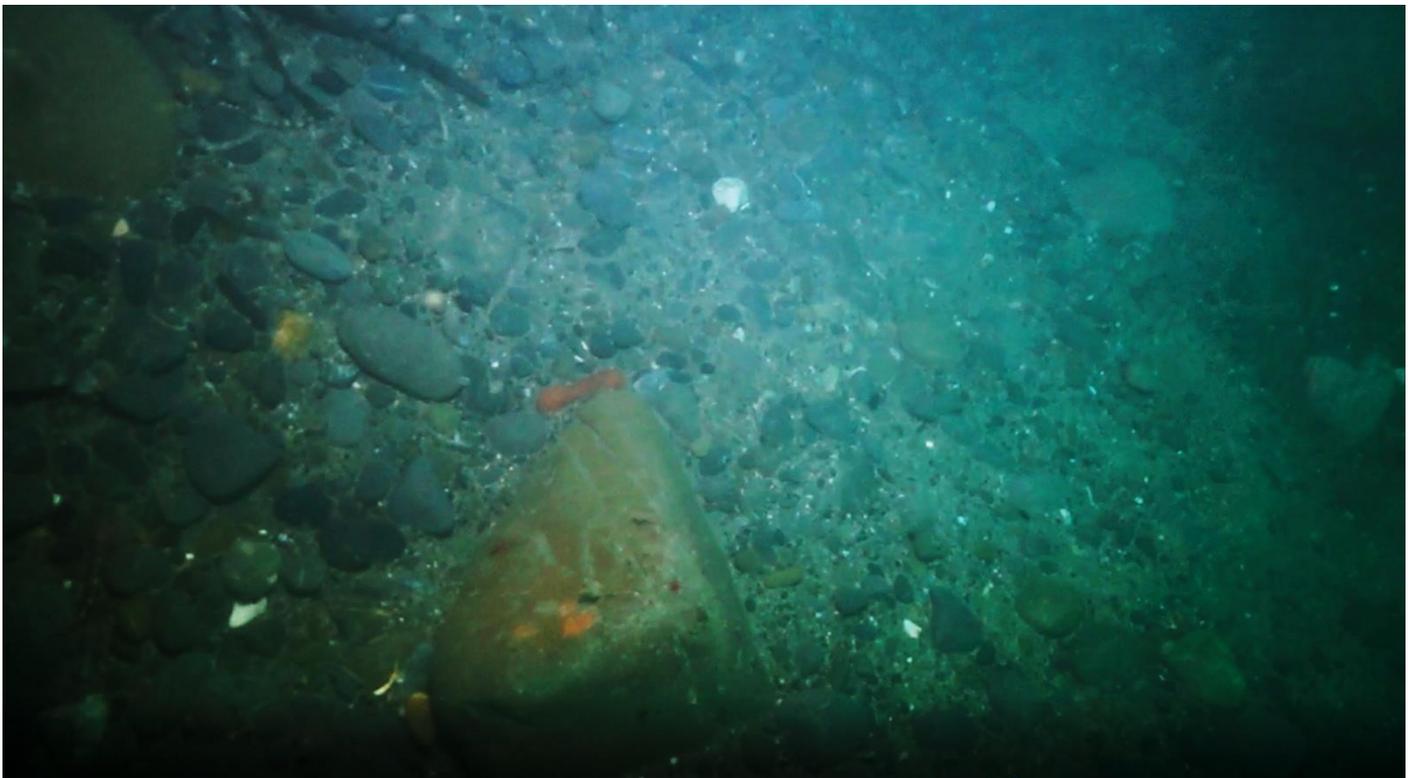
No evidence was observed of any damage or deterioration to any of the 18 diffuser assemblies. Seafloor deposits of rocks, coarse gravels and sand form undulating, peaks and depressions typically of +/- 300mm in west – east (shoreline) orientation around the diffuser positions.

Figure 20: Typical scale of aggregate sizing observed around the Diffuser positions

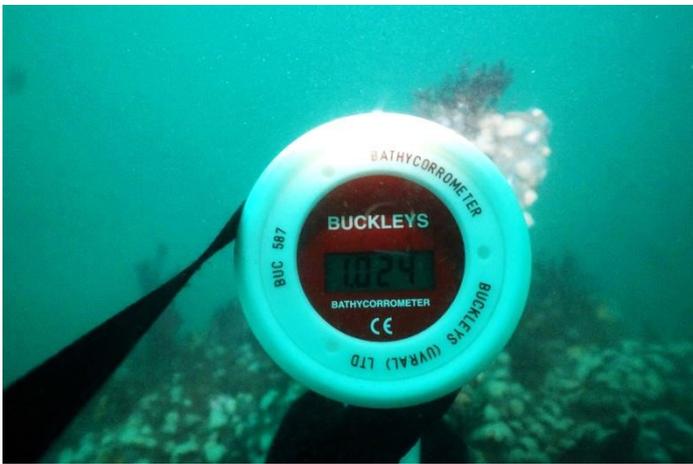
Figure 25: Diffuser # 1 test point – 1.024mV

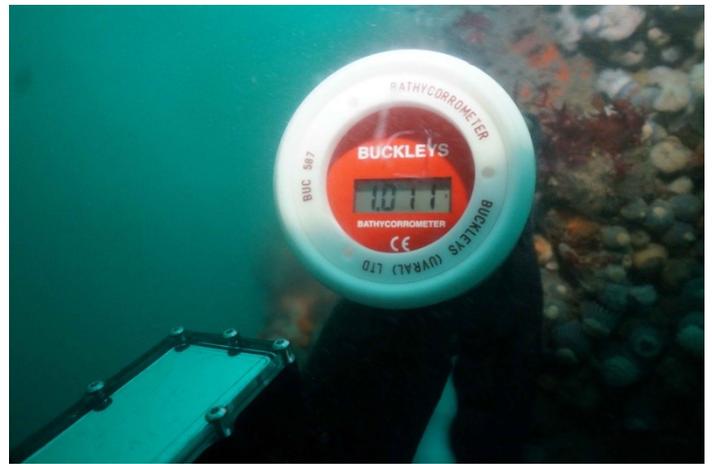
Figure 26: Diffuser # 5 port nozzle – 1.011mV

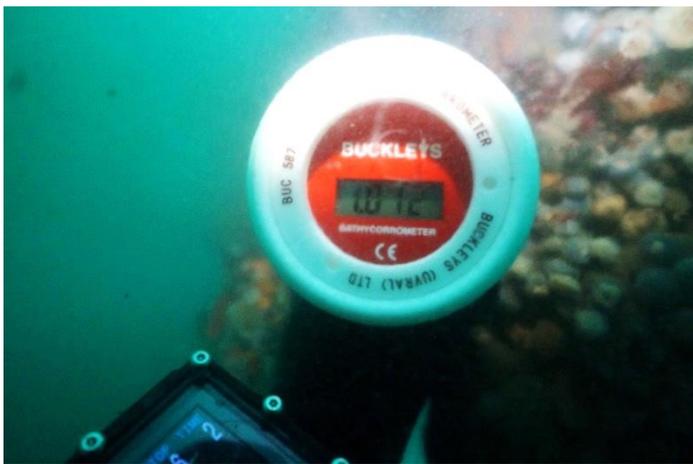
Figure 27: Diffuser # 10 port nozzle – 1.012mV

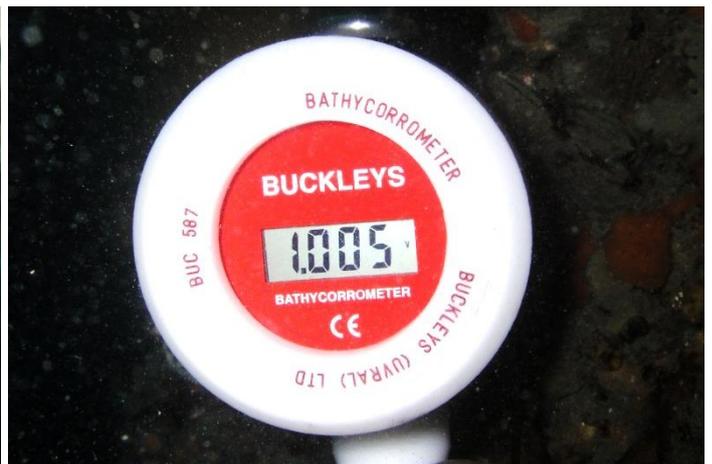
Figure 28: Diffuser # 15 port nozzle – 1.005mV

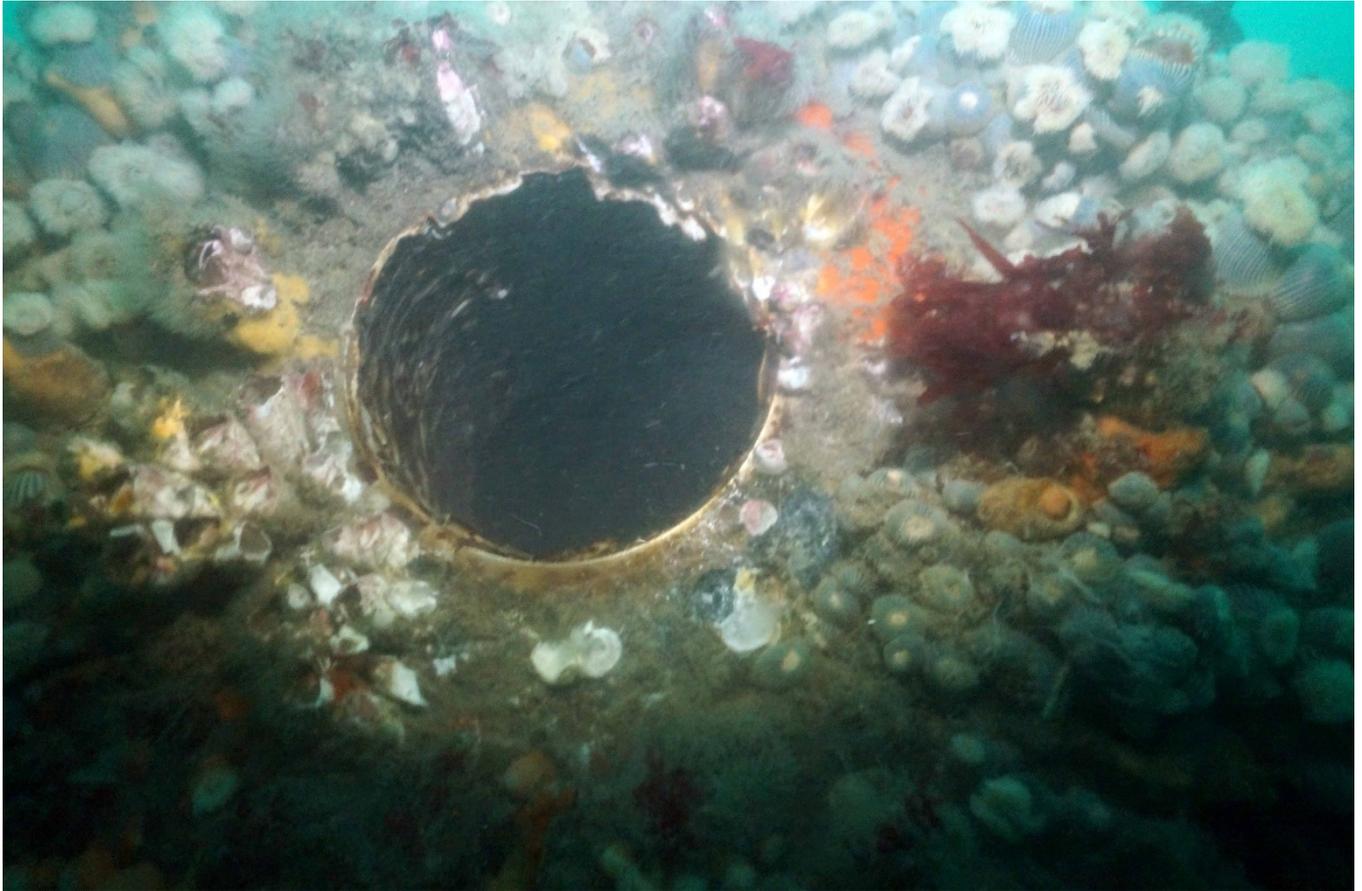
Figure 29: Diffuser Port intermittently stops flowing

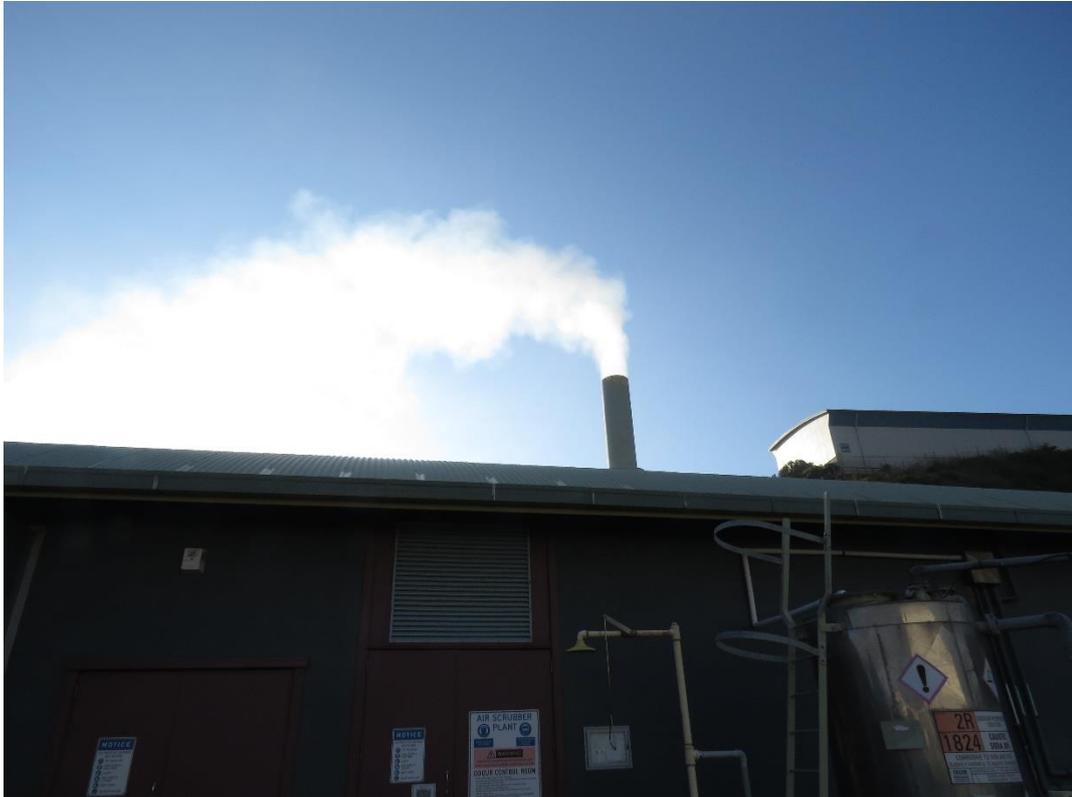
Within a few minutes, smoke was observed exiting the IPS scrubber stack (See Figure 2). A site walk around was conducted to assess the seals and try to identify any potential leaks. While one of the seals (See Figure 3) exhibited minor damage, the remainder were all in good working order. There were no visible discharges from any of the seals or any other locations, confirming the foul air within the IPS was being extracted at a ventilation rate significant enough to prevent any fugitive discharge.

■ **Figure 2: Moa Pt IPS Scrubber Stack, 10 March 2022**

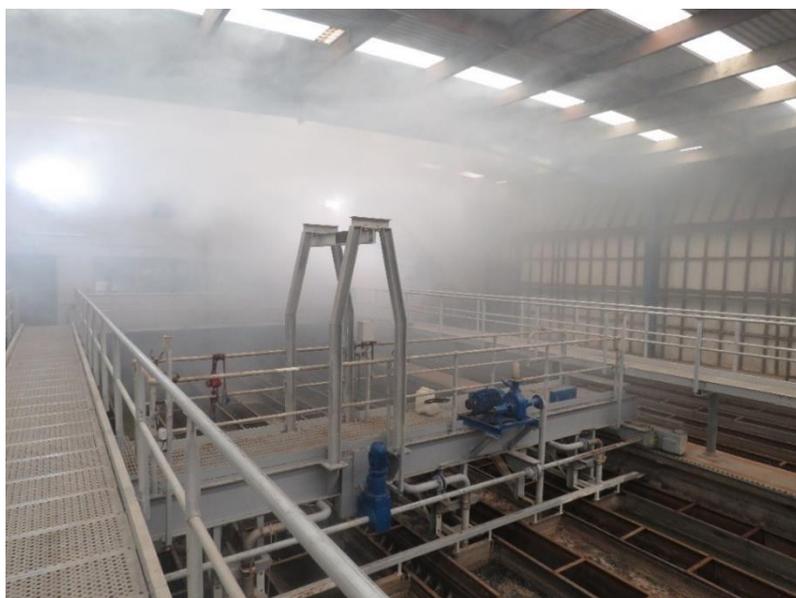
The results of the Moa Pt Primary Tanks smoke testing showed that the building was well sealed with a ventilation rate of approximately 3 room changes per hour. Hence, the extraction system is actively maintaining the building under negative pressure preventing any potential fugitive emissions.

■ **Figure 4: Moa Pt Primary Tanks, 10 March 2022**

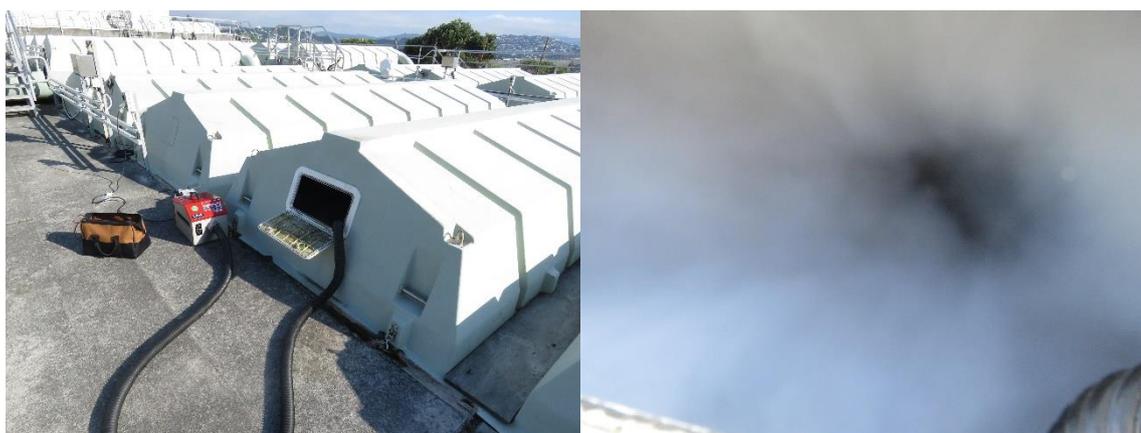
In summary, the smoke testing of the MBBR tanks demonstrated that the system was under sufficient negative pressure to prevent fugitive emissions of foul air. However, it is recommended that the replacement of worn seals be conducted as needed.

■ **Figure 8: Moa Pt MBBR Tanks Smoke Test, 10 March 2022**

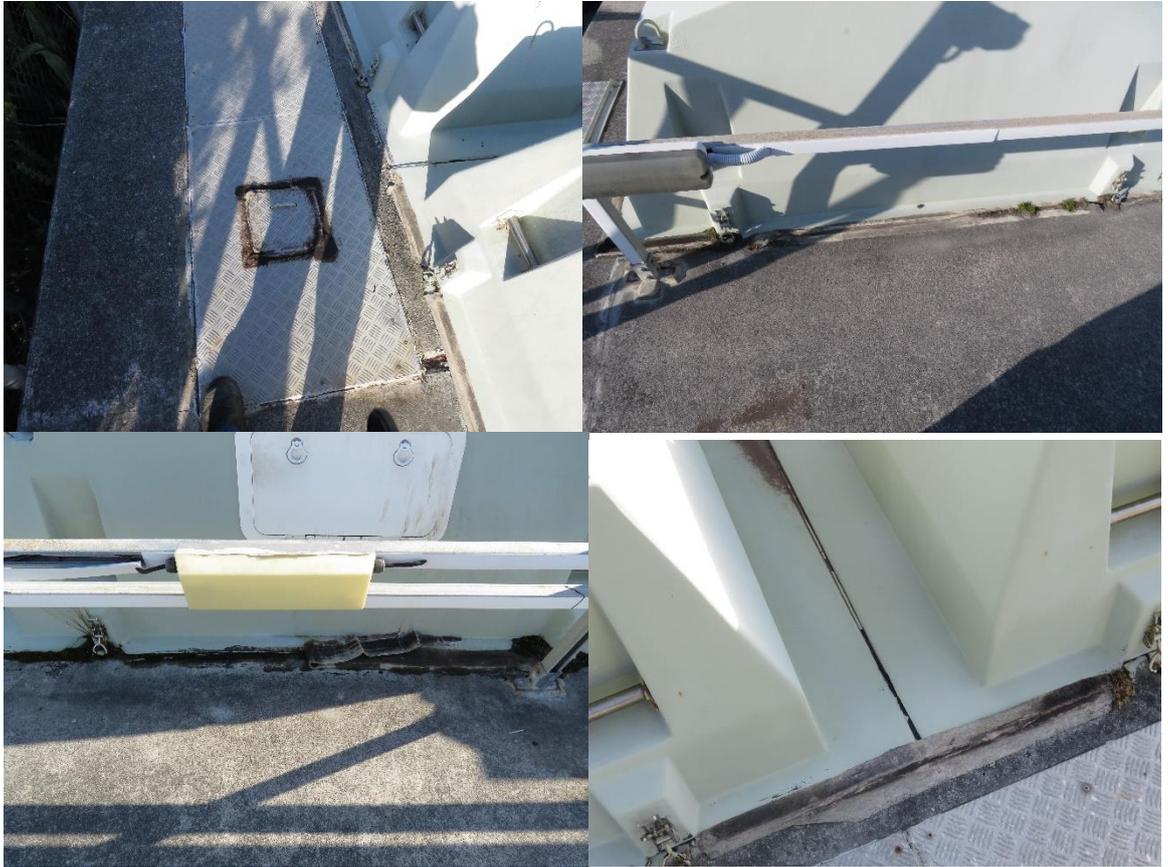
■ Figure 10: MBBR Seals, 10 March 2022
