Incident Investigation Report:
UVT values below 45% limit (May-July 2024)

| Document Title: | Investigation report - UVT values below 45% (May-July 2024) |

| Location | Porirua WWTP |

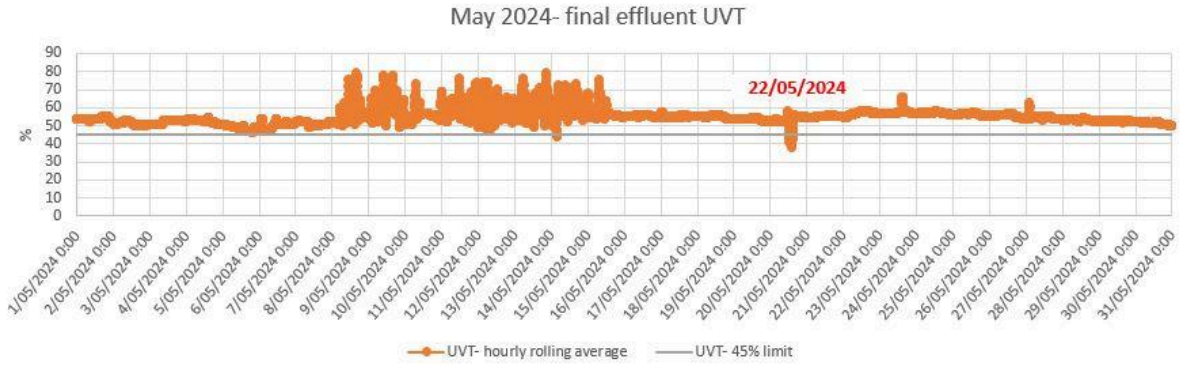
Figure 1, 2 and 3 show rolling hourly average of UVT readings (collected at 5-minute intervals) for months of May, June and July 2024, respectively. Grey line in each figure shows the limit of 45% and all the orange points below this line are occasions when the UVT value was non-compliant.

Figure 1- UVT values in the final effluent (May 2024)

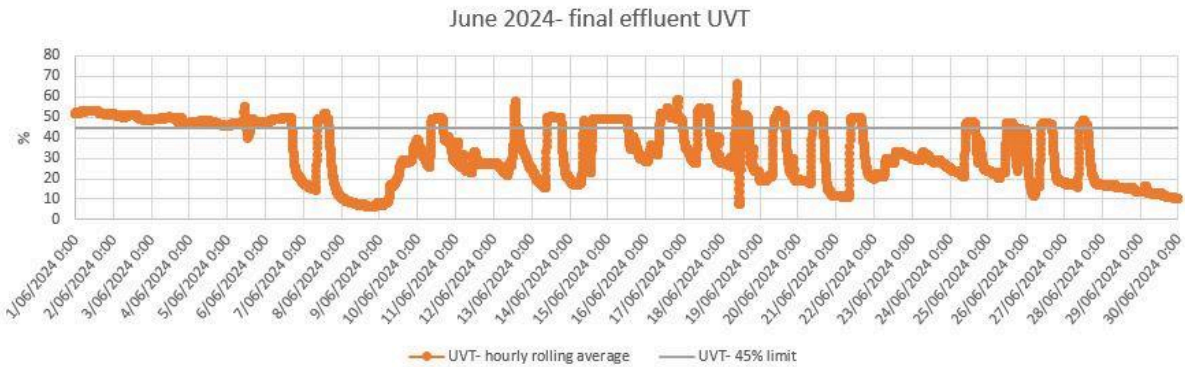
Figure 2- UVT values in the final effluent (June 2024)

When the Duron UV system is not in operation, there is no flow through the channel and the water column is stagnant. These conditions are not representative and explain the low UVT values during these time periods (when there is a constant flow through the channel, UVT readings increase). Periodical increases and decreases of the UVT values can be observed from the trend given in figures 2 and 3.

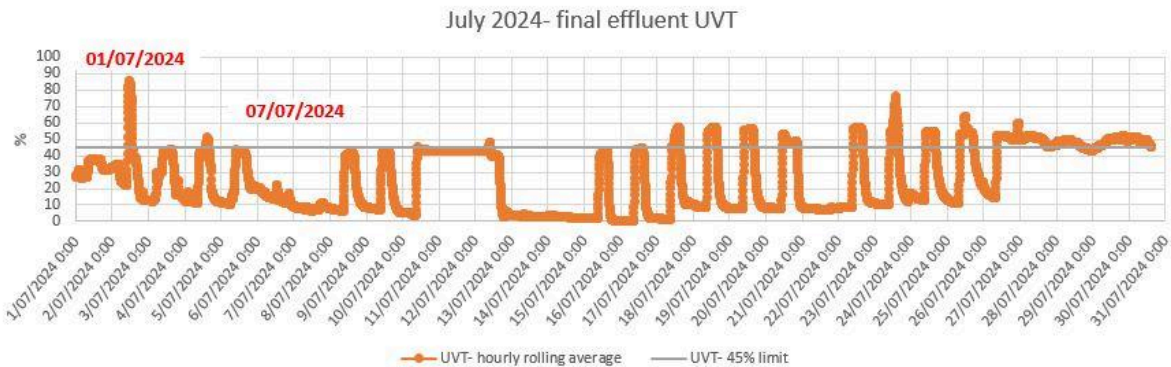
Figure 3- UVT values in the final effluent (July 2024)

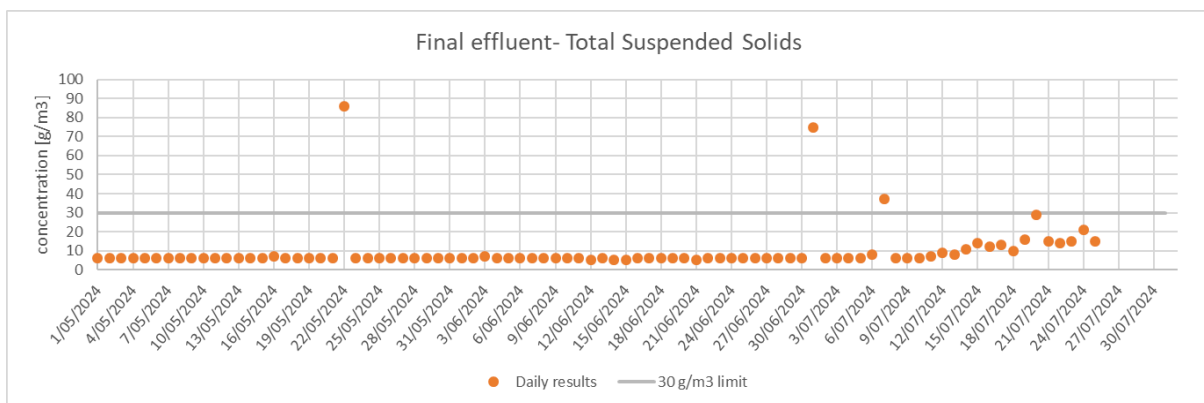
Figure 4 shows daily results for the Suspended Solids concentration in the final effluent. The grey line indicates the 30 g/m³ limit which defines the limit for the 90 days Geometric mean. Please note this value is not a limit for daily results; however, for this purpose, it was used as a reference value. Increased values of the suspended solids occurred on 22nd May, 1st July and 7th July 2024. The values were 86, 75 and 37 g/m³ respectively. Increased suspended solids on these days likely align with low UVT values.

Figure 4- Total Suspended Solids values in the final effluent (May-July 2024)

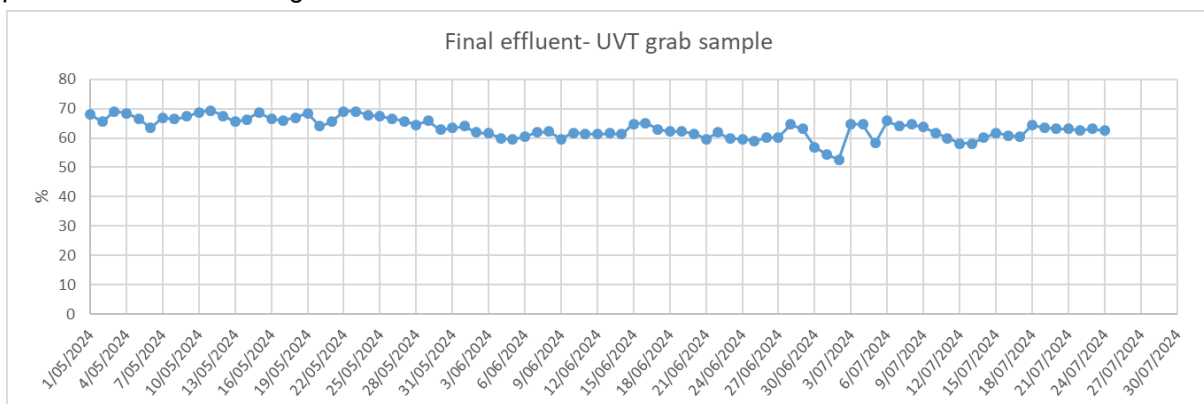
On a daily basis, a grab sample is collected from the effluent and analysed for the UV Transmissivity. Daily results are shown in Figure 4. From the trends provided in figures 1, 2 and 3, significant differences are observed between the probe online readings and laboratory analysis. Comparison of the grab sample results and the online readings indicated inaccuracy of the probe, and its performance was investigated further.

Figure 5- UVT values (daily grab samples) in the final effluent (May-July 2024)

Two corrective actions were suggested. Firstly, it was identified that the cleaning solution used for the standard cleaning may not be strong enough. Currently, a solution consisting of citric and phosphoric acid is used and it has historically provided good results. However, a stronger solution of phosphoric acid (60%) was recommended to achieve better results.

The second recommendation from the instrumentation technician was to set an offset value for the UVT value, aligning the probe measurements with the benchtop instrument and results from the external laboratory. This was implemented, and the verification process is ongoing.

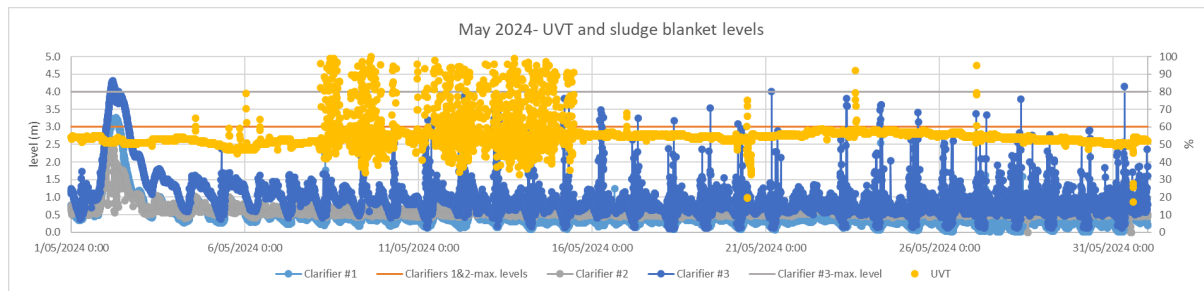
Figure 6- Sludge blanket levels in secondary clarifiers and UVT values trends-May 2024

UVT readings provide a good real-time indication of changes in the final effluent quality, specifically changes in the suspended solids concentrations. Increased sludge blankets can result in increased suspended solids in the final effluent and therefore, the blanket level trends were evaluated for the purpose of this investigation. Figure 6 shows blanket levels in individual clarifiers. At the same time, maximum acceptable levels are depicted. For clarifier 1 & 2, level of 3 metres is considered to be maximum, which once reached, increased solids in the effluent may occur. For clarifier #3 the maximum level is 4 metres. Figure 6-8 shows that the sludge blanket levels were below the maximum levels for the majority of the investigating period therefore no negative effect is assumed. The only exception is an event which occurred on 2 May 2024. From 2:40 am until 9:10 am the blanket levels in clarifier #1 oscillated above 3 meters with a maximum of 3.3 m. Blankets in clarifier #3 were above 4 meters between 3:15 and 6:20 am with a maximum of 4.3 m. It is important to note, that given instrument inaccuracy should be considered and the exceedance of the empirical maximum limits does not necessarily mean sludge carry-over. Considering low BOD₅ and TSS results in the final effluent and stable UVT values for these days, the blanket level increase did not result in significant solids increase.

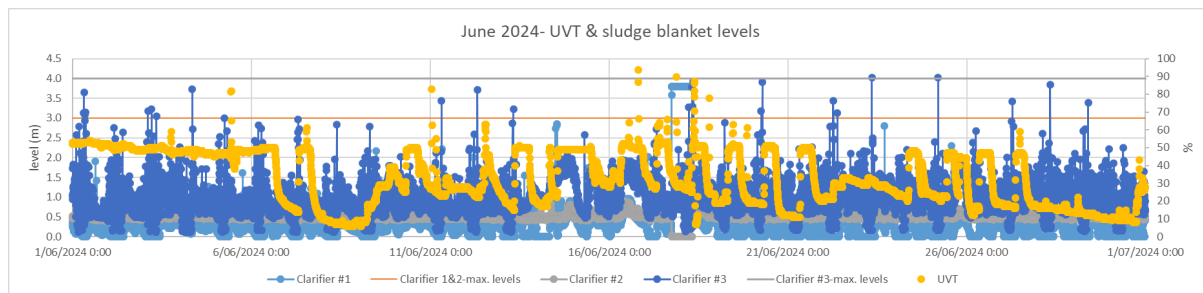
Figure 7- Sludge blanket levels in secondary clarifiers and UVT values trends-June 2024

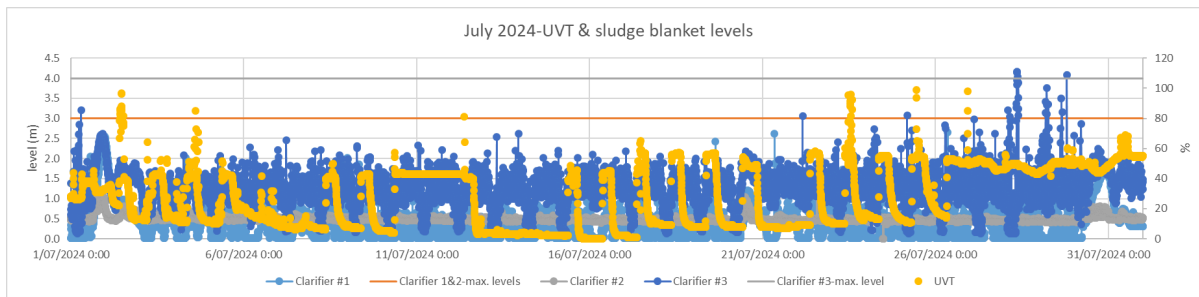
Figure 8- Sludge blanket levels in secondary clarifiers and UVT values trends-July 2024

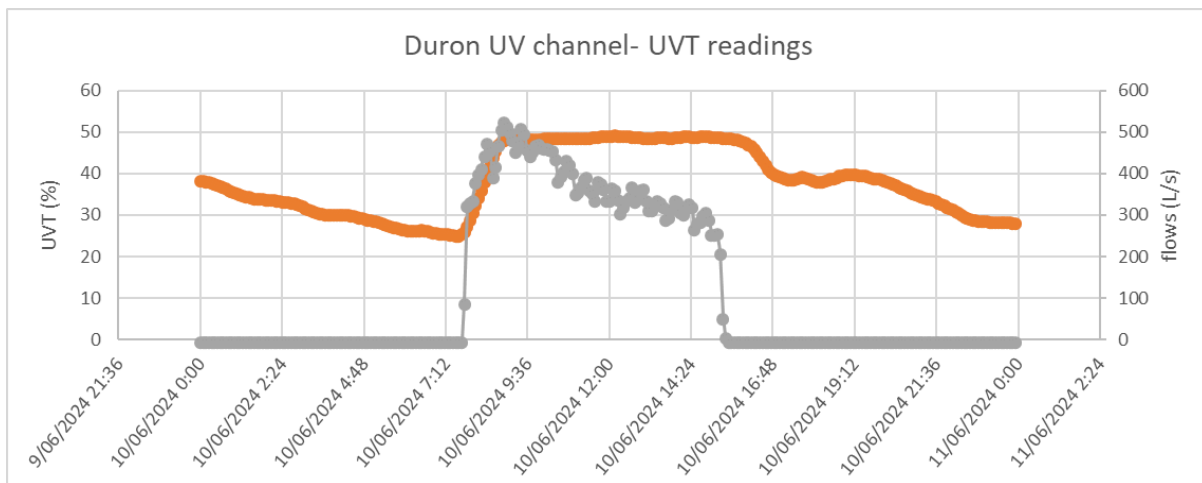
As an example, please see Figure 9 for a detailed snapshot. This figure captures the trend for the UVT readings and flow through the Duron channel, supporting the explanation given above.

Figure 9- Flows and UVT readings in the Duron UV channel (10 June 2024)

| Corrective Actions | Reference of issue on captured system or Defect raised | Responsibility | Measurement |
|---|---|---|---|
| Cooperation with the Duron UV system penstock supplier to address mechanical issue with the penstock is ongoing | Due to the unreliability of the Duron UV system, the flow through the Duron channel is intermittent negatively affecting the UVT readings | Team Leader/ Coordinator | Rivo action. |
| Installation of new UVT probe dedicated to the TAK channel | UVT readings will be independent from the UV system on duty | Process engineer/ Team Leader | Rivo action |
