Subject: Discolouration to the coastal marine area around Rukutane Point on 4th and 15 – 16th of March 2024

Incident Investigation Report:
Investigation report - UV Transmissivity reduction below
the compliance limit 45% (15 & 16/3/24)

Date	16. March 2024
Location	Porirua WWTP
Description	On 15. and 16. March 2024, UV Transmissivity (UVT) values in the final effluent dropped below the limit of 45 % defined by condition 12D of Resource Consent WGN200229.
Cause	Rain events during the 15 and 16. March 2024 led to increased flows entering the Porirua WWTP.
	At the time of the high flows, Mixed Liquor Suspended Solids (MLSS) in the treatment system were outside of the optimum range.
	The increased flows coupled with a high Mixed Liquor Suspended Solids resulted in higher than optimum sludge blanket levels in clarifier #3 leading to low UVT values in the final effluent.
Actions (during the day of the incident)	Low UVT values in the final effluent and high sludge blanket levels in clarifier #3 were observed during routine SCADA checks. This triggered the actions listed below.
	Inlet valves to clarifier 1 & 2 were adjusted to alter the flow distribution between the clarifiers. These were

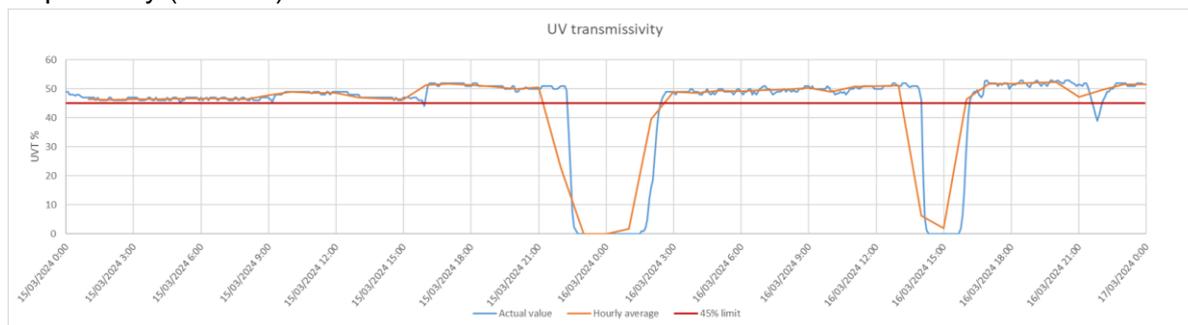
Figure 1 shows the trend for the UVT values in the final effluent. Two significant drops are visible on 15/03/2024 and 16/03/2024. Hourly averages for the UVT values were 13% and 4% respectively (Table 1).

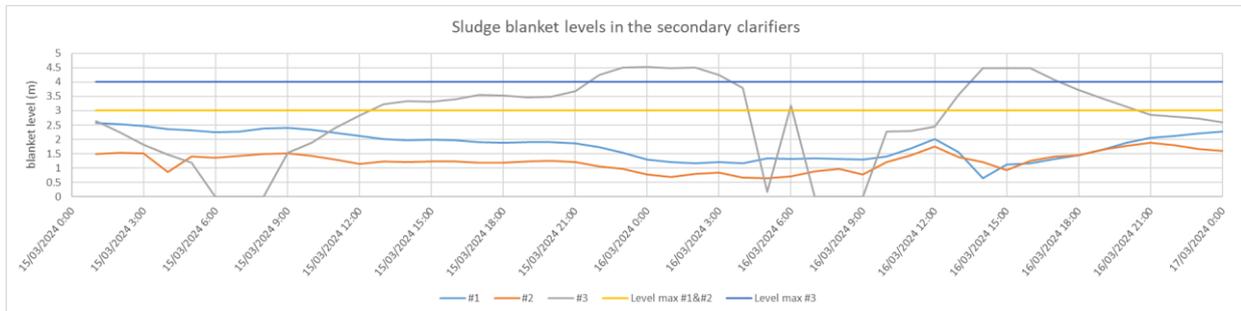
Figure 2

Analysis of the sludge blanket levels from March 15th and 16th shows that blanket levels in clarifiers #1 and #2 were around the average values and below a maximum level (3.0 m). For clarifier #3 the maximum level (4 m) was exceeded. The times of increased levels (4.5 m) correlate with times of low UVT values.

Exceedance of the maximum blanket levels and low UVT values indicate solids carry-over from the secondary clarifiers. However, this can't be seen in the final effluent results - which can be explained by short-duration of the carry-over and significant dilution. Table 3 shows the duration of the low UVT values period and volume of treated water during this time expressed as percentage of the total daily volume.

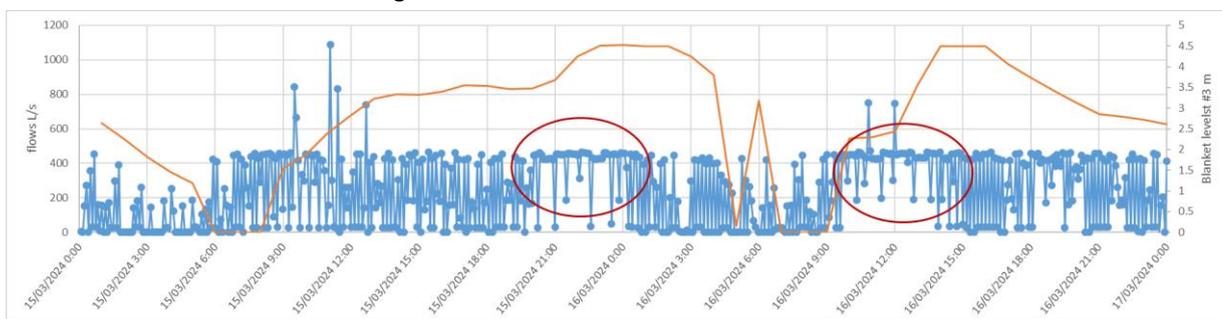
During March 15th and 16th, high flows entering the plant occurred. Figure 3 shows the trends for the inlet flows and the sludge blanket levels.

Periods highlighted in the red circle are periods of consistently increased flows causing the sludge blanket disturbance and its subsequent increase. It is important to note, that in this case the high flows were a contributing factor and the main reason for the blanket increase were high values of biomass in the aeration basin (MLSS).

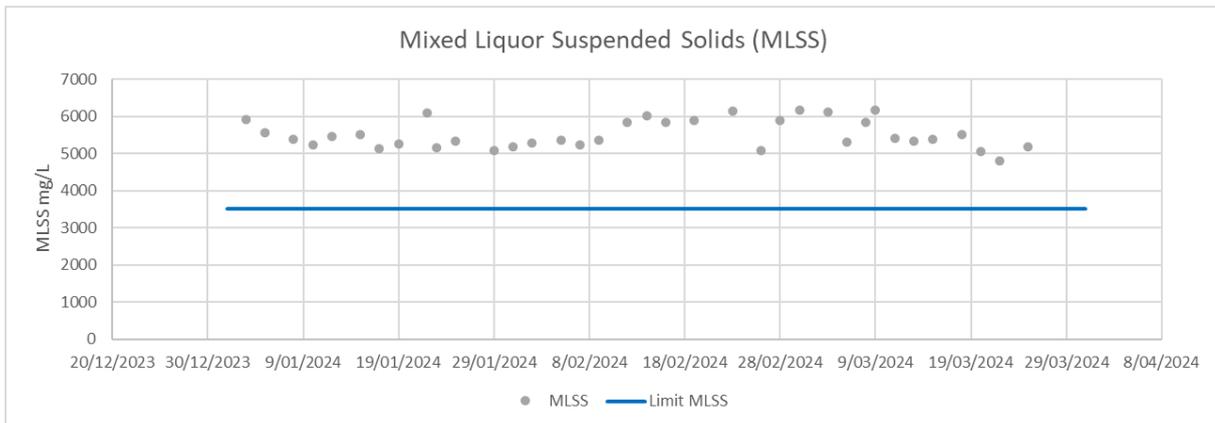
Figure 4

Due to a number of breakdowns of the dewatering system, the MLSS is higher than optimal. See the MLSS values in Figure 4.

The increased flows coupled with a high Mixed Liquor Suspended Solids resulted in low UVT values in the final effluent.

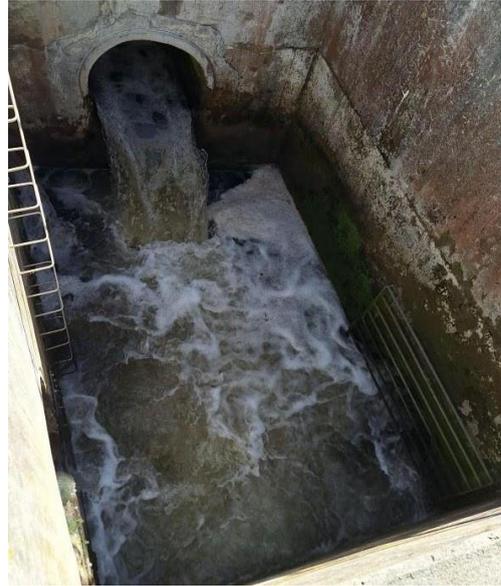
16/03/2024 16:11

Photo of the effluent common pit - This photo was taken as soon as the operator was onsite

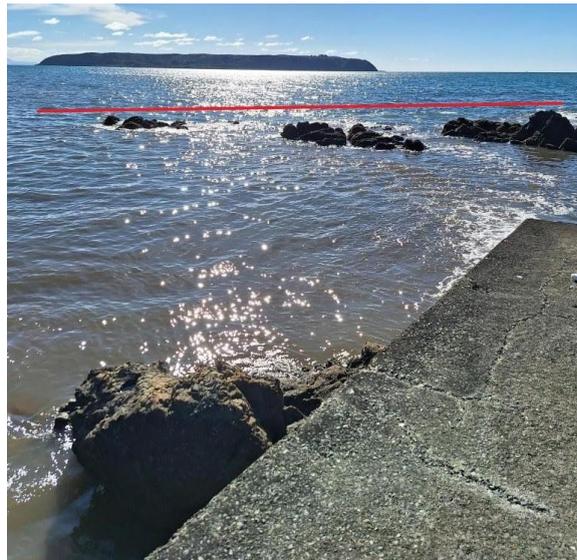
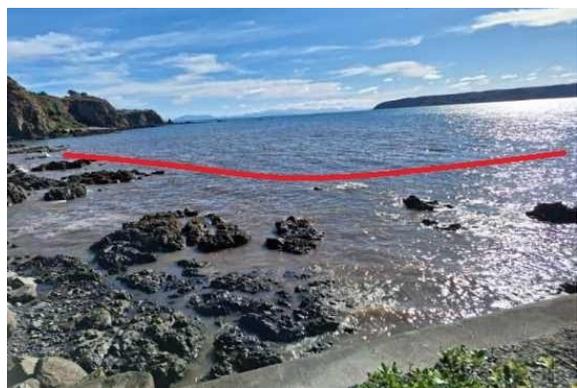
16/03/2024 16:38

Red line indicates approximately how far the discoloration made its way past the outfall. Operator approximates it less than 100m

- Pictures taken of the outfall on March 16th show the discoloration in the vicinity of the outfall however this was contained within the 200-metre radius.

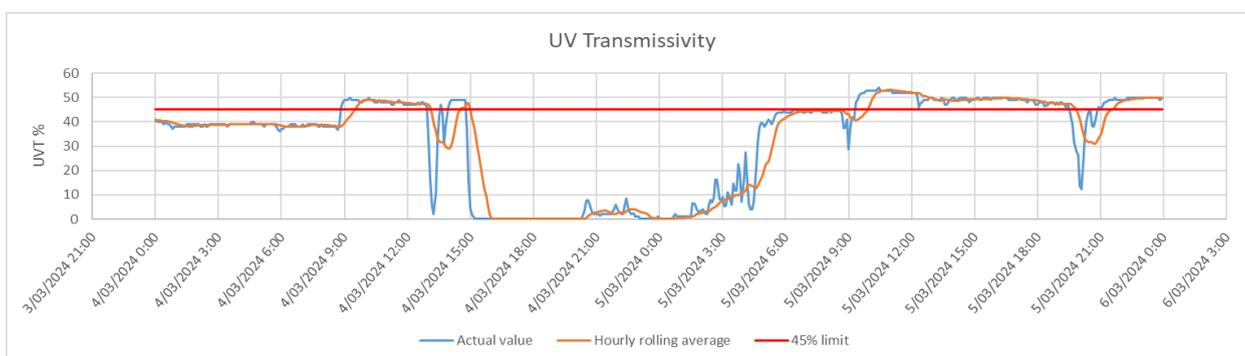
Figure 1 shows the trend for the UVT values in the final effluent. As per timeline given above, the hourly rolling average for UVT values dropped below 45% at 14:50 pm. The period of poor effluent quality lasted until March 5th 5:30am.

Number of minor drops can be seen as well (average values are provided in table 1). Given the sludge blanket trends shown on figure 2, it is suggested that these are related to poor effluent quality however it is important to note that minor UVT reductions of this magnitude are usually related to incorrect positioning of the UVT sensor (details on corrective action are given further).

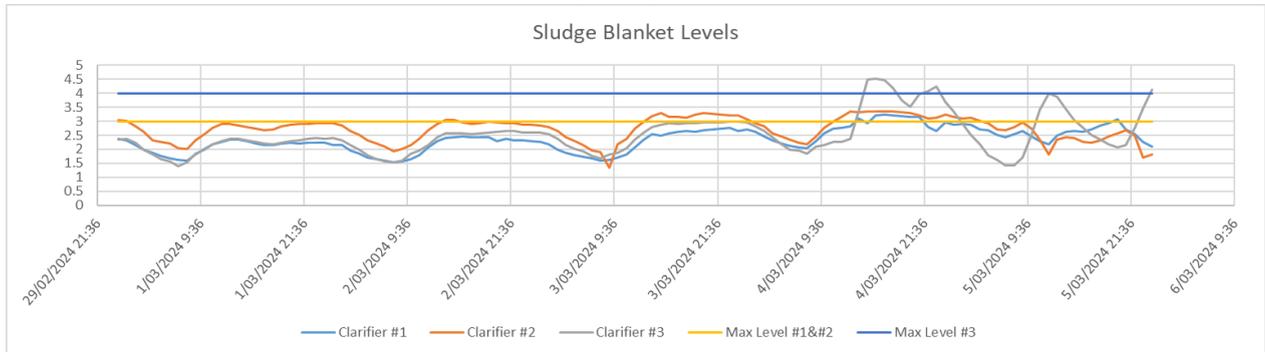
Figure 2

Analysis of the sludge blanket levels from the investigated periods shows that blanket levels in clarifiers #1 and #2 exceeded the maximum acceptable level (3.0 m) For clarifier #3 the maximum level (4 m) was exceeded as well. The times of increased levels (4.5 m) correlate with times of low UVT values.

Exceedance of the maximum blanket levels and low UVT values indicate solids carry-over from the secondary clarifiers.

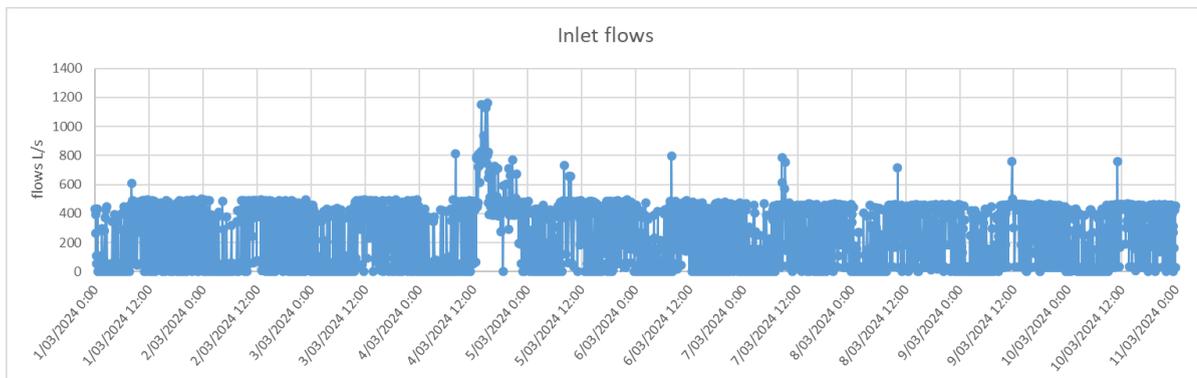
During the investigated period high flows entering the plant occurred. Figure 3 shows the trends for the inlet flows.

During the investigated period the average flow increased compared to the average flows with peak of 1163 L/s. Data are given in table 3.

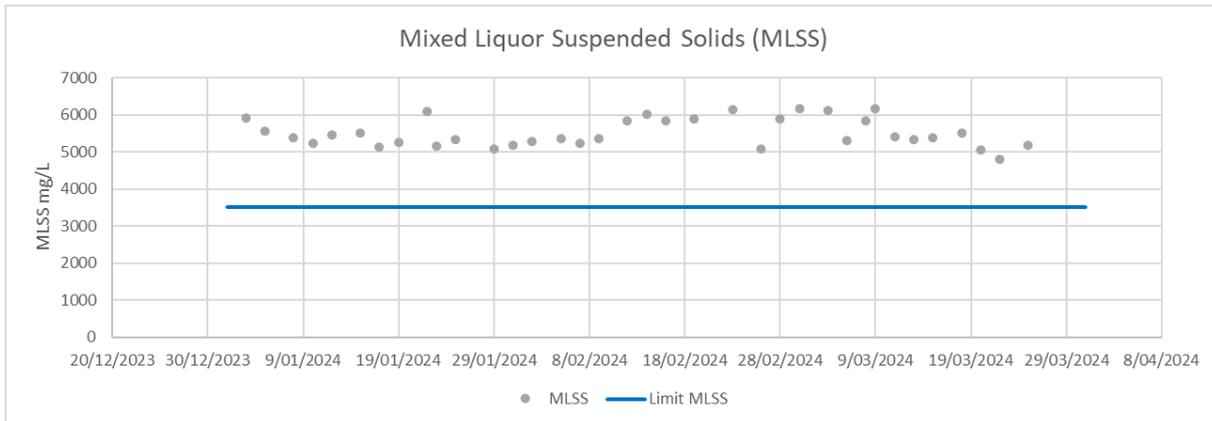
Figure 4

Due to a number of breakdowns of the dewatering system, the MLSS is higher than optimal. See the MLSS values in Figure 4.

The increased flows coupled with a high Mixed Liquor Suspended Solids resulted in low UVT values in the final effluent.

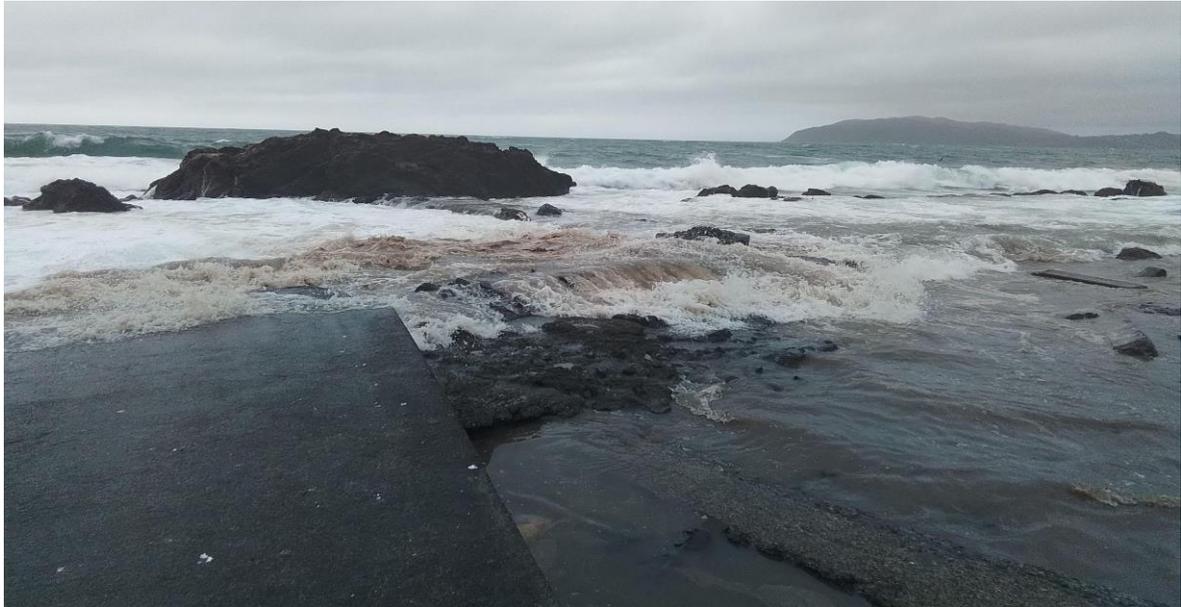
Time: 15:33

Discoloration was limited to the area immediately around the outfall.
