## Insecure Roof of Milling Machine

CAMs # 386845

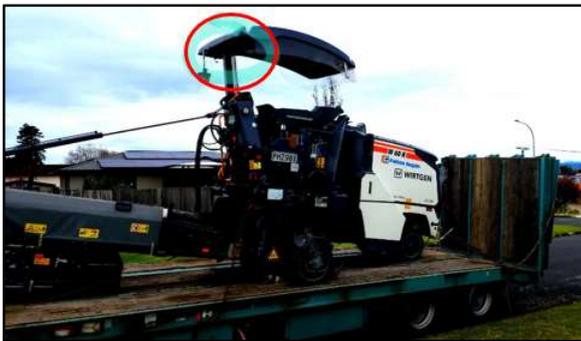
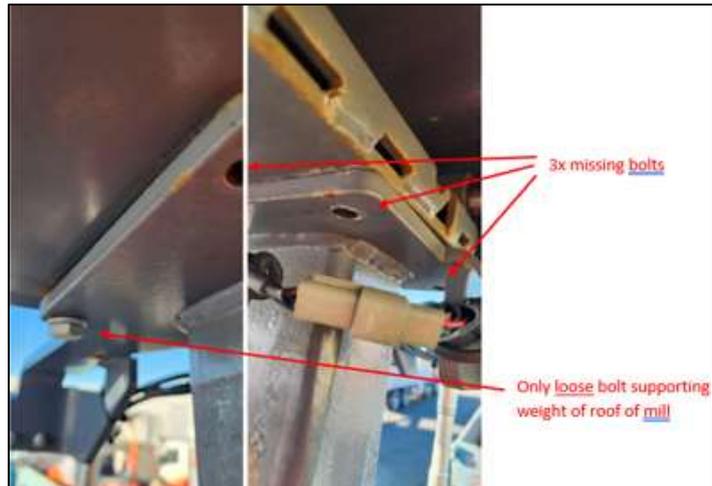
The small milling machine (below) had not been used for some time, so the operator completed a thorough prestart check. As part of this, he noticed that the roof was only being held in place by 1 loose bolt. It was not a requirement of the pre-start to check the bolts, but the operator knew of an incident with a previous company where the canopy had collapsed causing severe injuries.

The roof weighs up to 150kg. If the roof fell on somebody, or fell off during transport, this could have caused a serious injury or worse.

It is assumed, due to the nature of the work and design, that the bolts had vibrated out over time.

1. Check roofs are secure.
2. Refit bolts with Loctite and a shake proof washer.
3. Can relevant Project Managers please share this alert with their subcontractors.
