Senior Manager Incident Notification - NZ

Region / Project:	Fulton Hogan Canterbury	Responsible Manager:	Ryan McMahon
Client:	Waka Kotahi NZTA	Sub / contractor:	LB Civil
Date of incident:	24 September 2024	CAMs # (if available)	TBC

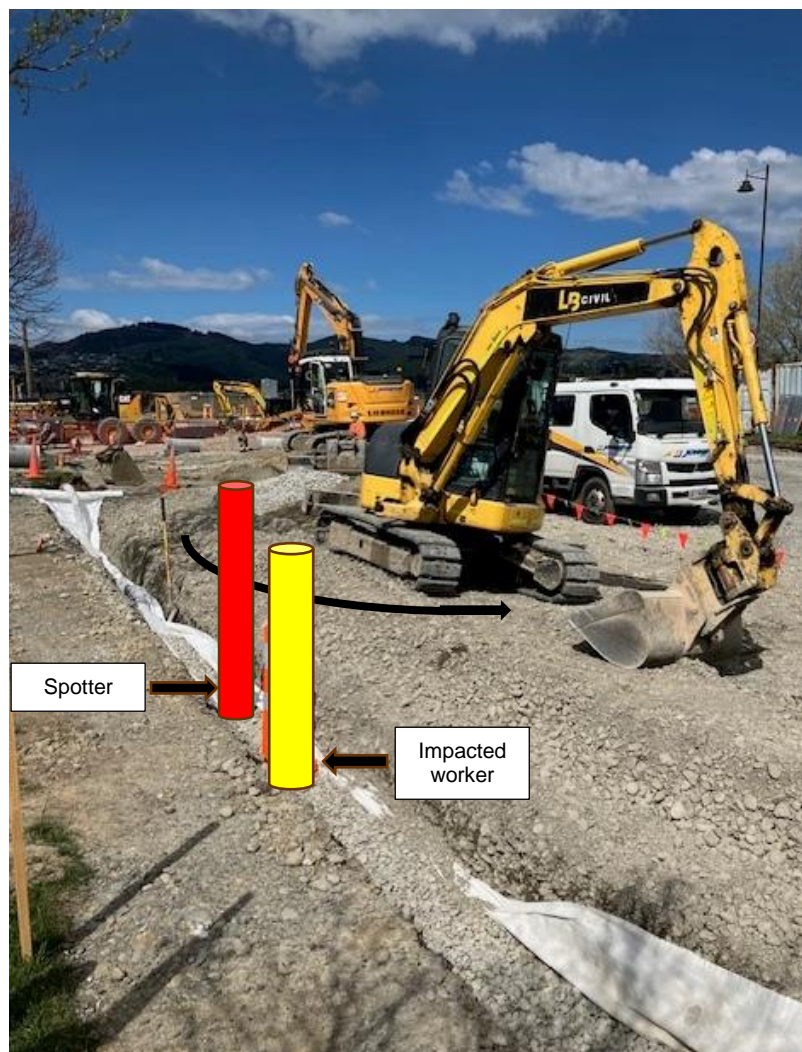
A subcontractor working for Fulton Hogan has been struck in the left shoulder and knocked to the ground by a slewing excavator bucket. The worker was not injured.

A subcontractor crew have installed a 100mm subsoil drain and was in the process of backfilling the trench using a 5.5t excavator.

A worker on foot has entered the shallow trench and walked into the excavator's slew area without making positive communication with the operator or the spotter.

Due to the work angle and the angle of approach, both the excavator operator and spotter have not sighted the worker on foot causing the worker to be struck by the excavator bucket.

Fulton Hogan Safety Advisor and the subcontractor's management have met onsite. Before recommencing work the subcontractor has completed a reset with their team.
