TBT 029 – Wallace St Road Plates

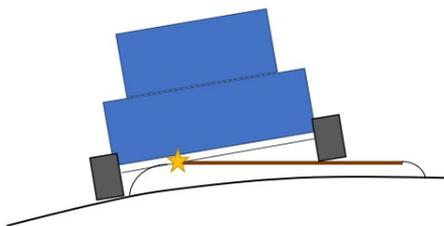
An investigation took place and the significant camber of the road was identified as one of the main contributing factors.

The camber meant that the side of the plate in the middle of the lane was high in comparison with the

surface of the road. Asphalt ramps were in place but if a vehicle traversed the arrangement with one wheel just off the ramp and the other on the plate then the clearance on the high side of the plate would be reduced.

The key learning is that on roads with significant camber additional controls are required:

- Consider low vehicles and ground clearance for all parts of the plate.
- Consider leaving positive TM in place to control vehicle paths over the plate.
- If there is low ground clearance, then extend the asphalt ramps to raise both wheels as they pass over the plate.
