SAFETY ALERT

| INCIDENT | Excavator Tipped onto Side |
| BUSINESS UNIT | Brian Perry Civil – Wellington Branch |

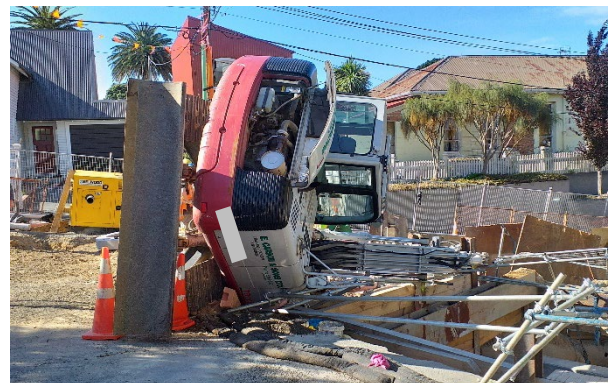
As the excavator neared the excavation, the operator extended the boom and started to slew the manhole over an existing services chamber towards the excavation. As the load has slewed the excavator has become unstable and has tipped over onto its side.

The excavator was fitted with a Roll Over Protective Structure (ROPS), and the operator was wearing his seatbelt so was not injured, an exclusion zone had been established prior to the task commencing and all workers were in a safe location at the time of the incident.

- The incident scene was frozen immediately
- BPC management team and Wellington Water were immediately advised of the incident
- The excavator was secured in position to ensure no further movement occurred overnight
- Post incident drug and alcohol testing was completed on the operator and dogman
- An investigation team has been formed and the investigation has commenced

- Ensure that workers operating plant and equipment are trained, competent and authorised
- Workers involved in lifting operations need to be trained and assessed as competent
- When using an excavator for lifting, the bucket must be removed prior to the task commencing
- If excavators are used for pick and place operations, ensure the travel route is clear of obstructions
- Always assess ground conditions when undertaking lifting operations
