Flash health & safety

Water – SUEZ Australia

Site: Prospect Water Filtration Plant, Wetherill Park, NSW

Serious Near Miss – Potential Fall From Ceiling Space

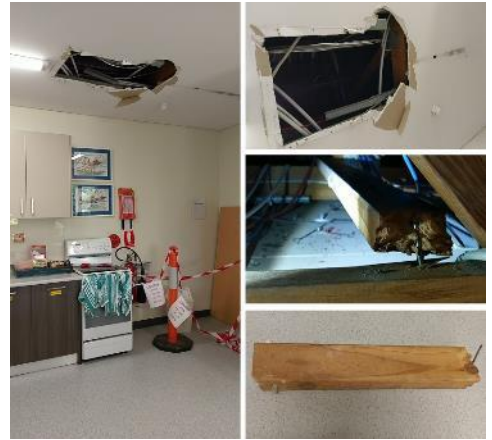
On 20/03/2019 a young worker and tradesman were installing air conditioning ductwork in the ceiling void. The young worker stood on a non-load bearing piece of wood that broke resulting in his foot penetrating the gyprock while he was moving between joists. Work was immediately stopped and the welfare of the both workers was checked. There were no injuries.

Gyprock Ceiling and Broken Timber

A fall through the ceiling (2 metres above the floor level) could have resulted in serious injuries to the worker

- Contractor SWMS did not address specific risks/controls of working in the ceiling space.
- Work clearance process was not robust and did not verify workers understanding of risks

- Ceiling joists were 1200mm apart. No engineering controls used to avoid risk of stepping across such wide spacing.
- Ceiling design does not allow work from ground level to avoid going inside the ceiling.

- Develop SWMS with specific risks and controls for working in ceiling space
- Pre-work risk assessment and toolbox meeting with workers prior to commencement of work to identify specific hazards of the task
- Ensure young workers are adequately trained and are supervised all the times.
- Ensure effective implementation of Contractor Safety Management program.
