Official information request Seaview Wastewater Treatment Plant.

HUTT VALLEY WASTEWATER TREATMENT PLANT, BIOFILTER ASSESSMENT, MARCH 2023

HUTT VALLEY WASTEWATER TREATMENT PLANT, ODOUR CONTROL SYSTEM ASSESSMENT, FEBRUARY 2023

HUTT VALLEY WASTEWATER TREATMENT PLANT, ODOUR CONTROL SYSTEM ASSESSMENT, JULY 2021

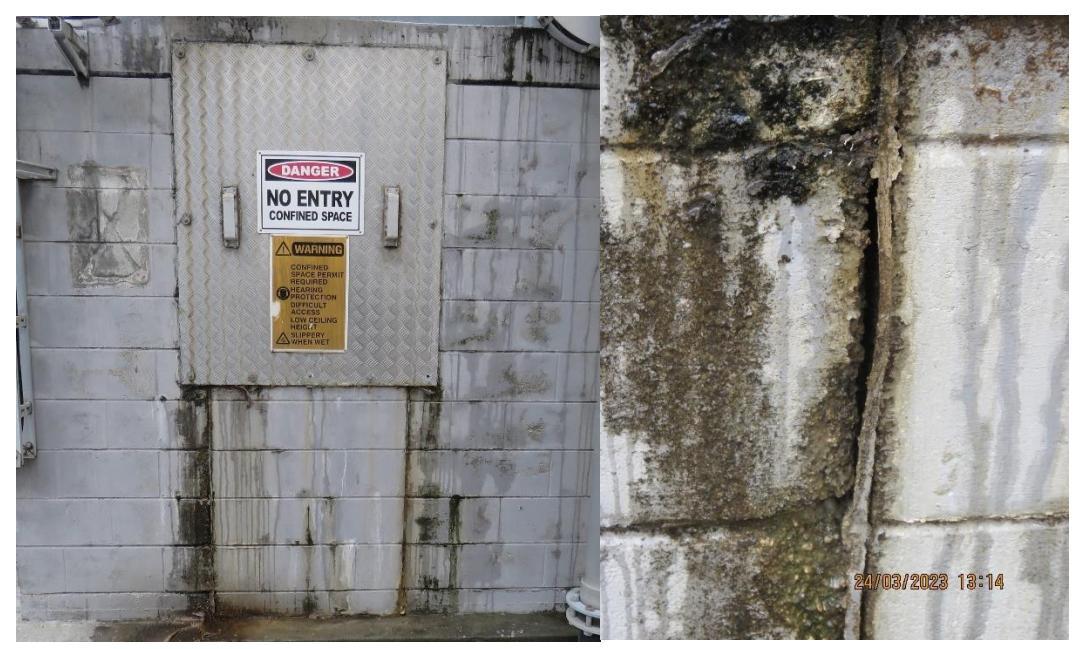
Figure 1: Biofilter Blockwork, 16 March 2023

The Hutt Valley WTP biofilter consists of a six-bed bark/soil biofilter. On 16 March 2023, the exterior block work was examined to identify any potential leaks and it was found that at both ends of the biofilter plenum there was significant degradation of the block work and numerous leaks (Figure 1). It is recommended that the block work be remediated.

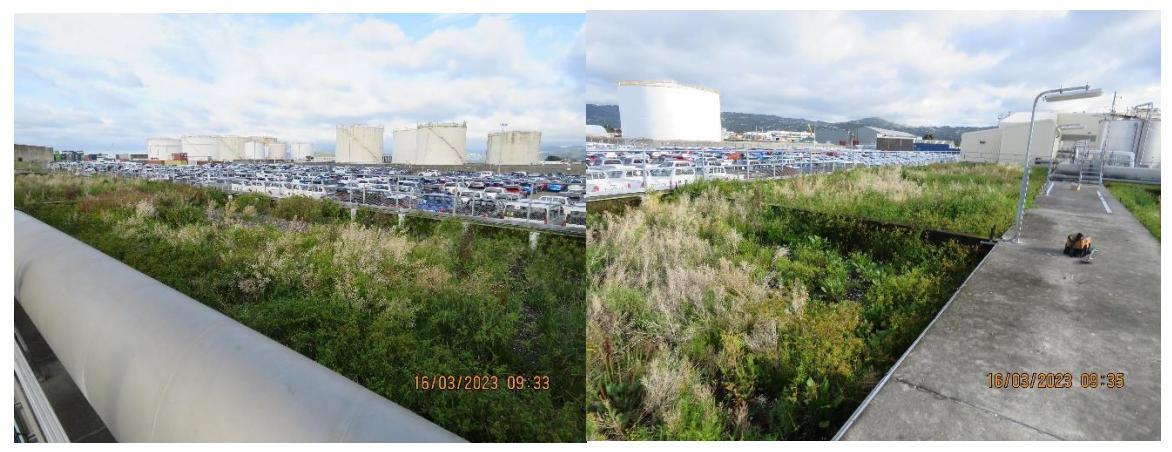
Figure 2: Biofilter Surface, 16 March 2023

The biofilter was also covered in a thick layer of vegetation up to 1 m in height (Figure 2). The extensive vegetation growth had resulted in roots penetrating the media to a depth of 300 to 500 mm as can be seen in Figure 3. The vegetation cover on the biofilter will act as a cap on the biofilter, increasing back pressure and forcing the flow to the perimeter, potentially resulting in short circuiting of the media. The vegetation and associated root system act to further compact the media.

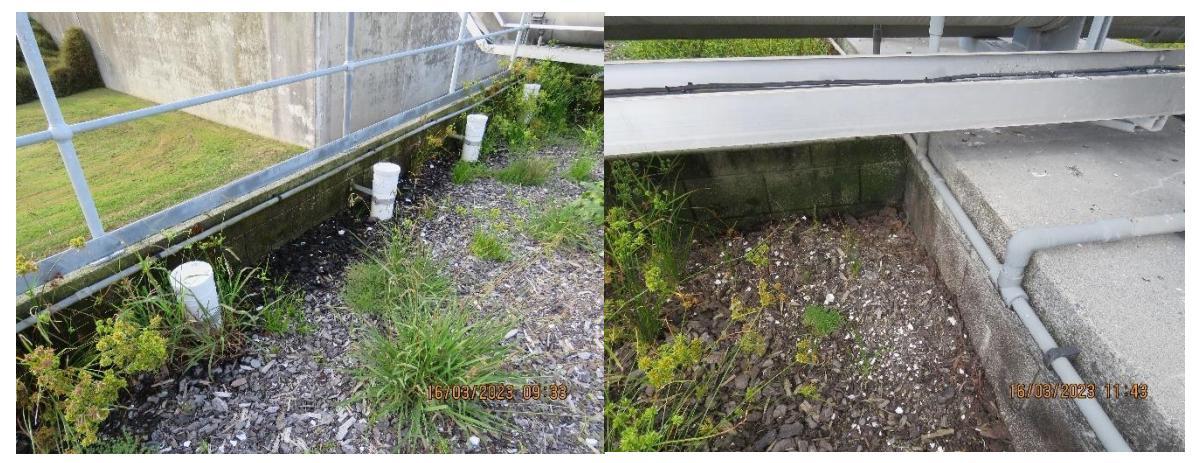
Figure 4: Biofilter Dry Spots and Short Circuiting, 16 March 2023

While it was difficult to see the full surface of the biofilter, there was evidence of dry spots and short circuiting on Cell 2 (Figure 4), particularly around the perimeter of the cell. The dry patches can be indicative of limited or uneven flow distribution caused by the compaction of the media.

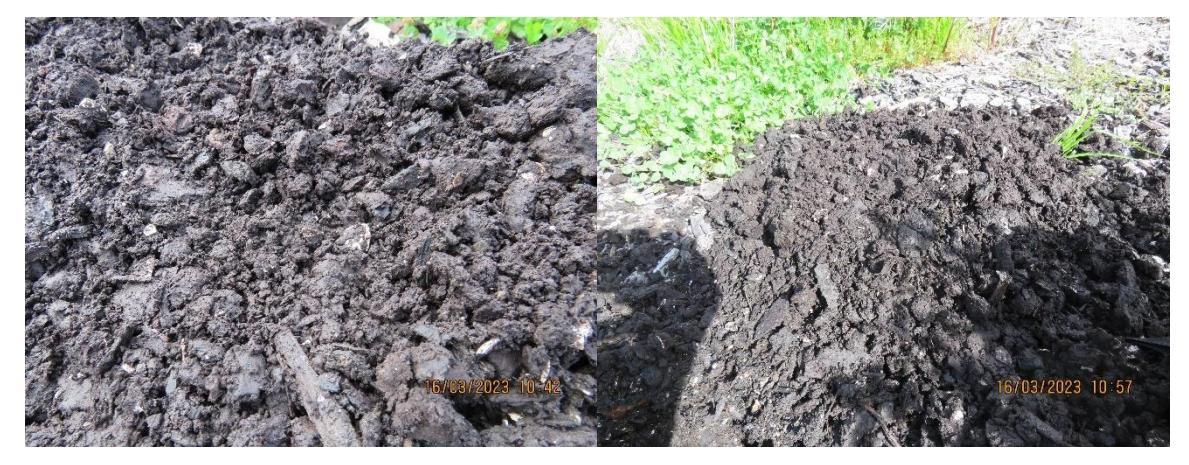
Figure 5: Biofilter Media 250 mm depth, 16 March 2023

The biofilter media consisted of medium (20 mm) to large (50 mm) bark nuggets, soil and seashells to buffer the media against acidification (Figure 5). The media was reasonably consistent between the cells and was highly degraded with a high proportion of fine/mud like material. The bark nuggets and the seashells were also highly degraded to the point the material could be broken with one's fingertips. The media in general was damp to touch and clumped together. However, there were also areas which were significantly drier than the bulk of the media.

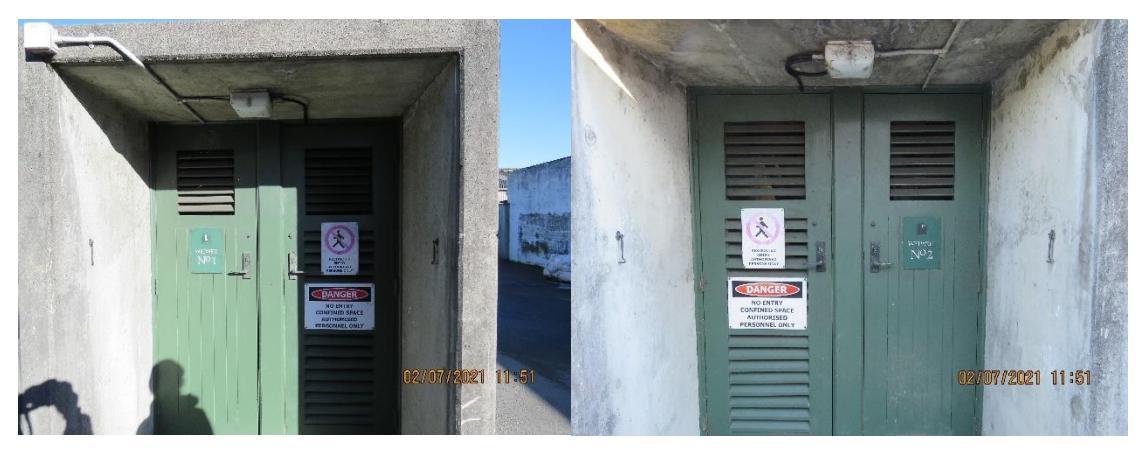
Figure 2: TWPS Wet Wells Entrance

The Trade Waste Pump Station (TWPS) acts as the inlet works for the plant, accepting effluent from a number of different communities including Wainuiomata, Seaview, Lower Hutt and Upper Hutt. The TWPS has two entrance stair wells which have vented doors (See Figure 2). The pumps are located within a sump which is covered by large concrete plates which have had new seals applied since the 2021 assessment.

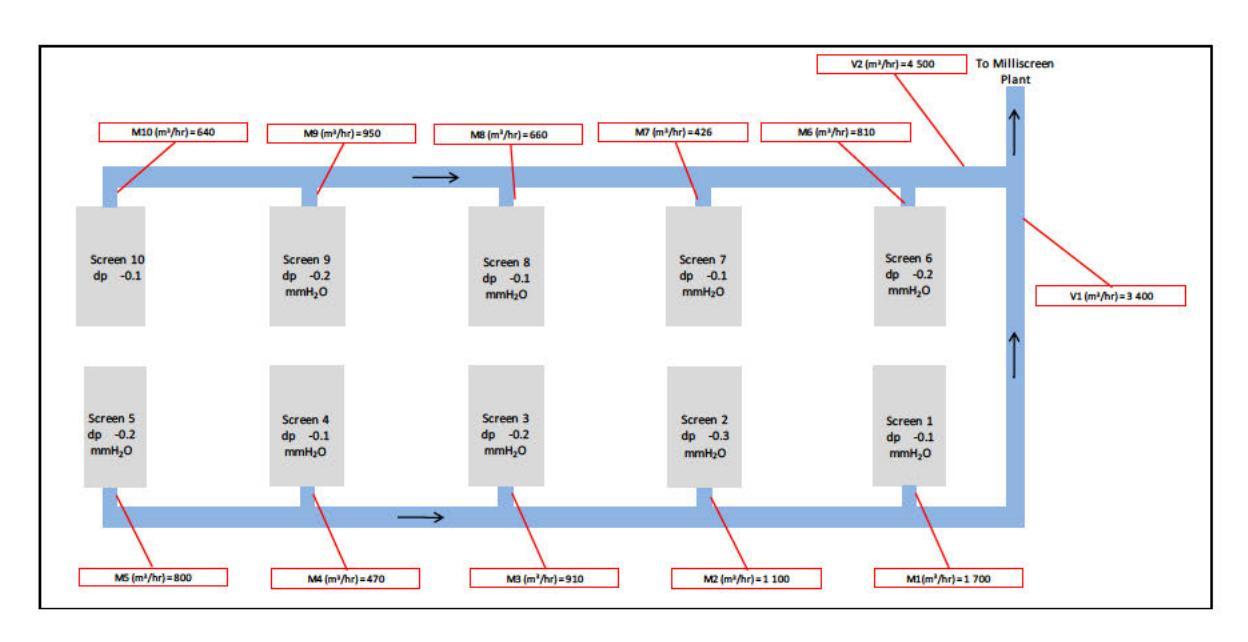
Figure 4: Milliscreen (First Floor) Extraction Rates, 24 February 2023

On 24 February 2023, the extraction rates were measured and showed that for screening enclosures 1 to 5 the flow ranged from 470 to $1,700 \text{ m}^3/\text{hr}$ with an average of $1,000 \text{ m}^3/\text{hr}$ and for screening enclosures 6 to 10 the flow rate ranged from 430 to 950 m³/hr with an average of 700 m³/hr. The total flow from milliscreens 1 to 5 and the total flow from milliscreens 6 to 10 were $3,400 \text{ m}^3/\text{hr}$ and $4,500 \text{ m}^3/\text{hr}$ respectively, which was similar to the flows measured in 2021.

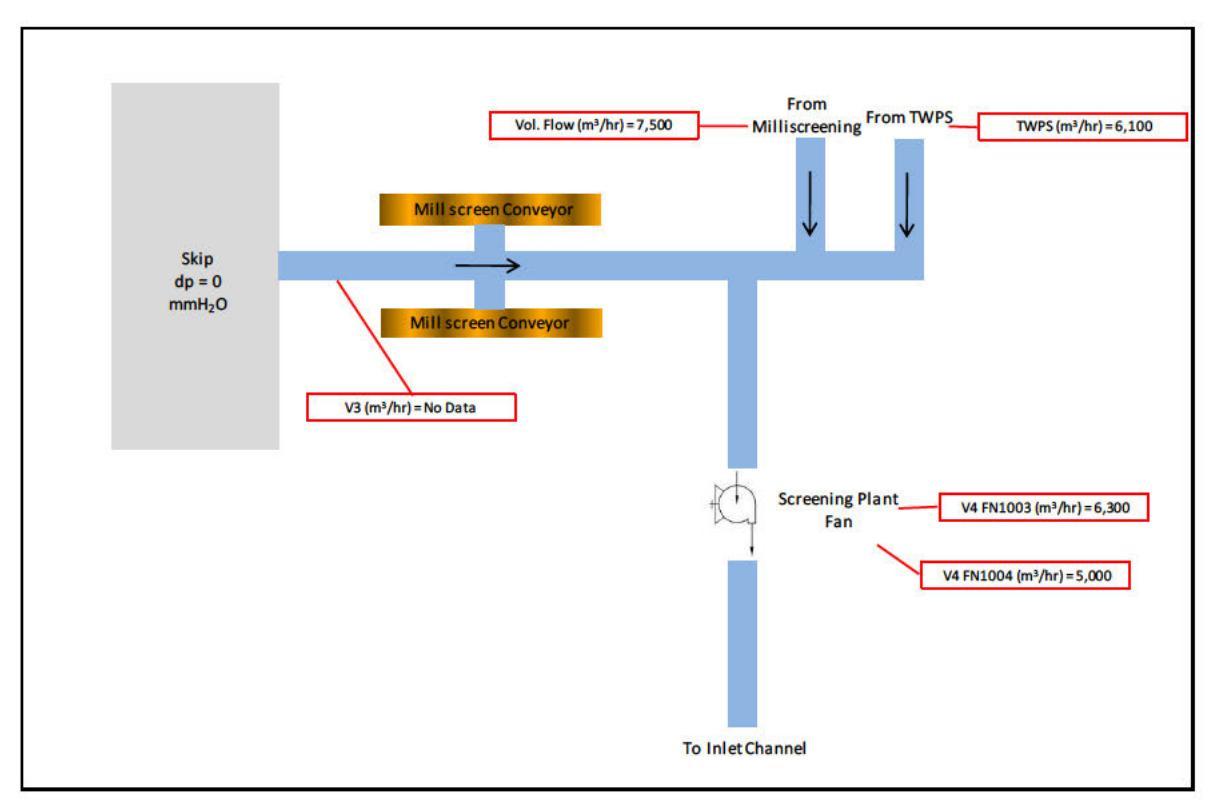
Figure 5: Milliscreen Plant (Ground Floor) Extraction Rate, 24 February 2023

On 24 February 2023, the total volume extracted from the Milliscreen Plant was approximately $11,300 \text{ m}^3/\text{hr}$. The flow consisted of approximately $6,100 \text{ m}^3/\text{hr}$ from the TWPS, $7,500 \text{ m}^3/\text{hr}$ from the milliscreening enclosures, and an unknown volume from the screenings skip (Total 13,600 m³/hr). As the extraction rates from the milliscreens and TWPS is higher than the extraction rates from the main plant fans, there is a potential for the excess flow to be discharged via the skip bay extraction. The main plant fans may be being hindered by upstream blockages, potentially the biofilter. *It is highly recommended that the main fans be investigated to improve the extraction rates*.

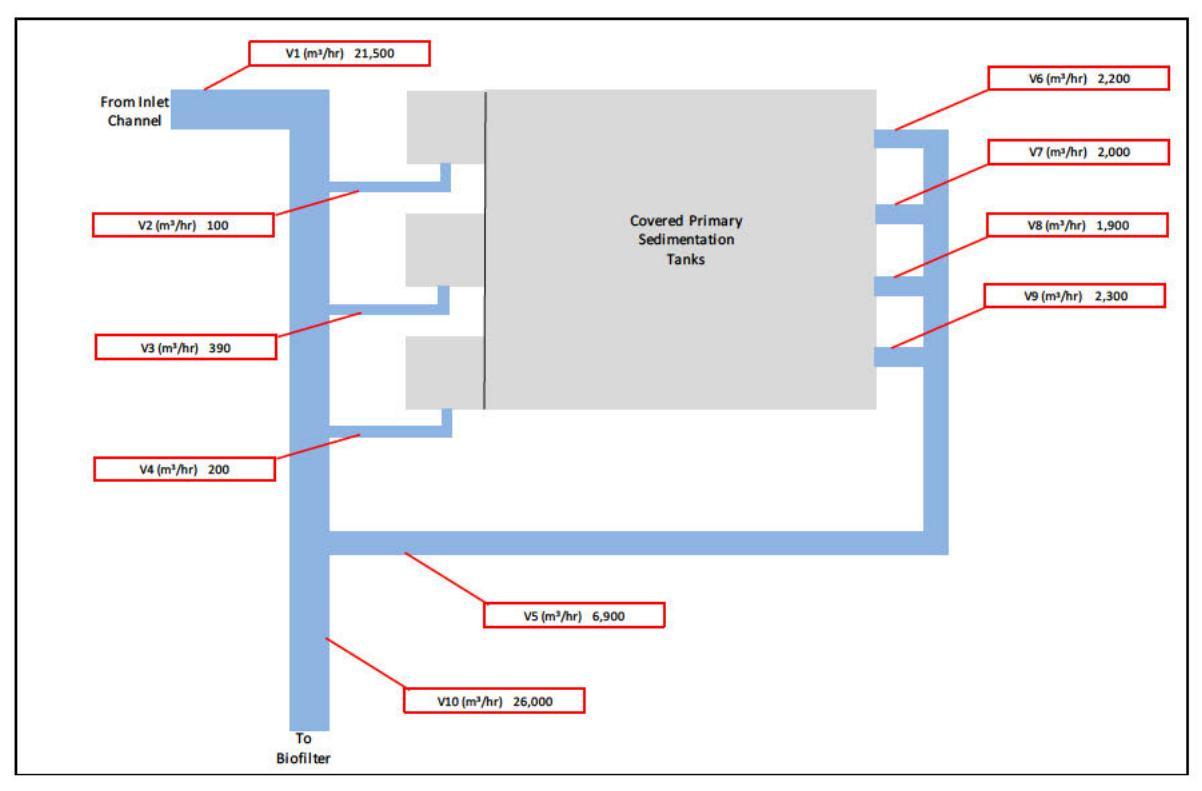
Figure 7: Primary Sedimentation Extraction Rate, 24 February 2023

On 24 February 2023, the volume of air extracted from the inlet channel was approximately 21,500 m³/hr, which was similar to the 20,600 m³/hr observed in 2021. The total volume extracted from the primary sedimentation tanks was 4,500 m³/hr (26,000 – 21,500 m³/hr) which was approximately 25 % lower than observed in July 2021. This is most likely due to an upstream blockage, potentially the biofilter.

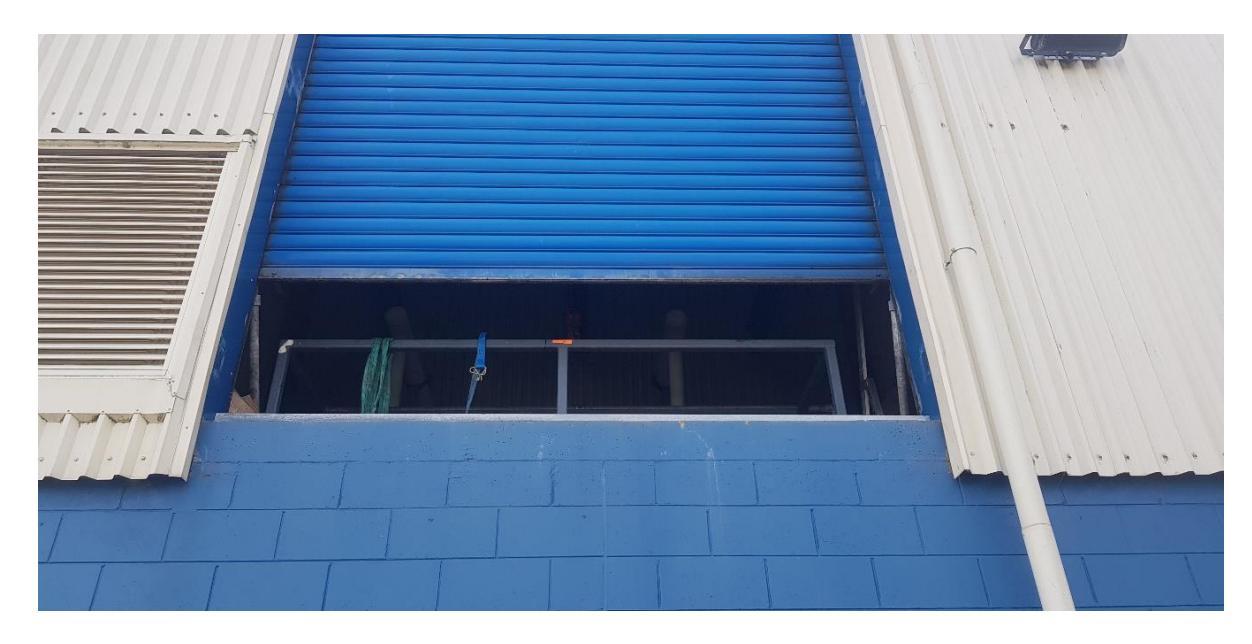
Figure 8: Centrifuge Room Side Roller Door, 24 February 2023

The Hutt Valley WTP has three sludge centrifuges located in the Centrifuge Room. Each unit has active extraction at either end to remove foul air from the centrifuges. The flow rates from only two of the six extraction ducts could be measured as some of the sampling ports had been sealed. There are two floor and two ceiling passive wall vents within the Centrifuge Room. Building pressures recorded from these vents indicated the room to be under a negative pressure of between -0.1 and -0.2 mmH₂O. Hence, while there was a significant odour within the centrifuge room, the likelihood of fugitive emissions would be low. However, it was noted that in the afternoon the side roller door was opened which would allow foul air to escape (See Figure 8). *It is recommended that this door remains closed unless in use.*

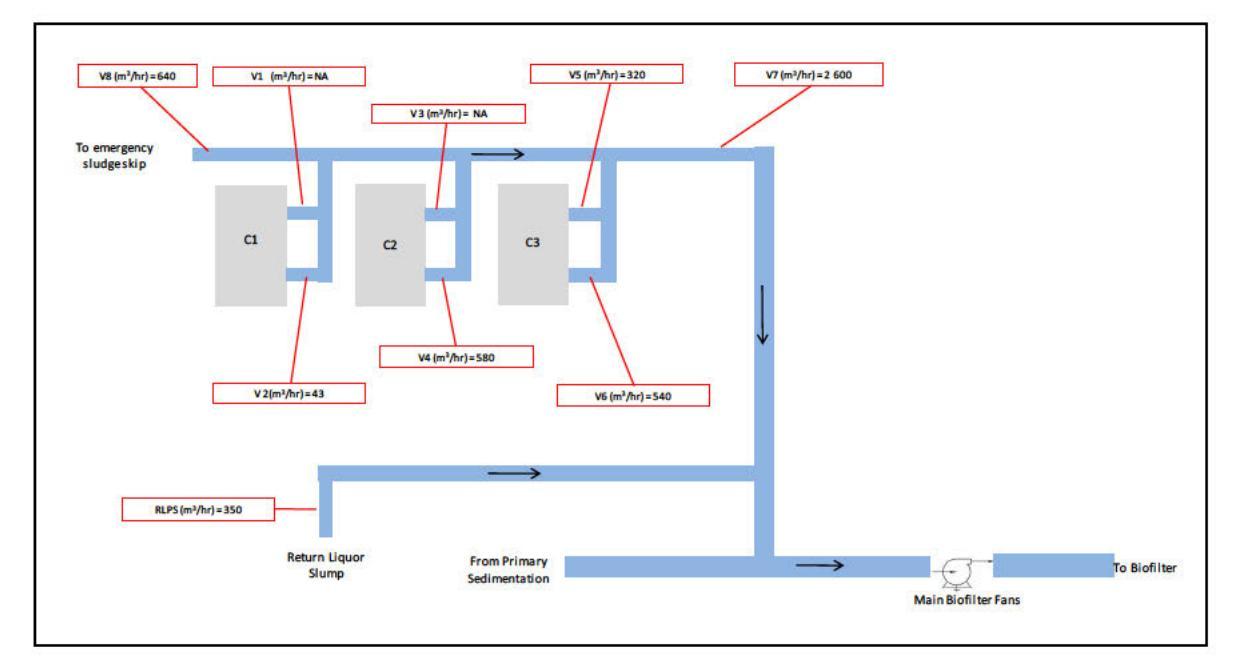
Figure 9: Centrifuge Room & Return Liquor Pump Station Extraction Rate, 24 February 2023

On 24 February 2023, the total flow extracted from the three centrifuges was approximately 2,600 m³/hr with approximately 350 m³/hr extracted from the RLPS. The extraction rate from the centrifuges was approximately 30 % higher than 2021 while the RLSP was similar.

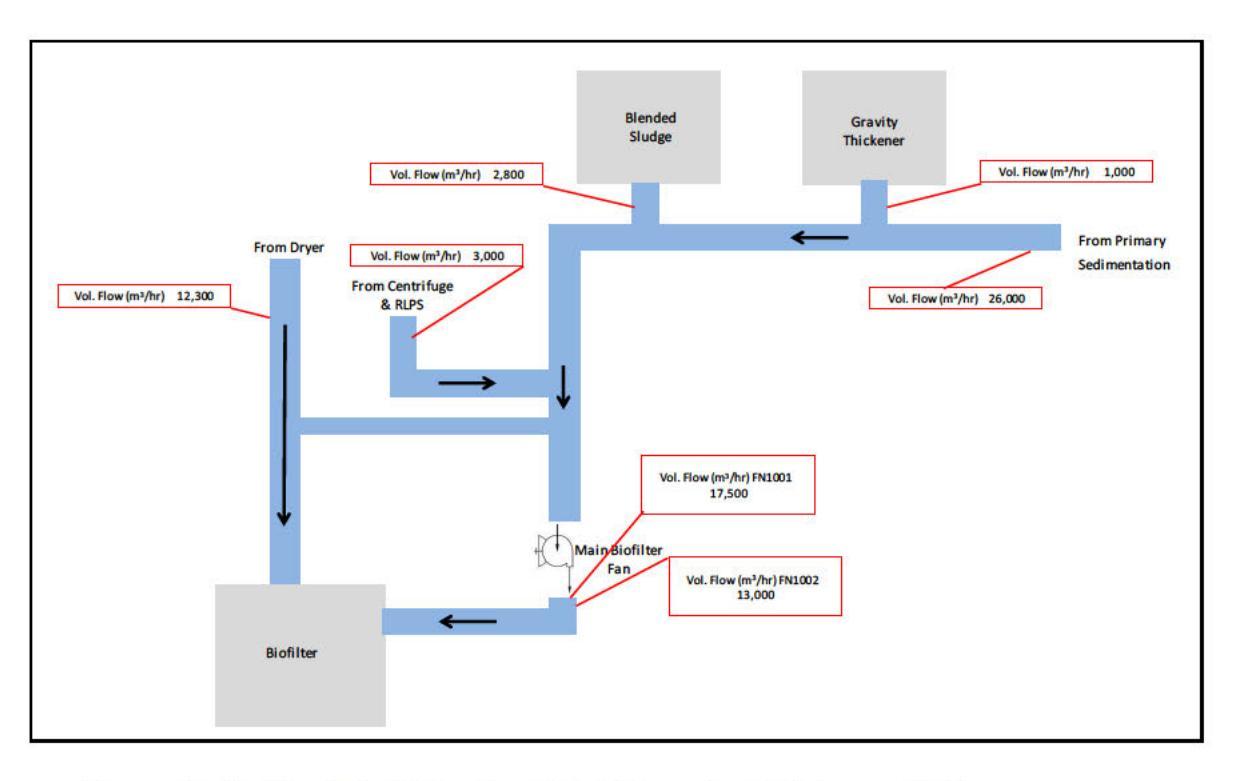
Figure 11: Biofilter Total Extraction Rate Schematic, 24 February 2023

On 24 February 2023, the total flow discharged to the biofilter from the biofilter fans was approximately 30,500 m³/hr which consisted of approximately 26,000 m³/hr from the Primary Sedimentation works (including the Milliscreen Plant/Inlet Channel), approximately 3,800 m³/hr from the Gravity Thickener and Sludge Blend tank, and approximately 3,000 m³/hr from the Centrifuge Room and RLPS.

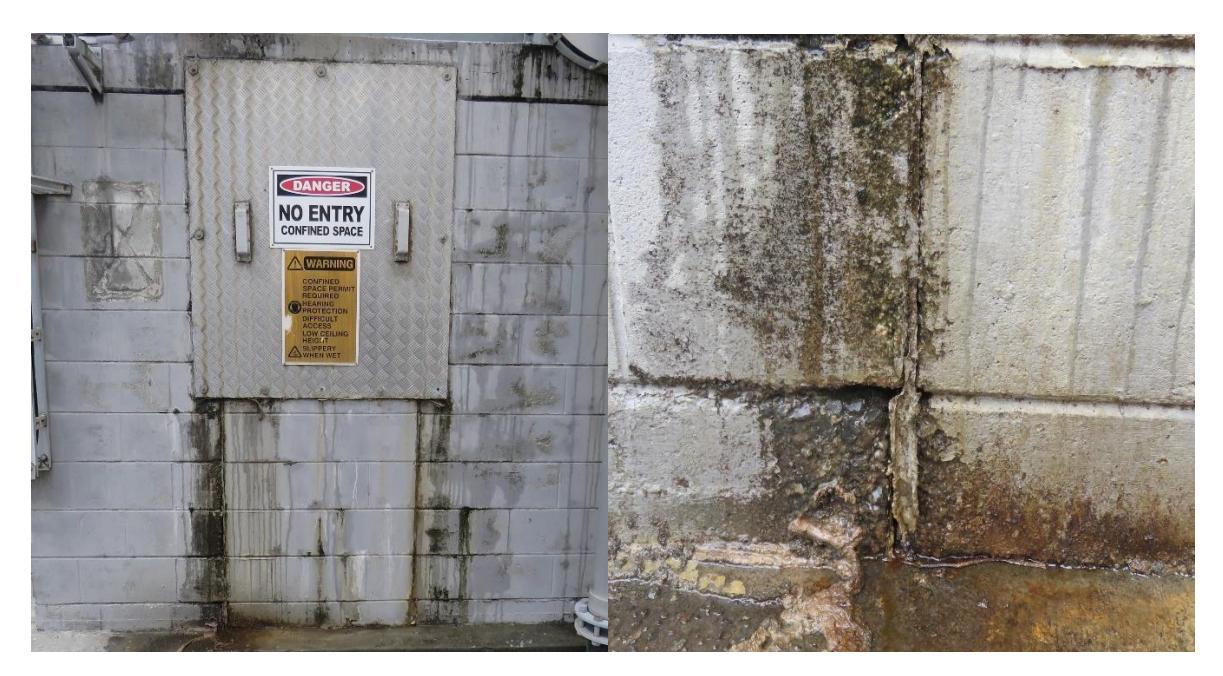
Figure 12: Biofilter Plenum, 24 February 2023

It is worth noting that there was a significant sludge odour present in the vicinity of the Return Liquor slump and biofilter fans. Inspection of the biofilter plenum identified a number of holes and cracks which resulted in foul air being directly discharged into the atmosphere. Further holes/cracks were also observed at the opposite end of the biofilter (See Figure 12).

It is recommended that the plenum be repaired to prevent fugitive emissions.

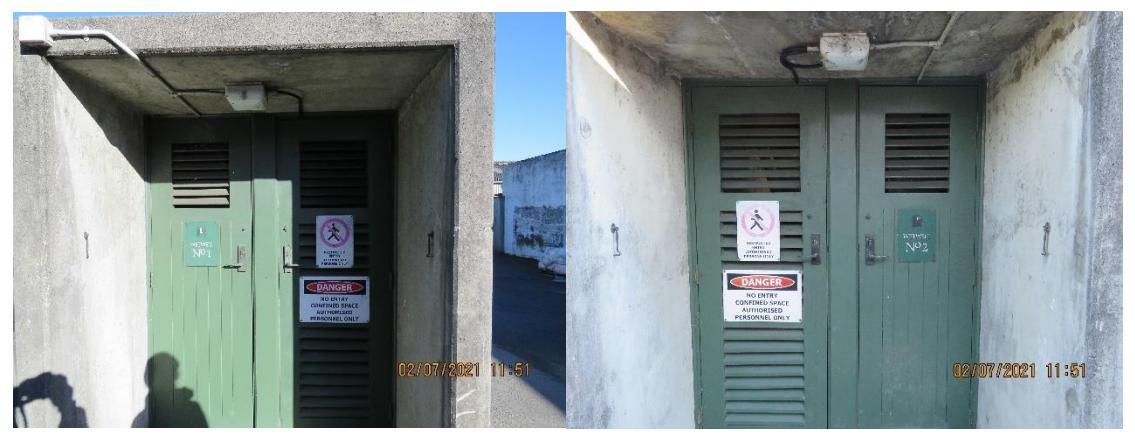
Figure 2: TWPS Wet Wells Entrance

The Trade Waste Pump Station (TWPS) acts as the inlet works for the plant, accepting effluent from a number of different communities including Wainuiomata, Seaview, Lower Hutt and Upper Hutt. The TWPS has two entrance stair wells which have vented doors (See Figure 2). The pumps are located within a sump which is covered by large concrete plates which have been sealed since the last assessment in 2018.

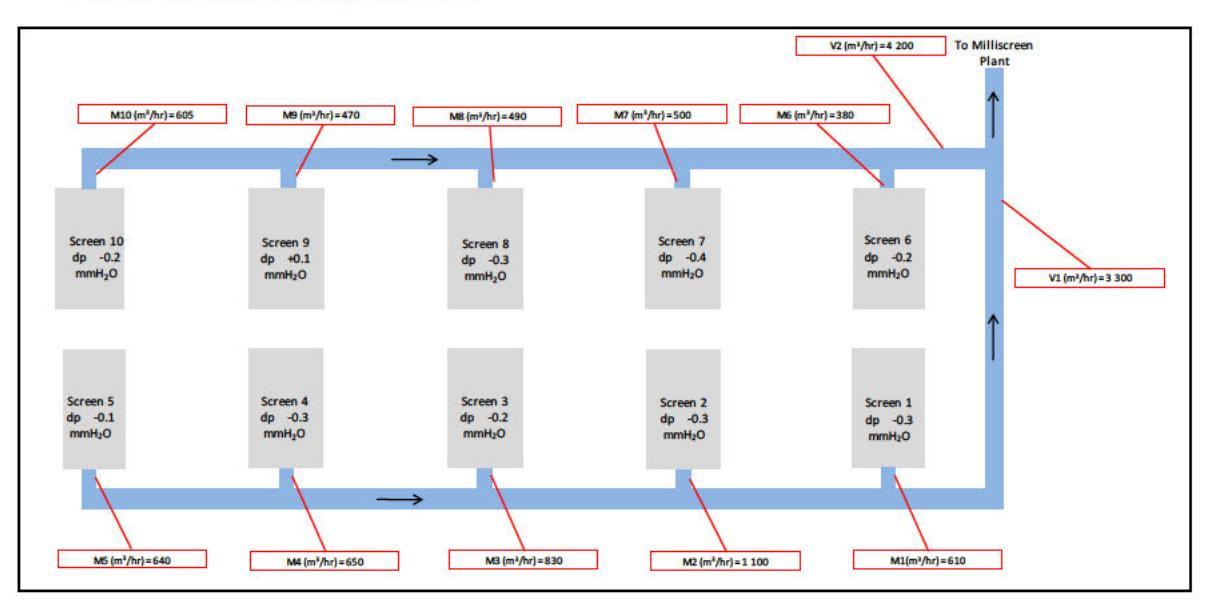
Figure 5: Milliscreen (First Floor) Extraction Rates, 2 July 2021

On 2 July 2021, the extraction rates were measured and showed that for screening enclosures 1 to 5 the flow ranged from 610 to 1,100 m³/hr with an average of 766 m³/hr and for screening enclosures 6 to 10 the flow rate ranged from 380 to 610 m³/hr with an average of 490 m³/hr. The extraction rates for screens 6 -10 were generally lower than for screens 1 to 5 even though the total extracted from screen 1 to 5 was lower than what was extracted from screens 6 to 10 indicating a possible leak in the ducting. The extraction rate from Milliscreen 2 was significantly higher than from the others and it is recommended that the flow be adjusted.

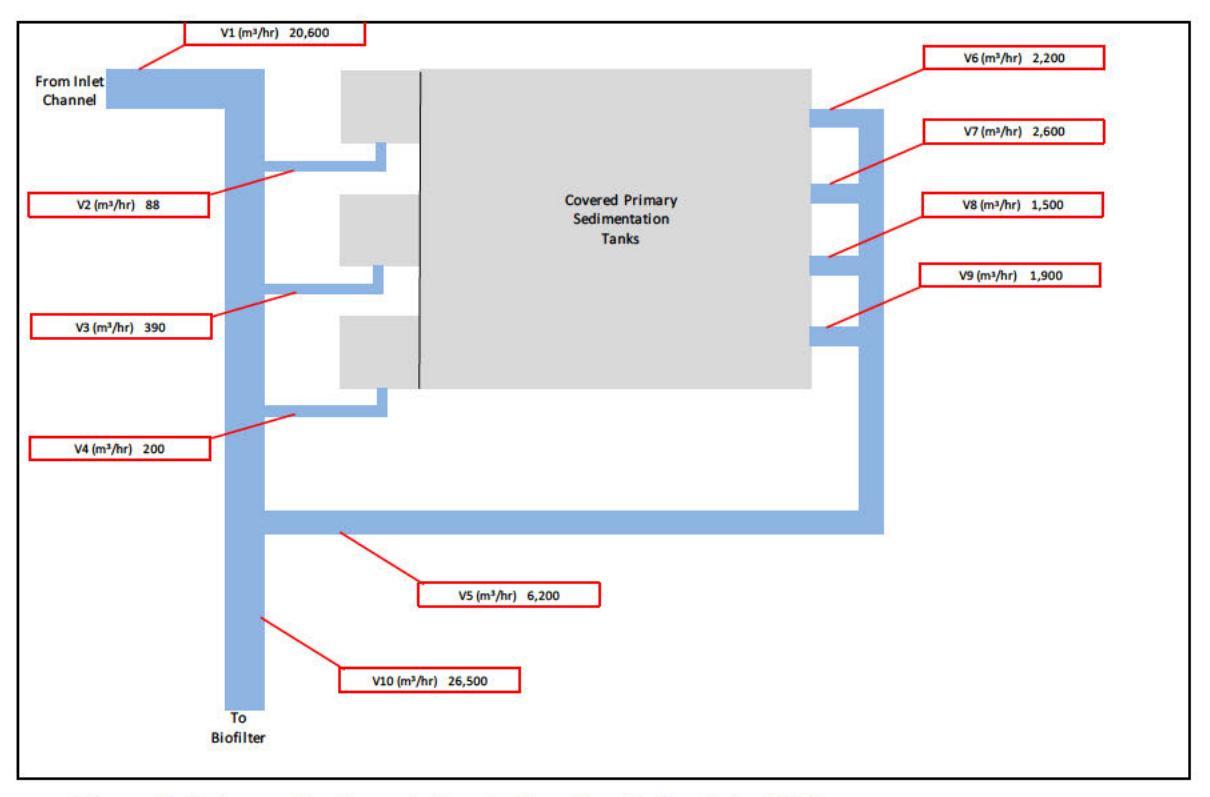
Figure 7: Primary Sedimentation Extraction Rate, July 2021

In July 2021 the volume of air extracted from the inlet channel was approximately $20,600 \text{ m}^3/\text{hr}$, which was higher than the $16,000 \text{ m}^3/\text{hr}$ observed in 2018 with the additional flow being a result of the higher ventilation rate of the milliscreen enclosures.
