**OIA IRO-495**

**Official information request re the stormwater/wastewater fault at 31 View Road, Titahi Bay.**

## Drainage Investigation Report

## CCTV PIPE INSPECTION LOG SHEET

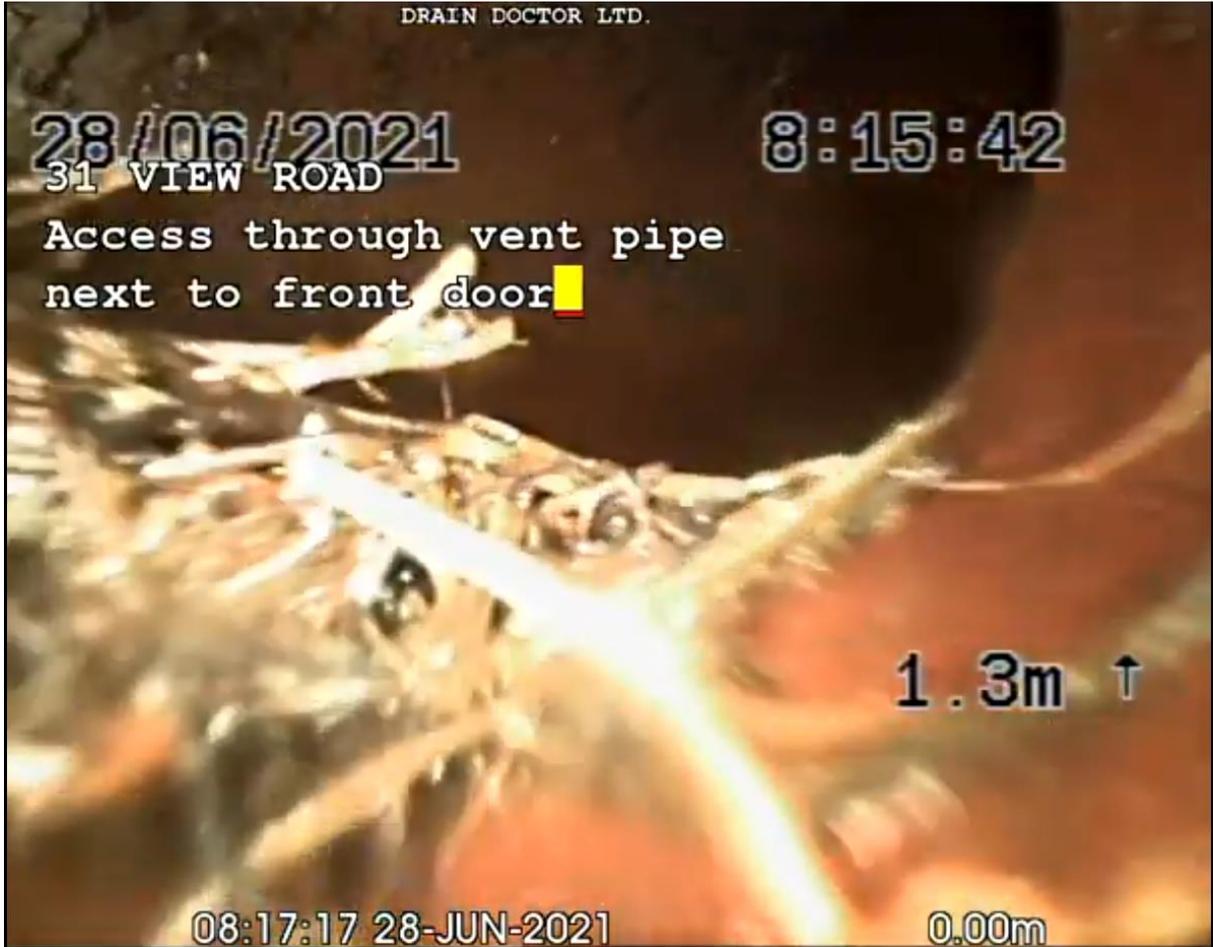
1.3m ↑

Access through vent pipe  
next to front door
