SEAVIEW WASTEWATER TREATMENT PLANT

BIOFILTER FLOW ASSESSMENT, JANUARY 2024

Issue II

March 2024

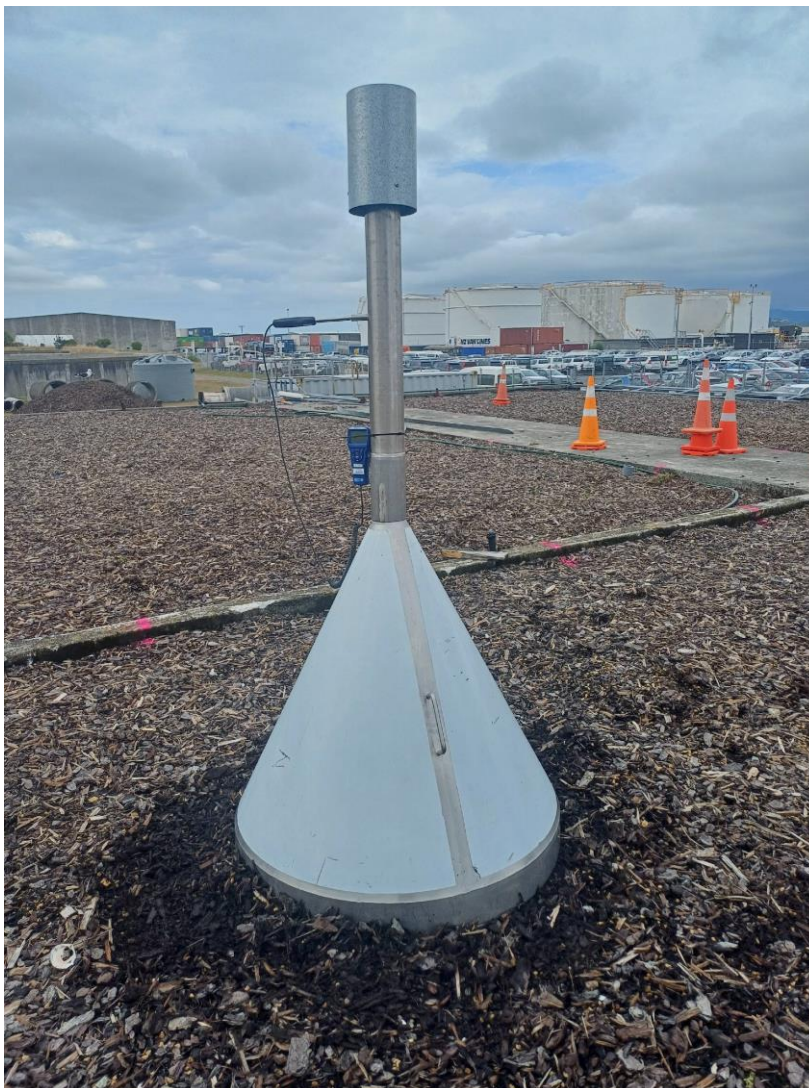
The discharge from the biofilter was measured using a purpose, built biofilter sampling hood (See Figure 1). Due to the large surface area of biofilters, the discharge rate at the surface is very low and easily adversely affected by the wind speed. To account for the low discharge velocity the sampling hood captures the flow from an area of 0.785 m² and reduces to 0.00785 m² concentrating the air volume to measurable level. An extension placed on the outlet of the hood allows laminar flow to develop and reduce the impact of any wind.

■ **Figure 1: Biofilter Sampling Hood, 23 January 2024**

To ensure the data collected was representative of the total surface area of the biofilter, the flow rate for each cell was measured on a 3 x 4 grid for a total 72 sampling points. Prior to recording the velocity, the sampling hood was sealed at the base with media and allowed to equilibrate for approximately 5-minutes. The velocity was then observed over several minutes prior to recording the data to account for any fluctuations associated with the wind speed. On the day of the assessment, relatively calm conditions persisted which limited the impact on the observed velocities.

To determine the discharge rate at the surface of the biofilter using the biofilter sampling hood requires the velocities measured to be converted to the volumetric flow through the hood, which is then used to back calculate the velocity at the surface of the biofilter based on the different diameters/areas of the inlet and outlet of the hood. The surface velocity was then used to determine the volumetric flow for each cell and the biofilter.
