OIA IRO-315

Official information request for clarification on response to OIA IRO-269 as well as further information on 18 Creswick Terrace.

Stormwater Investigations - Infrastructure Checks in Your Neighbourhood

Regarding Property: 18 Creswick Terrace, Northland, Wellington

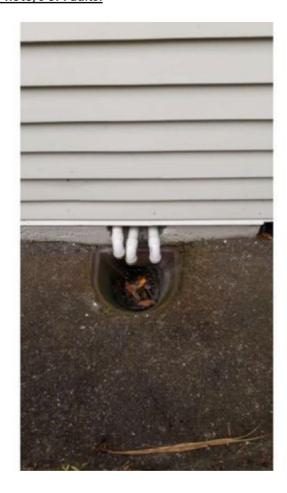
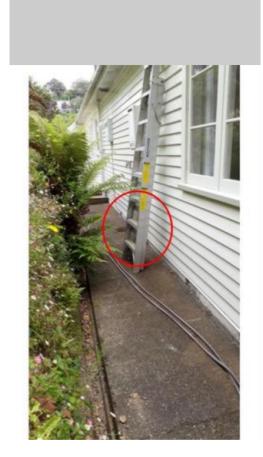
Photo/s of Faults:

1× Low gully trap on a paved area (less than 25mm)

- LETS STORMWATER INTO WASTEWATER NETWORK

Build up the height of the gully trap surround to a minimum height of 25mm on a paved surface (path or driveway etc). This can be done with concrete mortar or by fitting a premade concrete surround and sealing it in place. Wellington Water is aware that premade concrete surrounds can be purchased at Humes and Hynds plumbing suppliers (not currently stocked at DIY stores).
