Memorandum

Attention:	Mel Wykes
Company:	Beca
Date:	15 April 2020
From:	Jeremy Garrett-Walker
Message Ref:	Omāroro – Rolleston Street Pipework and Valve Chamber – Effects on The Waitangi Stream tributary
Project No:	W16117

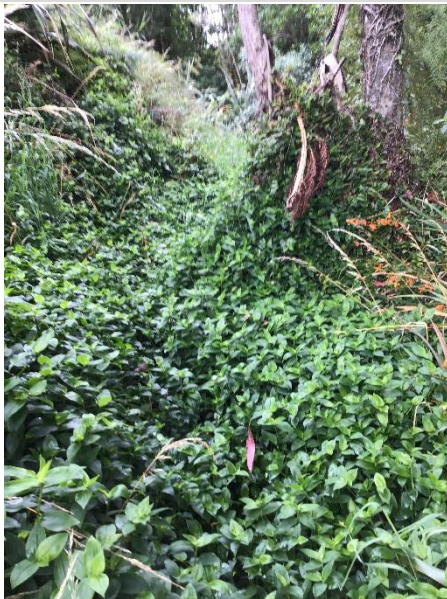
Photo 1: Dense Tradescantia dominates the gully floor within the affected reach.

- The lower section, which is proposed for reclamation, flows through the above-mentioned, dense *Tradescantia*. Within the area of reclamation, thick silts (>25 cm in places) covers 100% of the streambed, which limits (along with the *Tradescantia*) EPT² habitat diversity and colonisation opportunities.

- The physical habitat within the affected reach is substantially poorer and degraded, relative to habitat opportunities further upstream.
- The stream channel is choked with dense *Tradescantia* which is causing extensive silt accumulations while excluding upstream gravels from being transported into the reach from upper areas.
- Flows, at the time of survey, were subsurface in places.
- Riparian vegetation is dominated by an exotic, weed undergrowth, native sub-canopy, and an exotic canopy.
- There is limited, if any, fish and EPT colonisation opportunities.
- The affected reach provides habitat for kōura which is common in the absence of fish.

- We recommend that the current planting design contained in the LEMP be re-visited to:
 - Include additional planting between the location of works and the existing native bush canopy over Waitangi Stream (approximately 25-30 m upstream of works).

- The additional plants should be planted directly into the *Tradescantia* along with protective sleeves to prevent smothering.
 - The existing *Tradescantia*, rank grass and bracken vegetation should be left in place during the construction phase as it will provide a barrier in the event of sediment discharge from the site reducing any entry to the stream channel (and downstream pipe network).

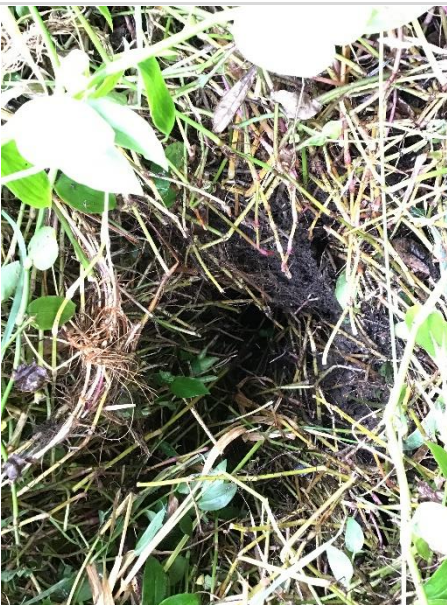
Photo 2: No surface flows in some places (determined once the Tradescantia had been pulled back).

- Irrespective of the extensive downstream stormwater piped network, fish habitat is limited within the affected reach because of thick muds and minimal surface flows (at the time of survey the max surface water depth was 10 mm, spread across the entire bed).

- Within the affected area, flows are limited to shallow, slow run conditions interspersed with small sections (up to 0.75 m) of subsurface flow.
- The riparian zone, while extensive on the true left, is dominated by exotic weed species in the undergrowth, and large exotic trees in the canopy. Shading of the streambed (excluding *Tradescantia*) is provided by a few large trees on the True left, with no vegetation providing effective shading on the true right. This results in the stream being effectively shaded for only approximately 40% of the day.

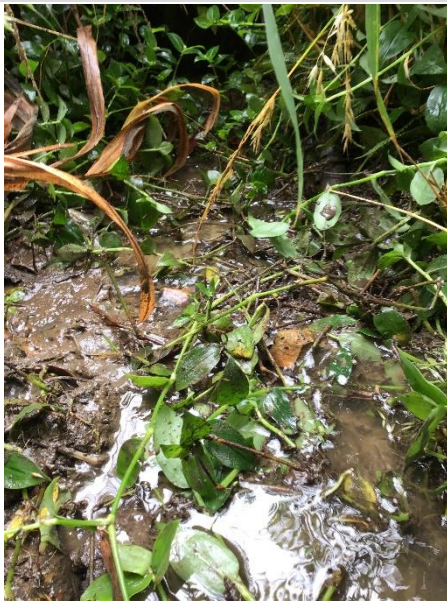
Photo 3: Shallow, soft-bottom flows visible once the Tradescantia had been pulled back.

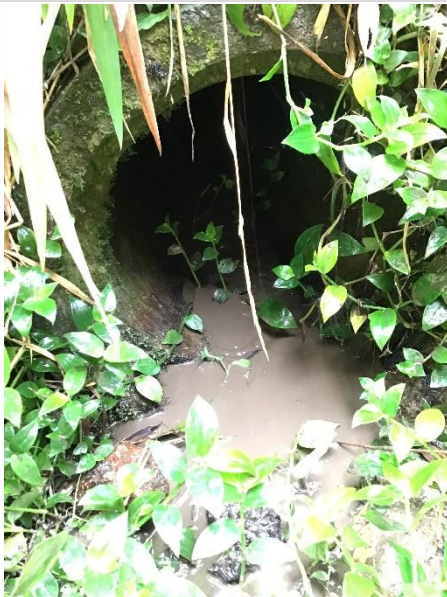
Photo 4: The entrance into the existing stormwater pipe (note the dirty water is from pulling back the Tradescantia).

- The extension of the existing stormwater pipe by 3m will need to consider potential fish passage. Fish have not previously been recorded in this stream, but the potential exists for occasional occupation in the lower sections where a more continuous flow exists. This risk can be avoided by good design.

- Any potential effects of culvert installation on fish passage can be avoided by good design and installation which ensures acceptable gradients and that there is not a hydrological "jump" at the entrance.
