Appendix D (3 of 3)

Hutt and Upper Hutt Catchment Characteristics DRAFT

Te Awa Kairangi / Hutt River Catchment

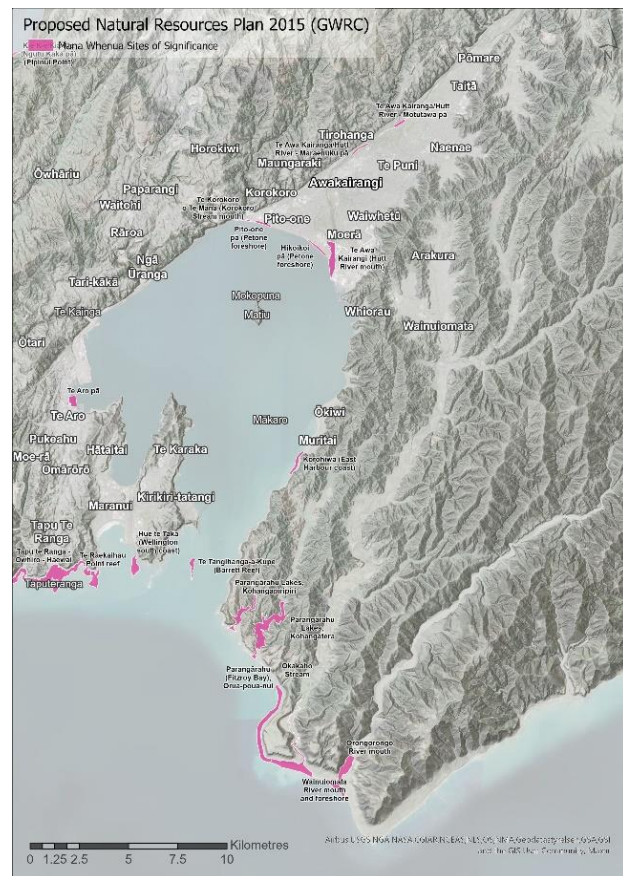
Figure D 4 Map showing the outstanding water Hutt City bodies, Ngā Taonga Nui-a-Kiwa and aquatic sites with significant mana whenua values identified (Sch A-C of NRP)

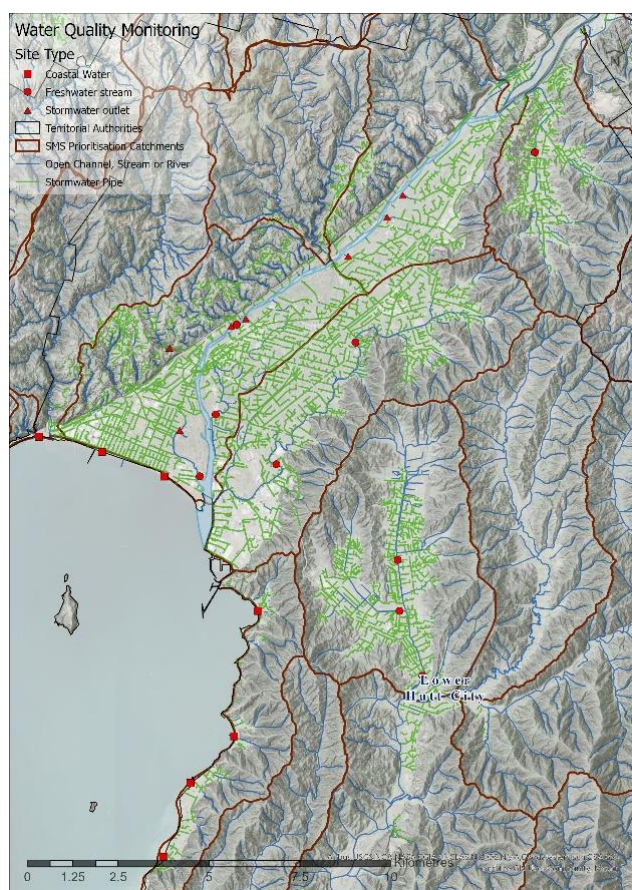
Figure D 5 Monitoring locations for the Stage 1 Stormwater Discharge Consent in Hutt City catchments.

Monitoring results ¹ from the Stage 1 Global Stormwater Discharge Consent shown in Figure D 5 and **Error! Reference source not found.** indicate better water in the upper reaches of the Hutt River, but other sites have poor water quality in regards to E. coli, copper, zinc and nutrients, shown in Table D 1 and Table D 2.

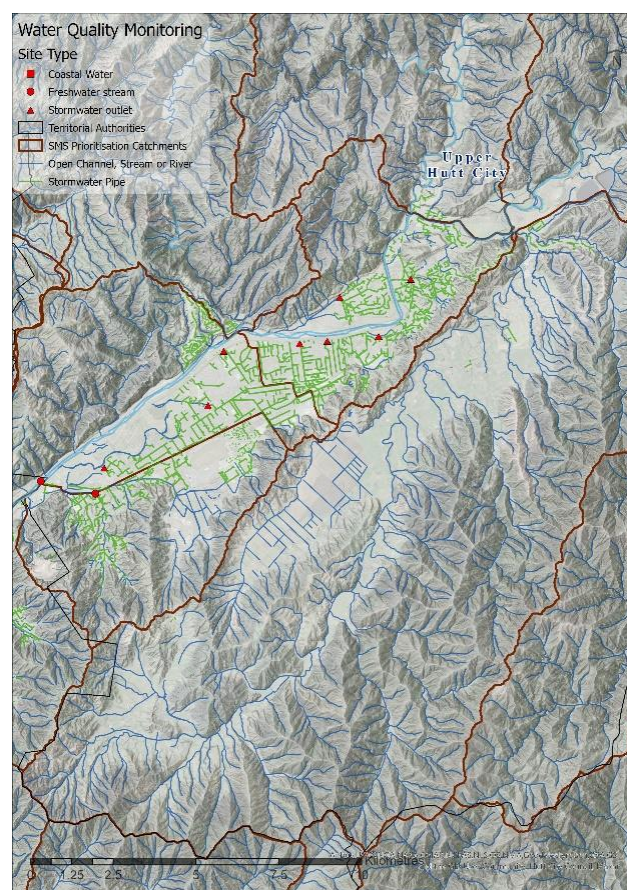
Figure D 6 Monitoring locations for the Stage 1 Global Stormwater Discharge Consent in Upper Hutt Catchments

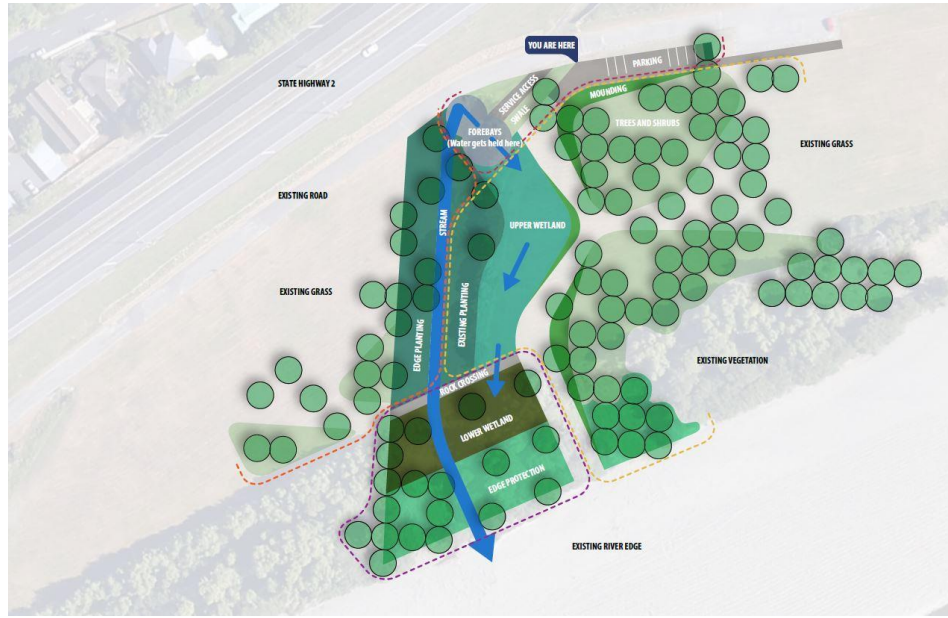
Case Study 5: Riverlink Project (Belmont Wetland)

In the River Link project location there is no treatment of stormwater discharges to the Te Awa Kairangi/Hutt River. The proposed stormwater design for the Riverlink Project at the Belmont Wetland includes treatment of discharges from the area of the highway upgrade, the railway station development, the new bridge and areas of road narrowing and carpark upgrade. The addition of treatment at Belmont Wetland will result in a reduction in the contaminant load discharged to the Te Awa Kairangi/Hutt River. This will result in improvements in water quality in the receiving environment, particularly during and immediately following rainfall events.

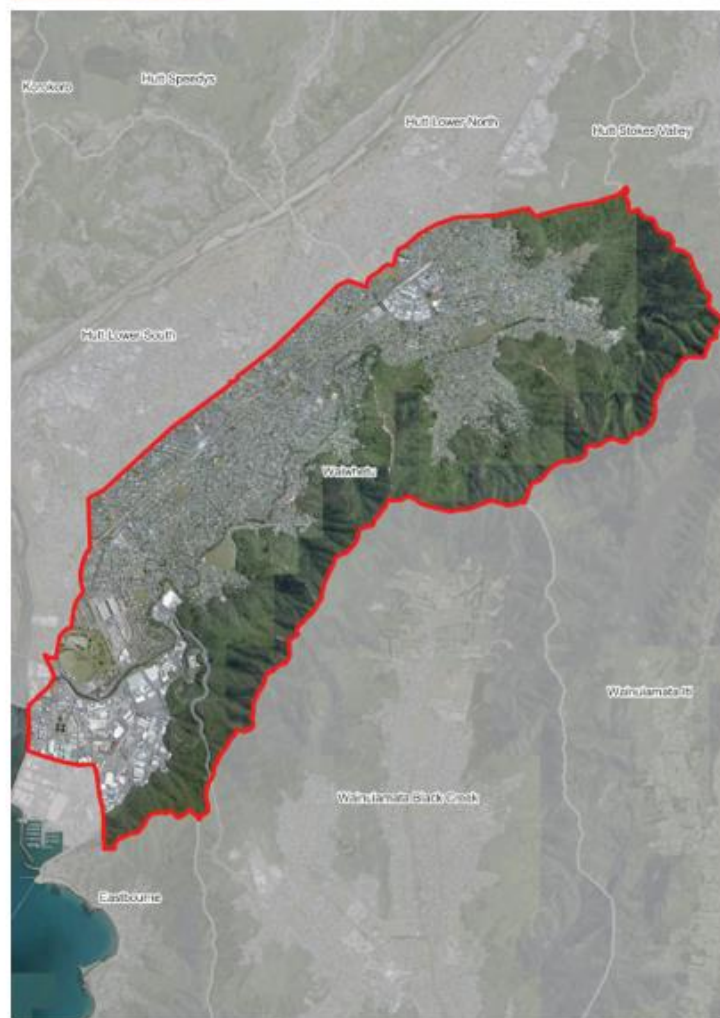
The Waiwhetu catchment is located between the Lower Hutt and Wainuiomata boundaries. It has an area of 11 km² and the Waiwhetu Stream is the primary channel. The Wainuiomata Hills are to the west of the catchment with some low-lying land at the base of the hills. Settlement, gorse and broom, and broadleaved indigenous forest dominate the land use types and there are over 20 contaminated land sites which include a railway, landfill and metal works. There is a small area to the northeast of the catchment that is susceptible to a 0.1% AEP flood event from the Wainuiomata River.

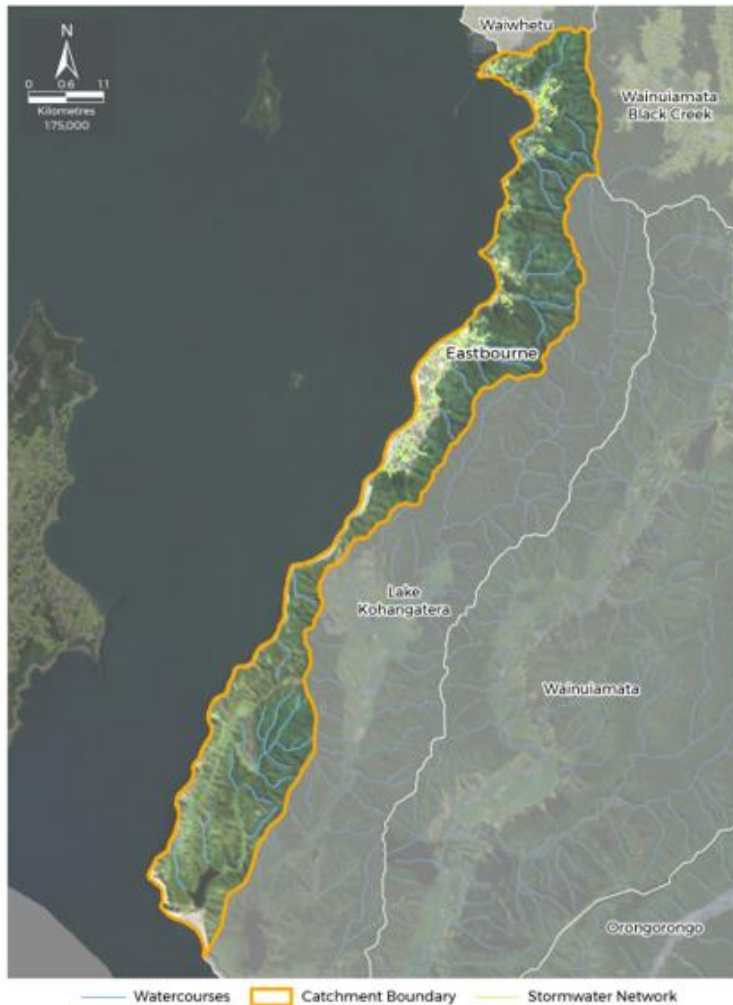
Located along the eastern shoreline of the Wellington Harbour, the Eastbourne Catchment is primarily a coastal area with steep hills reaching elevations up to 343m. The catchment area is [] and Gollans Stream is the primary channel. There is some settlement with indigenous forest and broadleaved indigenous hardwoods being the primary land use. Eastbourne has no classified flood risk and there are more than 20 contaminated land sites including chemical and fuel storage.

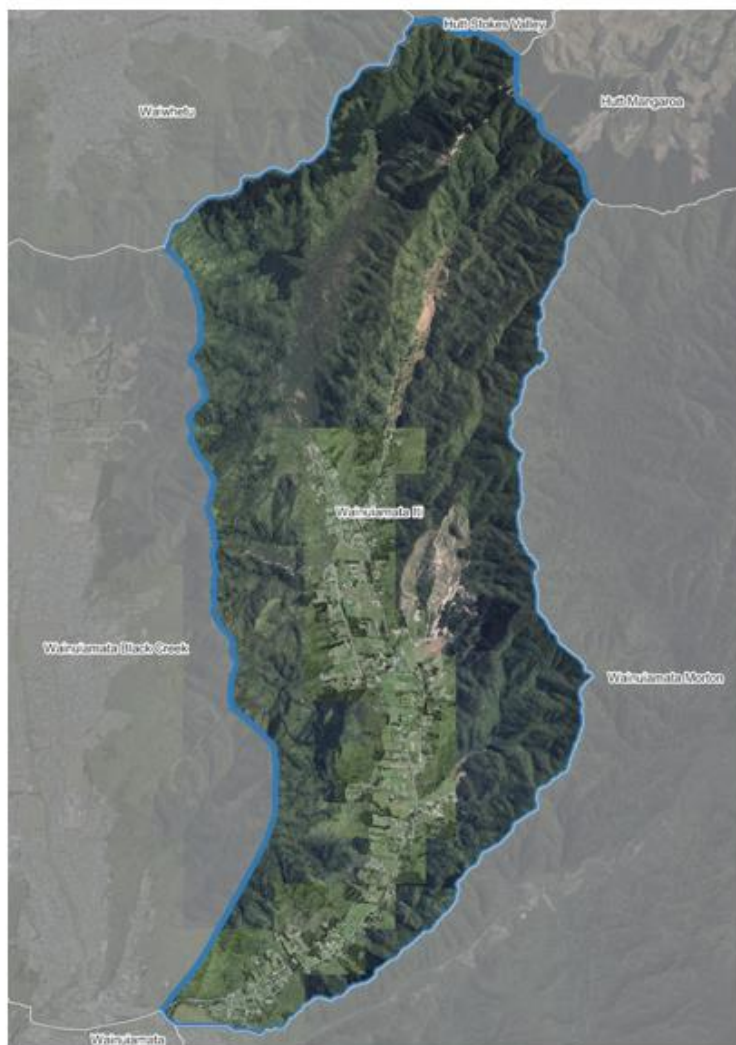
Wainuiomata - Iti

The Wainuiomata – Iti catchment is located west of the Wainuiomata township. The Wainuiomata Stream runs through the valley in the catchment and is surrounded by steep hillslopes. High producing grassland, Manuka and Kanuka and settlement are common land use types and there are no contaminated land sites. The areas south east of the catchment is susceptible to flooding from the Wainuiomata River in a 0.1% AEP event.

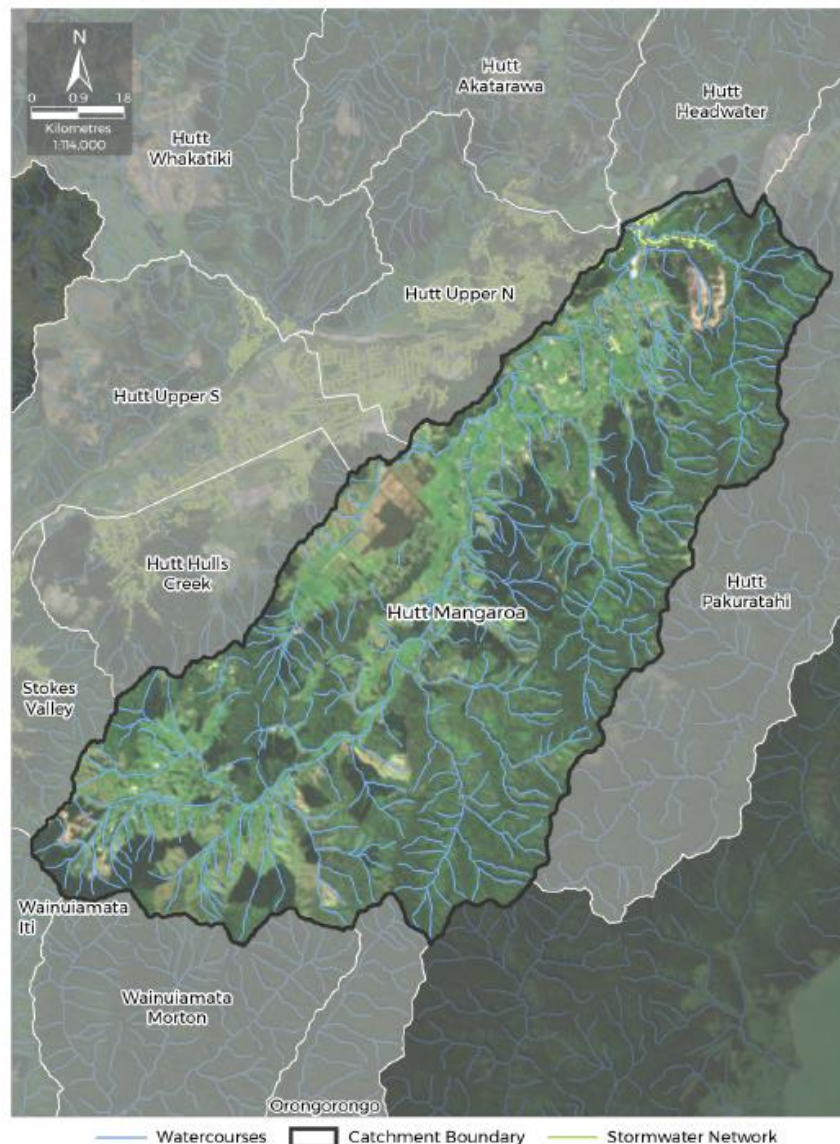
The Hutt – Mangaroa catchment is the largest catchment in the area covering the eastern areas of Upper Hutt through to Stokes Valley. The topography is steep and land use is primarily indigenous forest and high producing exotic grassland as well as some settlement. There are ten contaminated land sites which include a landfill and chemical storage. The area surrounding the Mangaroa River, which flows through the centre of the catchment, are susceptible to a 1% AEP flood event.

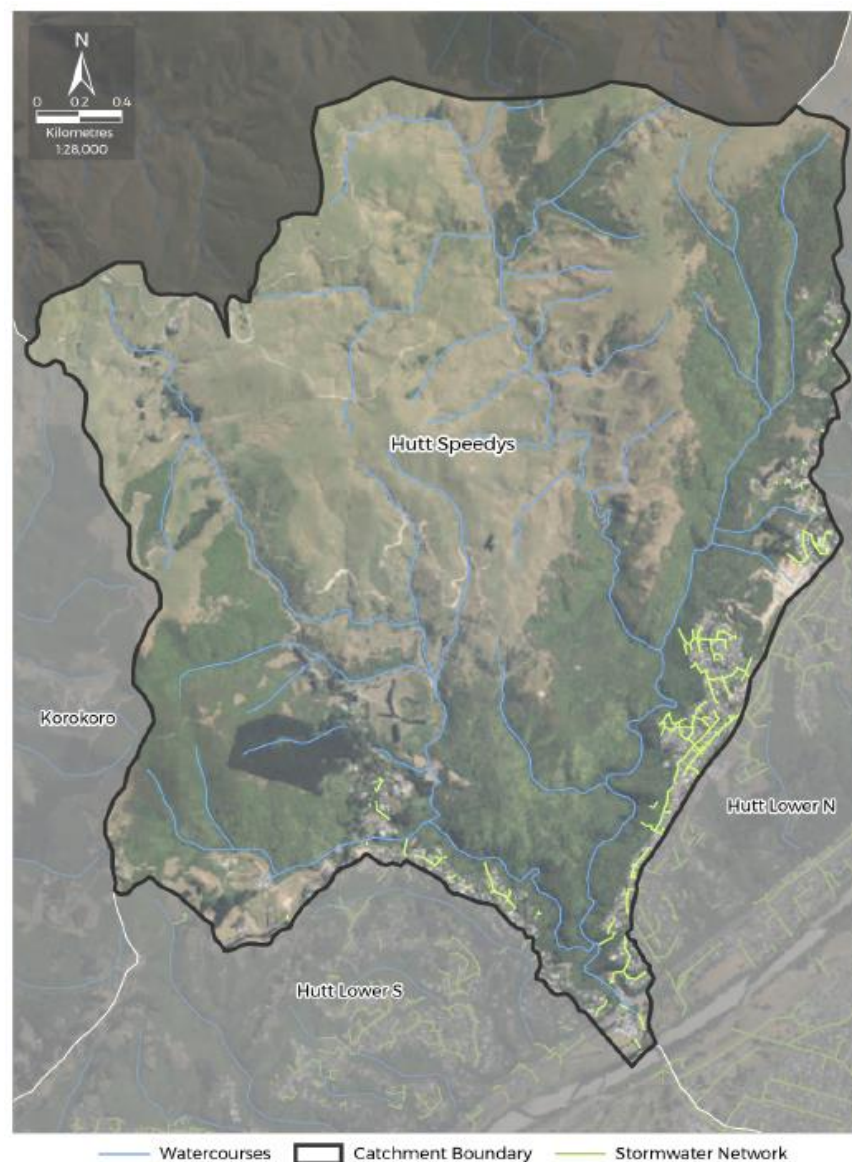
Located on the hills to the west of Lower Hutt the Hutt – Speedys catchment resides on the rolling hills that slope into the Hutt Valley. High producing grassland and broadleaved indigenous hardwoods are the predominant land uses with one historic contaminated land site. There is no flood risk classified in this catchment.

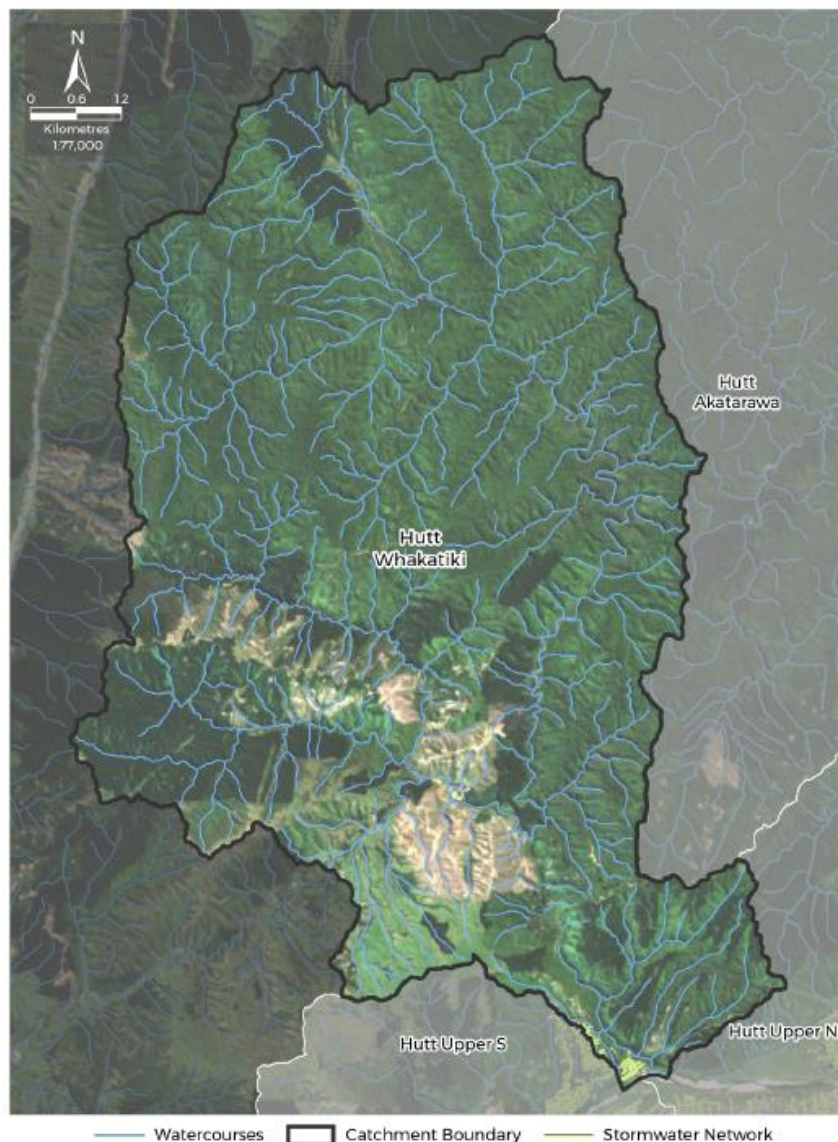
The Hutt – Whakatikei catchment is located to the west of Upper Hutt. The topography of the catchment is made up of hills that slope into the Hutt Valley. Native forest, indigenous forest and exotic forest are the key land use types and there are no contaminated land sites. Areas within this catchment have been classified as susceptible to a 0.23% AEP flood event, located at the confluence of the Whakatikei and Hutt Rivers.

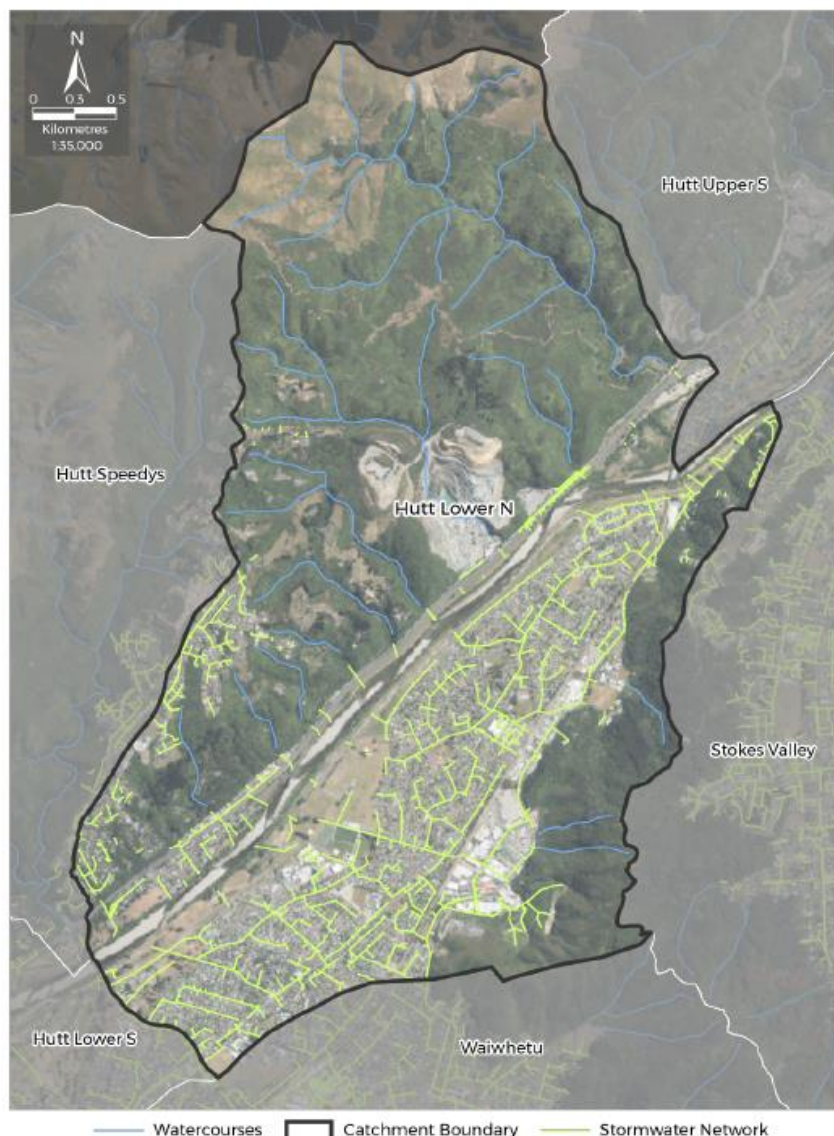
Hutt – Lower North is an urban catchment with State Highway 2 running through the catchment following the Hutt River. The topography is relatively flat, due to being located on the flood plain of the Hutt River, and rolling hills are located to the east and west side of the catchment. The land use type is predominantly settlement, gravel rock, and gorse and broom. There are more than 20 contaminated land sites which include service stations and mining sites. The catchment is susceptible to a 0.23% AEP flood event with the most at risk areas located around the river as well as the suburbs Avon and Wingate.

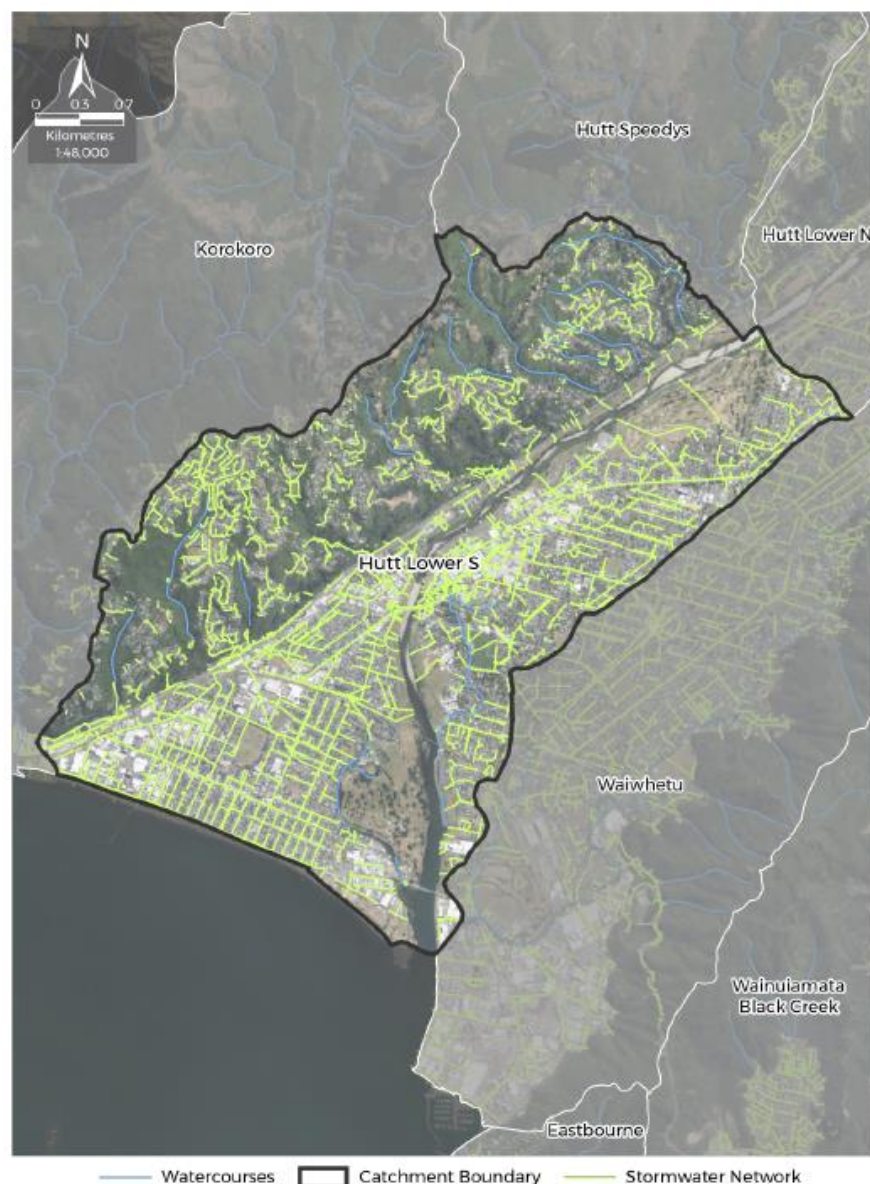
▲ Hutt – Lower South

The Hutt – Lower South catchment is primarily urban and contains the suburbs of Lower Hutt and Petone, as well as the mouth of the [Hutt river](#) into the Wellington Harbour. The topography is predominantly flat and coastal. Settlement and transport infrastructure are the major land use types and there are more than 20 contaminated land sites. Areas within the catchment are susceptible 0.23% AEP flood events with the areas surrounding the Hutt River and the entire Petone area at risk. Petone Seaview is also susceptible to a 0.1% AEP flood event.

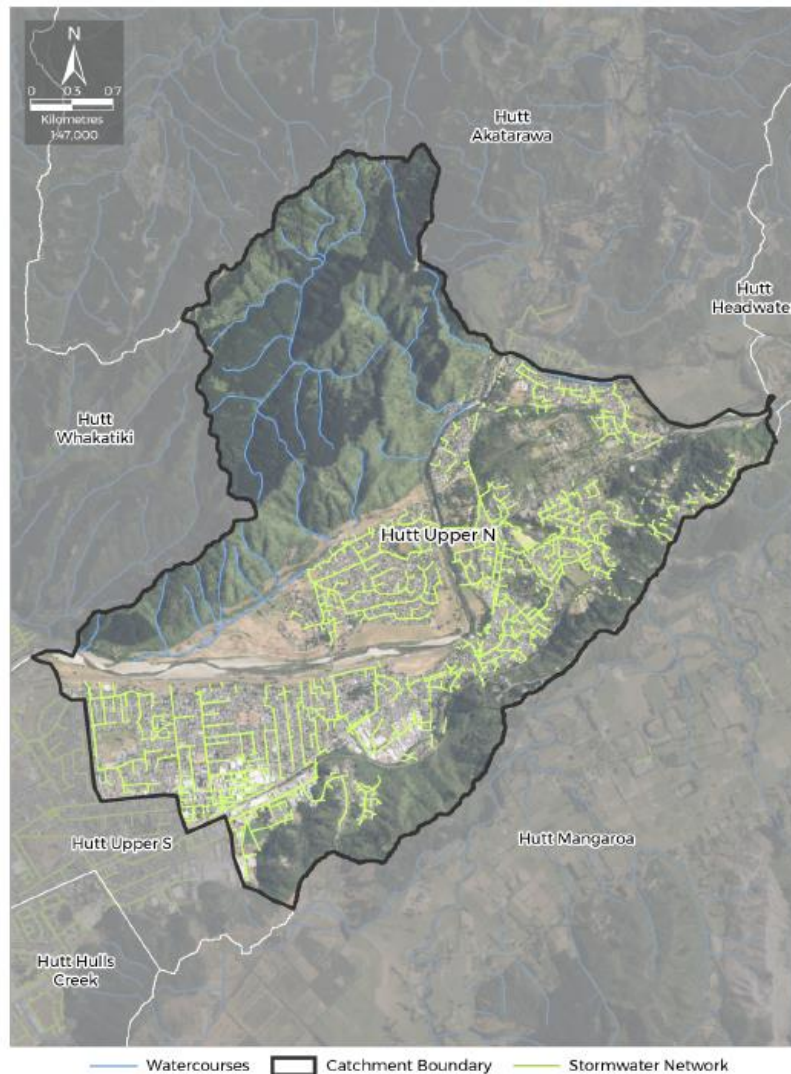
Located north of the Hutt Valley from Upper Hutt Central to Te Marua is the Hutt – Upper North catchment. This catchment is primarily flat land with rolling hills that slope towards the Hutt River with settlement and broadleaved indigenous forest dominating the land use types. There are more than 20 contaminated land sites, and the catchment is susceptible to a 0.23% AEP flood event. Areas most susceptible to flooding are located on the flat land surrounding the Hutt River.

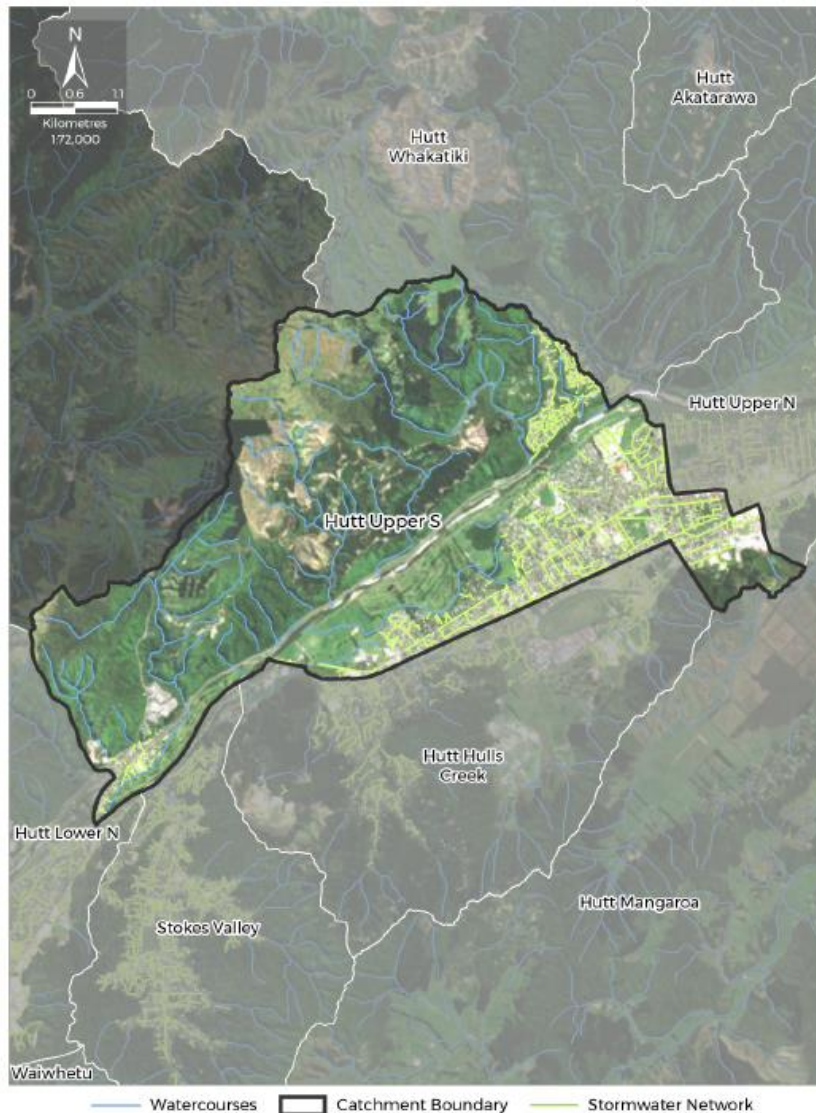
The Hutt – Upper South catchment is in the Hutt Valley between Lower Hutt and Eldersea. Many tributaries of the Hutt River flow through this catchment. The topography is flat with the Hayward Hills to the eastern side of the catchment. Transport infrastructure, settlement and broadleaved indigenous hardwoods are the main land use types and there are more than 20 contaminated land sites. The catchment is susceptible to a 0.23% AEP flood event with the flat urban land being the most at risk areas.

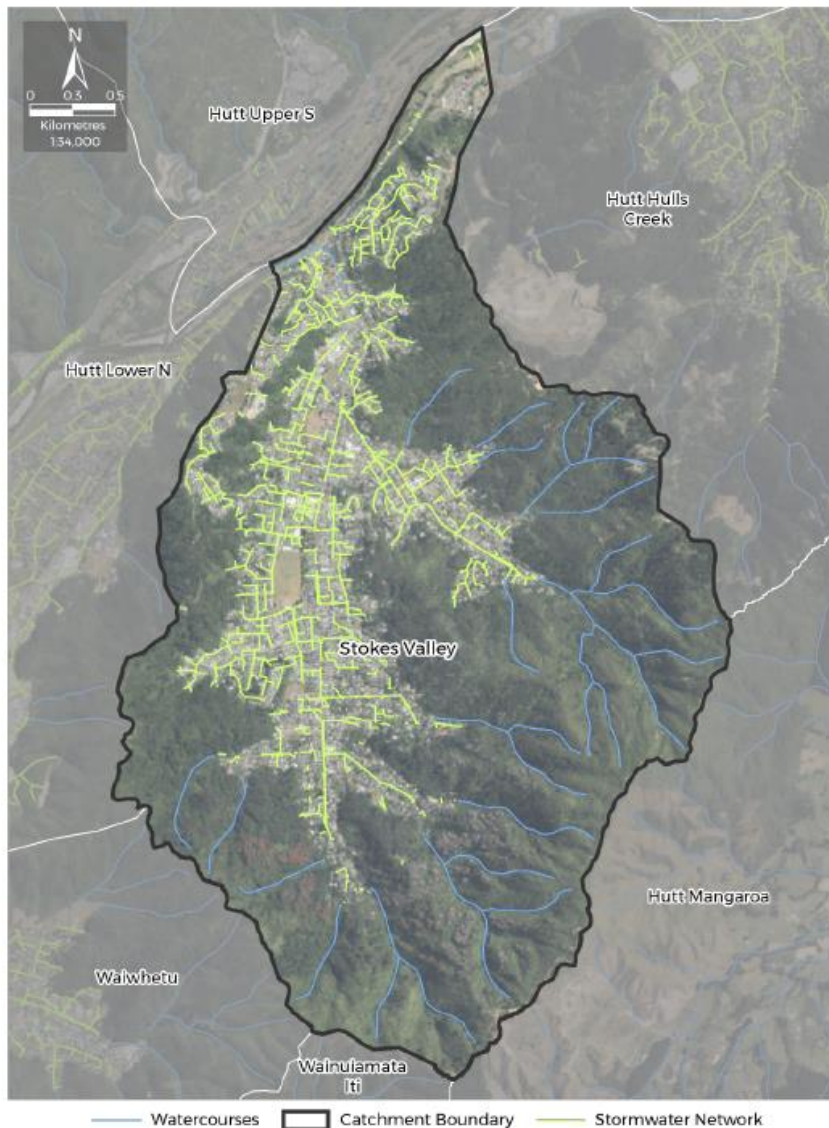
Located to the east of Lower Hutt bordering the boundary with Upper Hutt, the Hutt – Stokes Valley Catchment is a low-lying catchment nestled into valleys of steep hills. The catchments land use is predominantly settlement and broadleaved indigenous hardwoods. There are four contaminated land sites which include mechanics and the Silverstream Landfill. Areas within the catchment are susceptible to a 0.23% AEP flood event with the most at risk areas at the confluence of the Stokes Valley Stream and the Hutt River.

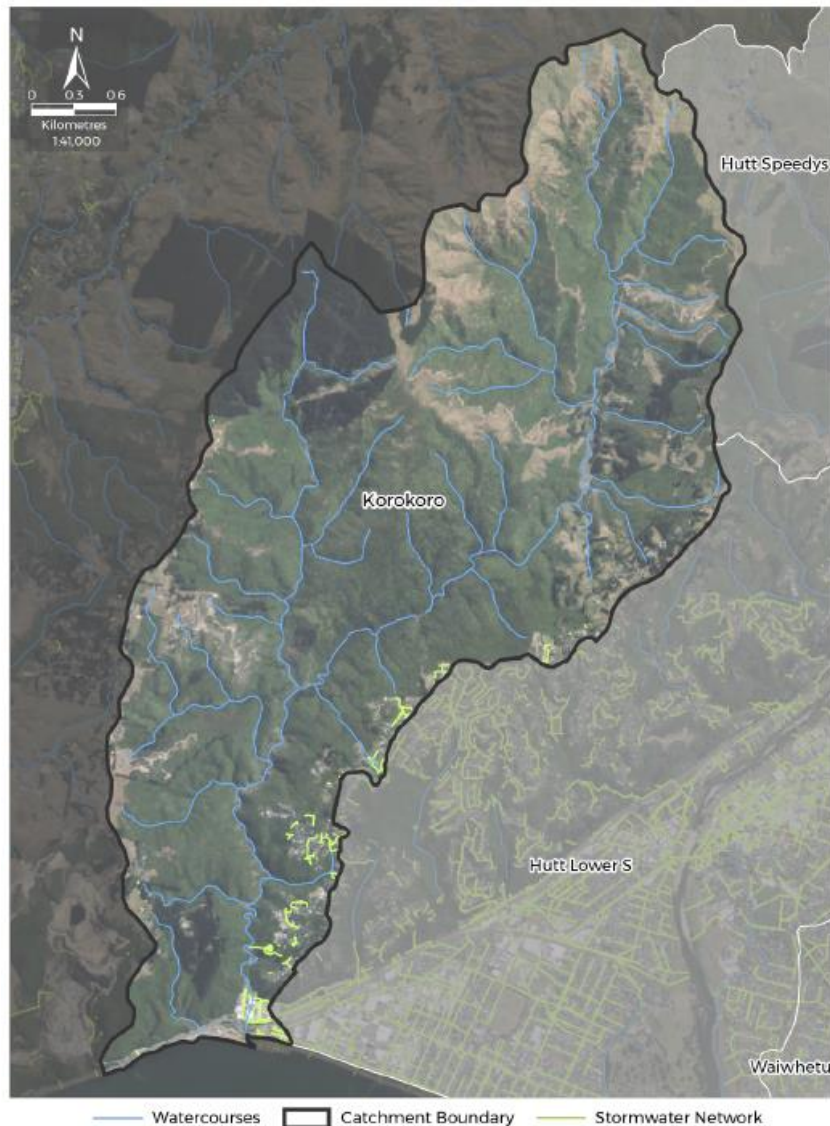
The Korokoro catchment is located to the west of Petone with the Korokoro Stream tributaries flowing into the Wellington Harbour. Steep hillslopes make up the topography of the catchment with broadleaved hardwood forest, exotic forest and high producing grassland being the main land use types. There are four contaminated land sites in the catchment that include a wastewater treatment plant. Areas along the bottom of the catchment, around State Highway 2 are susceptible to a 1% AEP flood event.

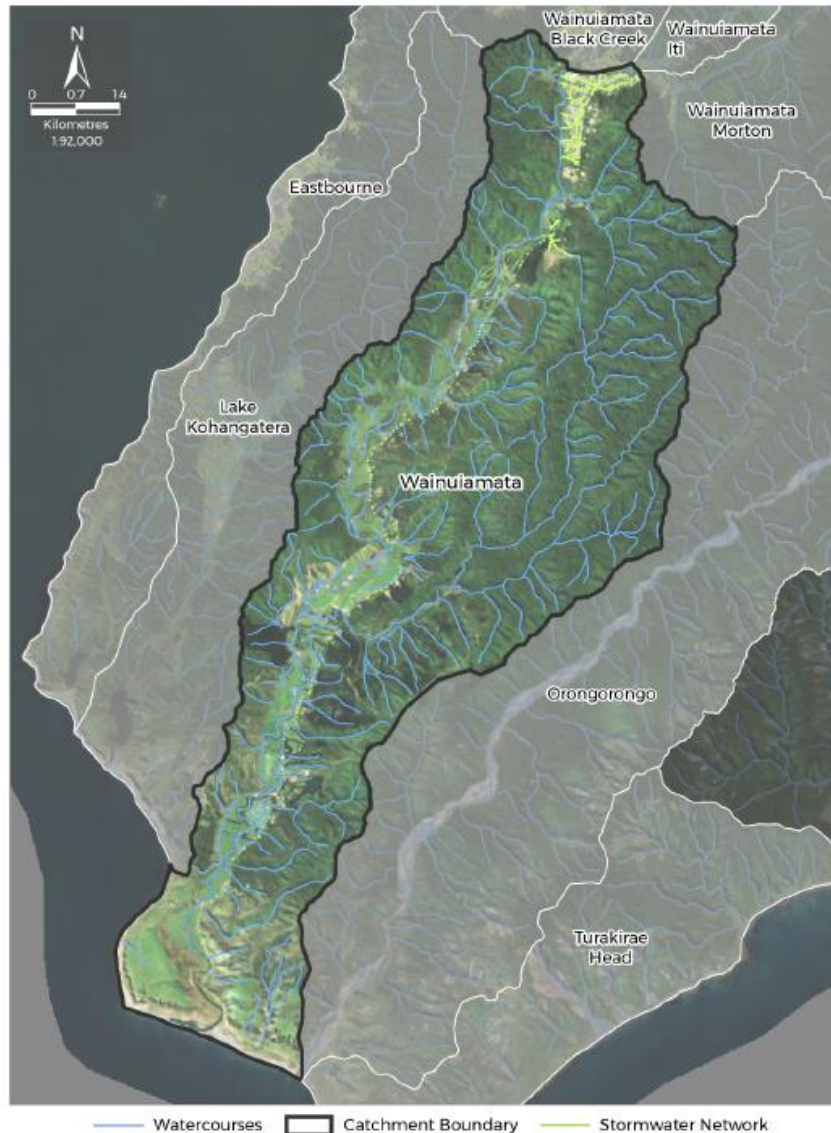
Hutt – Wainuiomata

The Wainuiomata catchment is located on the peninsula to the east of the Wellington Harbour. The topography is varied with some flat low-lying land near the Wainuiomata River and some hilly areas, such as Mt Grace. Land use in this catchment is predominantly settled with a mixture of exotic and indigenous vegetation. There are four contaminated land sites, including a wastewater treatment plant. The flat land surrounding the Wainuiomata River is susceptible to a 0.1% AEP flood event.

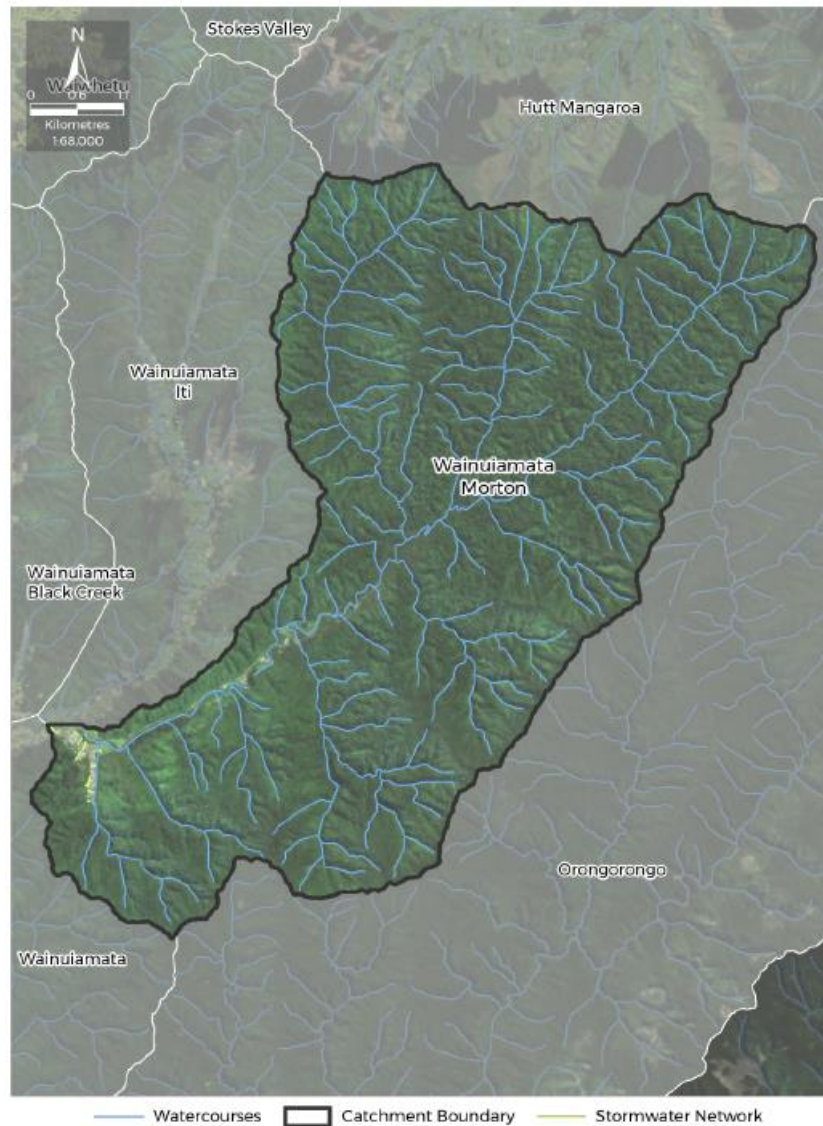
Wainuiomata - Morton

The Wainuiomata Stream flows through the centre of the catchment. The topography of the catchment is very hilly with steep slopes and ridges as well as many stream tributaries. Indigenous and exotic forest dominates the land use types and there are no contaminated land sites in the catchment. The area to the south east of the catchment is susceptible to a 0.1% AEP flood event from the Wainuiomata River.

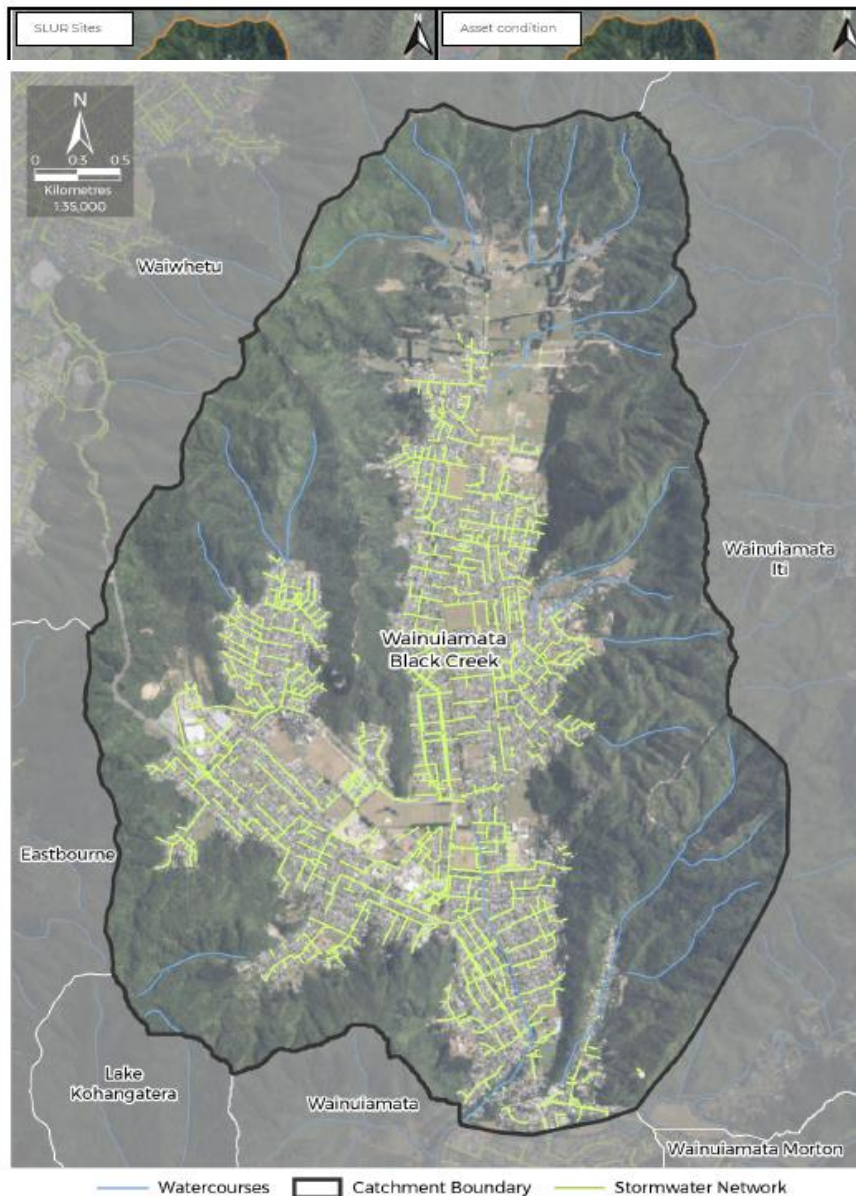
Wainuiomata – Black Creek

The topography is varied with low lying flat land surrounded by rolling hills. Land use on valley floor predominantly sub-urban settlement with central stream-side green space areas, hills are a mix of indigenous and exotic vegetation. North catchment branch is identified for urban growth.
