Investigation report -  
Porirua UV Bypass Event - 2 December 2024

# INCIDENT DETAILS

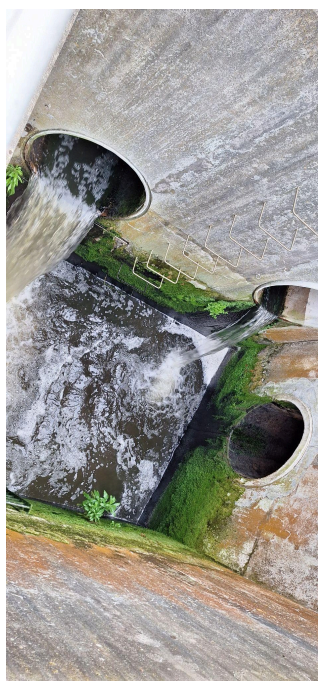
**Image 1**

Taken at 06:49 - most of the effluent is being discharged from the TAK UV channel, some discharge is evident from the overflow bypass. There is no discolouration in the bypass discharge.

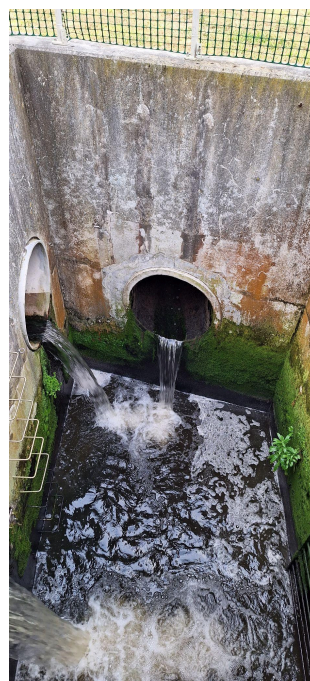
**Image 2**

Taken at 06:51 - effluent is being discharged from the Duron UV and the TAK UV channels. Some discharge is evident from the overflow bypass. There is no discolouration in the bypass discharge.

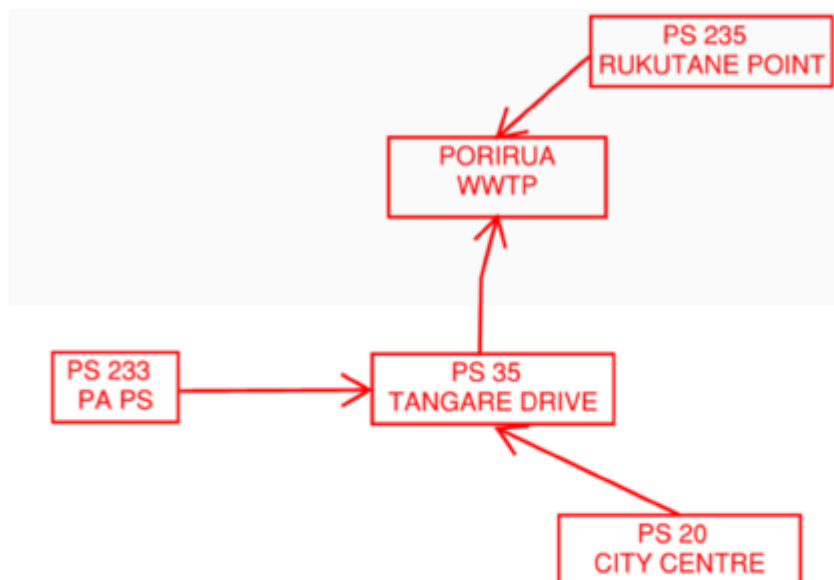
The following schematic shows a simplified overview of the pump stations feeding Porirua WWTP.

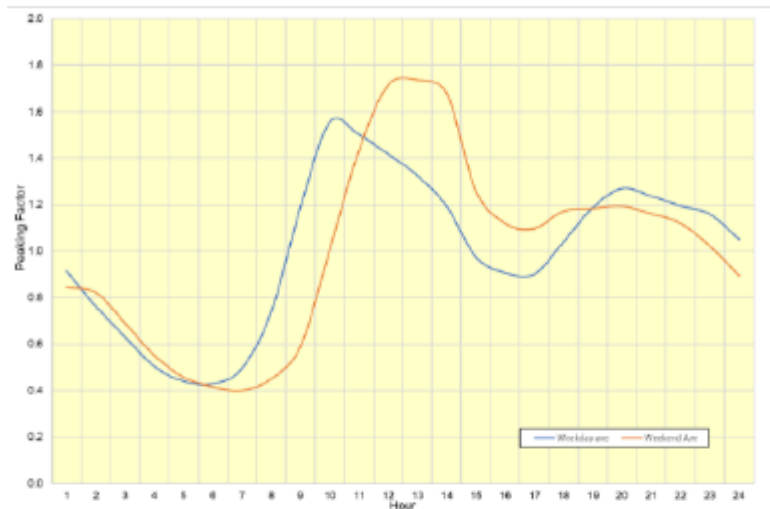
Figure 1 Diurnal flow pattern entering the WWTP

Based on an assessment of the flows to the WWTP and to the pump stations, the project team is proposing to carry out the shutdown from 3 am – 7am. Refer graphs below showing data for a typical weekday.
