# Moa Point Wastewater Treatment Plant

Annual Resource Consents Report 2019/2020

21<sup>st</sup> June 2020  
Moa Point Wastewater Ocean Outfall Pipeline & Seabed Annual Inspection  
UCL – 2020.06 – WWPT Outfall Pipeline – IR001  
Released for Client review and comment – 24<sup>th</sup> June 2020

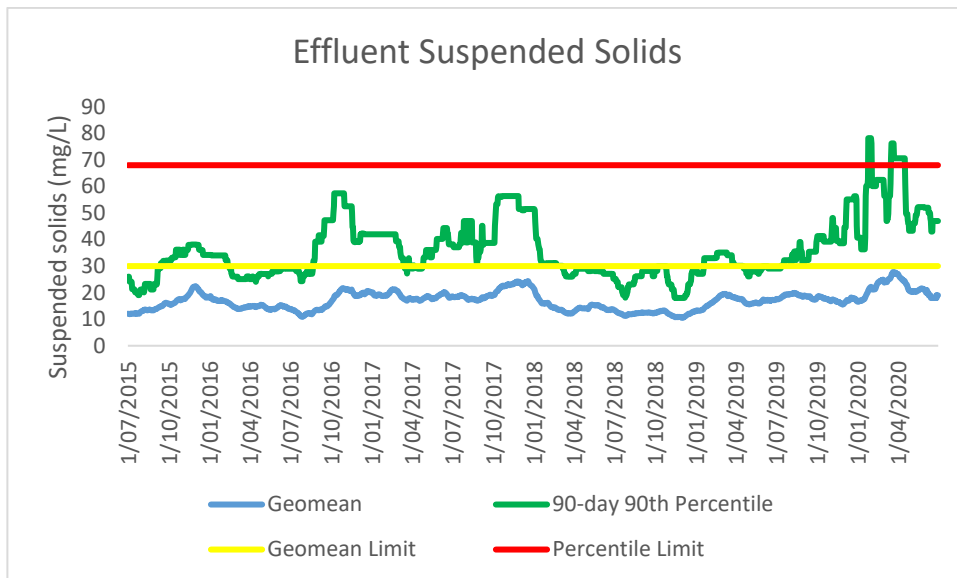
**Chart 6: Final Effluent suspended solids Geometric Mean and Percentile Values**

The effluent suspended solids has an upward trend in FY2019/2020 as compared to the previous 4 years. This was due to the sludge pipeline failure which happened this financial year.

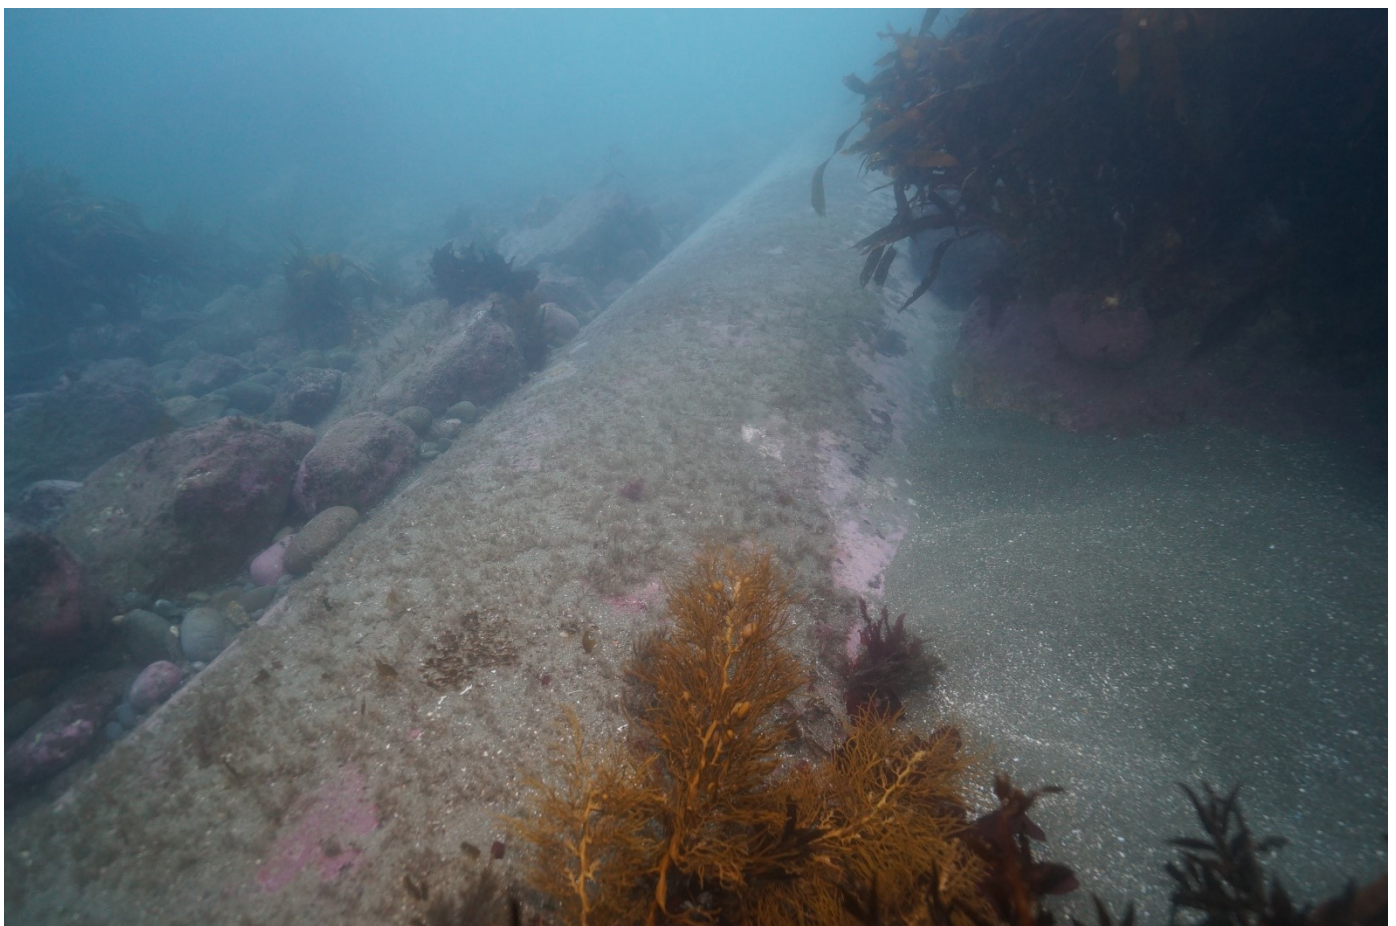
The inshore exposed pipeline section (position 'C') commences 44.0 metres below the MHWL at a depth of 3.0M, and extends approximately 80.0 metres to a depth of 7.0M.

Over the past year (between 2019 to 2020 Inspections) there's tendered to be a greater frequency of Southerly wind conditions and moderate swells experienced. During these types of conditions, an increased volume of sand and fine gravel gets deposited in the shallows; while at the same time, moderate swells erode the shoreline.

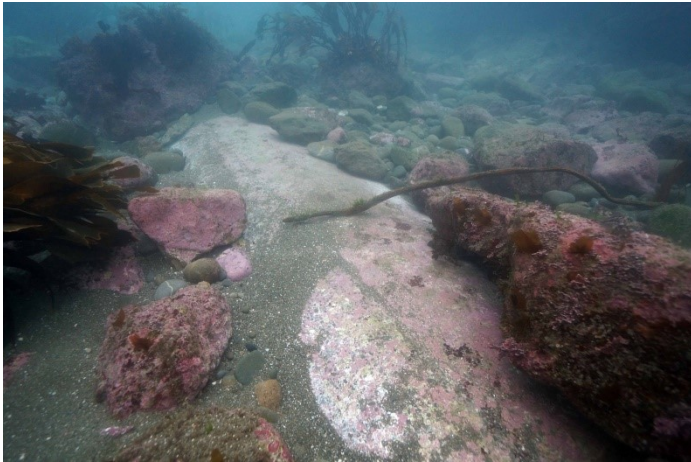
Figure 4: 00.0 metres

Video footage of Inshore Exposed Pipeline Section can be viewed in file: Inshore – exposed pipeline section 2020.

Due to inshore swell conditions on the day; suspended particle in the water resulted in poor visibility conditions during the recording of this footage.

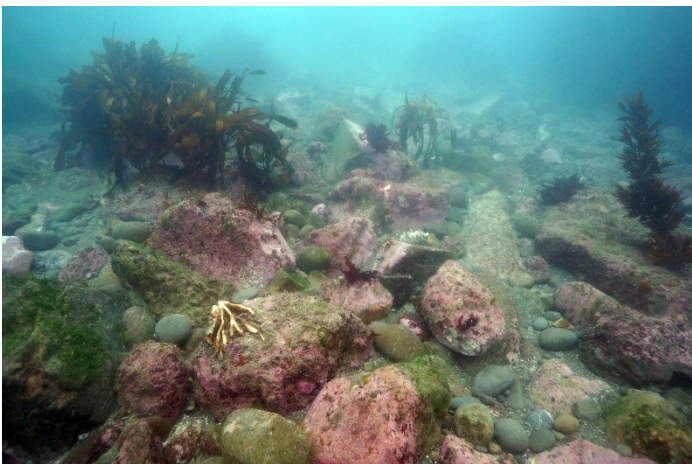
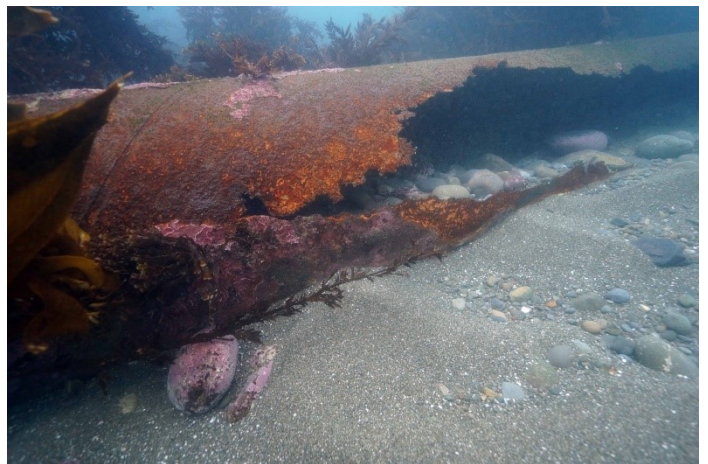
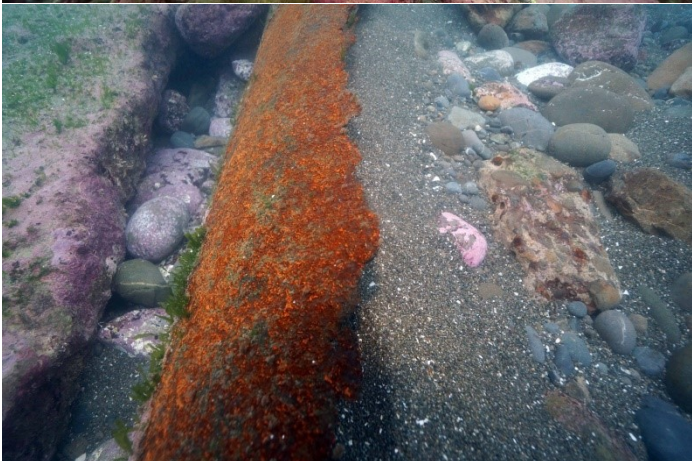
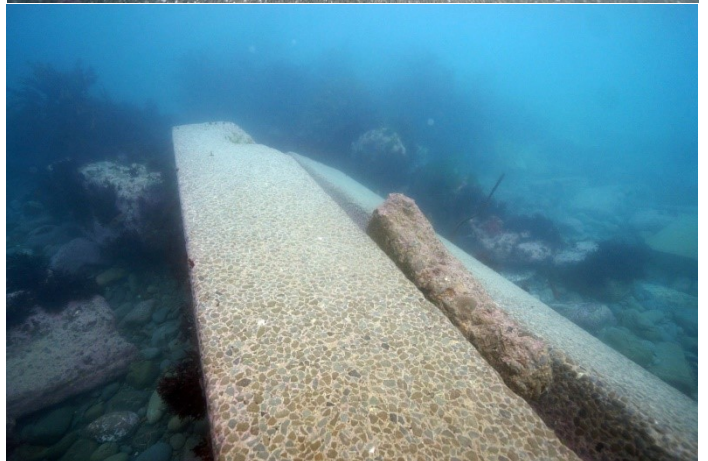
Figures 13, 14, 15, 16: Pipeline route through intertidal zone – seabed & exposed demolition material

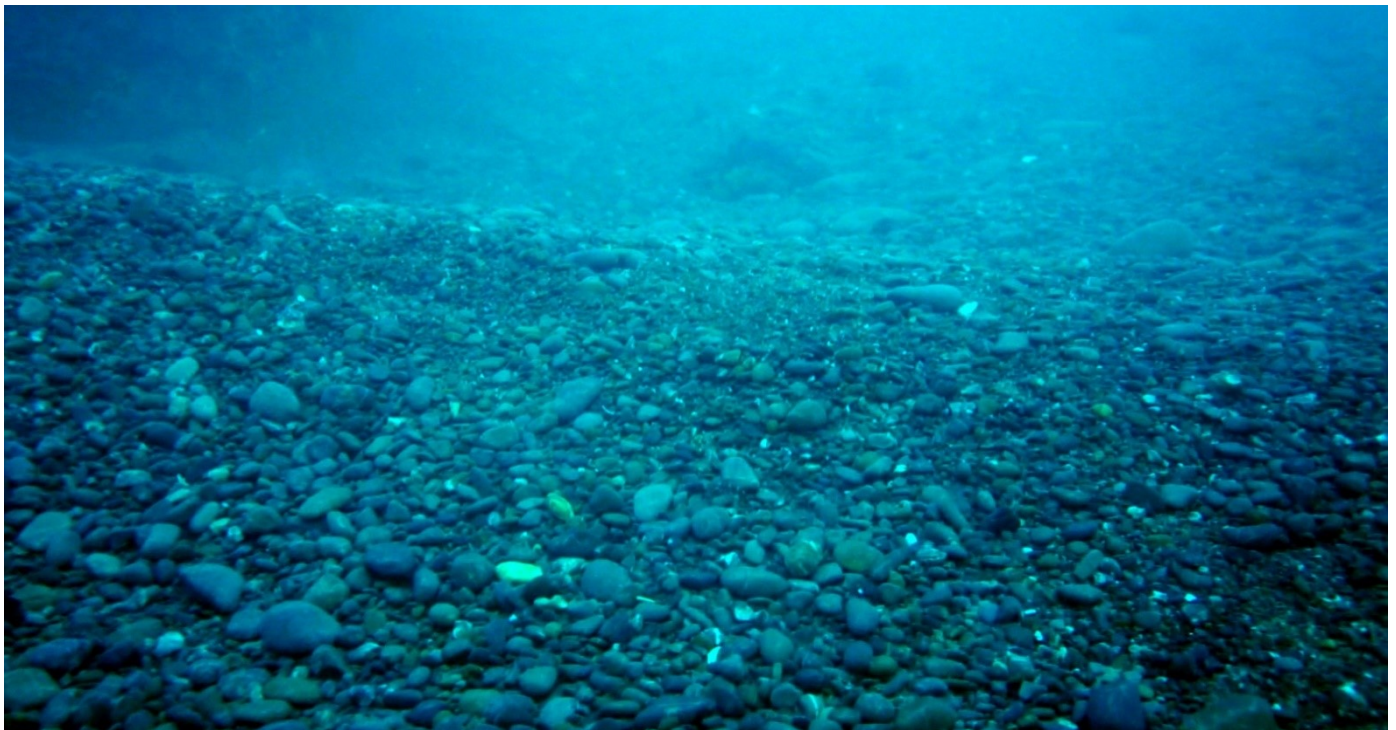
Figure 18: Typical seabed composition – offshore route – Position E

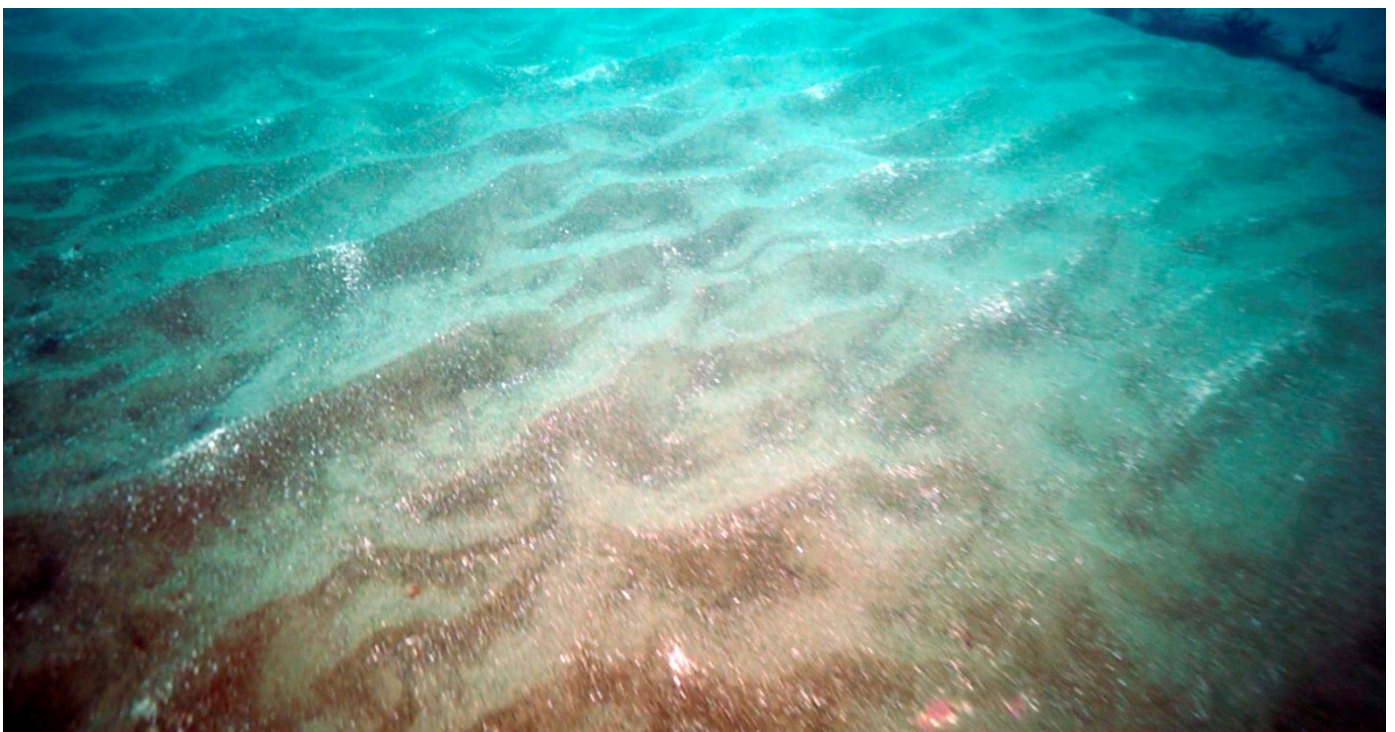
Figure 19: Typical seabed composition – offshore route – Position D

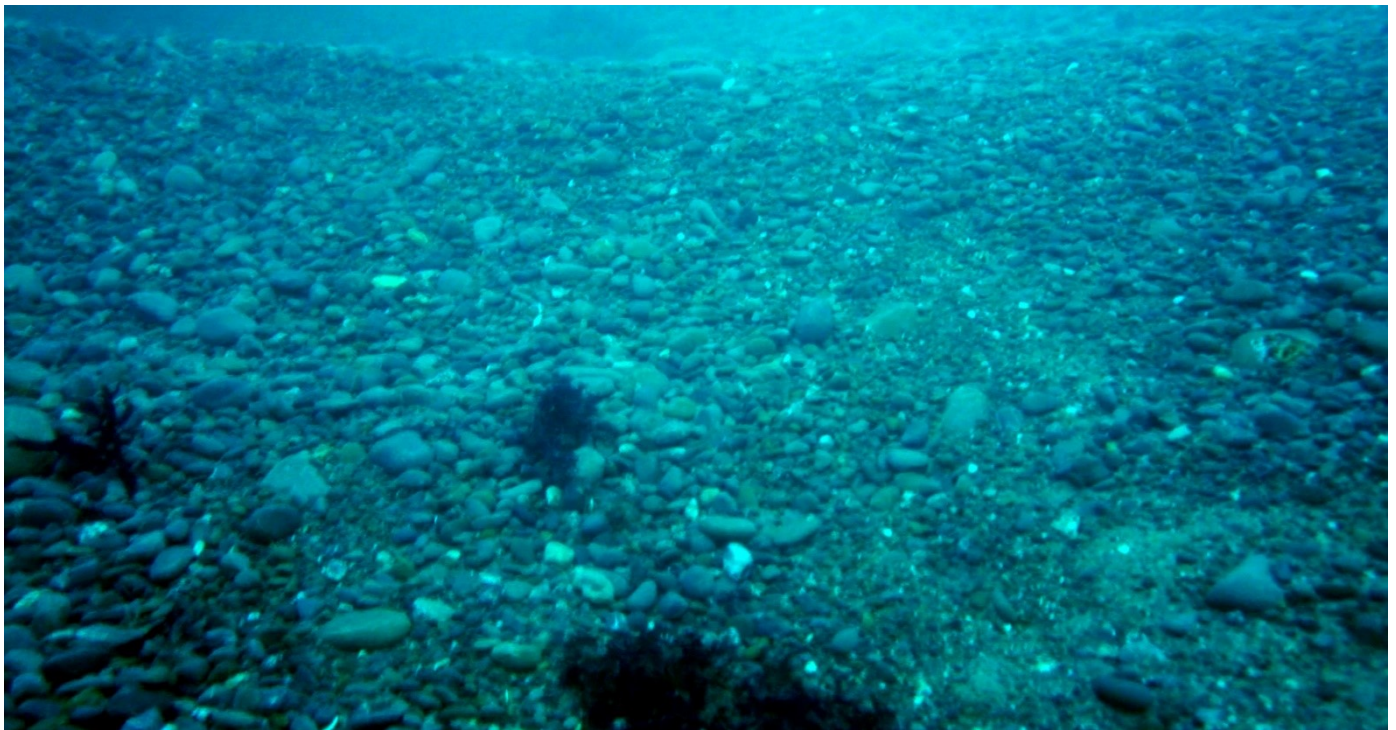
Figure 23: Typical scale of aggregate sizing observed around the Diffuser positions

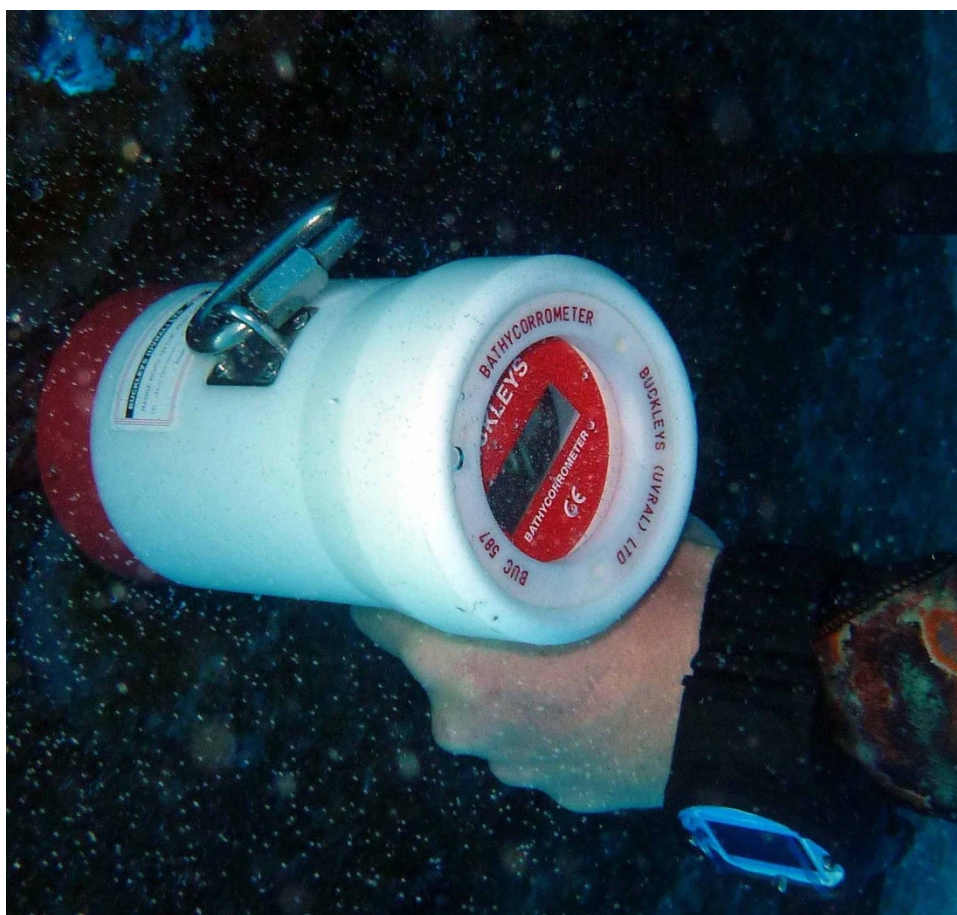
To protect a steel structure or installation in seawater, a more active metal than the steel is selected from the galvanic series and placed in contact with the steel below water level. Current flows as a result of the electrochemical difference, from the active metal, through the seawater, to the steel. Thus the active metal becomes anodic and corrodes, whilst the steel becomes cathodic and is protected; so that in fact the active metal corrodes in order to protect the steel.

The Cathodic Protection System on the Moa Point Wastewater Ocean Outfall Pipeline consists of 26 Zinc Alloy Sacrificial Anodes on the outfall pipeline, and 18 Zinc Alloy Sacrificial Anodes installed on the diffuser risers. The system has a minimum design life of 30 years.

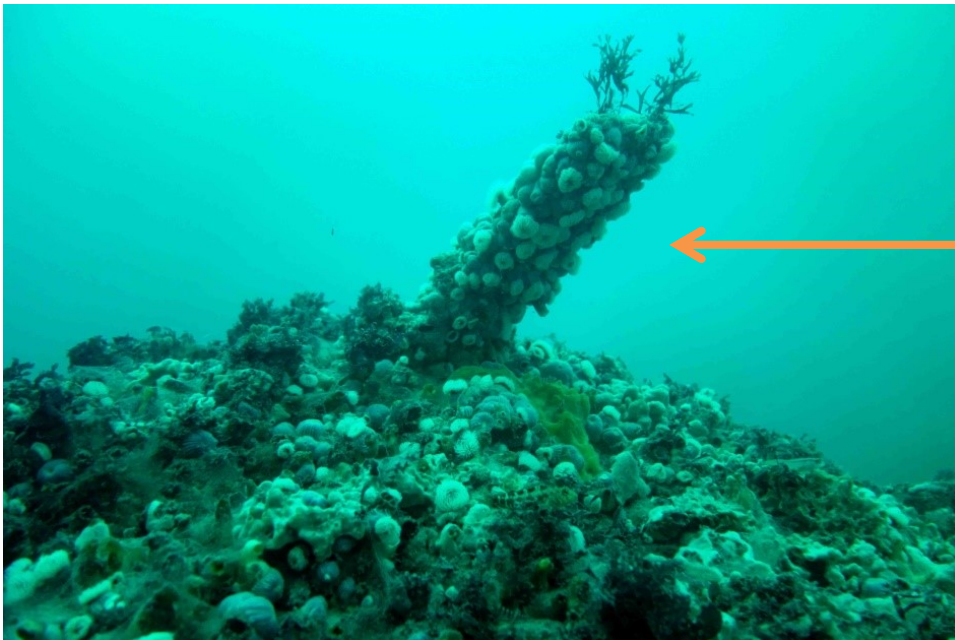
Figure 25:  
Diffuser # 1 (seaward southern-most diffuser) – CP test point.  
Readings at this position provide evidence of electrical continuity through the diffuser section

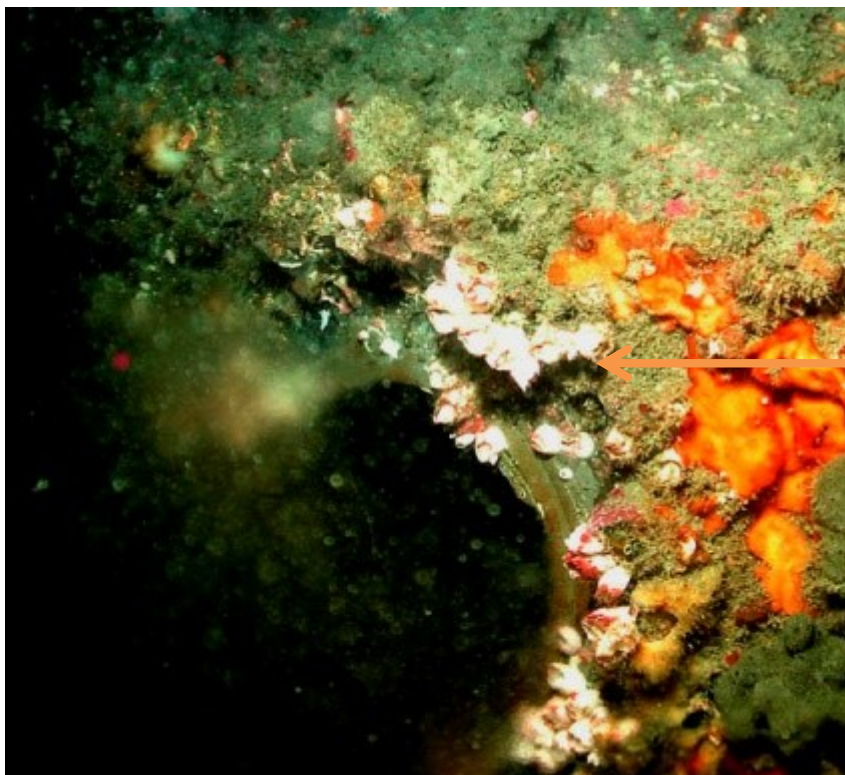
Figure 27:  
The steel diffuser nozzle outer flange is where the diver makes contact with the Bathykorrometer to obtain the Cathodic Potential values

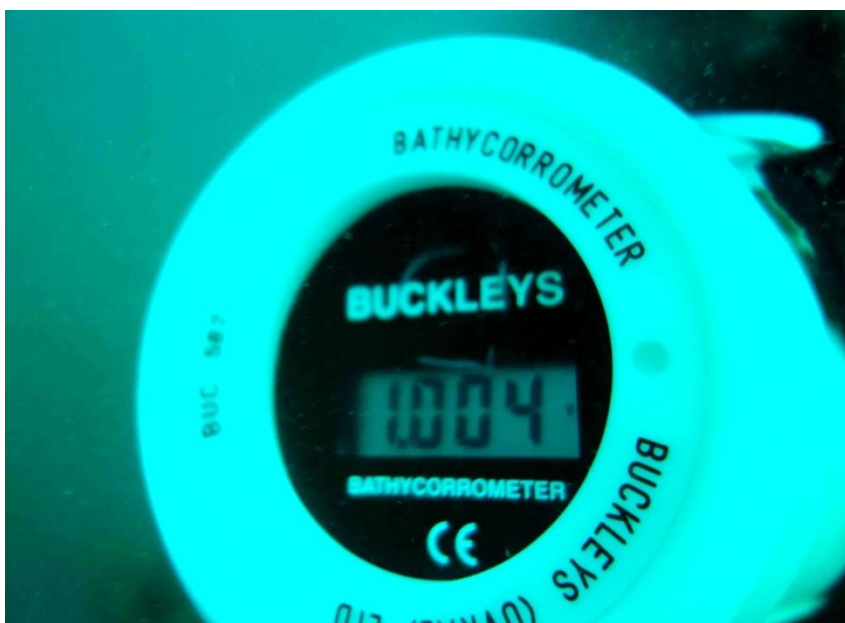
Figure 28: Taking CP reading at Diffuser # 3

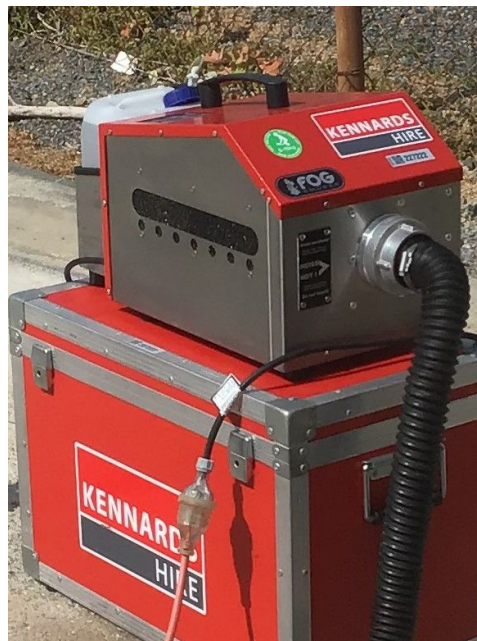
Smoke was generated and discharged into the IPS inlet sampler chamber, the Primary Tank area and Moving Bed Bio Reactors. The hatches and seals were visually checked and photographs were taken. There were no issues with the process or results.

*Smoke Generator*

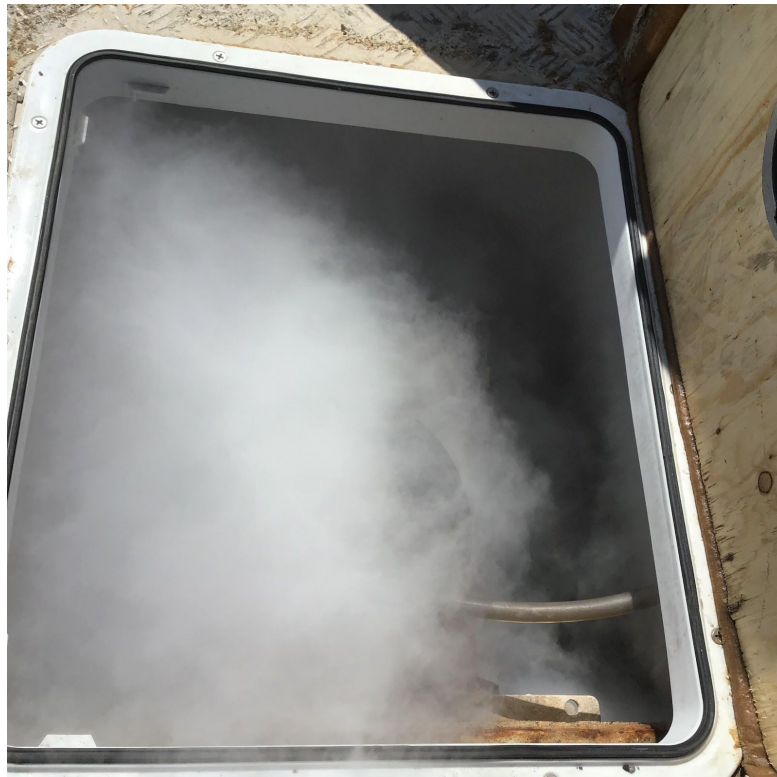
*Smoke inside sample hatch*

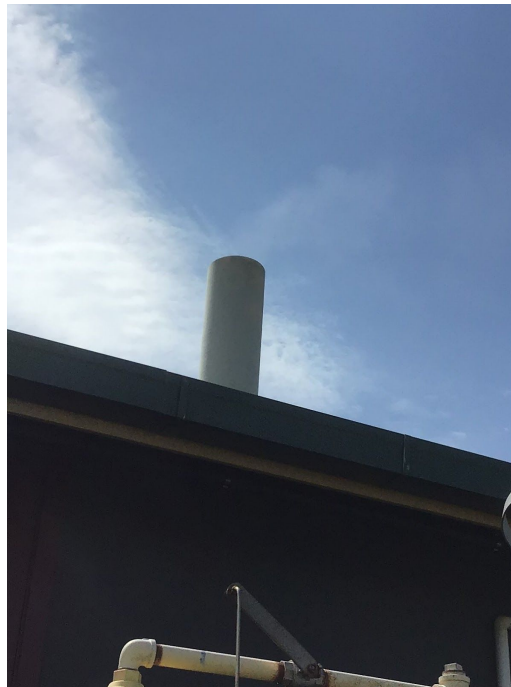
Smoke was discharged into the IPS inlet chamber, and after approximately 20 minutes visible smoke was noted coming out of the IPS stack and being carried south by the Northerly wind. The smoke machine was left operating for another 30 minutes after this to ensure complete saturation of the wet well chamber and ventilation system. During this time constant monitoring took place, and no smoke was seen to be escaping from any hatches.

*Smoke discharging from the IPS stack*

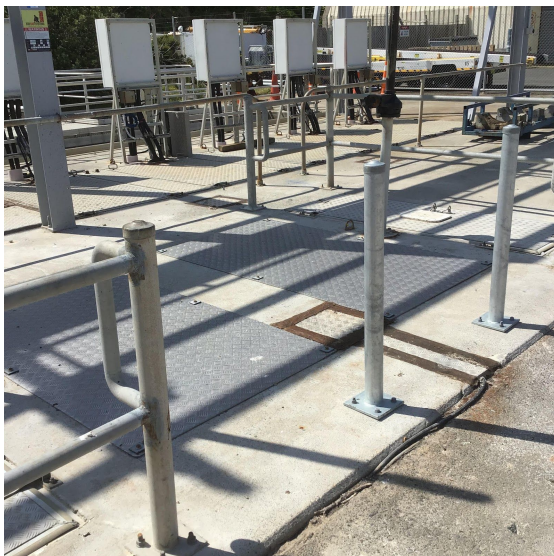
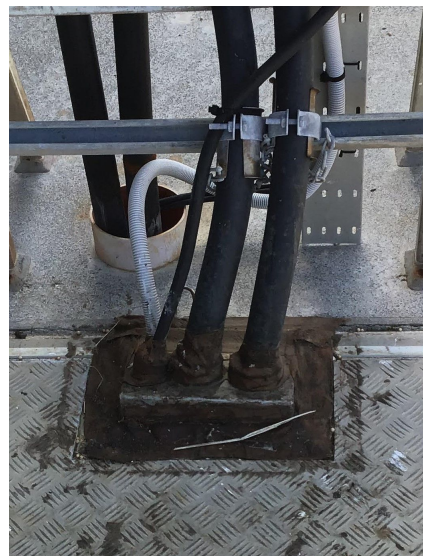
Once smoke saturation was confirmed by checking in the wet wells through the hatches, a visual inspection of all the various sealing faces took place, and any weathered sealing tape was replaced.

*Sealing tape around hatches*

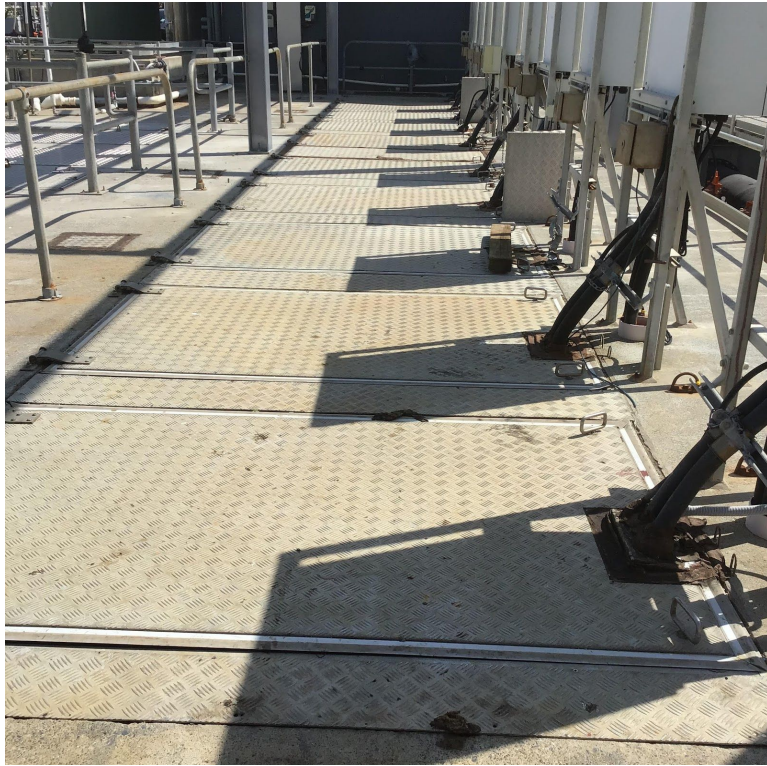
*IPS Pump Hatches*

No indication of smoke could be detected escaping from around the hatch covers, hinged hatches and the wet and dry wells coverings. With no indication of smoke escaping, the smoke testing of the IPS site was brought to a close.

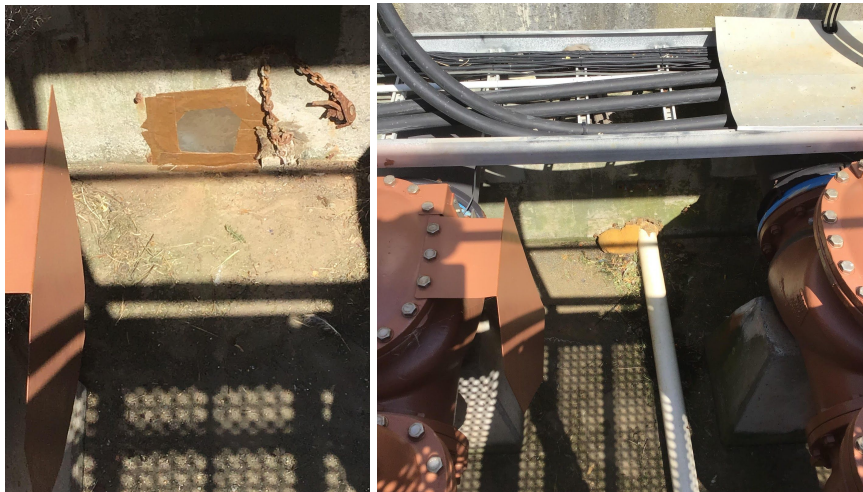
*Seal around IPS Dry Well*

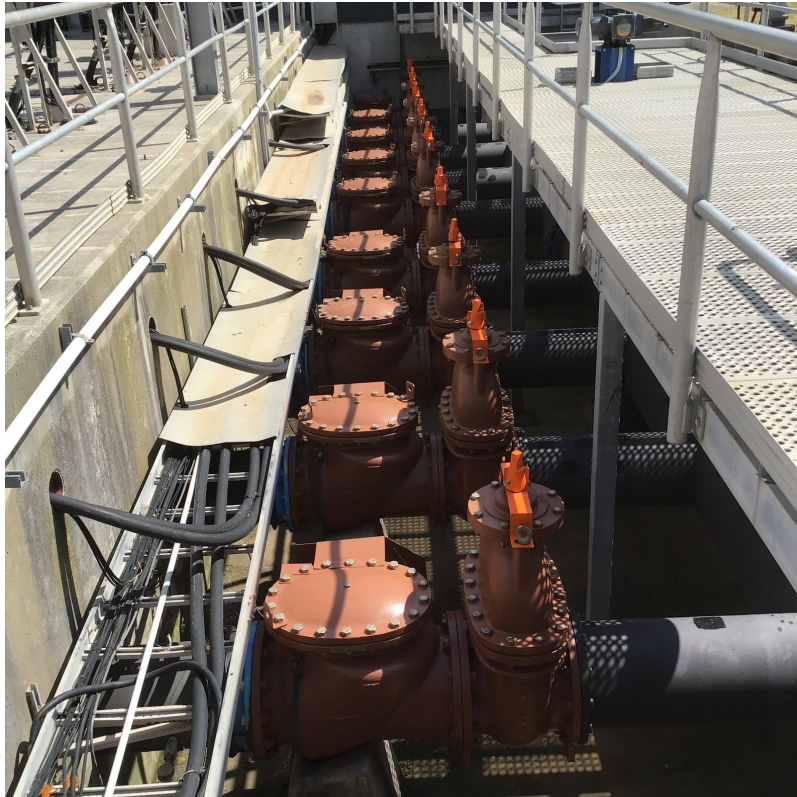
*IPS Dry Well*

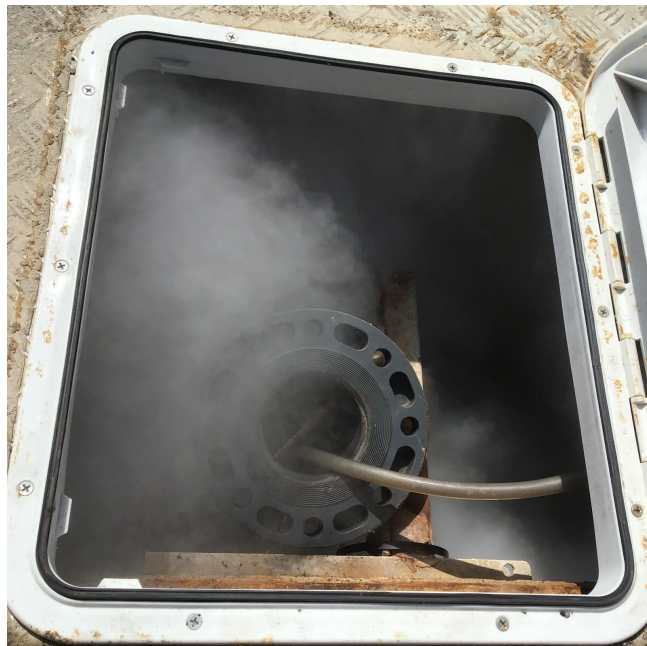
*Smoke being drawn in by the vacuum inside the well once the temporary cover was removed.*

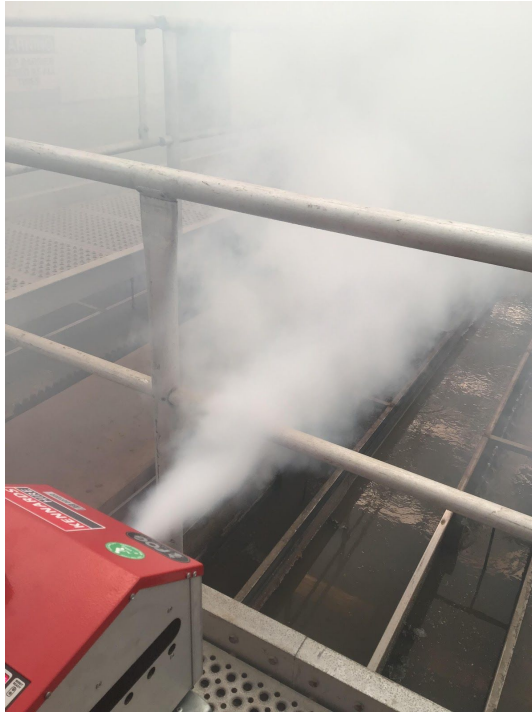
*Smoke machine starting to saturate the Primary Tank area*

The actions of the foul air extraction system meant that the generator was mainly located towards the western end of the room, as the drift of the smoke towards the extract grills at the eastern wall evened out density of the cloud.

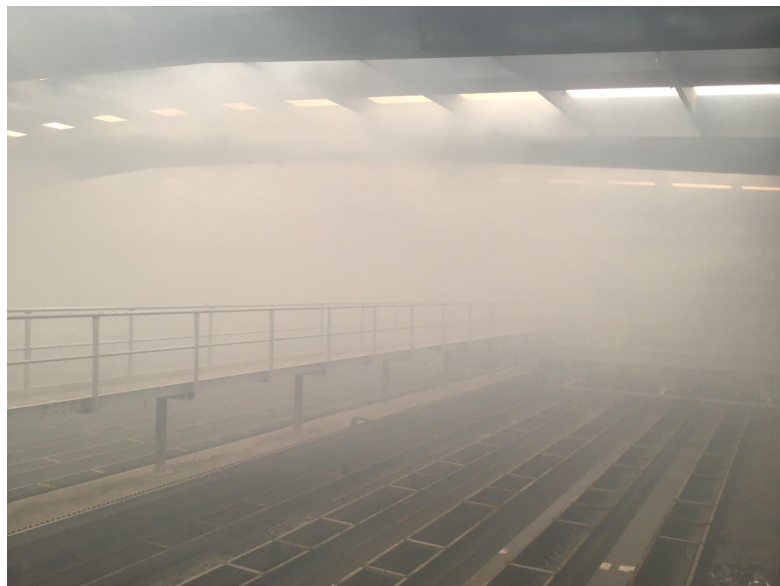
*Smoke starting to build up under Primary Tank Roof*

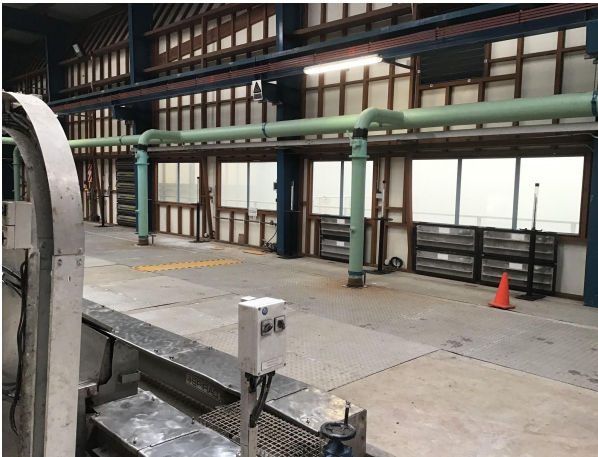
The smoke generator was run until sufficient smoke had accumulated to form a smoke cloud on the underside of the roof rafters. Then an inspection of the inlet works room and an external inspection of the roof was carried out and with no smoke leakage observed, no further action was taken.

*Inlet Works*

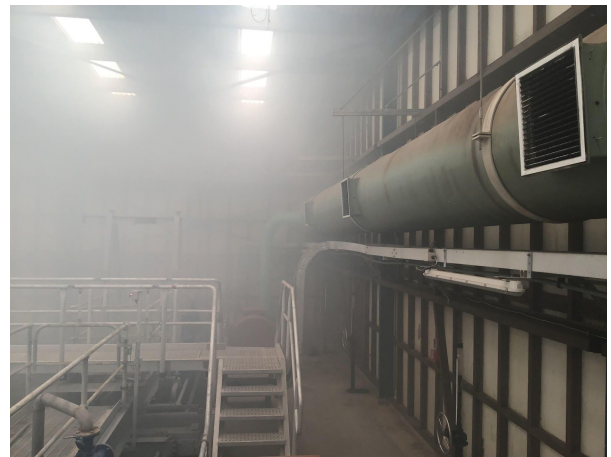
*Smoke being drawn into the extract grills*

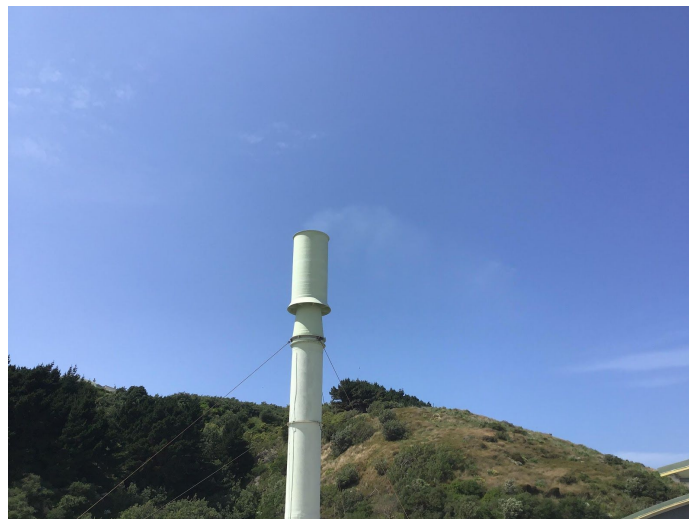
*Smoke discharging from Moa Point stack*

During the testing of the Primary tanks and the MBBR tanks smoke was observed exiting from the Moa scrubber stack.

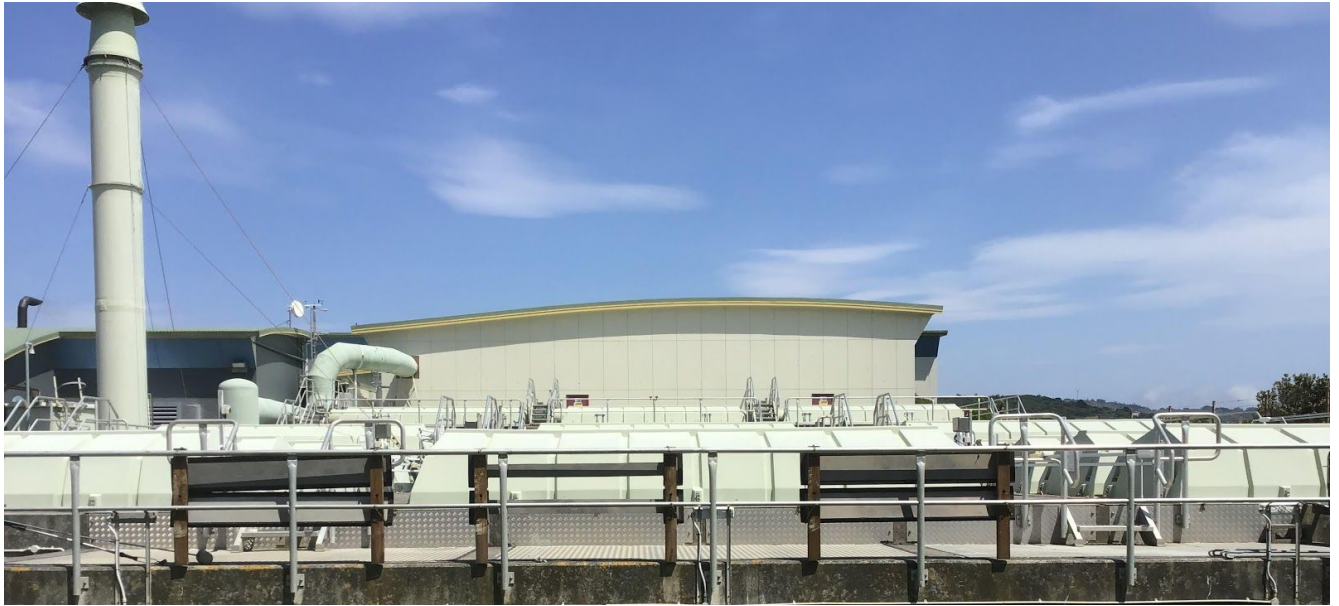
*Primary Tank Roof looking West*

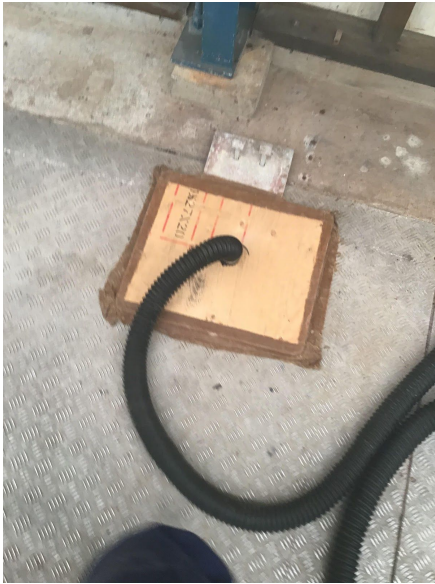
*Smoke directed flooding channel to MBBR*

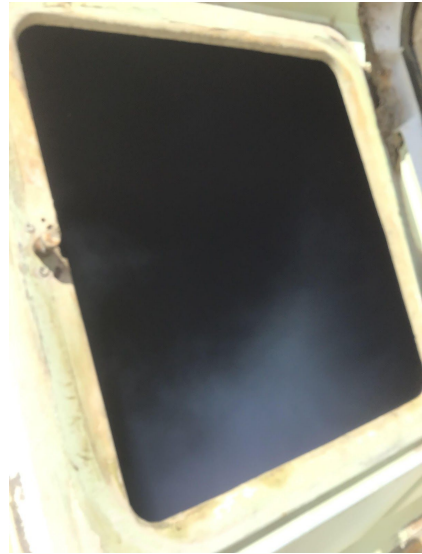
*Smoke saturation in MBBR Tank*

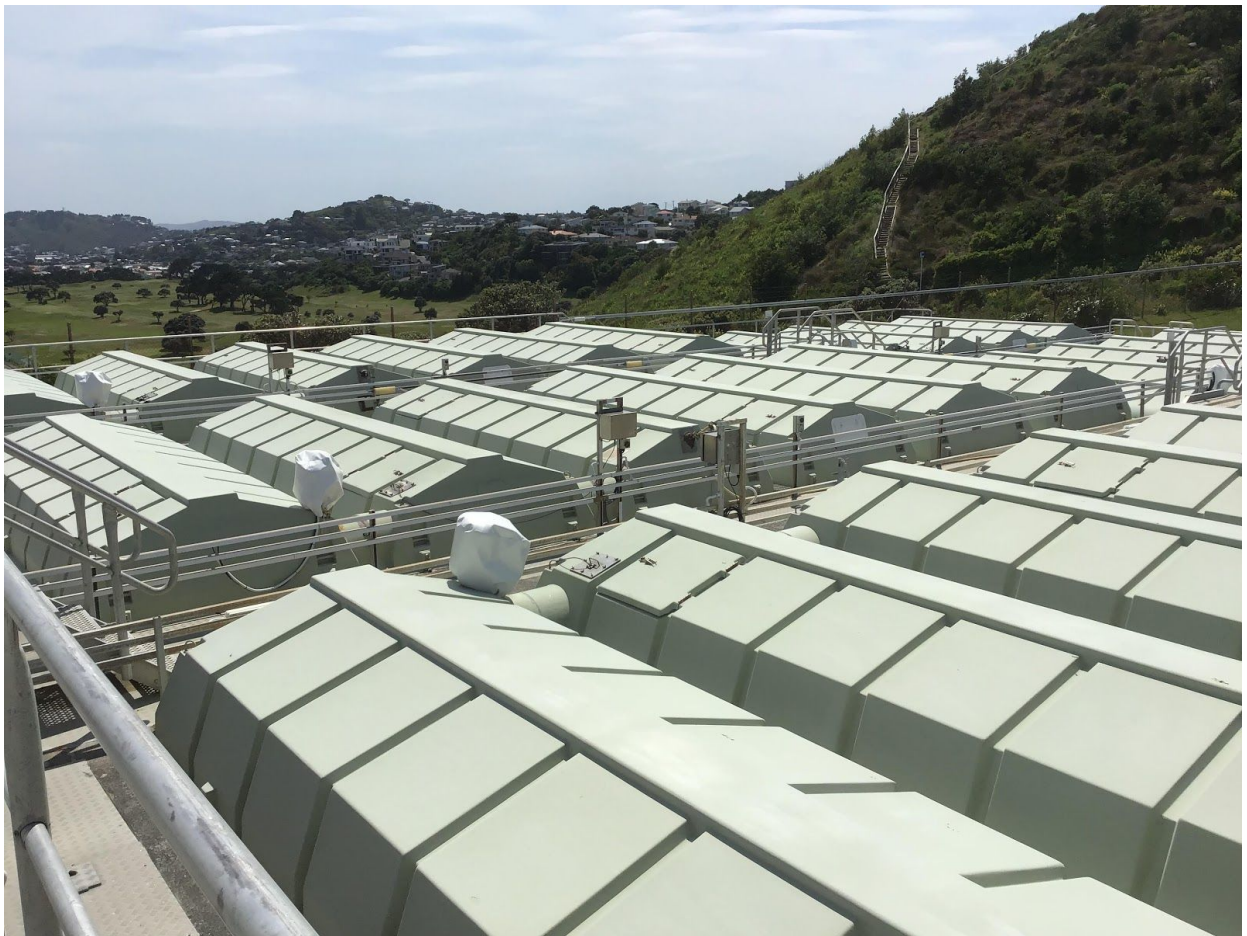
Full smoke saturation was achieved with evidence noted through examination of the access hatch. Following full smoke saturation of the tank system an inspection of all sealing joints on the MBBR covers was conducted with no indication of smoke escaping, no remedial action was necessary, therefore the smoke test was brought to a finish.

*MBBR covers*
