# Seaview Wastewater Treatment Plant

Annual Resource Consents Report 2020/2021

### Seaview WWTP Main Outfall Pipe Repair July 2021

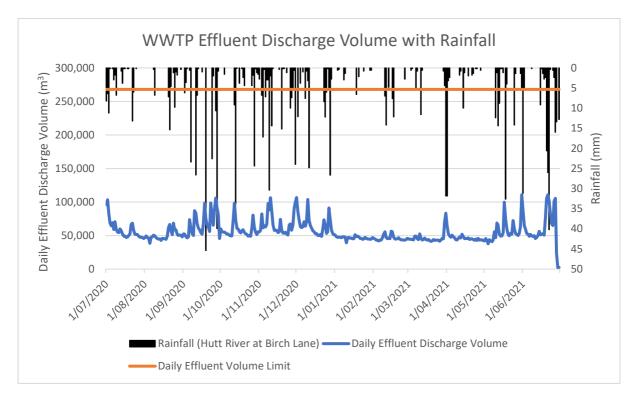
Figure 1: WWTP Effluent Flow Summary

The rainfall data was taken from GWRC Environmental Monitoring and Research Hutt River at Birch Lane site. Plant's flow data was taken from Veolia's system.

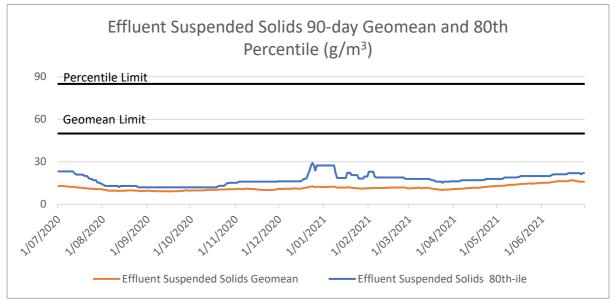
Figure 3: Effluent TSS Summary

Below is a summary of the 90-day geometric mean and 90-day 80<sup>th</sup> percentile for the effluent total suspended solids. The facility has been compliant to the effluent suspended solids requirements this FY2020/2021. Daily values can be viewed in the quarterly reports.

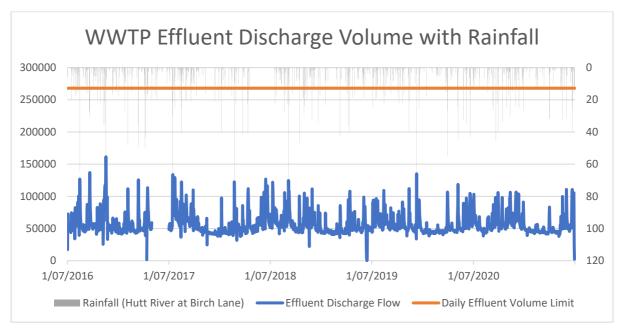
Figure 5: Effluent Discharge Flow

WWTP effluent discharge volume is used to establish a trend. Rainfall data from GWRC site is compared with the WWTP effluent daily discharge volume. In figure 4, it can be noted that the plant's effluent discharge volume is affected during wet weather.

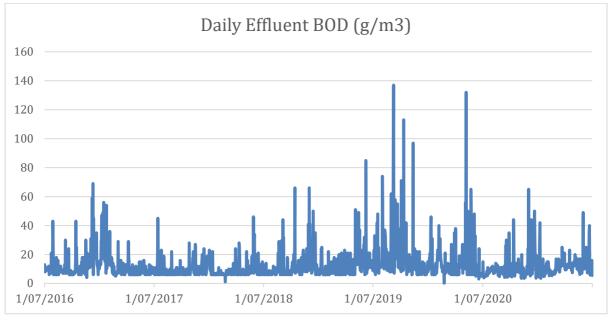
Figure 5: Effluent Daily cBOD5 Results

To establish a trend, all daily effluent  $BOD_5$  in the last five years have been used. The daily results seem to be consistent for the past years. It can be noted that BOD results tend to increase during summer as the process tries to adapt to the seasonal change.

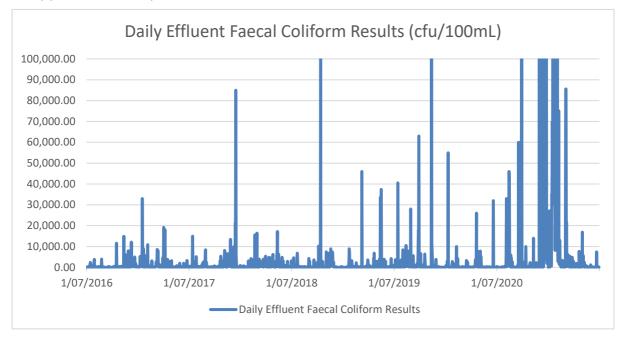
Figure 7: Effluent Daily Faecal Coliform Results

The plant was non-compliant for the faecal coliform requirements from December 2020 to April 2021. An investigation report was provided to GWRC regarding the cause of the exceedances. In summary, the exceedances were caused by disinfection failure due to component failures of the UV system.

To establish a trend, all daily effluent faecal coliform in the last five years have been used. The daily results seem to be consistent for the past years but experienced a step change in December 2020 to March 2021. This is due to the inefficiencies in UV disinfection process due to asset failure. After faulty parts of the UV system had been fixed the results went down to normal levels.

Veolia implemented a replacement scheme for the UV lamps and other defective parts of the UV system. There was a delay in procurement on the replacement of parts due to restrictions imposed by the pandemic. The plant was able to return to compliance as soon as the completion of the replacement activity.

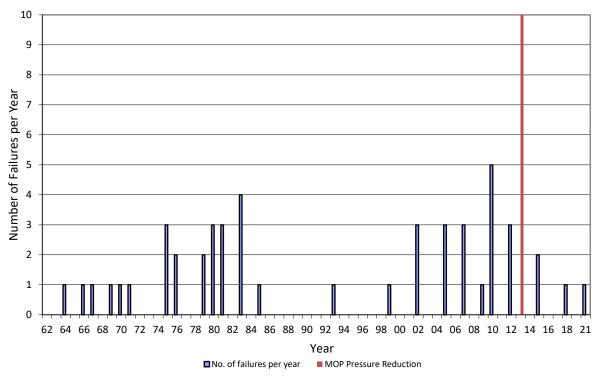
Figure 1: Record of Outfall Failures

The record of Seaview WWTP main outfall pipeline failure is illustrated in Figure 1. It can be noted that the frequency of failure in the outfall pipe has decreased since the reduction of the operating pressure of the outfall pipe.

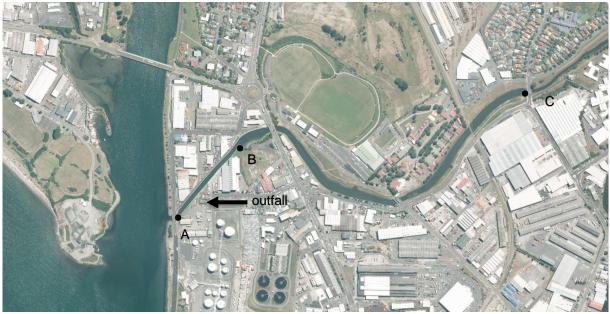
Site A (Port Road Bridge) is regarded as being downstream of the discharge while Site B (Waiwhetu Pa and urupā) and Site C (Bell Road Bridge) are upstream of the discharge from the outfall (which is indicated with an arrow on Figure 2-1 below).

Figure 2-1: Waiwhetu Stream monitoring locations on true left bank of Waiwhetu Stream

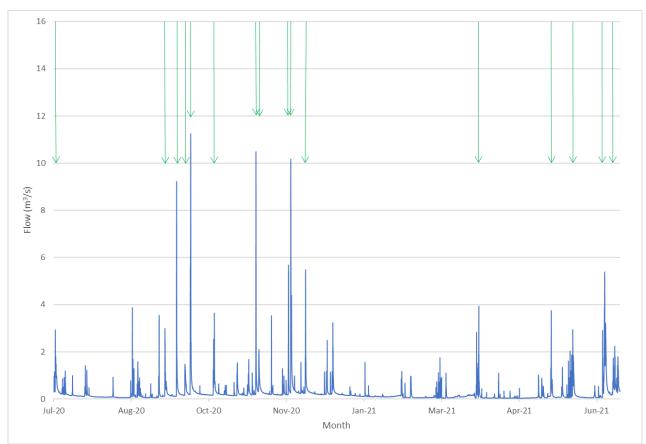
Overflow events (green arrows, shown on Figure 3-1) all correspond with high flow events in the Waiwhetu Stream. A flow record for Waiwhetu Stream at Whites Line East (GWRC data) during the 12 months from 1 July 2020 to 30 June 2021 is shown in Figure 3-1. This monitoring station is located approximately 3 km upstream of the Seaview main pumping station outfall but provides an estimate of stream flows on discharge days.

Figure 3-1: Flow in Waiwhetu Stream at Whites Line East during the year from 1 July 2020 to 30 June 2021

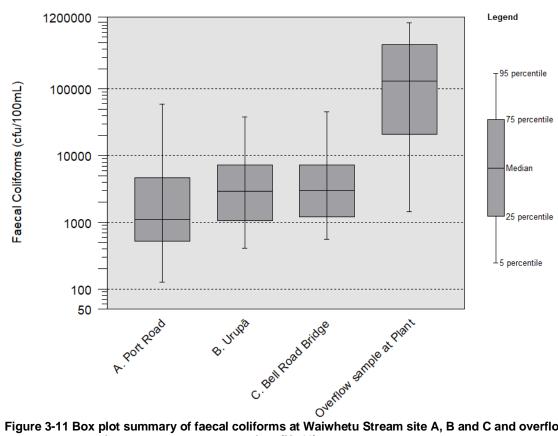
Faecal indicator bacteria (faecal coliforms, *E. coli* and enterococci) counts were higher in the treated wastewater discharge than in the receiving environment. While the Table 2-2 guideline values were almost always exceeded for *E. coli* and Enterococci during overflow events as well as immediately after overflow events, there was a general decrease after the events. Higher indicator bacteria counts were mostly recorded upstream at Site C with lower indicator bacteria counts recorded downstream at Site A. Therefore, significant upstream sources of bacterial contamination are indicated (possibly including wastewater network overflow or cross connections).

Figure 3-11 Box plot summary of faecal coliforms at Waiwhetu Stream site A, B and C and overflow sample at the wastewater treatment plant (N=41).

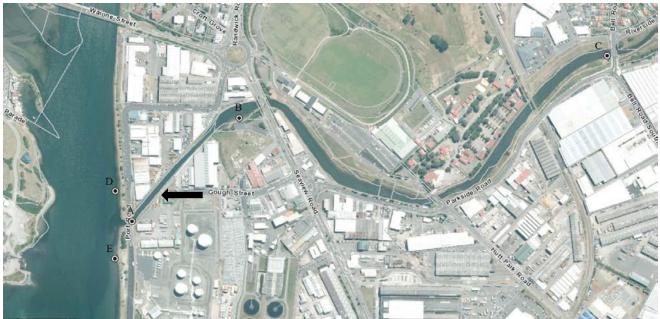
Figure 2-1: Waiwhetu Stream monitoring locations on Waiwhetu Stream and Hutt River (outfall location = arrow)

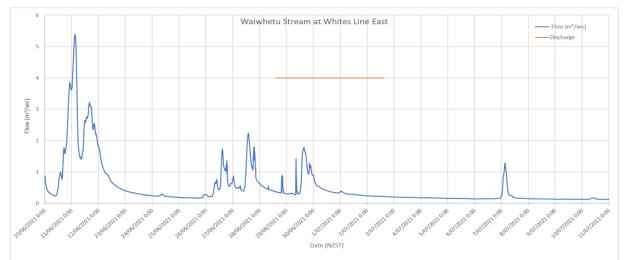
Waiwhetu Stream flow at Whites Line East during the overflow discharge period is shown in Figure 3-1. This flow station, operated by GWRC, is located upstream of the tidal influence. Additional monitoring of the Waiwhetu Stream flow is conducted by HCC at a site immediately above the Seaview WWTP Outfall, within the tidal reach (Figure 3-2). The HCC record indicates typical peak flows ranging from 5 to 18 m<sup>3</sup>/sec on the ebb tide (flowing downstream) and from 6 to 10 m<sup>3</sup>/sec on the flood tide (upstream).

Figure 3-1: Flow at Whites Line East, Waiwhetu Stream (GWRC data). The discharge duration is shown by the orange line

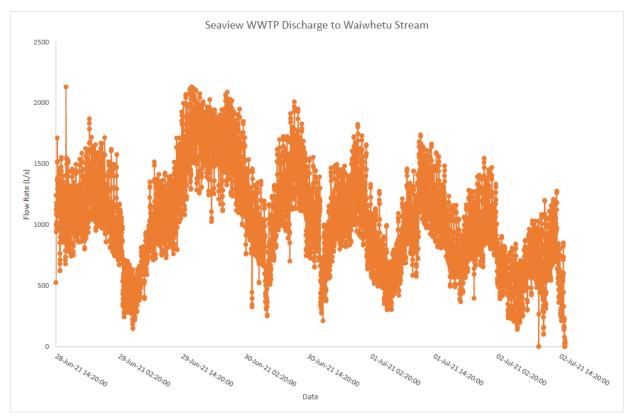
Seaview WWTP flow monitoring data indicate that the discharge at the overflow weir had a mean flow rate of 1039 L/s (Figure 3-3). Based on the mean wastewater flow of 1039 L/ and a typical stream flow of 5000 L/s at mid ebb tide, a fully mixed dilution ratio of approximately 1:5 (6-fold dilution factor) would be available on the outgoing tide. There would be periods of time when the available dilution is either higher or lower than 6-fold.

Figure 3-3: Seaview WWTP discharge to Waiwhetu Stream (L/s)
