Western Wastewater Treatment Plant

Annual Resource Consents Report 2020/2021

Document Title: Western Wastewater Treatment Plant Annual Resource Consents Report 2020/2021

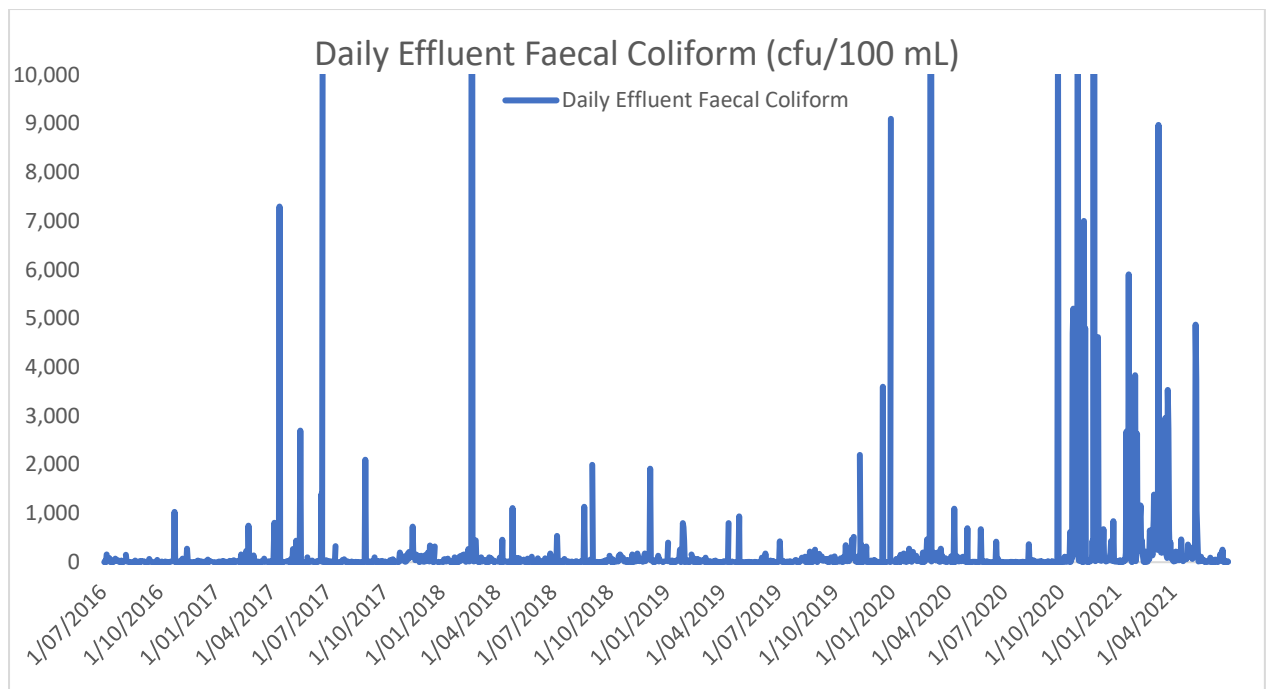
Figure 5: Daily Effluent Faecal Coliform Results

In figure 5, it can be noted that the daily effluent faecal coliform was consistent until April 2020 when an increase in daily values can be seen. There are some isolated spikes in the previous years but this can be associated with wet weather events. As UV disinfection is dependent in the quality of the effluent, high suspended solids content in the effluent would cause a decrease in disinfection efficiency. Veolia have provided investigation reports to GWRC to explain these exceedances. Wellington Water and Veolia are currently working on their performance plan to ensure the plant performance returns to compliance.

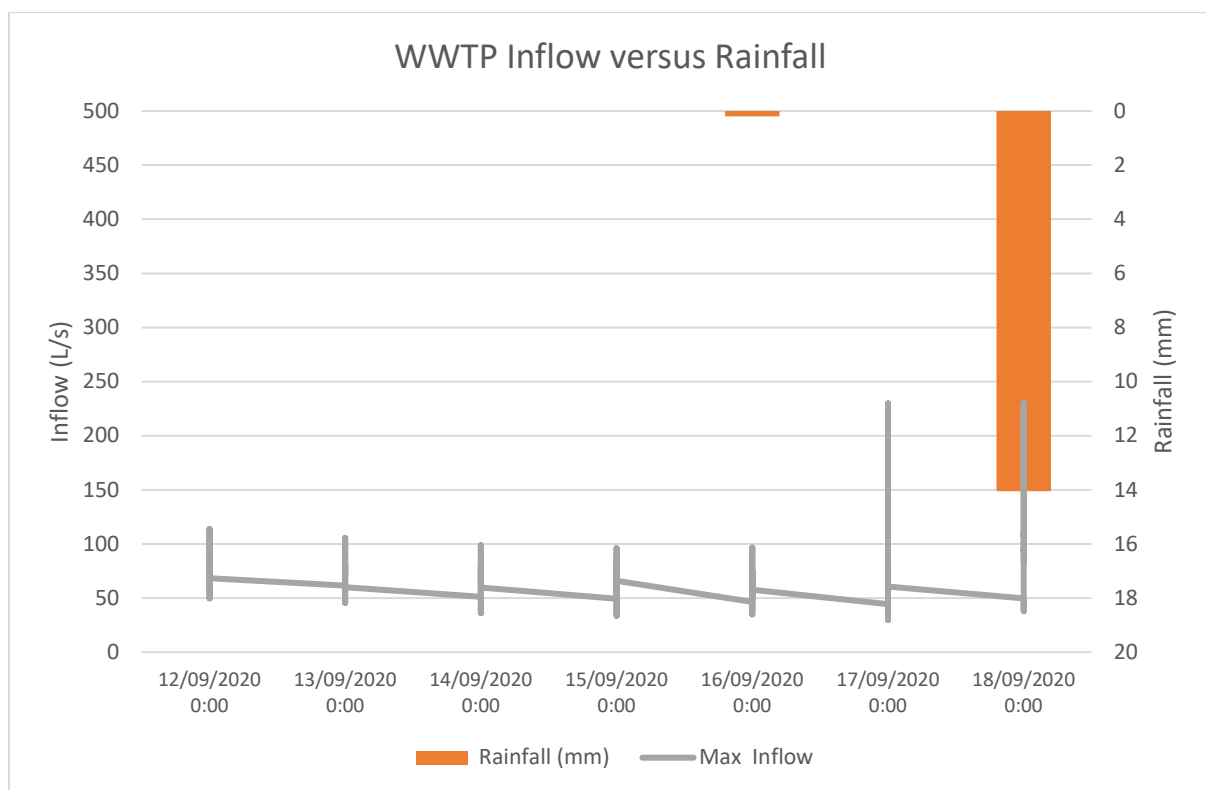
Figure 11: Rainfall and Max Inflow Data for 7 days prior 18th September Bypass Event

Figure 12 shows the rainfall data for the unconsented discharge in 18th September versus the maximum hourly inflow. It can be noted that the plant experienced a rainfall event on the 18th but the Storm tank was not full.

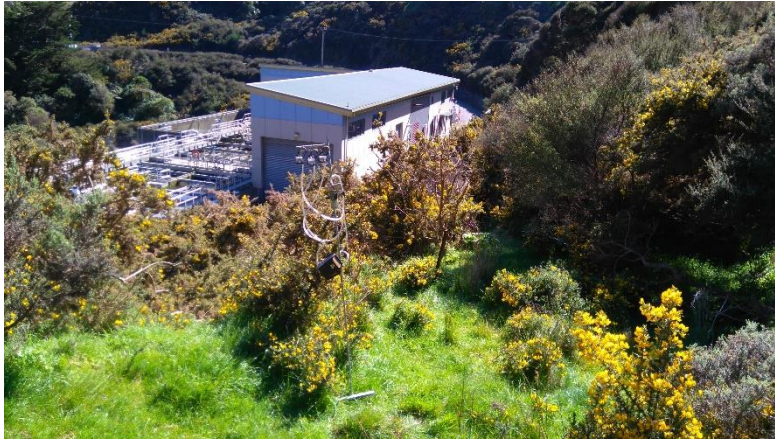
■ **Figure 1: WTP Monitoring Site 1**

There are a total of three monitoring sites confirmed with the Wellington Regional Council for monitoring the concentration of ambient microbes in the vicinity of the WTP. These monitoring sites are depicted in Appendix A. Figures 1, 2 and 3 depict the three sampling sites erected in the vicinity of the WTP on 28 October 2020. Samples were collected from each site for determination of the following microbes;

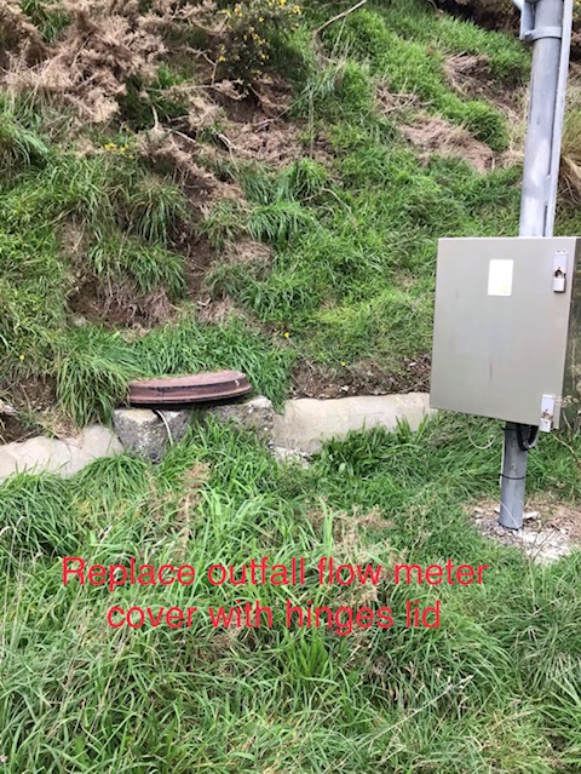
4	850	Manhole lid is not secure	(Optional) Replace existing manhole lid cover with a hinged lid for ease of access.

Complete – No replacement required.
5	900	Accumulated debris around pillars. Potential risk of scouring.	In the stream, gravel needs to be redistributed to form a larger channel to better distribute flow across the whole stream span back to its normal path.

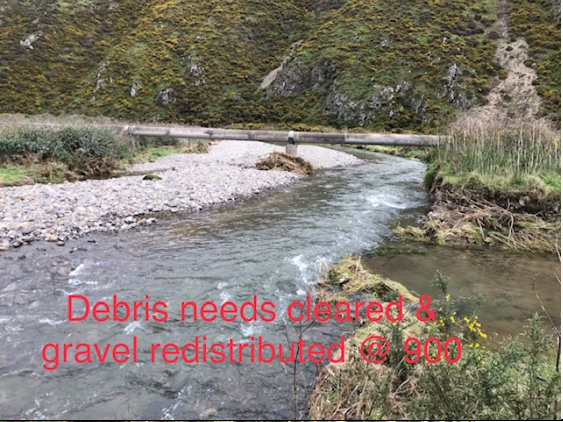
6	1300	Vegetation blocking tunnel exit.	Remove vegetation and debris around tunnel exit.

Complete – Vegetation and debris cleared.

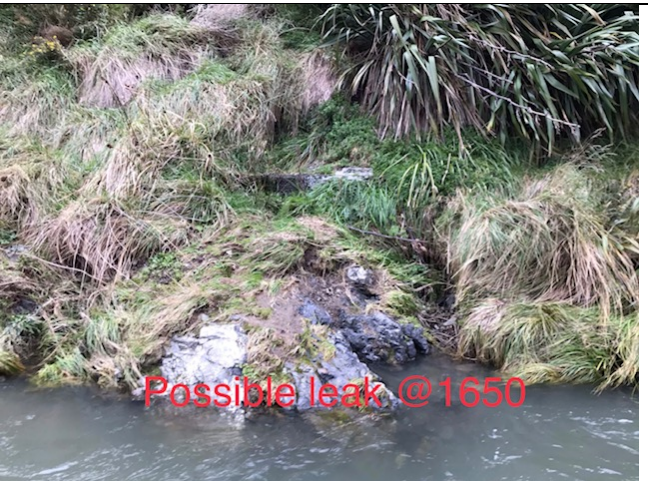
8	1650	Possible minor leak from pipe structure, no sample taken as flow insufficient	Further investigation required to determine if this seepage or sewer leak.

Planned Works - Site inspected; Leak requires monitoring.
9	1860	Vegetation growing on manhole, possible leak from manhole structure	Clear vegetation from manhole structure. Further investigate whether structure leaking

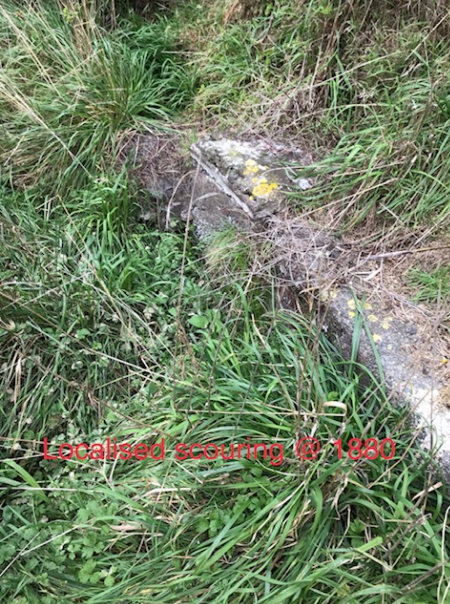
10	1880	Vegetation growing on manhole, possible localised scouring	Clear vegetation around manhole. Fill in localised scouring to restabilise bank.

Complete – Vegetation and debris cleared. Localised scouring self-filled since last inspection.
11	1900	Pipe Undermined for 1.5m section.	Potential undermining of pipe structure, monitor asset.

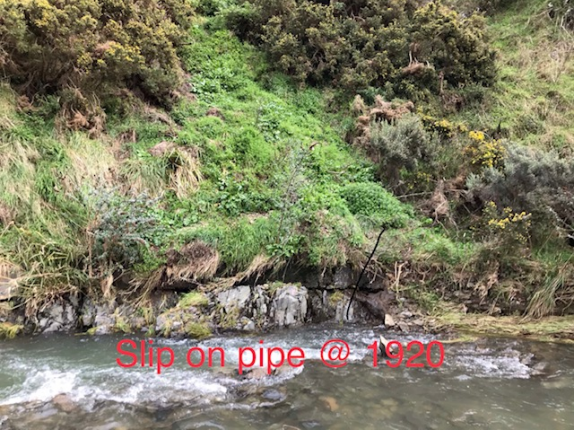
12	1920	Slip on pipe, looks to be historical. With no sign of leaks or disturbance to the integrity of the pipe structure.	This is to be monitored.

Planned Works - Site inspected; Requires monitoring.
13	2450	Weeping manhole structure, seepage flow insufficient to capture sample.	Further investigation required to determine if this is pipe leaking or natural seepage.	 	Planned Works - Site inspected; Requires monitoring.

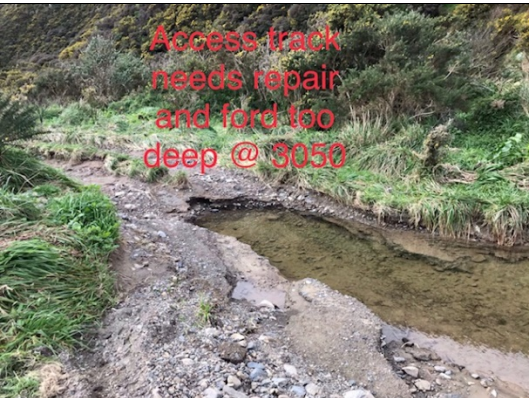
14	3050	Access track washed away, needs re-establishing	Make safe adjustments to track.

Complete – Track self-adjusted, no addition material or excavations required.
15	3150-3500	Vegetation covering length of above ground pipe section	This section needs to be cleared to allow access to pipe for inspection

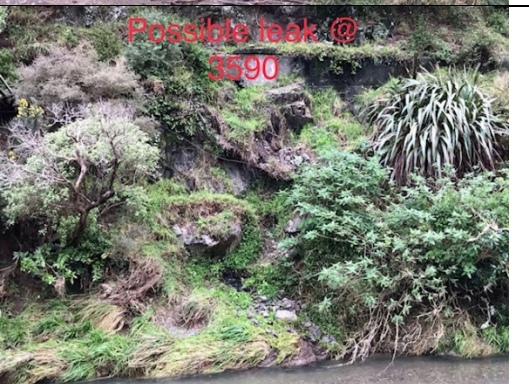
Complete – Vegetation cleared. Tracks restored.
16	3590	Weeping manhole structure, the seepage flow was too insufficient to get sample.	Further investigation to determine if it is natural seepage or pipe leak.

Planned Works - Site inspected; Requires monitoring.

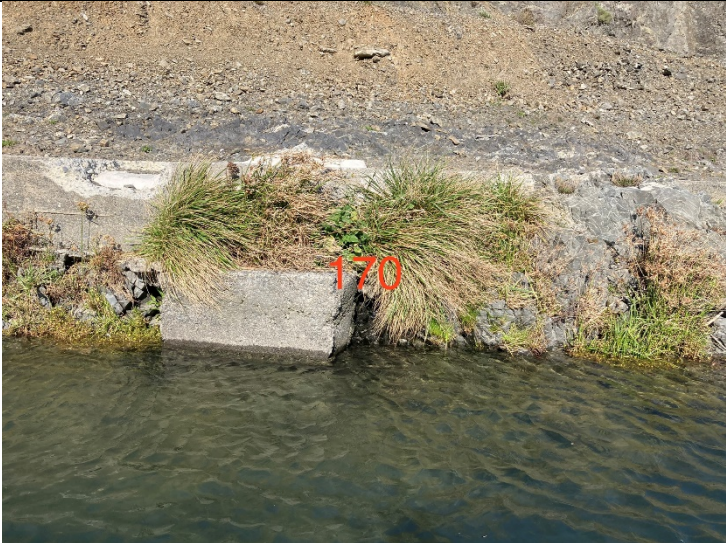
No.	Chainage (m)	Comments	Actions	Photo	Sample Result (Fluoride)
1	170	Leak visible. Repair required	Inspect leak, make repair as required.

0.24g/m ³

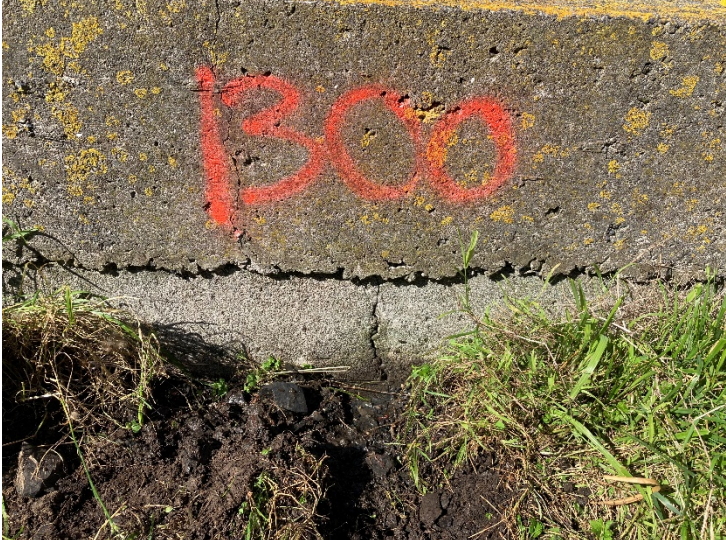
2	1300	Crack in pipe casing, visible leaking. Areas either side of encasing is lush green. Seepage volume not currently enough to capture sample.	Further inspect fault, apply temporary fix to manage seepage. Monitor seepage going forward.

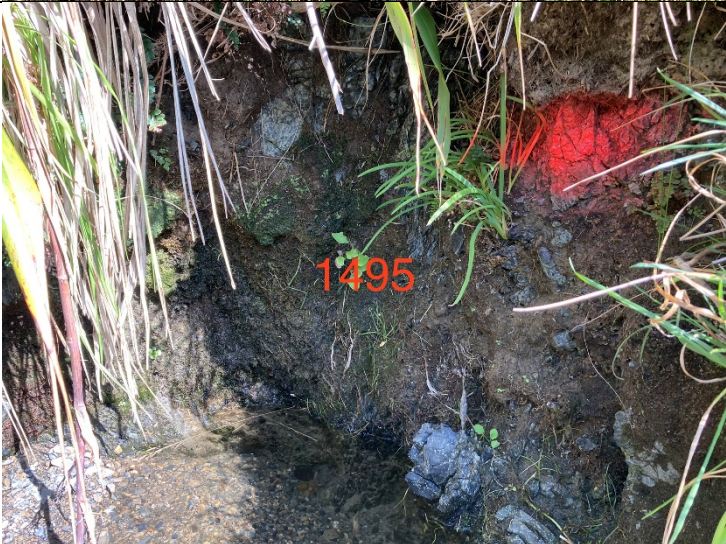
N/A
3	1495	Potential leak in area of green vegetation. Seepage volume not enough to capture sample.	Clear vegetation and gravels to gain visibility. Temporary repair if required.

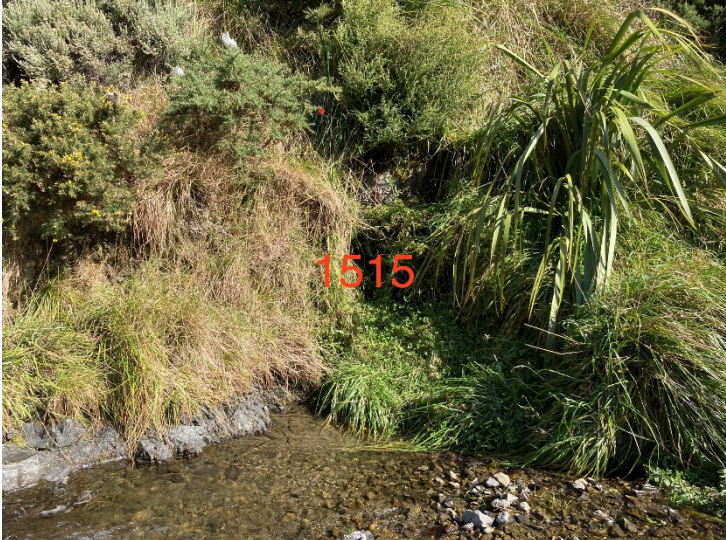
4	1515	Potential leak in area of green vegetation. Sample acquired.	Clear vegetation to gain visibility. Temporary repair as required

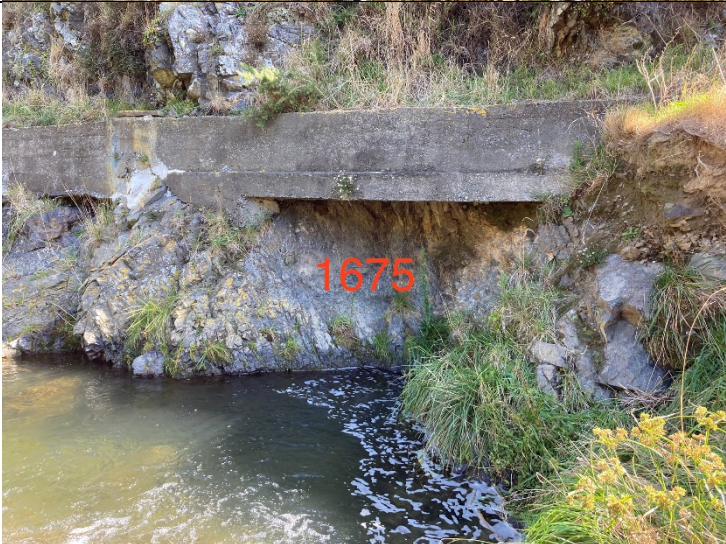
0.16
5	1675	Pipe is partially undermined.	Requires monitoring.

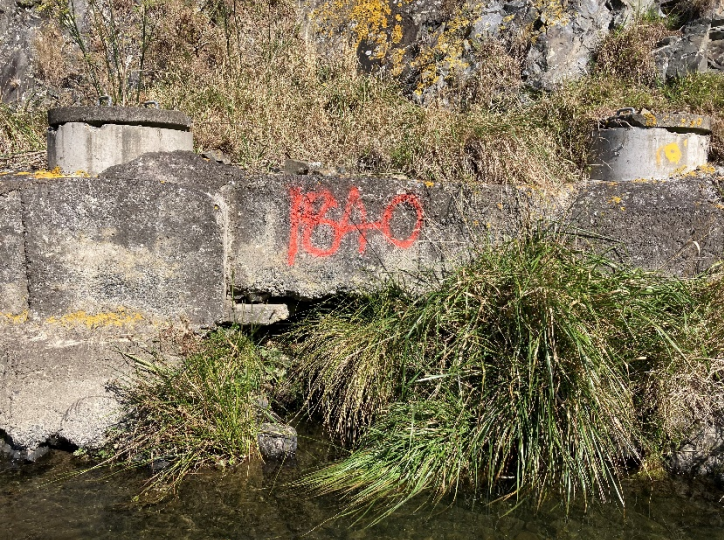
6	1840	Structure partially undermined.	Requires monitoring.

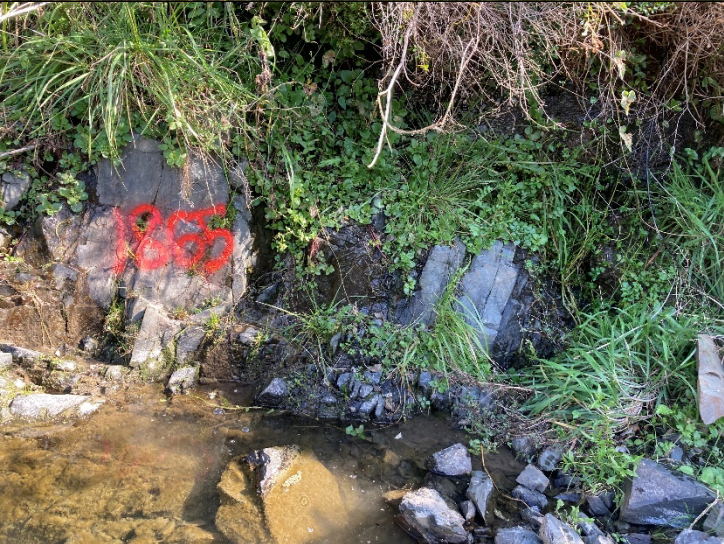
N/A
7	1860	Weeping bank, potential leak. Unable to capture sample due to low volume.	Remove vegetation to get visibility on issue.

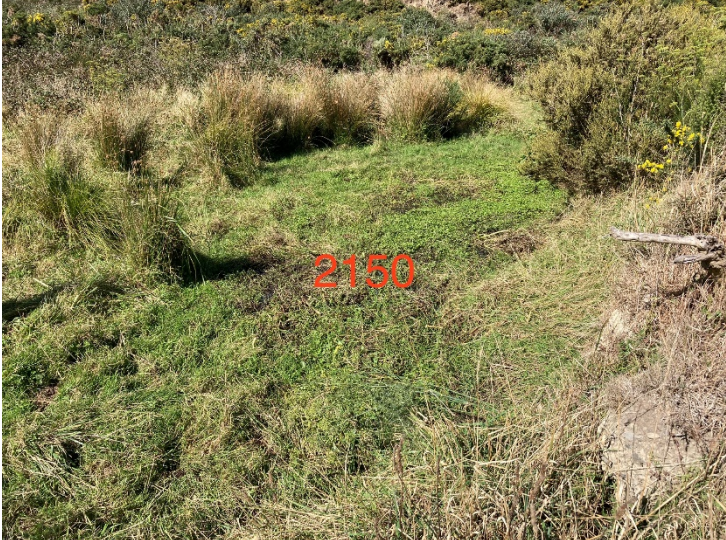
8	2140-2150	Large amount of boggy ground at the toe of earth edge. Requires further investigating	Re-inspect site, capture sample from pit and determined if Fluoride levels are elevated.

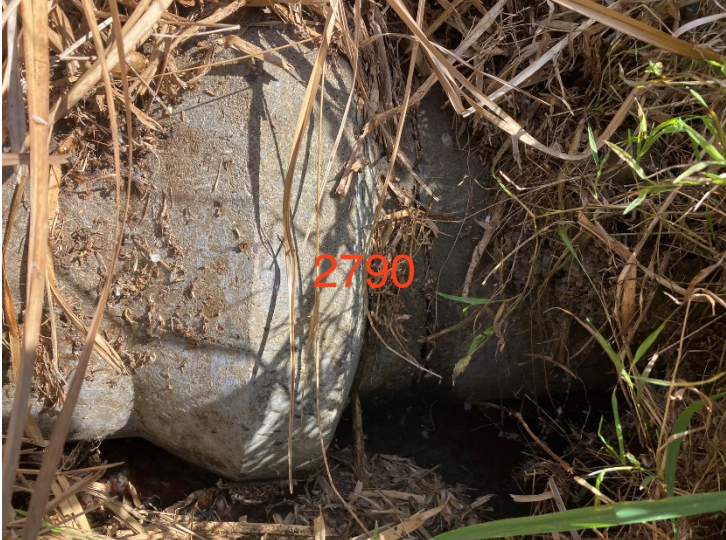
12	2790	Circumferential crack in pipe upstream of joint.	Repair required (Market pink x or MH)

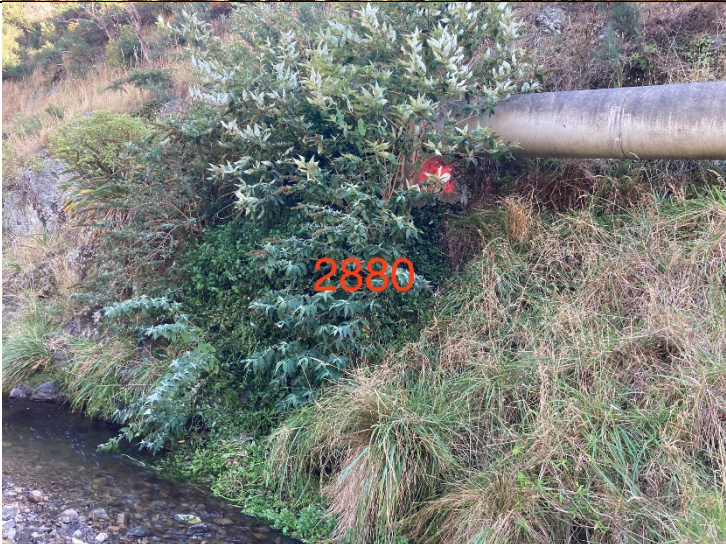
N/A
13	2880	Green vegetation, visible leaking. Sample acquired.	This is to be monitored. Clear vegetation to gain greater visibility. Seal if required.

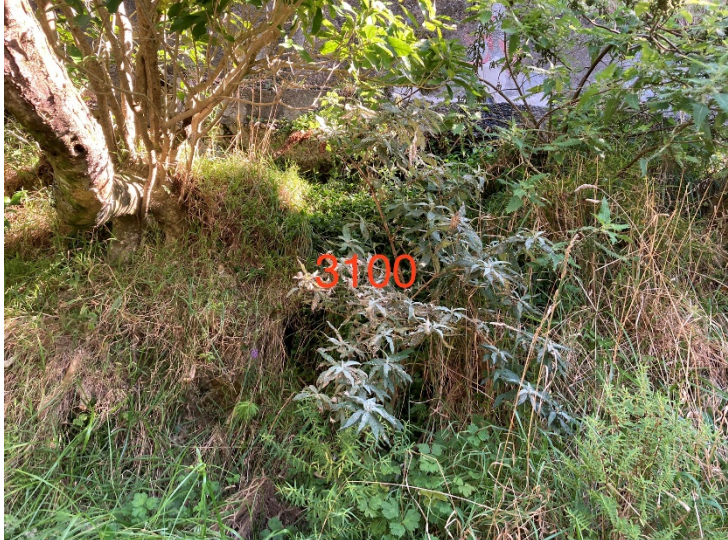
16	3100	Weeping pipe enclosure. Sample acquired.	Clear vegetation and further inspect for network leak.

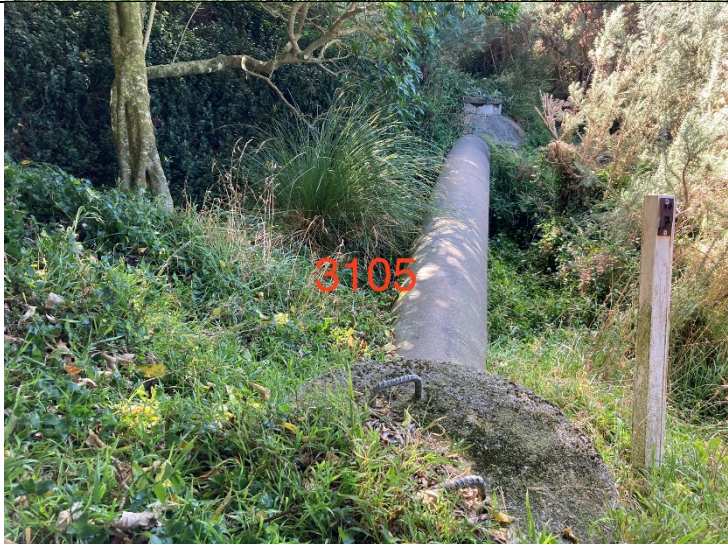
0.15 g/m ³
17	3105	Vegetation heavy towards asset, access track needs clearing.	Clear section of vegetation to allow access to pipe for inspection.

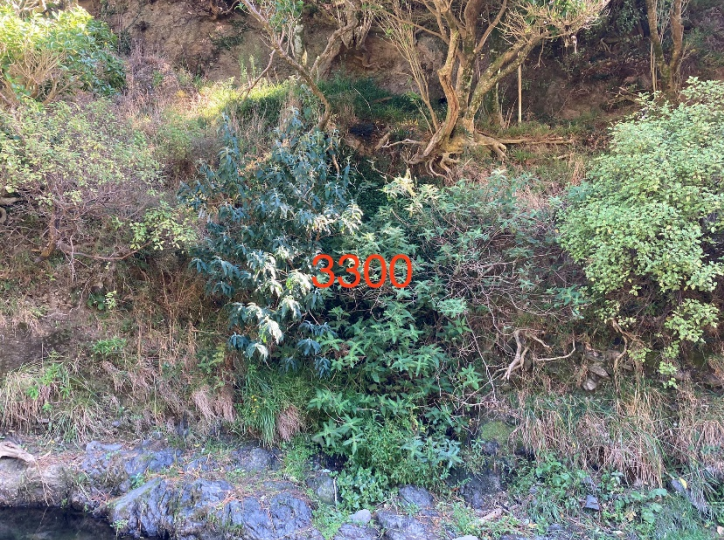
18	3300	Possible leak, green vegetation present. Sample acquired	Further investigation to determine if it is natural seepage or pipe leak.

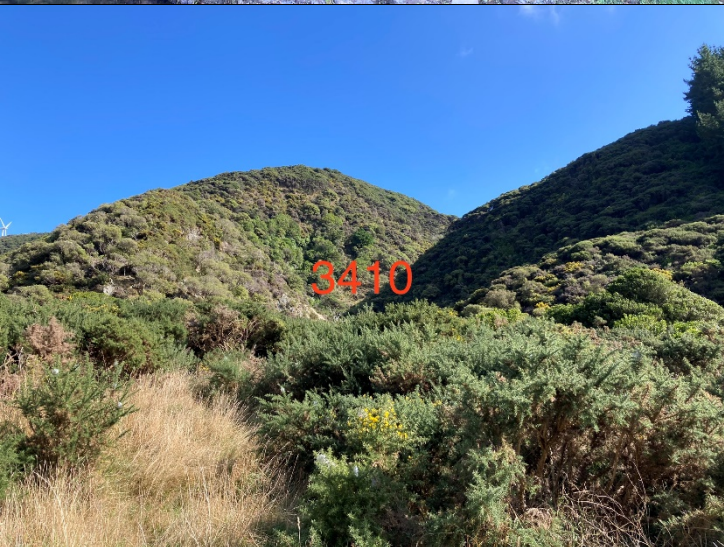
0.16 g/m ³
19	3510	Vegetation heavy, grown through tract to pipe bridge.	Cut back and spray vegetation to allow access to inspect bridge.

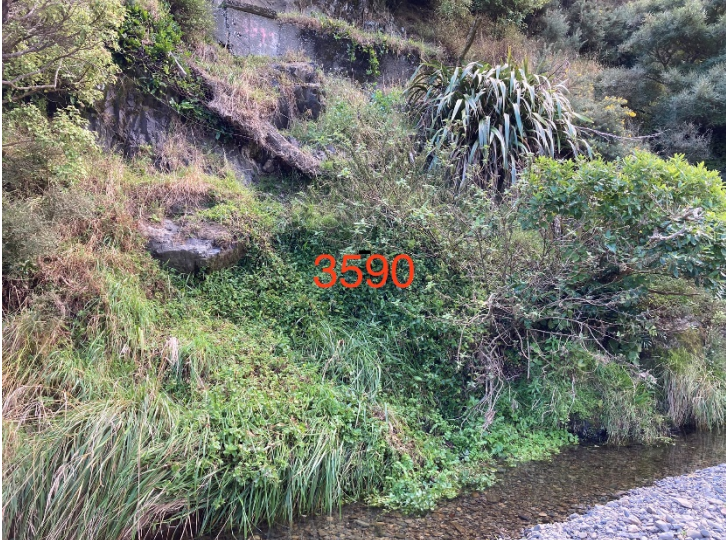
20	3590	Weeping manhole, lush vegetation, leaking into stream. Sample acquired	Further investigate area to confirm if leak is network related.

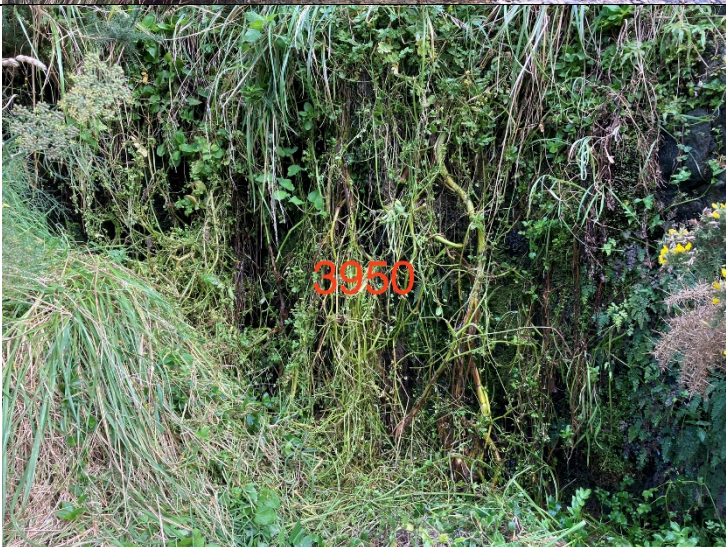
0.15 g/m ³
21	3950	Green vegetation with visible leakage. Sample acquired	Further investigate area to confirm if leak is network related.

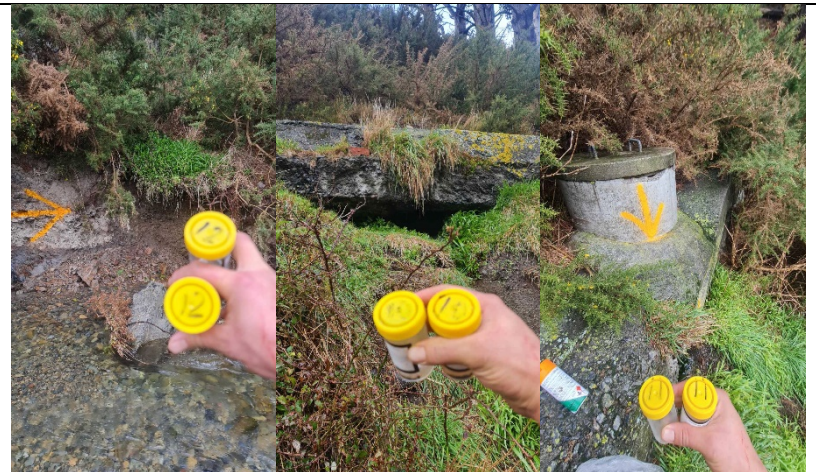
26	4590, 4610, 4640	Leaks identified from concrete encasing. Samples collected.	Further inspect seepage locations to gauge repair.

0.14 g/m ³ , 0.13 g/m ³ , 0.15 g/m ³
27	5280, 5290	Leaks identified from manhole structure. Seepage present at marked locations. Samples collected.	Further investigate asset, repair as required.

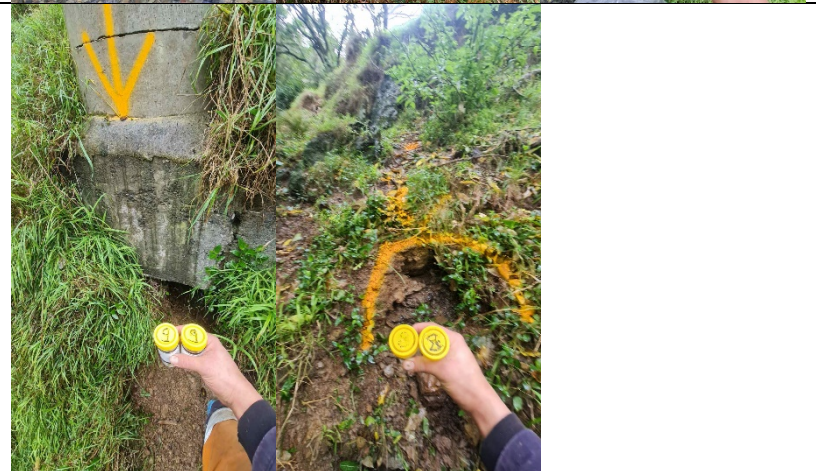
0.13 g/m ³ , 0.14 g/m ³
