Seaview Wastewater Treatment Plant

Annual Resource Consents Report 2022/2023

Document Title: Seaview Wastewater Treatment Plant Annual Resource Consents Report 2022/2023

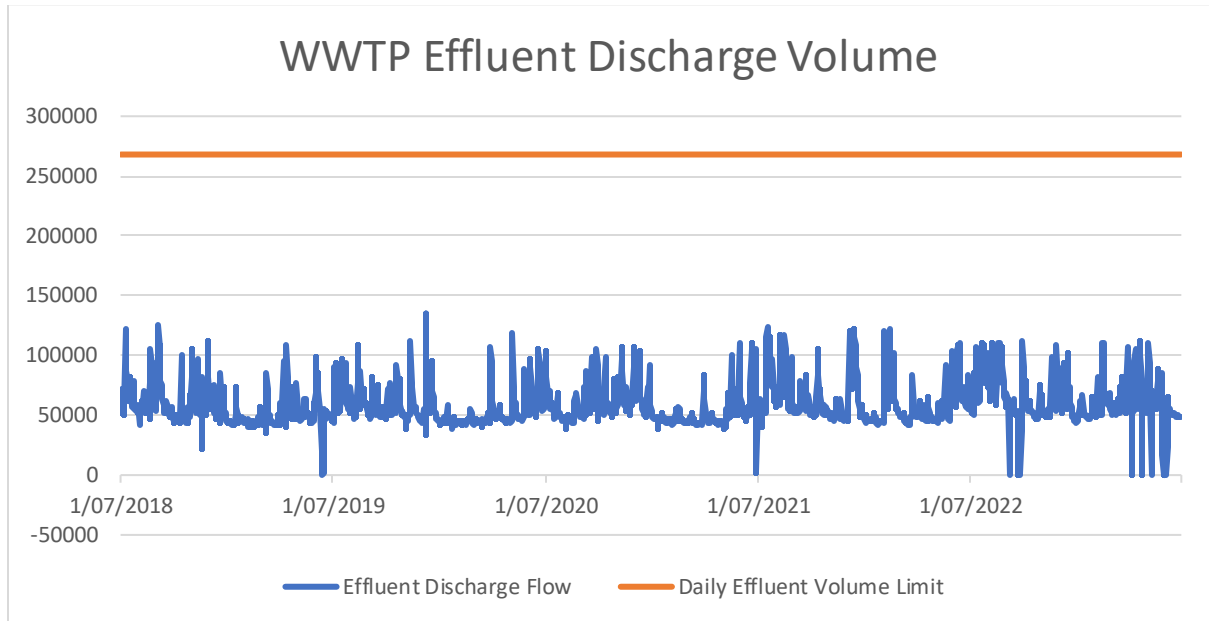
Figure 5: Effluent Discharge Flow

WWTP effluent discharge volume is used to establish a trend. In figure 5, it can be noted that the plant's effluent discharge volume is affected during wet weather.

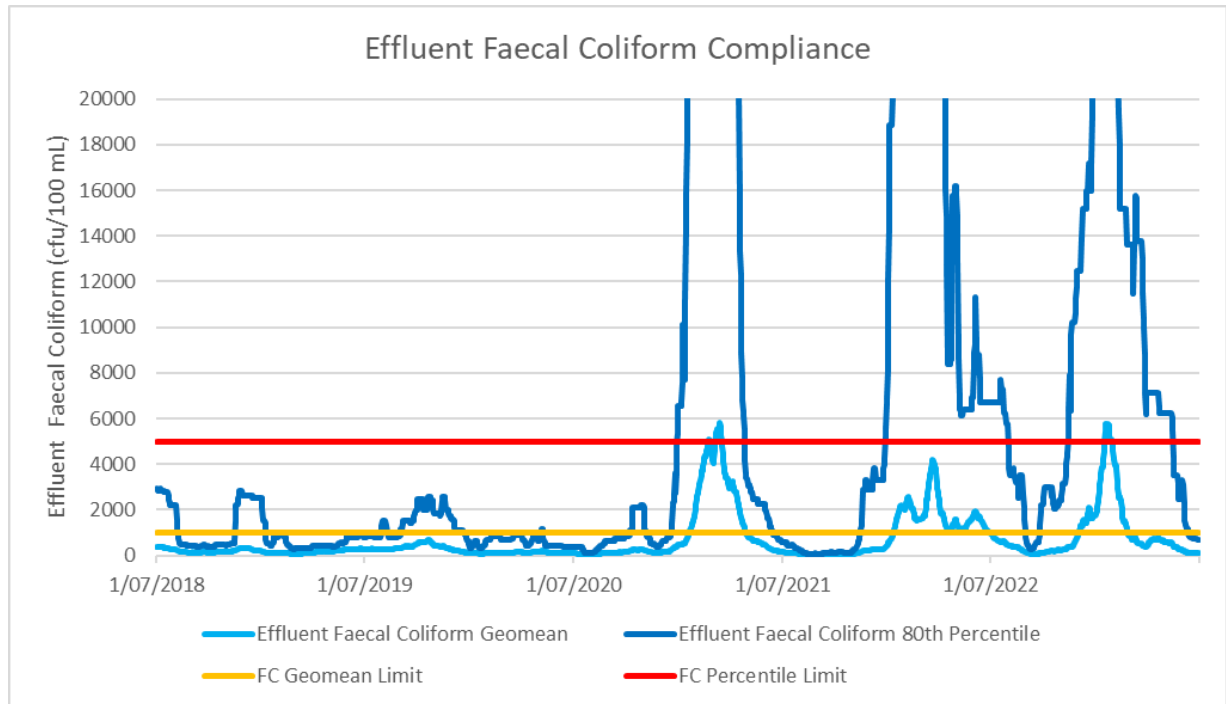
Figure 7: Effluent Faecal Coliform Compliance

To establish a trend, effluent faecal coliform 90-day rolling geometrical mean and 80th percentile in the last five financial years has been used. The plant experienced exceedances in the last three summer periods. The exceedances in FY2020/21 were due to inefficiencies in the UV system due to aging UV lamps, while exceedances in FY2021/22 were due to algae fouling of the UV lamps in the UV system. A similar issue was experienced during the summer of FY2022/23, although at a reduced level.

In summary the non-compliance was caused by reduction of UV disinfection effectiveness due to the following reasons:

- Failure of a post-UV weir gate drive early in the FY22/23 that affected accurate level control and hindering the disinfection effectiveness of the UV system
- Supply chain issues delayed procurement of replacement parts to allow the post-UV weir gate to be repaired early 2023
- A failed ballast was identified in the UV system and replaced in December 2022
- Significant wet weather events elevate faecal coliform levels
- In November 2022, a large petrochemical contamination entered the plant from the catchment and negatively impacted the treatment process, especially the UV system
- Algae build up around UV lamps

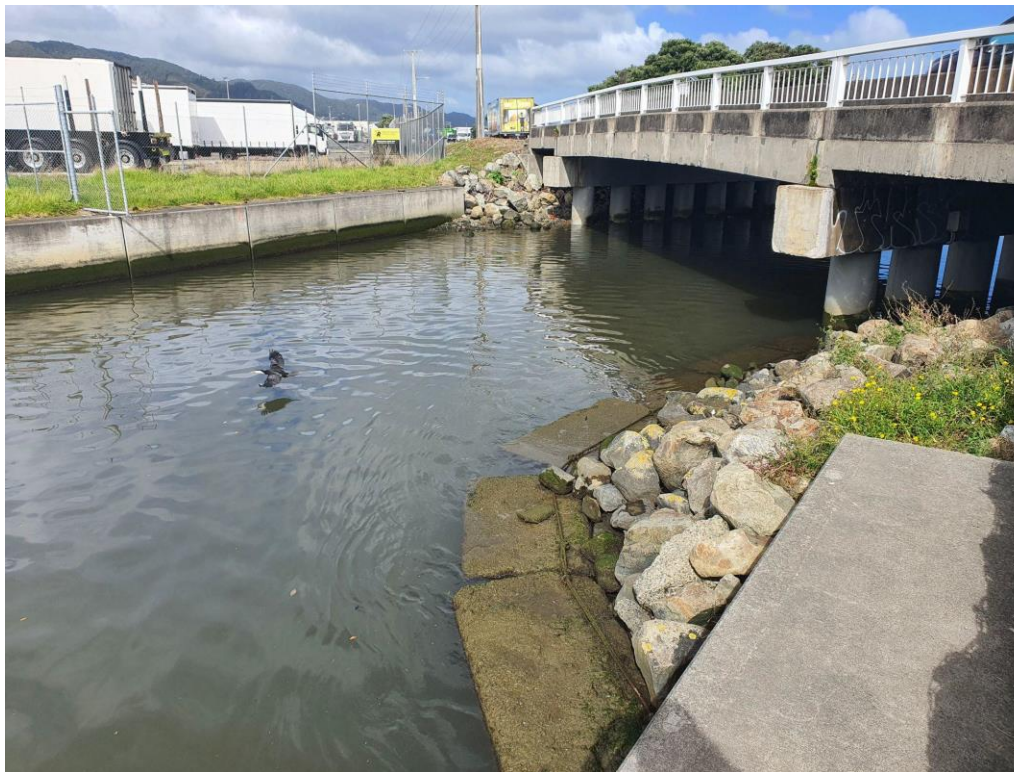
Date	Upstream of Port Road Bridge
11-Apr-23 13:36:00

A photograph showing a concrete-lined stream channel. On the right, a concrete bridge with a white metal railing spans the channel. The water is dark and still. In the foreground, there are concrete blocks and a pile of rocks along the bank. In the background, a fenced area contains several white trucks and a yellow vehicle. The sky is blue with some clouds.
