Western Wastewater Treatment Plant

Annual Resource Consents Report 2021/2022

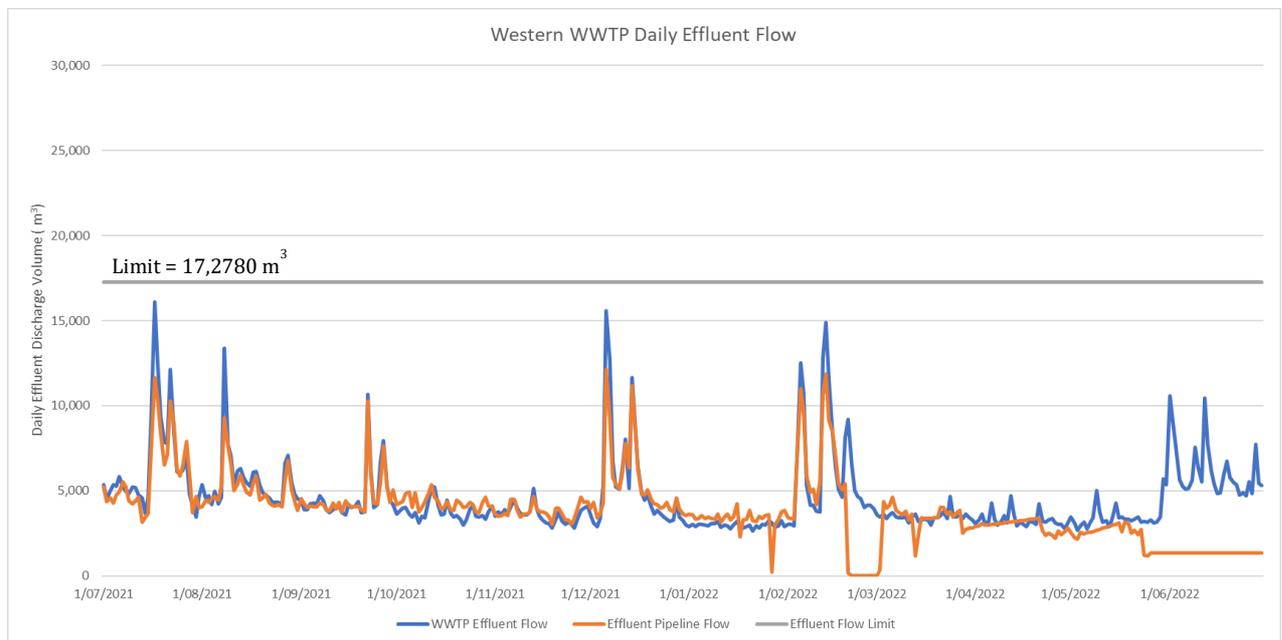
Figure 1: Western WWTP Effluent Flow

The daily discharge volume from the WWTP and the pipeline is illustrated in Figure 1. Daily rainfall was also included to show the effect of wet weather events to the volume being discharged by the plant. It is evident that high discharge volumes occur when there is heavy rainfall in the catchment.

It can be noted that although the values do not match, they trend with each other.

The effluent pipeline was damaged during the cyclone Dovi last February 2022. Wellington Water had over-pumping setup to continuously discharge to the outfall pipe. The main repair on the outfall had been completed in July 2022. The details of the repair can be found on the Outfall Maintenance Annual Report.

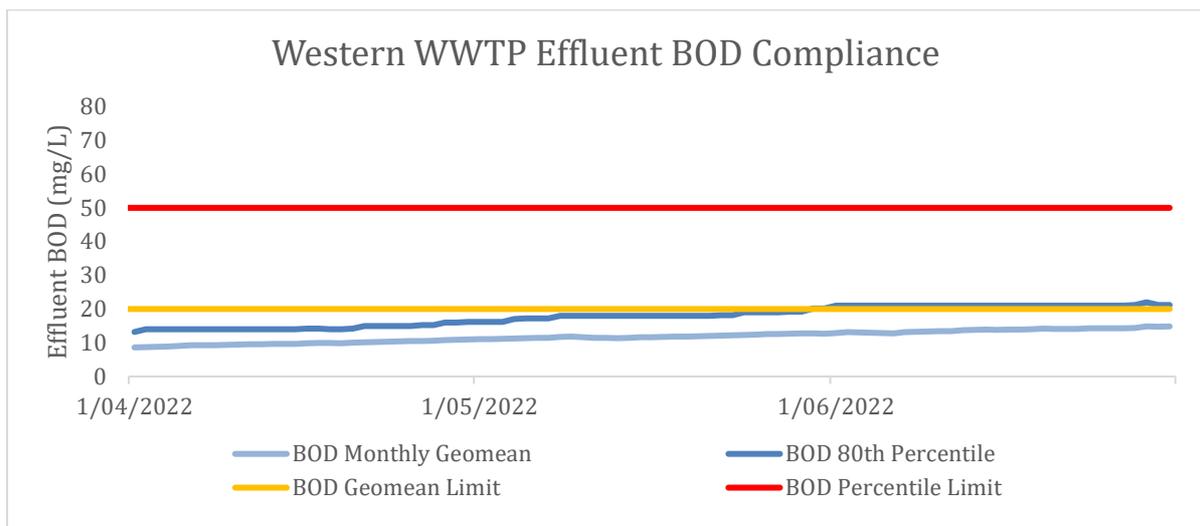
Figure 2: Western WWTP Carbonaceous Biological Oxygen Demand Compliance

Below is a summary of the geometric mean and 80th percentile for the effluent Biological Oxygen Demand from April 2022 to June 2022.

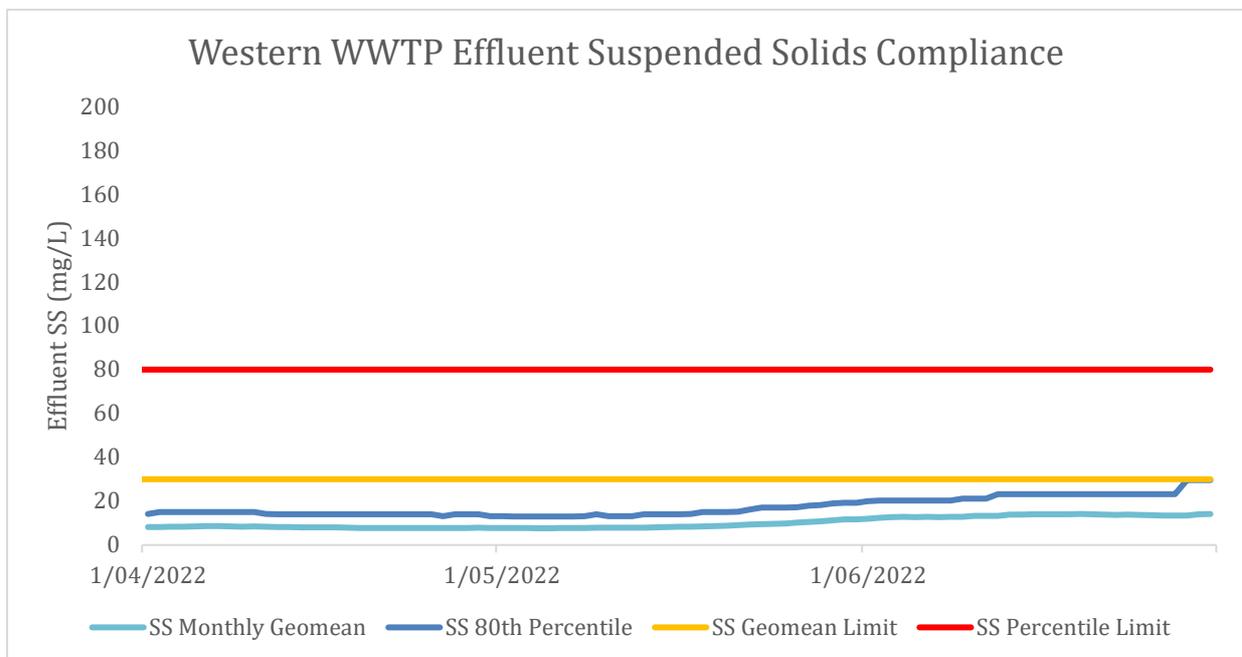
Figure 3: Western WWTP Suspended Solids Compliance

Below is a summary of the geometric mean and 80th percentile for effluent suspended solids from April 2022 to June 2022.

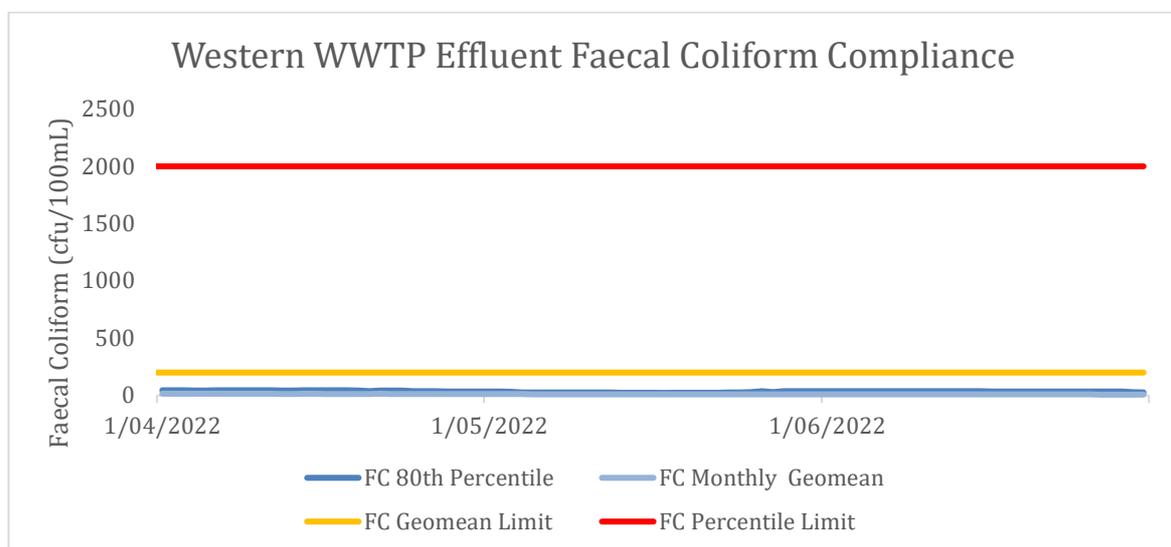
Figure 4: Western WWTP Faecal Coliform Compliance

Below is a summary of the geometric mean and 80th percentile for effluent faecal coliform from April 2022 to June 2022.

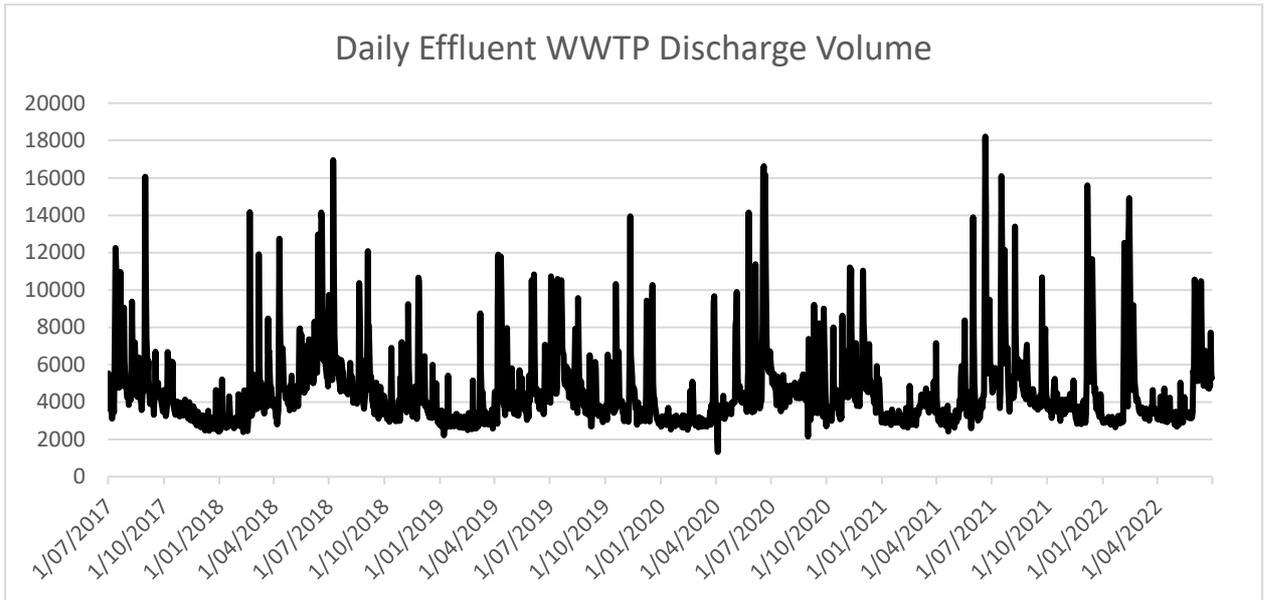
Figure 5: WWTP Effluent Discharge Volume versus Rainfall

Due to some missing data in the outfall effluent pipeline daily discharge volumes, WWTP effluent discharge volume is used to establish a trend. The WWTP discharge volume tends to increase during winter season and decreases during summer.

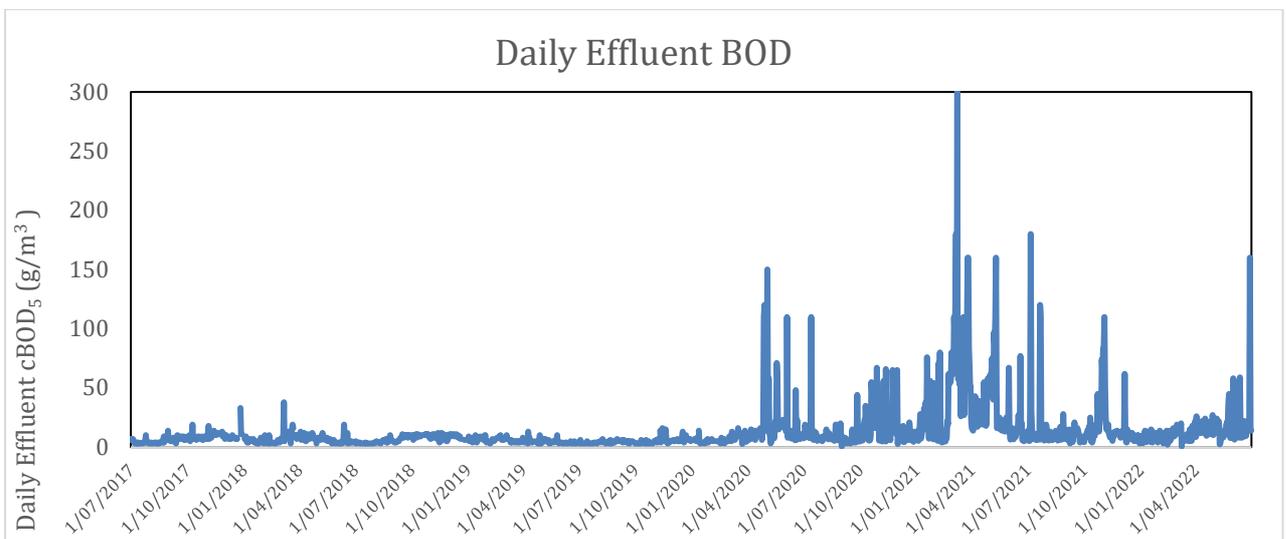
Figure 6: Daily Effluent BOD₅ results

To establish a trend, all daily effluent BOD in the last five (5) years have been used. Please note that only the first 20 samples of each calendar month are used to assess compliance as stated in the resource consent until end of March 2022. The consent does not require daily effluent sampling thus there are some days with missing effluent BOD₅ results in the past years.

In figures 6,7 and 8, the effluent quality of the treatment plant seems to have deteriorated in financial year 2020/2021. A report regarding this exceedance was submitted to GWRC previously. The plant's performance had improved in FY2021/22 after some modifications have been made in the plant's operation.

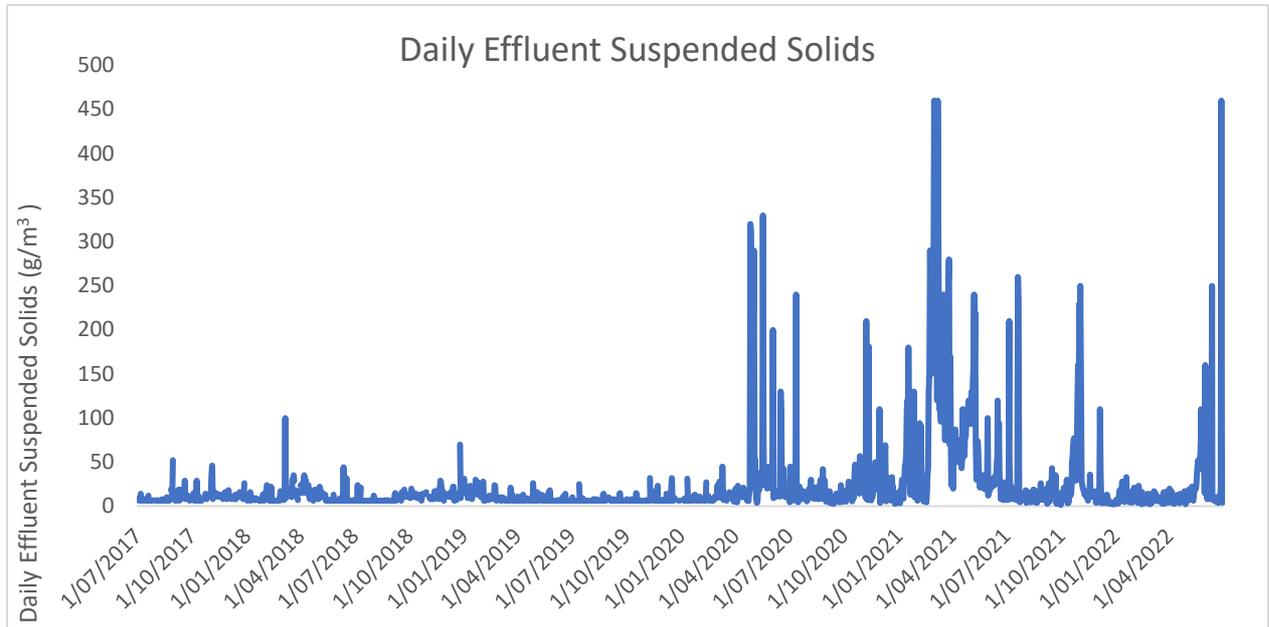
Figure 7: Daily Effluent Suspended Solids Results

To establish a trend, all daily effluent suspended solids in the last 5 years have been used. Please note that only the first 20 samples of each calendar month are used to assess compliance as stated in the resource consent until end of March 2022. The consent does not require daily effluent sampling thus there are some days with missing effluent suspended solids results in the past years.

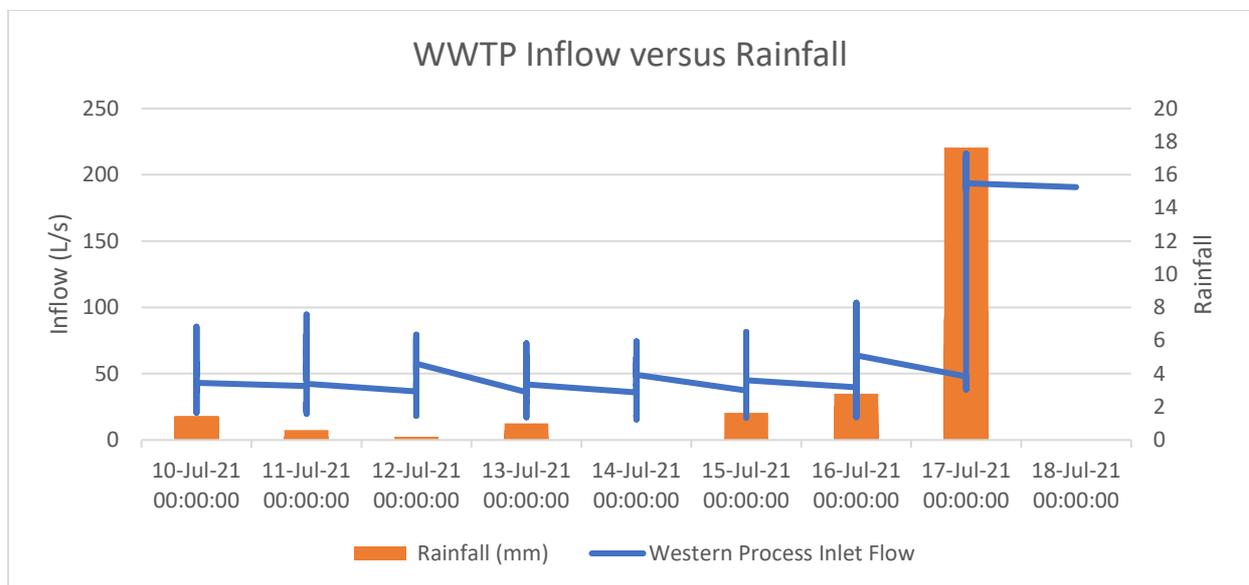
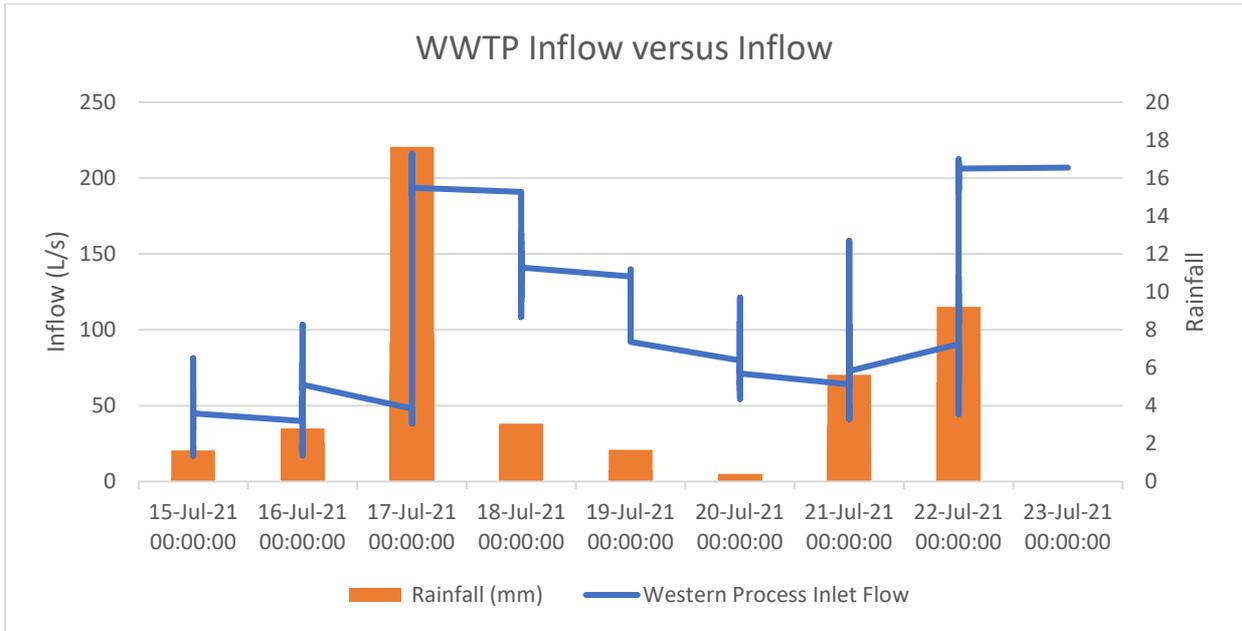
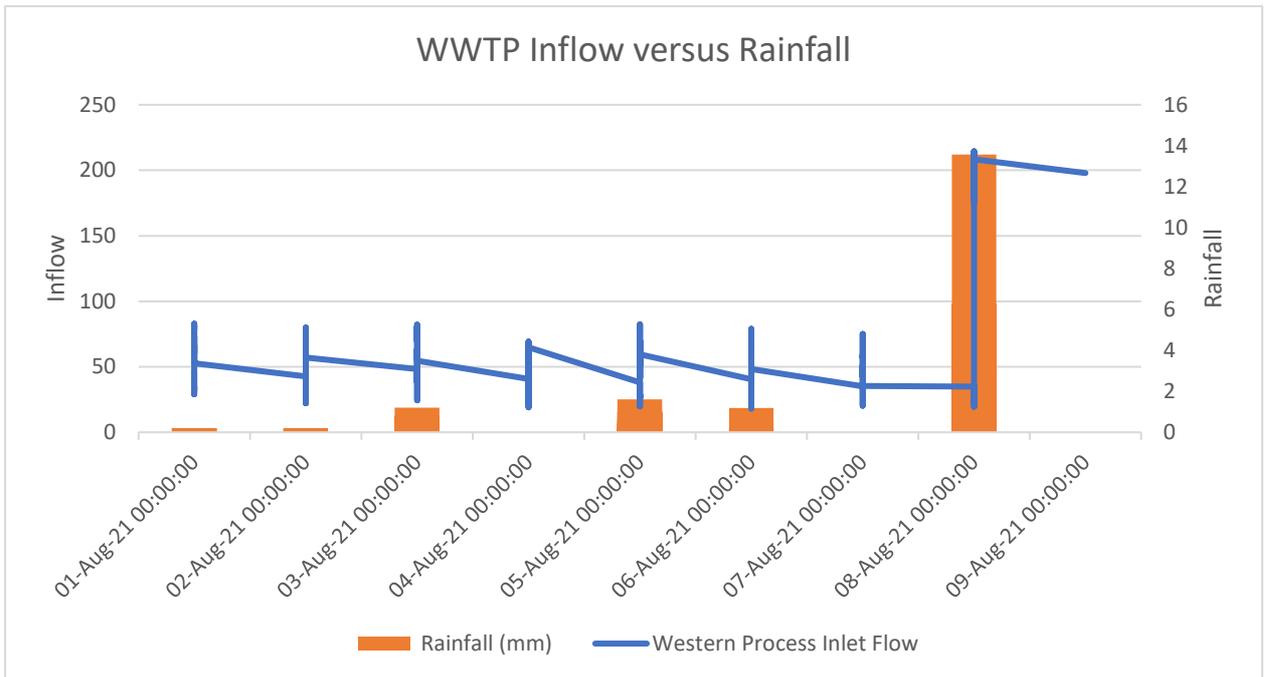
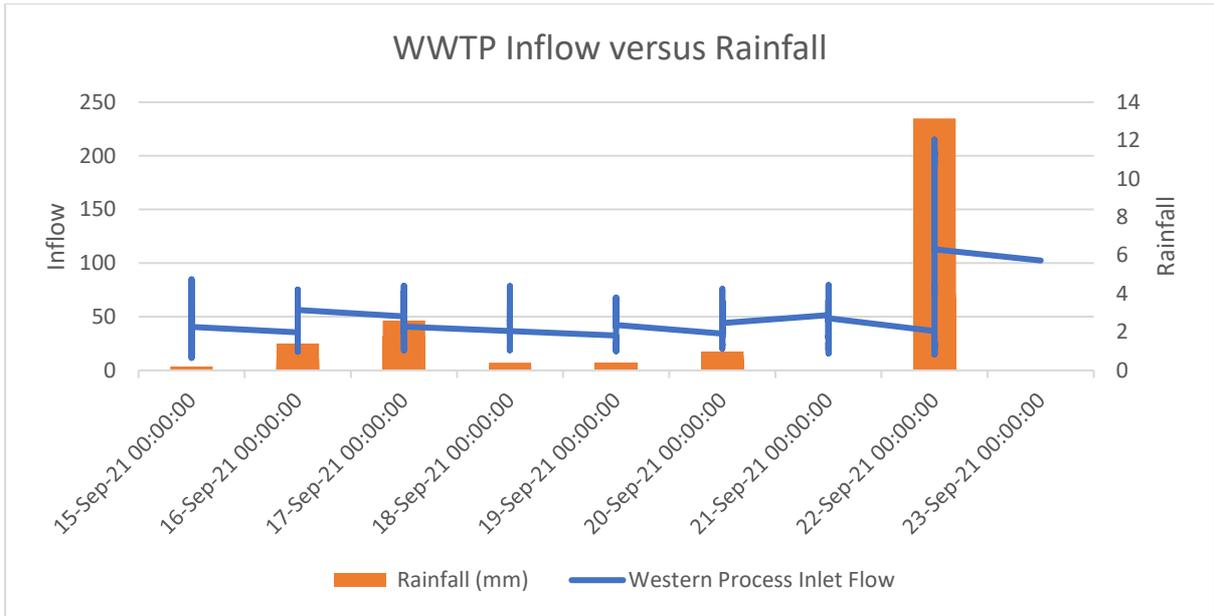
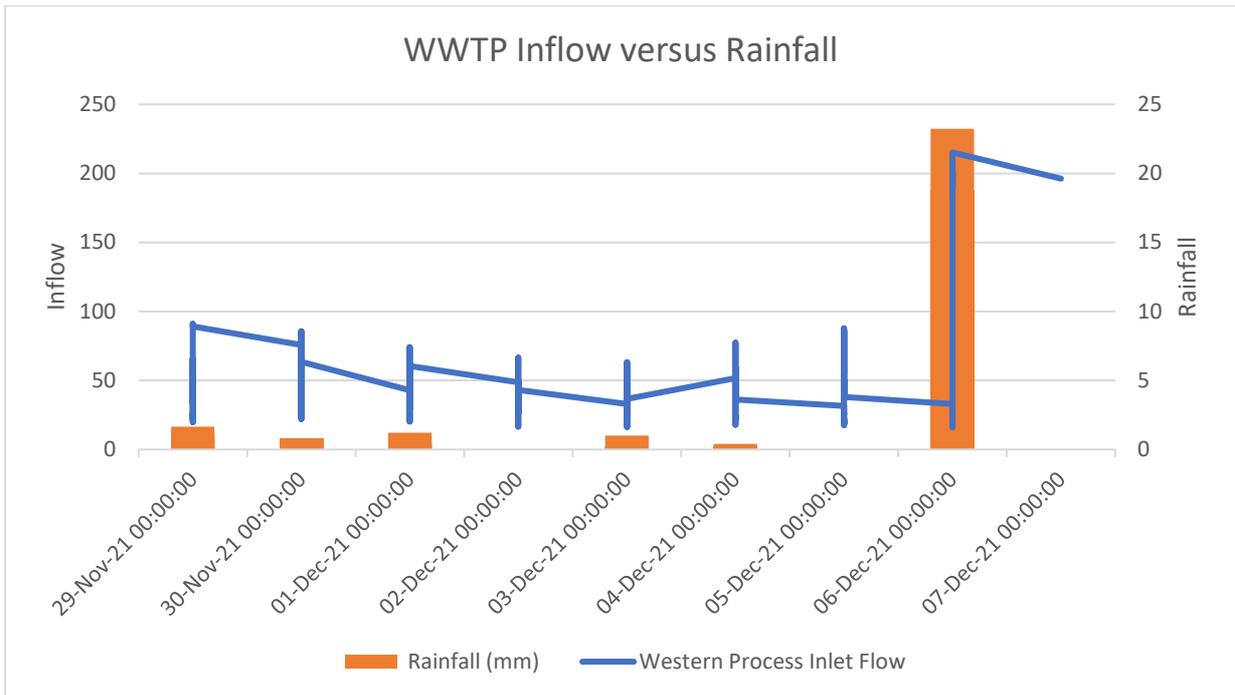
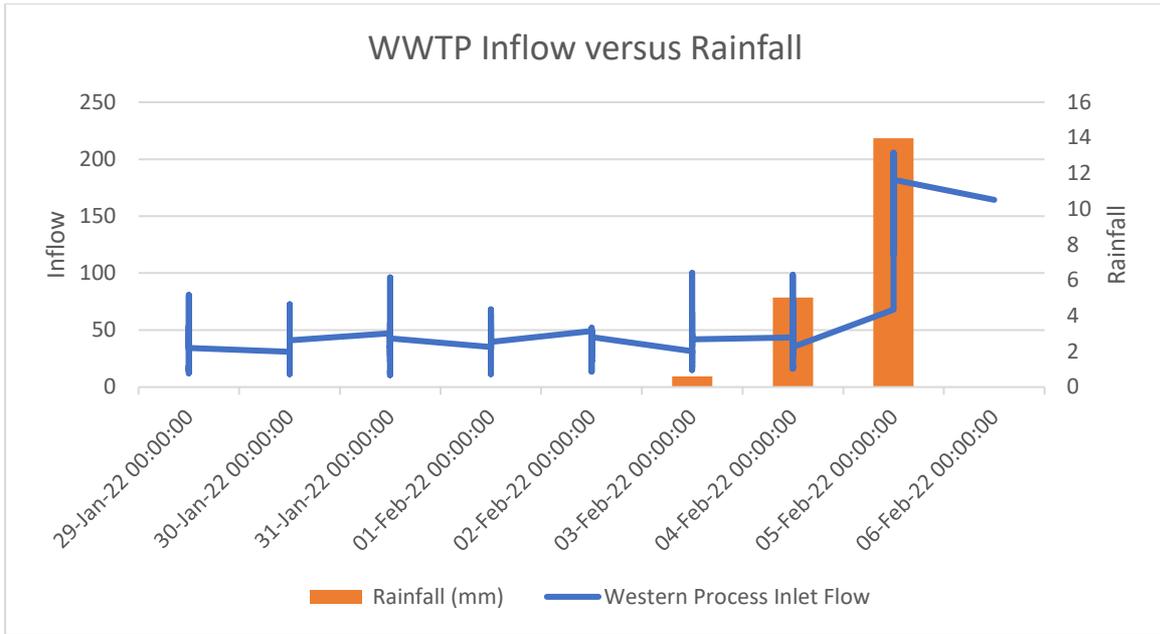
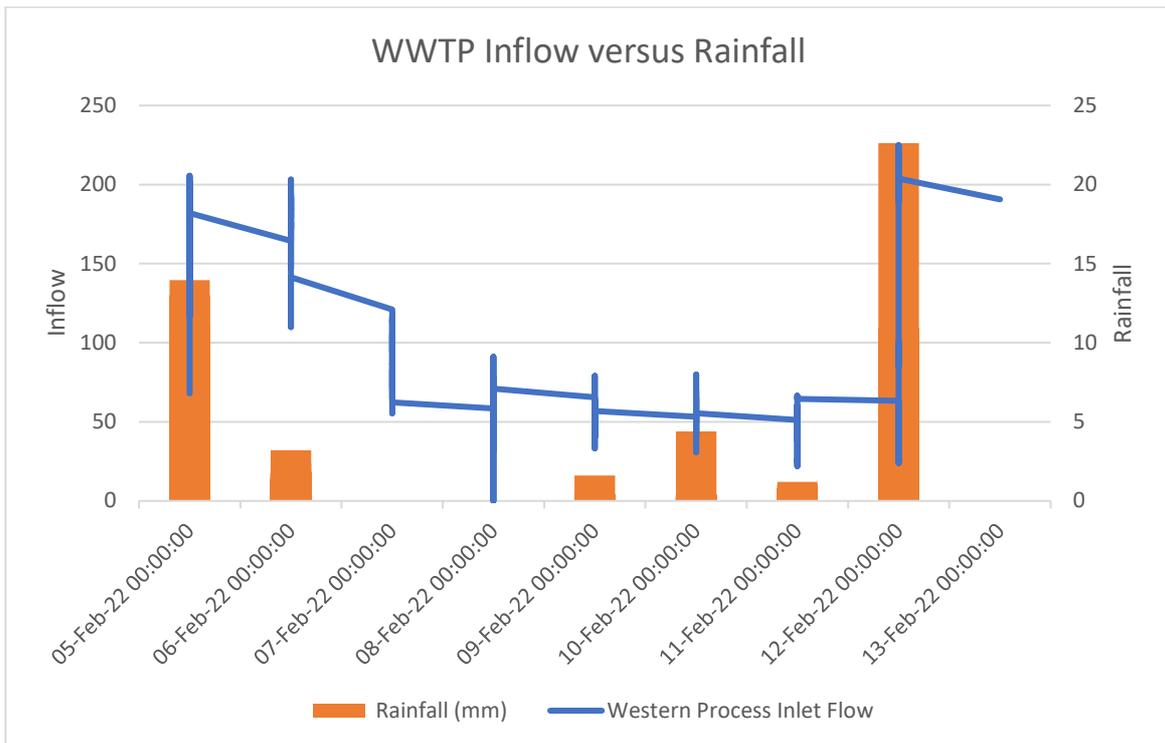
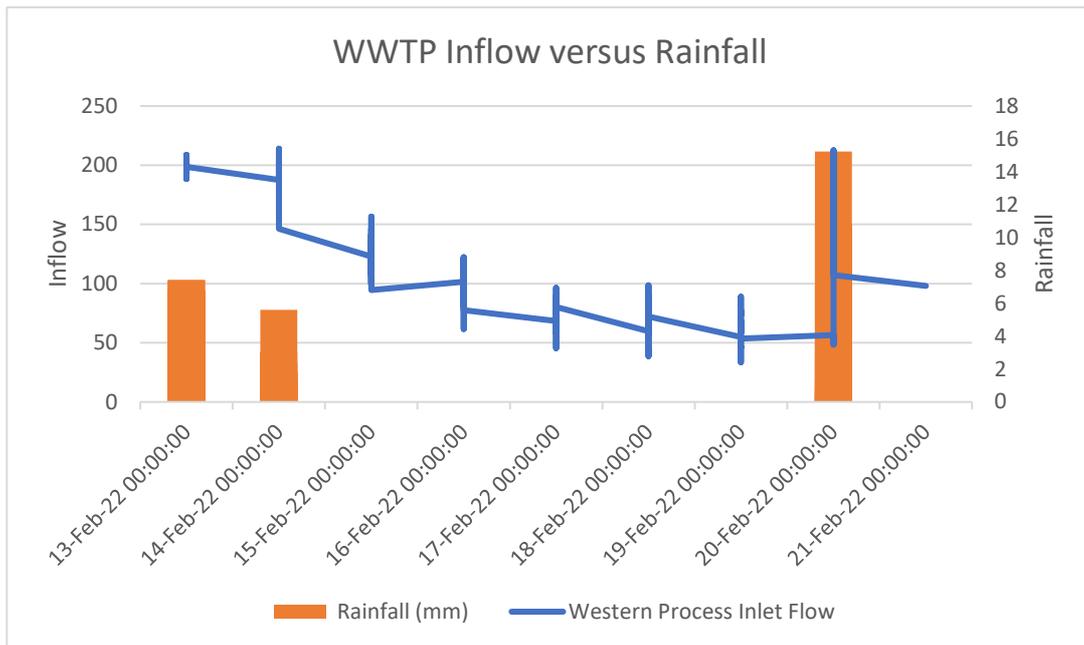
The bypass events occurred on several days during the reporting period. The following figures are of the hourly rainfall rate for the seven days prior to the overflow events. All rainfall data is obtained from the GWRC Environmental Monitoring and Research website. The current rain gauge used is Karori Sream at Samuel Marsden School. A graphical representation of the plant’s hourly inflow versus the hourly rainfall data are shown for all the bypass discharge events. It can be noted that the plant’s inflow is greatly affected by inflow and infiltration in the catchment especially during wet weather events.

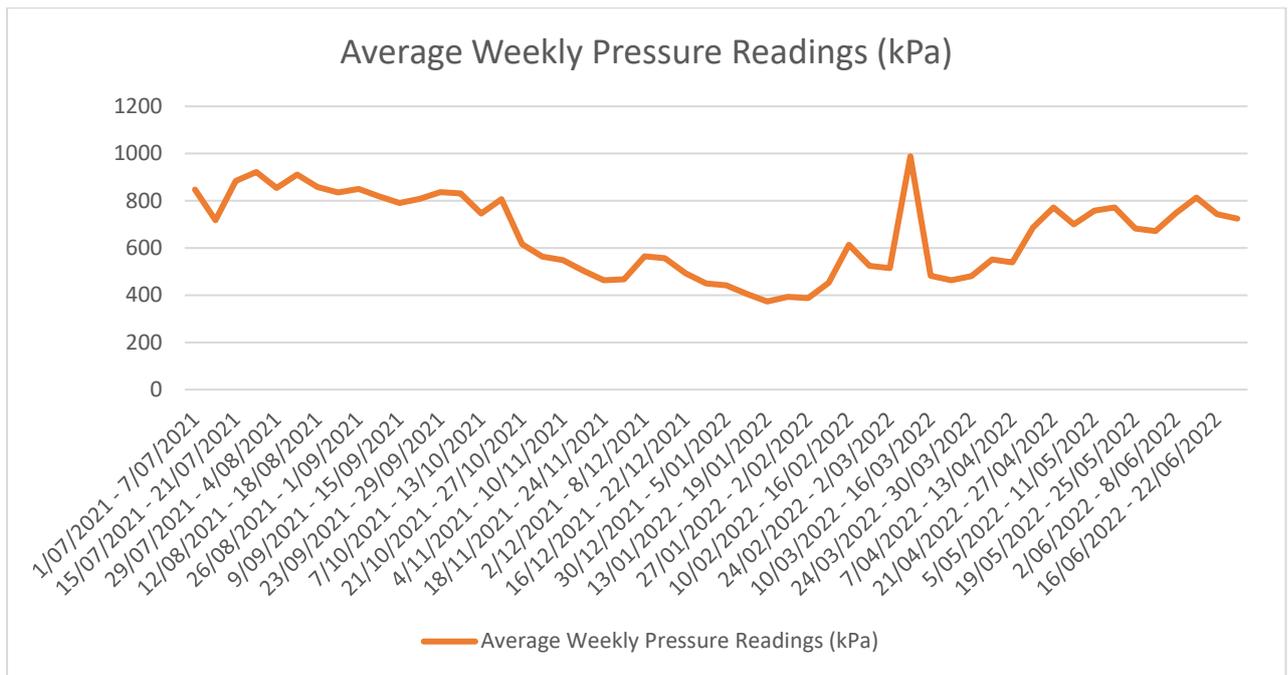
Figure 17: Average Weekly Pressure Readings in Biofilter

The following graphs summarise the observations for July 2021 – June 2022 Reporting Period:

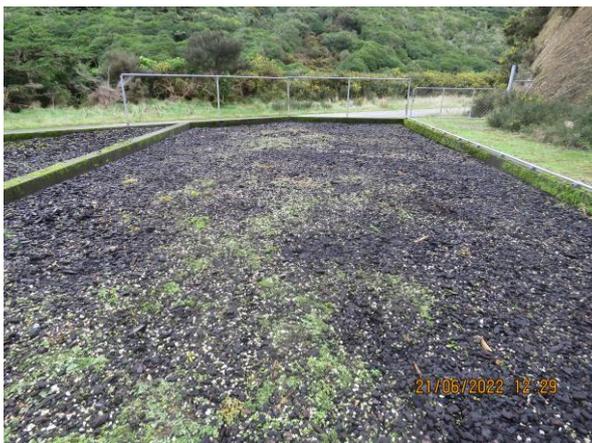
Figure 1: Biofilter Lichen/Moss Covering

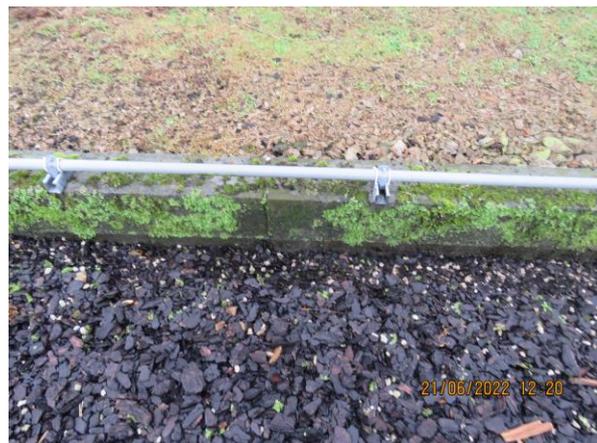
The flow rate to Cell 2 was approximately 20 % higher than Cell 1 despite being highly compacted. This would suggest there is a significant amount of short circuiting occurring in Cell 2. It is recommended that the media in Cell 2 be replaced as soon as possible to prevent any possible odour complaints.

Figure 2: Biofilter Short Circuiting

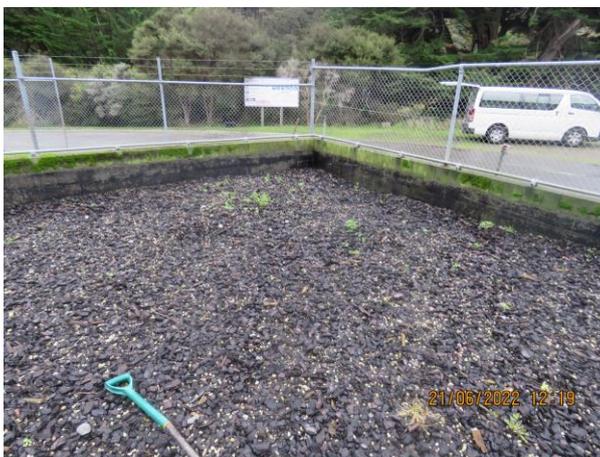
Figure 3: Missing Media in Cell 1

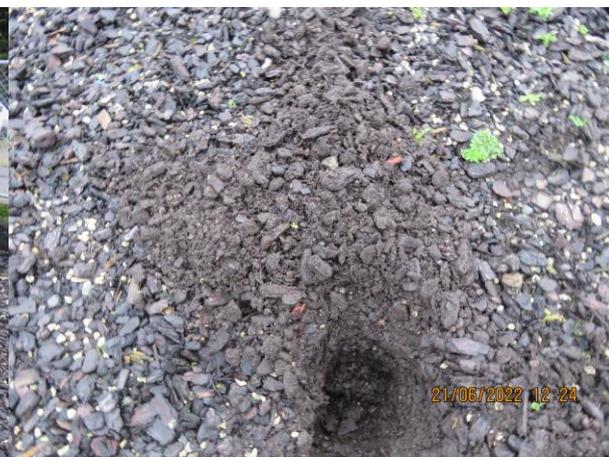
Figure 4: Media in Cell 1 at 500 mm

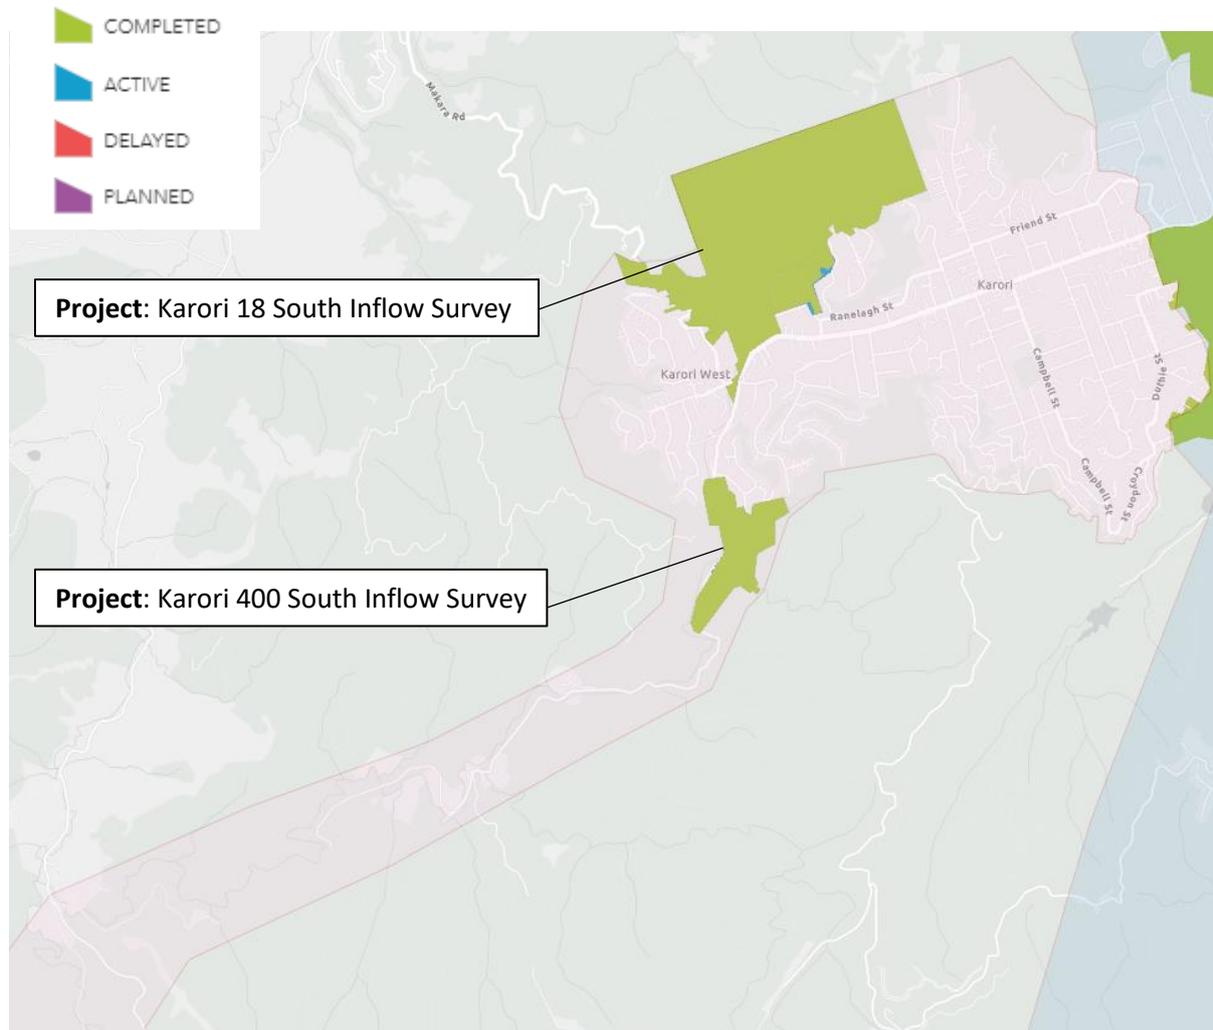
A map showing where the recent Inflow Surveys Projects were completed is shown in Figure 1 below. The two Inflow Surveys that were completed are shown in green.

Figure 1 - Inflow Survey summary for Western WWTP catchment

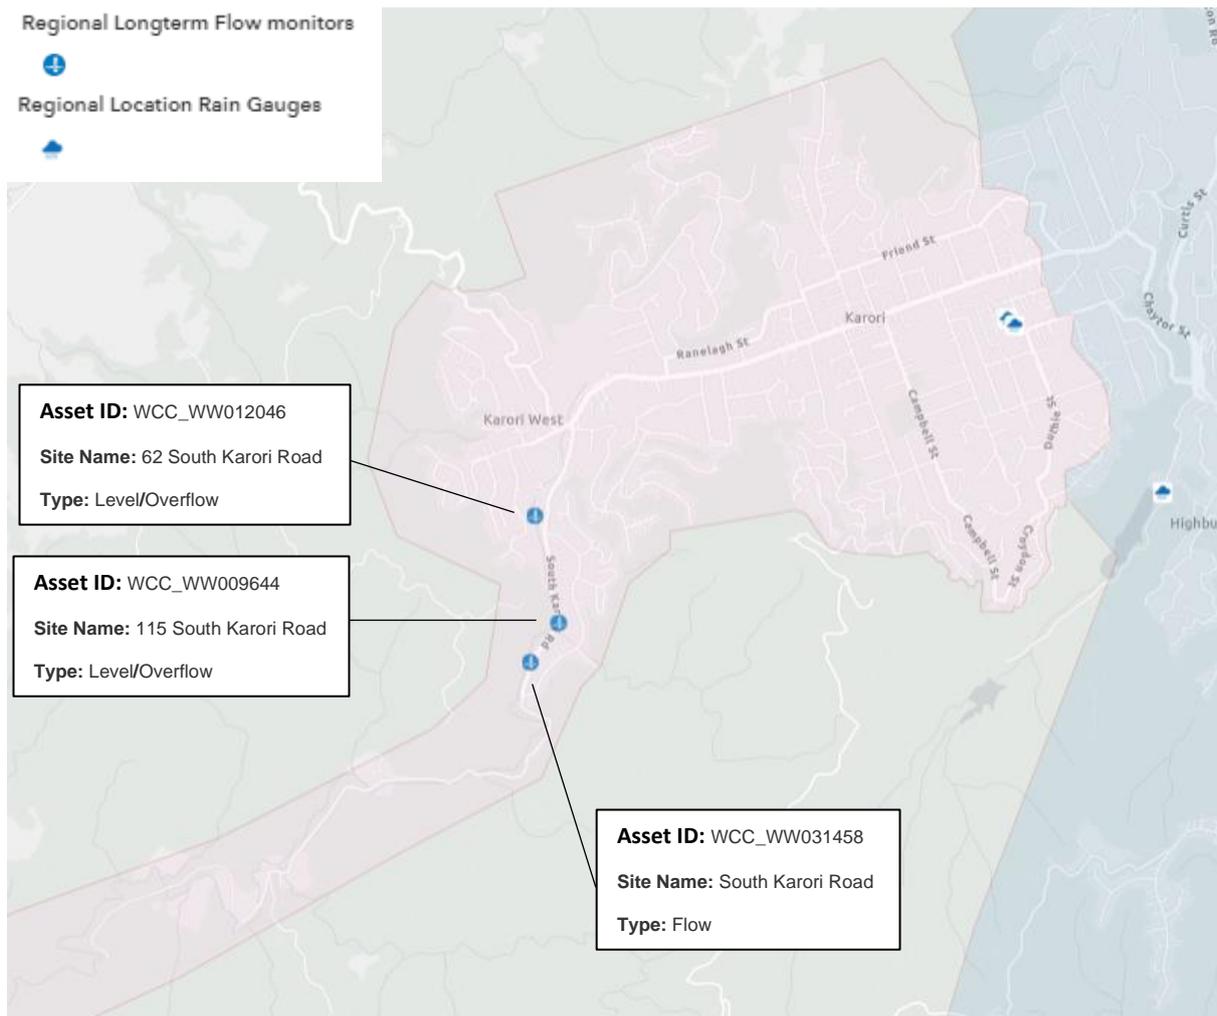
There are two long term overflow monitoring sites at '62 South Karori Road' and '115 South Karori Road' and one long term flow monitoring site 'South Karori FM' in the Western WWTP Catchment as shown in Figure 2 below.

There are currently two rain gauges located in Karori which are Kaiwharawhara Stream at Karori Reservoir and Karori Res RG at Montgomery Avenue as indicated below in Figure 2.

Figure 2 - Map of Wastewater Long-term Flow and Overflow Monitoring Sites and Rain Gauges

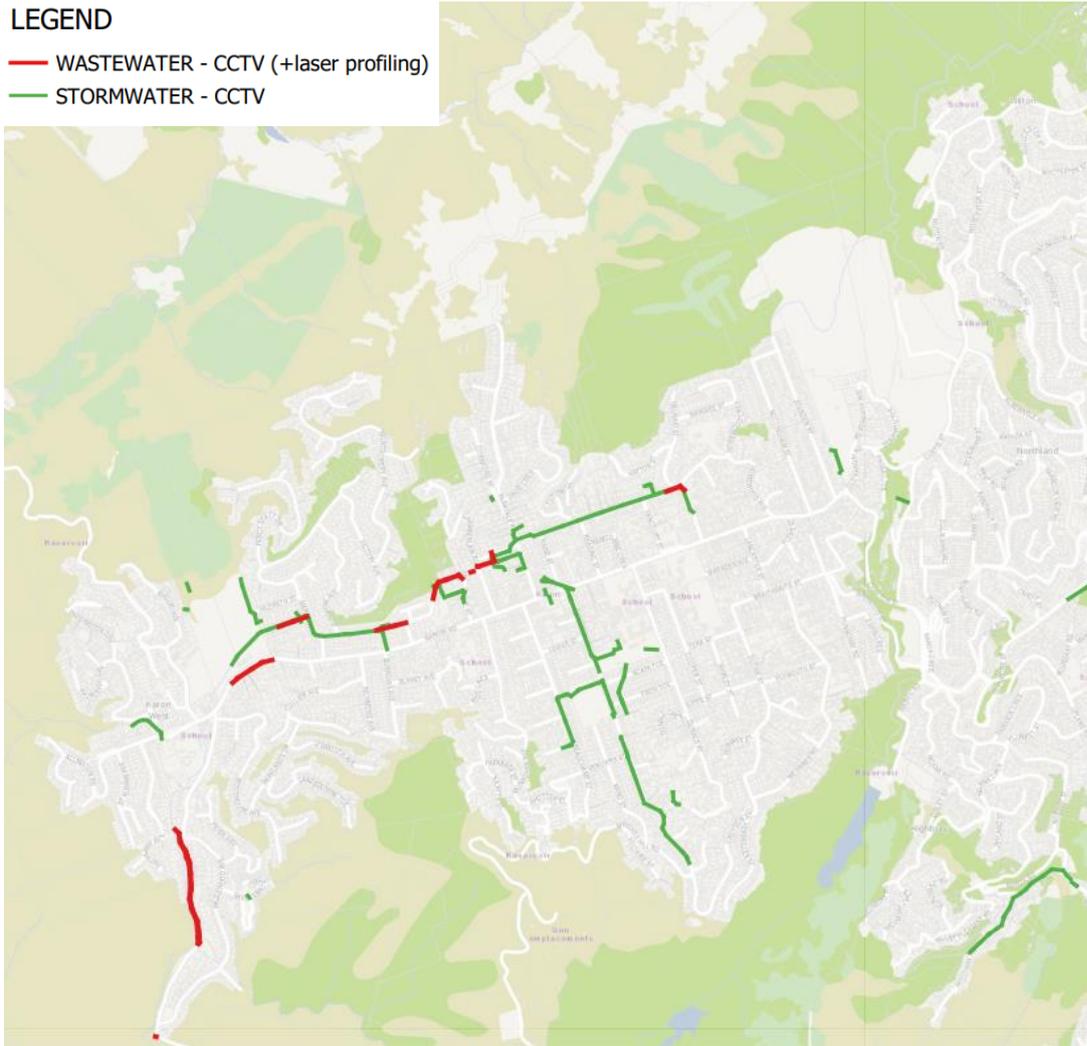
Figure 3 - Very High Critical Assets (VHCA) CCTV inspections completed as of June 2022.
