Health, Safety and Wellbeing Update February 2023

Noteworthy Incidents & Injuries

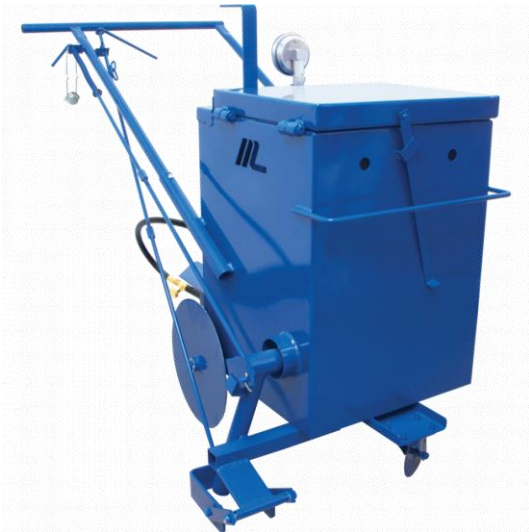
- A worker received second-degree burns when using a crack bandaging machine. The machine had run low of rubberized bitumen and needed topping up. The worker removed his gloves to unpack a new block. While inserting the cold block into the machine, the bitumen (200 °C) splashed up onto his left hand scolding the top of his 4 fingers.
- The worker ran his hand under cold water for 45 minutes before going to A&E.
- The worker has made a full recovery and the process has been updated with chemical and heat resistant gloves.

Band sealing machine

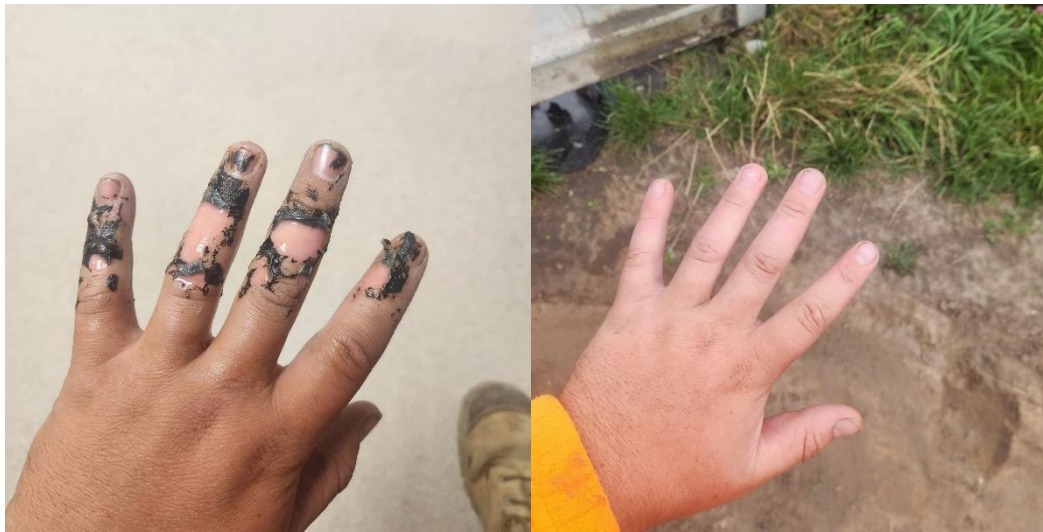
Left hand immediately following incident

Left hand two months after incident

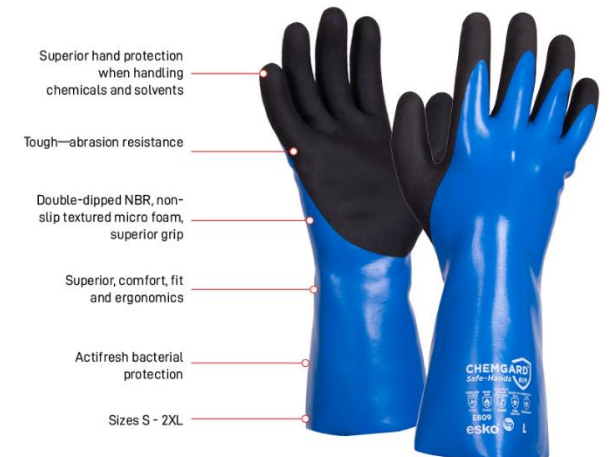
Updated hot work gloves for the task

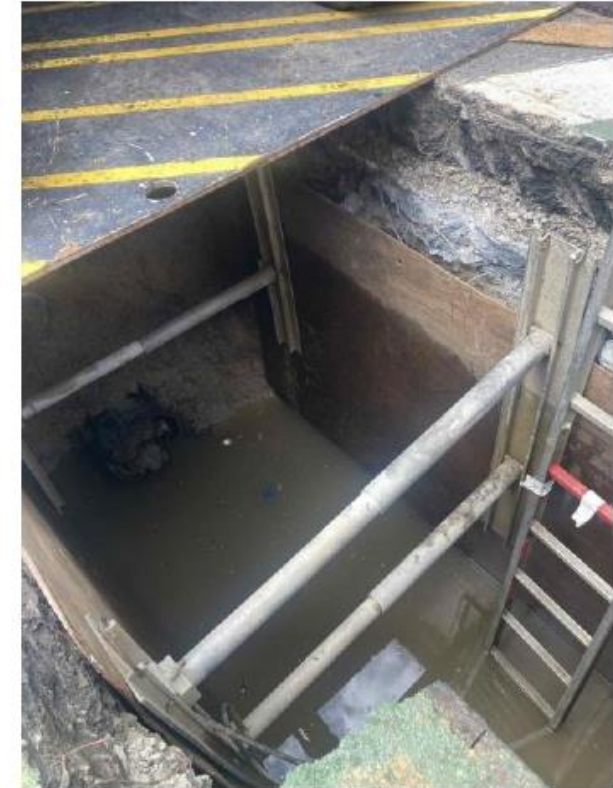
Lock Out/Tag Out Failure – Wastewater in Excavation

In November 2022 wastewater began discharging into an open excavation after a lockout was removed from a nearby wastewater pump.

No crew or plant were in the excavation at the time, but there were nearby workers that were able to notify the WWL COG utilities team by phone call and subsequently shut the pump down. The wastewater was caught within the excavation.

- The isolation was carried out by the contractor under instruction from Wellington Water.
- The pump was isolated with a *zip tie* – **No Lock** and **No Tag** was used.
 - This was in case the pump needed to be operated by Wellington Water during an emergency .
- The shutdown plan did not reference the Wellington Water Lock Out/ Tag Out Procedure.
- Key stakeholders (e.g., COG Utilities Team) were only involved with the shut down after the plan was approved and there was poor clarity around trial shutdowns vs. actual shutdowns.

1. Always refer to the Wellington Water Lock Out/ Tag Out Procedure when isolating Wellington Water assets
2. Ensure everyone impacted by the lockout is aware of the isolation plan
3. Always Tag Out isolated equipment, Lock Out where possible
