Lock Out/Tag Out Failure – Wastewater in Excavation

In November 2022 wastewater began discharging into an open excavation after a lockout was removed from a nearby wastewater pump.

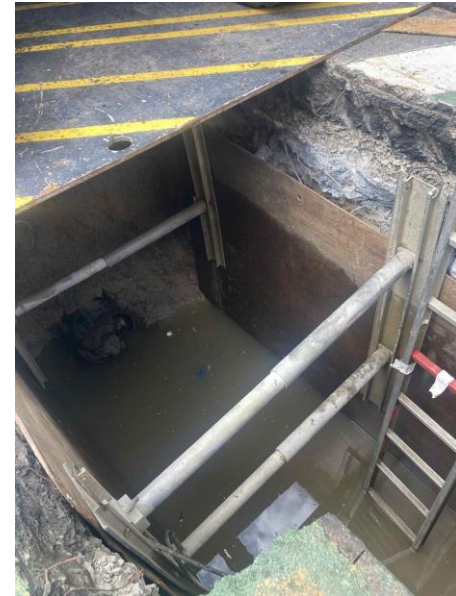
No crew or plant were in the excavation at the time, but there were nearby workers that were able to notify the WWL COG utilities team by phone call and subsequently shut the pump down. The wastewater was caught within the excavation.

- The isolation was carried out by the contractor under instruction from Wellington Water.
- The pump was isolated with a *zip tie* – **No Lock** and **No Tag** was used.
 - This was in case the pump needed to be operated by Wellington Water during an emergency .
- The shutdown plan did not reference the Wellington Water Lock Out/ Tag Out Procedure.
- Key stakeholders (e.g., COG Utilities Team) were only involved with the shut down after the plan was approved and there was poor clarity around trial shutdowns vs. actual shutdowns.

1. Always refer to the Wellington Water Lock Out/ Tag Out Procedure when isolating Wellington Water assets
2. Ensure everyone impacted by the lockout is aware of the isolation plan
3. Always Tag Out isolated equipment, Lock Out where possible
