Walk behind concrete saws – Runaway saw blades

CAMs-469066

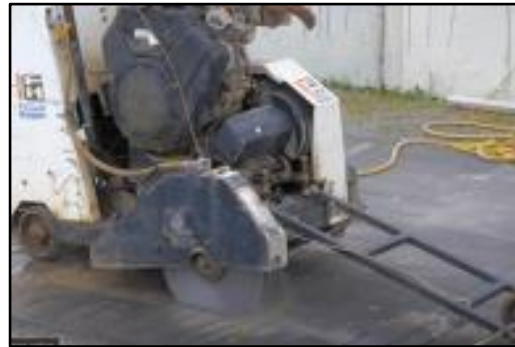
The uncontrolled escape of a fast-rotating saw blade has the potential to cause life changing injuries.

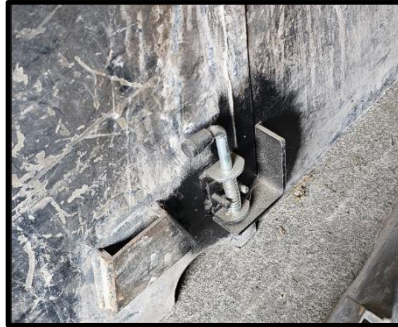
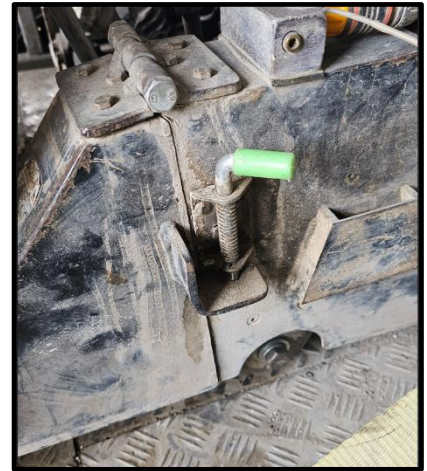
These spring-loaded pin locks should automatically drop when the hinge guard is placed in its operating position and require pulling up and releasing for the hinge guard to be lifted.

- 5.1 Go through this alert and the videos linked with all employees who use or are likely to use concrete saws.
- 5.2 Work with their engineering teams to install a spring-loaded pin lock (similar to the picture) to all hinge guards on walk behind concrete floor saws.
- 5.3 Share this alert with our subcontractors and hire companies. Ask them to confirm in writing that they will make these changes too.
