SUBJECT **Welded Standpipe Barrels**

DATE 30 October 2019

FROM Paul Turner, National Manager Response Capability

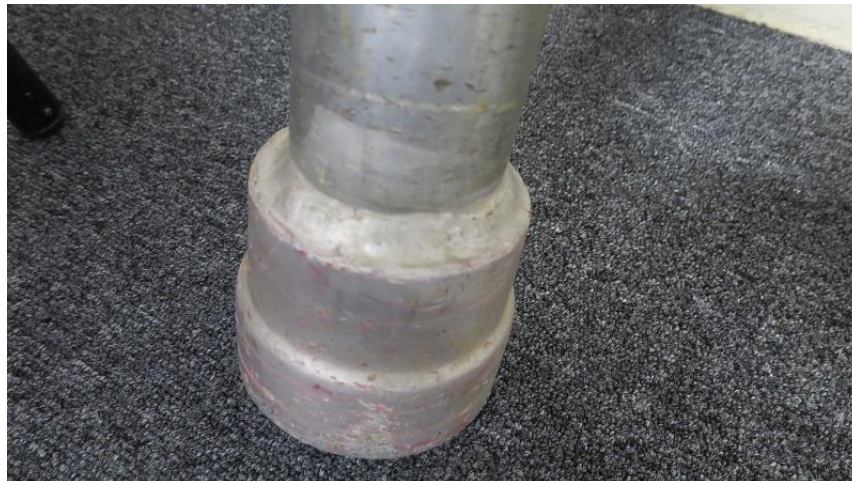
- Recently a standpipe failed under pressure at a point on the barrel that had been repaired by welding.
- **Welding of a standpipe will weaken the alloy by up to 50%.**
- The NZ Standard for firefighting waterway equipment (SNZ PAS 4505) states that “... ***for this reason standpipes shall never be welded***”.

Example of a welded standpipe

- Check **all** standpipes. If any are found to have welded barrels they are to be removed immediately from service and the Region Equipment Coordinator is to be contacted for a replacement.
- Replacement will be done on a one for one exchange.
- Some appliances only carry one standpipe. If this is found to be defective and there is no suitable spare on station the Region Equipment Coordinator should be contacted as soon as possible for an urgent replacement.
