Official information request Seaview Wastewater Treatment Plant.

HUTT VALLEY WASTEWATER TREATMENT PLANT, BIOFILTER ASSESSMENT, MARCH 2023

HUTT VALLEY WASTEWATER TREATMENT PLANT, ODOUR CONTROL SYSTEM ASSESSMENT, FEBRUARY 2023

HUTT VALLEY WASTEWATER TREATMENT PLANT, ODOUR CONTROL SYSTEM ASSESSMENT, JULY 2021

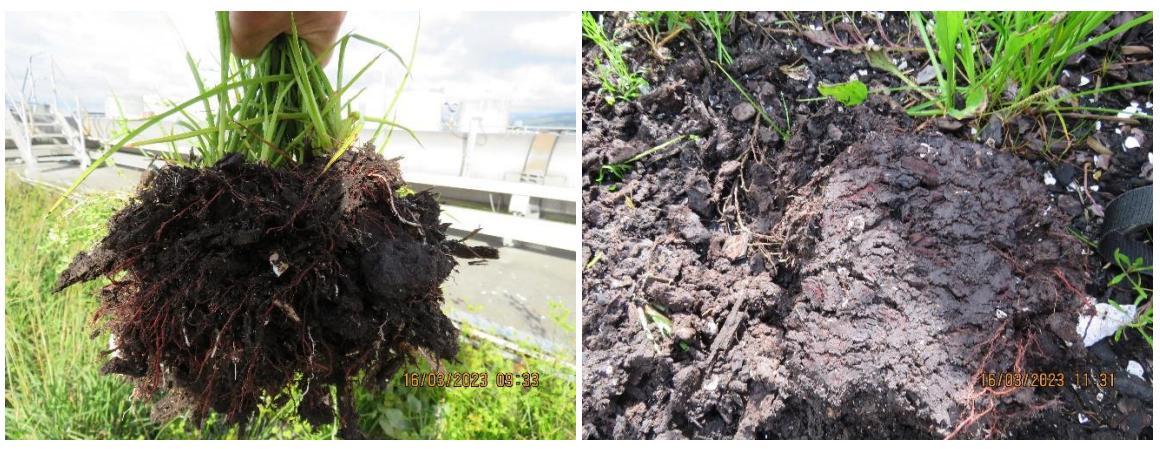
Figure 3: Biofilter Root Base, 16 March 2023

The biofilter was also covered in a thick layer of vegetation up to 1 m in height (Figure 2). The extensive vegetation growth had resulted in roots penetrating the media to a depth of 300 to 500 mm as can be seen in Figure 3. The vegetation cover on the biofilter will act as a cap on the biofilter, increasing back pressure and forcing the flow to the perimeter, potentially resulting in short circuiting of the media. The vegetation and associated root system act to further compact the media.

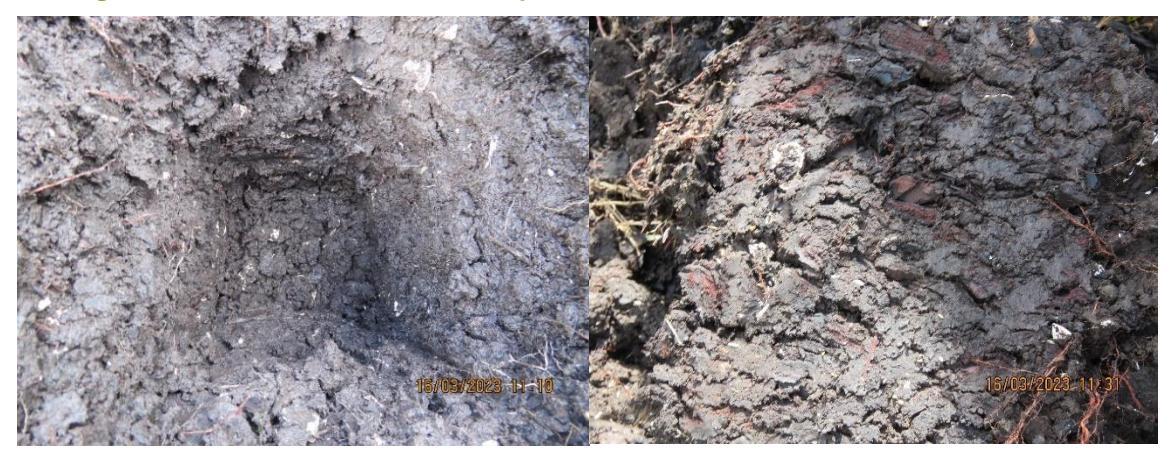
Figure 6: Biofilter Media 750 mm depth, 16 March 2023

The media at 750 mm (Figure 6) was also highly degraded with a high proportion of fines and significant root growth in several locations. The media at this depth was also highly compact, to the extent it was difficult to dig the test pits. There were also significant dry zones and even mould in one location (Figure 7). The presence of mould in the media indicates low to no flow is penetrating the media.

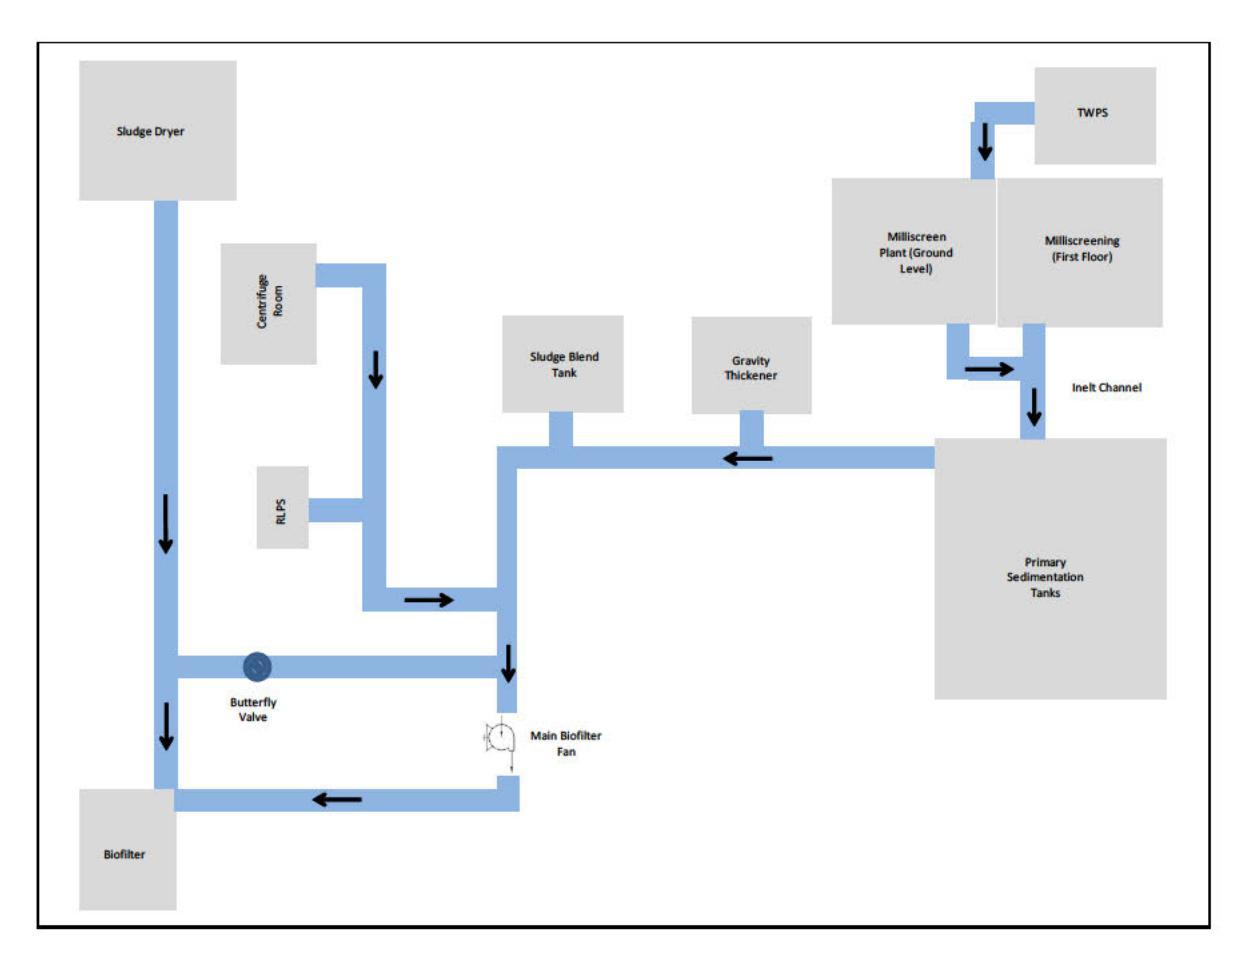
Figure 1: Hutt Valley WTP Odour Control System

A schematic of the Hutt Valley WTP Odour Control System identifying the primary odour sources and how these interact with the odour control system is presented in Figure 1. Subsequent sections provide flow rate details for each of the sources.

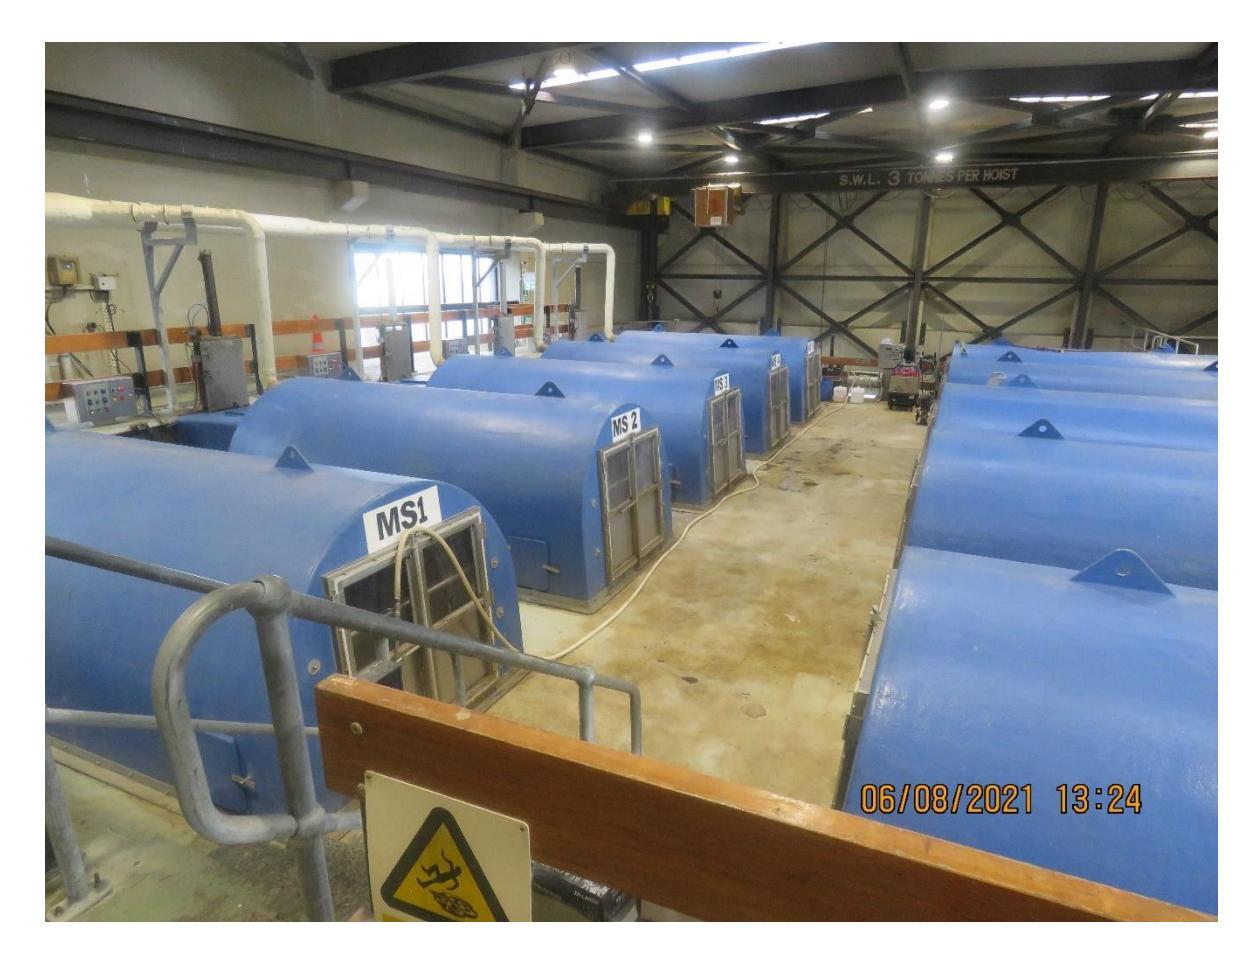
Figure 3: Milliscreen Plant

The Milliscreen Plant incorporates a number of different processes. Milliscreening is carried out on the first floor (Milliscreen (First Floor). On the ground floor of the Milliscreen Plant (Milliscreen Plant (Ground Floor) includes disposal of the screened material, odour control fans, the plant pump station and discharge wet well. The odour control system only extracts foul air from the milliscreen enclosures (First Floor) and the skip bin used for the disposal of the screened material. The milliscreening process consists of 10 enclosed milliscreening rotary drums, each of which is under extraction to the biofilter (See Figure 3).

In 2018, all the ducting in the Milliscreen Plant had been sealed with fibre glass and two of the four extraction ducts from the screw conveyers had been disconnected and sealed. In 2021, all 10 of the milliscreen enclosures were replaced. In addition, a section of ducting from the milliscreen skip to the extraction ducting had been replaced.

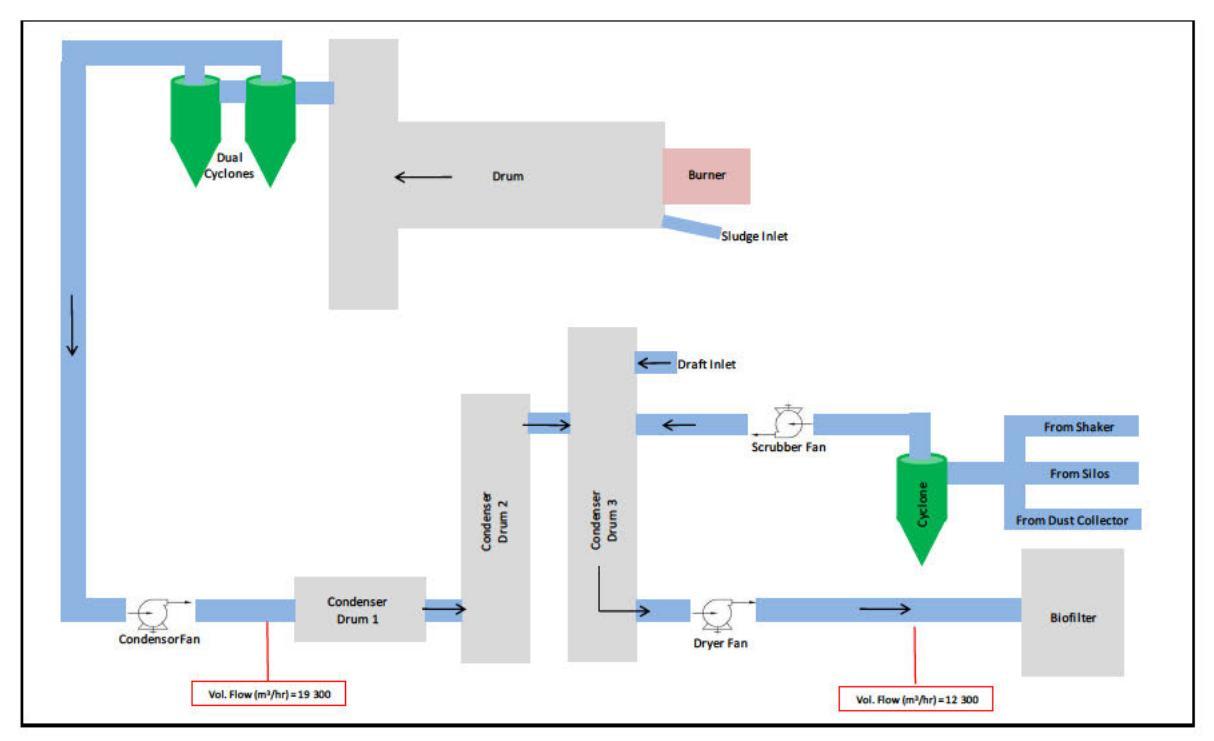
Figure 10: Sludge Dryer Extraction Rate Schematic, 24 February 2023

A number of other associated processes are extracted via a secondary scrubber fan which operates continuously and discharges to the final condenser drum. These processes include the dry sludge shaker, storage silos and truck loading dust collector. The final condenser drum also has a butterfly valve open near the top of the drum.

Figure 10 depicts a schematic of the odour control system extraction for the sludge dryer measured on 24 February 2023. The flow rate calculation data is presented in Appendix A. Due to the high moisture content and temperature of the dryer exhaust gas; Pitot tubes were used to determine the gas velocity for the dryer fan with the raw data presented in Appendix B.

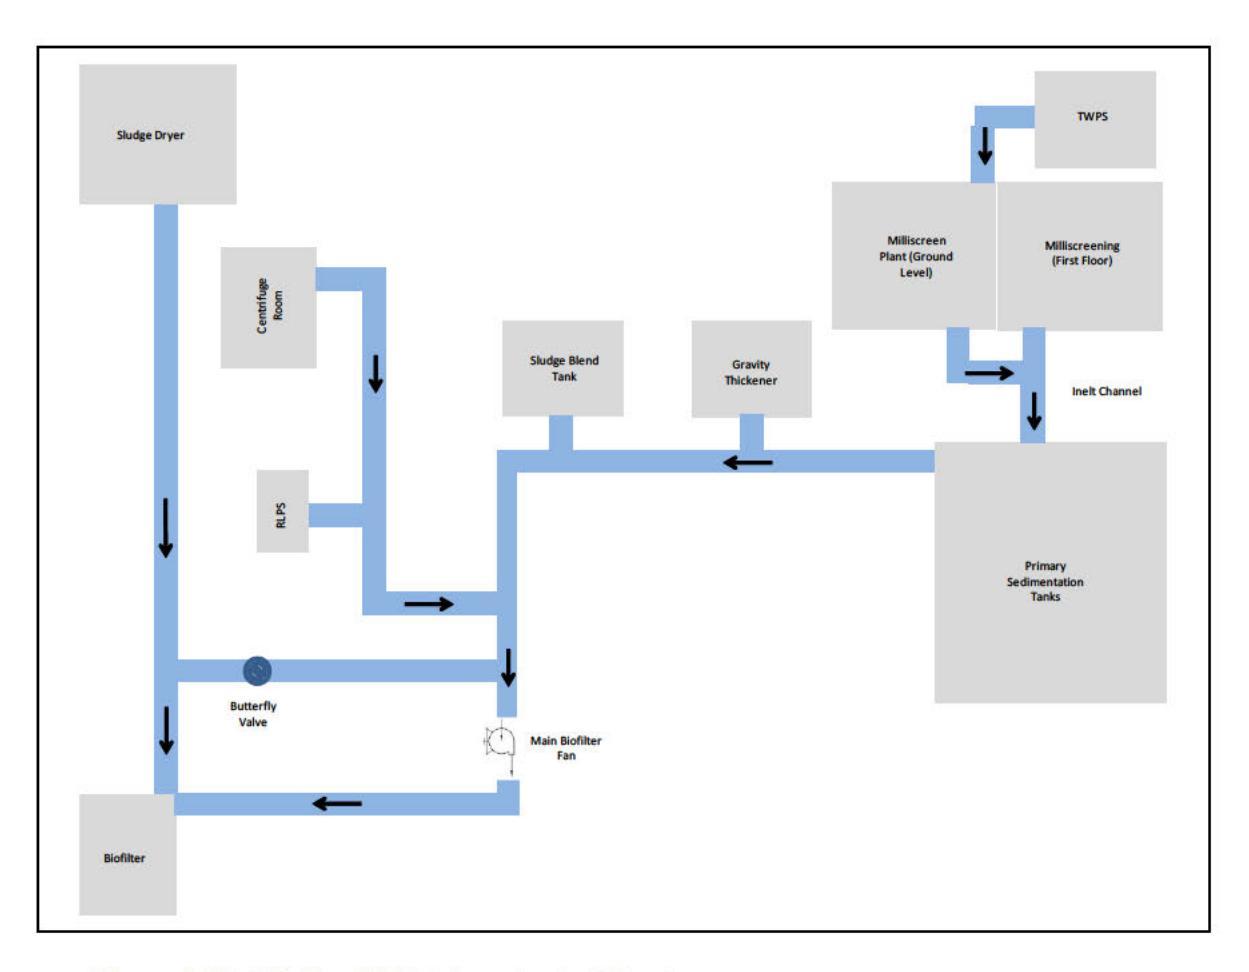
Figure 1: Hutt Valley WTP Odour Control System

A schematic of the Hutt Valley WTP Odour Control System identifying the primary odour sources and how these interact with the odour control system is presented in Figure 1. Subsequent sections provide flow rate details for each of the sources.

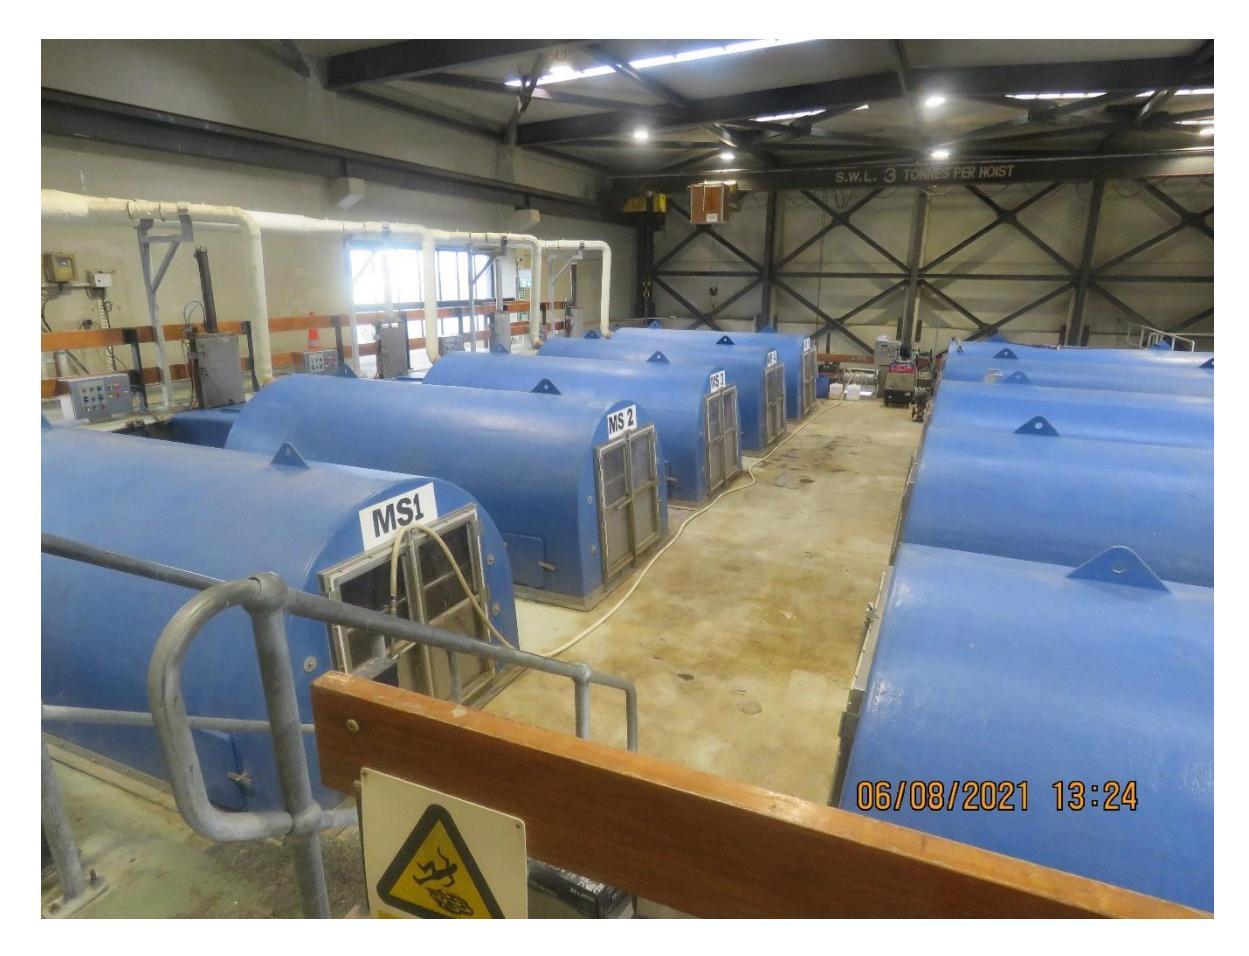
Figure 3: Milliscreen Plant

The Milliscreen Plant incorporates a number of different processes. Milliscreening is carried out on the first floor (Milliscreen (First Floor)). On the ground floor of the Milliscreen Plant (Milliscreen Plant (Ground Floor)) includes disposal of the screened material, odour control fans, the plant pump station and discharge wet well. The odour control system only extracts foul air from the milliscreen enclosures (First Floor) and the skip bin used for the disposal of the screened material. The milliscreening process consists of 10 enclosed milliscreening rotary drums, each of which is under extraction to the biofilter (See Figure 3).

In 2018, all the ducting in the Milliscreen Plant had been sealed with fibre glass and two of the four extraction ducts from the screw conveyers had been disconnected and sealed. In 2021, all 10 of the milliscreen enclosures were replaced. In addition, a section of ducting from the milliscreen skip to the extraction ducting had been replaced.

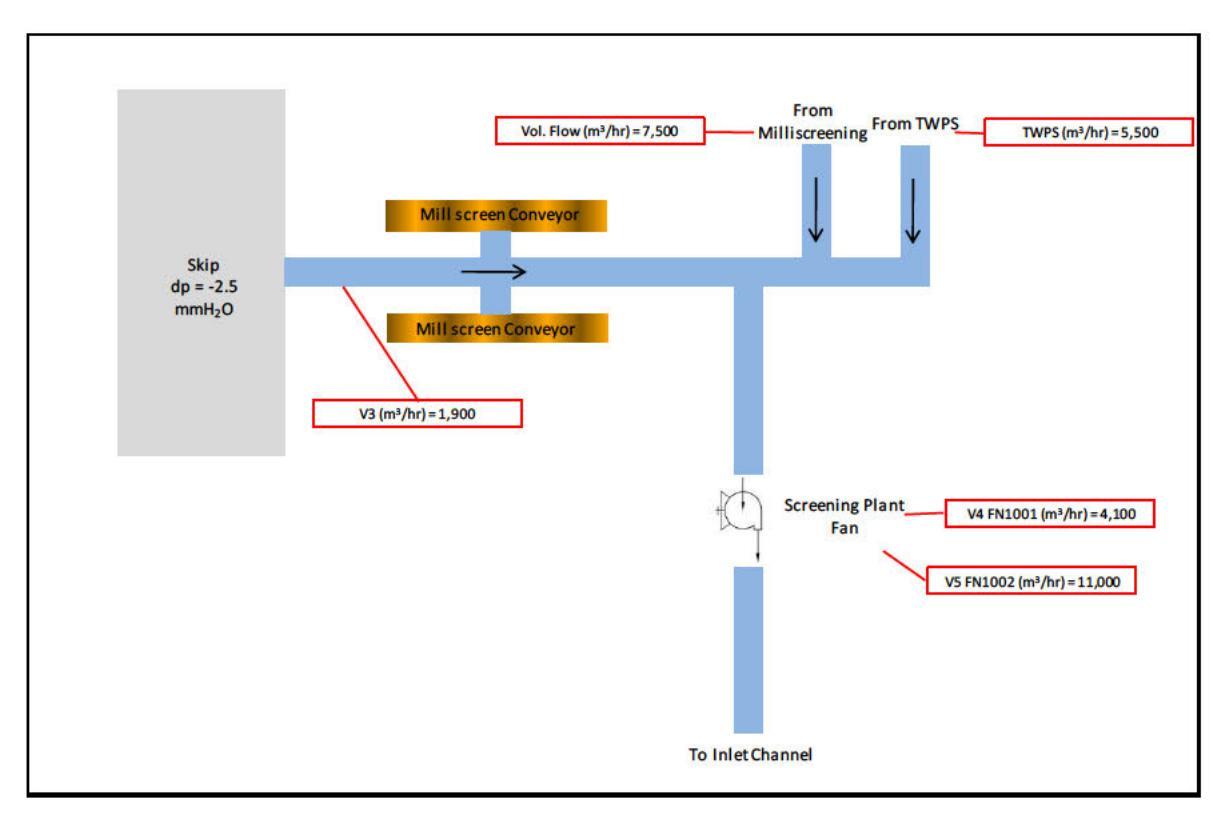
Figure 6: Milliscreen Plant (Ground Floor) Extraction Rate, July 2021

Figure 6 depicts the flow rates measured on the ground floor of the Milliscreen Plant July 2021. The flow rate calculation data is presented in Appendix A.

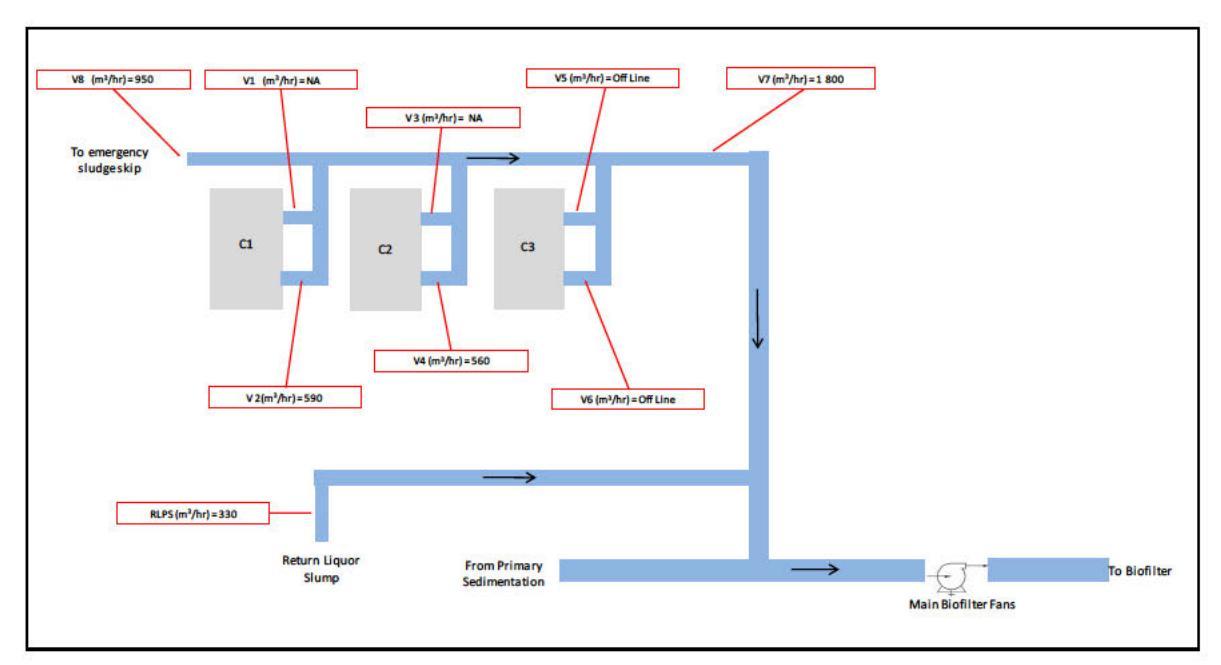
Figure 8: Centrifuge Room & Return Liquor Pump Station Extraction Rate, July 2021

The Return Liquor Pump Station (RLPS) captures liquor from a number of processes on site including the centrifuges and biofilter. The captured liquid is pumped back into the system for treatment. The RLPS is covered, with active extraction to the biofilter. Inspection of the RLPS identified significant leaks and was generally in poor condition. However, the slump was under a good vacuum with a pressure of -0.9 mmH₂O. There were also several leaks in the pipes discharging into the slump all of which were a potential source of odours.

On 20 July 2021, the total flow extracted from the three centrifuges was approximately $1,800 \text{ m}^3/\text{hr}$ with approximately $330 \text{ m}^3/\text{hr}$ extracted from the RLPS. The flows were similar to those measured in 2018 of $1,500 \text{ m}^3/\text{hr}$ and $390 \text{ m}^3/\text{hr}$ respectively.

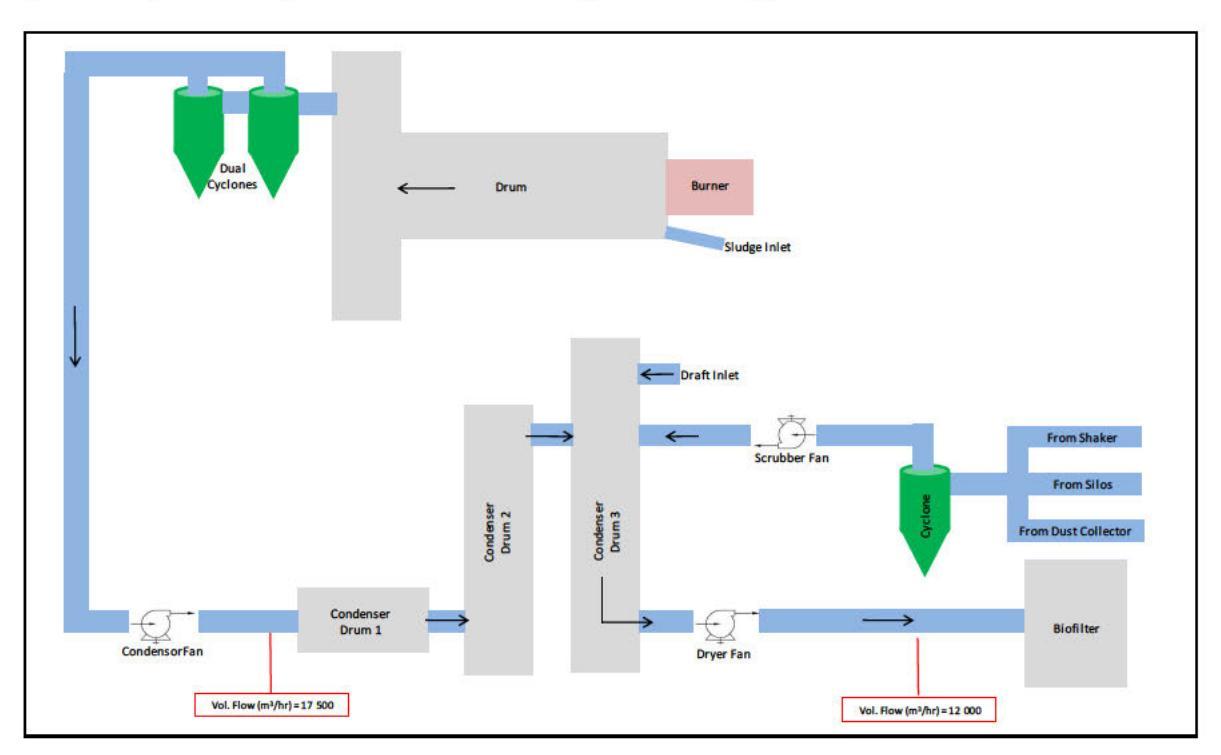
Figure 9: Sludge Dryer Extraction Rate Schematic, 20 July 2021

Figure 9 depicts a schematic of the odour control system extraction for the sludge dryer measured on 20 July 2021. The flow rate calculation data is presented in Appendix A. Due to the high moisture content and temperature of the dryer exhaust gas; Pitot tubes were used to determine the gas velocity for the dryer fan with the raw data presented in Appendix B.

On 20 July 2021, the total flow discharged by the dryer fan to the biofilter was approximately $12,000 \text{ m}^3/\text{hr}$ which was similar to the $11,000 \text{ m}^3/\text{hr}$ observed in 2018. The condenser fan flow rate was approximately $17,500 \text{ m}^3/\text{hr}$ which was similar to the $18,400 \text{ m}^3/\text{hr}$ measured in 2017. The difference between the flow from the condenser and the flow to the biofilter is primarily due to the different temperature and moisture content of the two sources and does not suggest that air from the dryer is being discharged into the building.

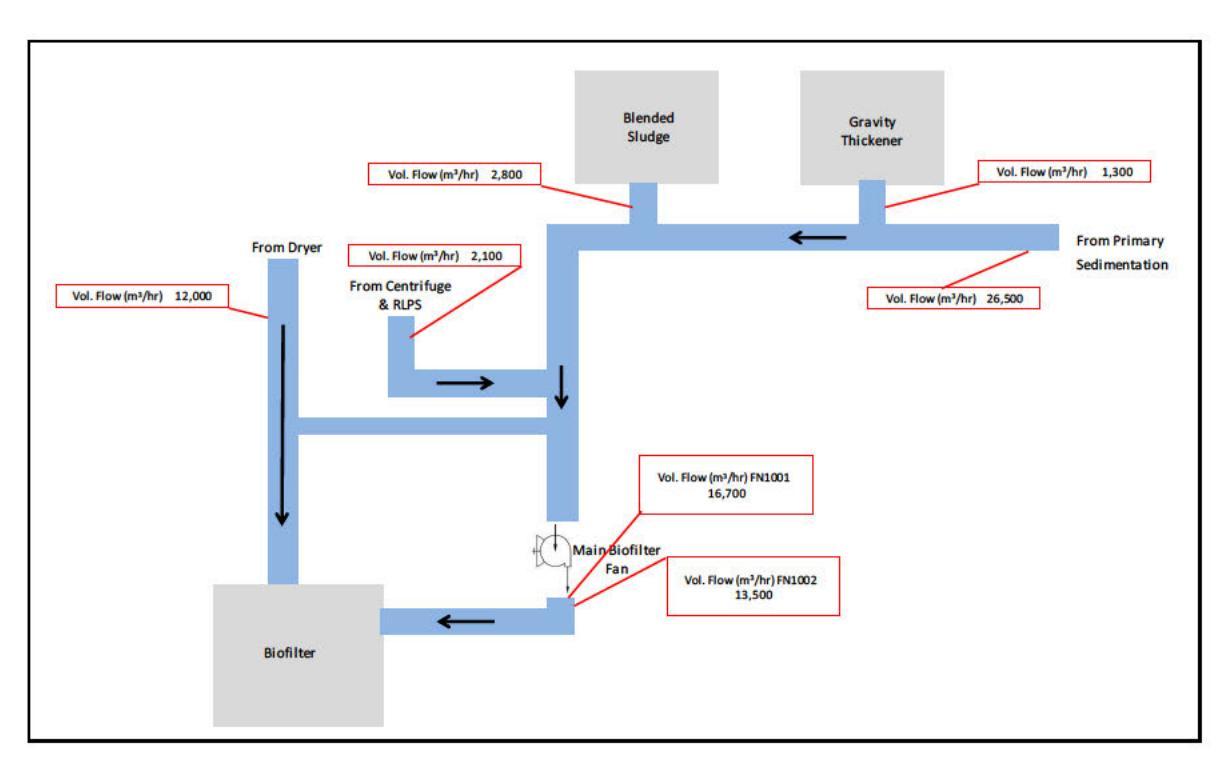
Figure 10: Biofilter Total Extraction Rate Schematic, July 2021

The main biofilter fan incorporates foul air extracted from the Primary Sedimentation works (which includes the Milliscreen Plant), the Gravity Thickener tank, Sludge Blend tank, Centrifuge Room and RLPS. Figure 10 depicts a schematic of the odour control system inlet to the biofilter measured in July 2021. The flow rate calculation data is presented in Appendix A.

In July 2021, the total flow discharged to the biofilter from the biofilter fans was approximately 30,100 m³/hr which consisted of approximately 26,500 m³/hr from the Primary Sedimentation works (including the Milliscreen Plant/Inlet Channel), approximately 4,000 m³/hr from the Gravity Thickener and Sludge Blend tank, and approximately 2,100 m³/hr from the Centrifuge Room and RLPS.
