**Pre-construction Pavement
Condition Assessment**

**Omāroro Reservoir, Mt Cook,
Wellington**

Prepared for
HEB Construction Ltd

Prepared by
Tonkin & Taylor Ltd

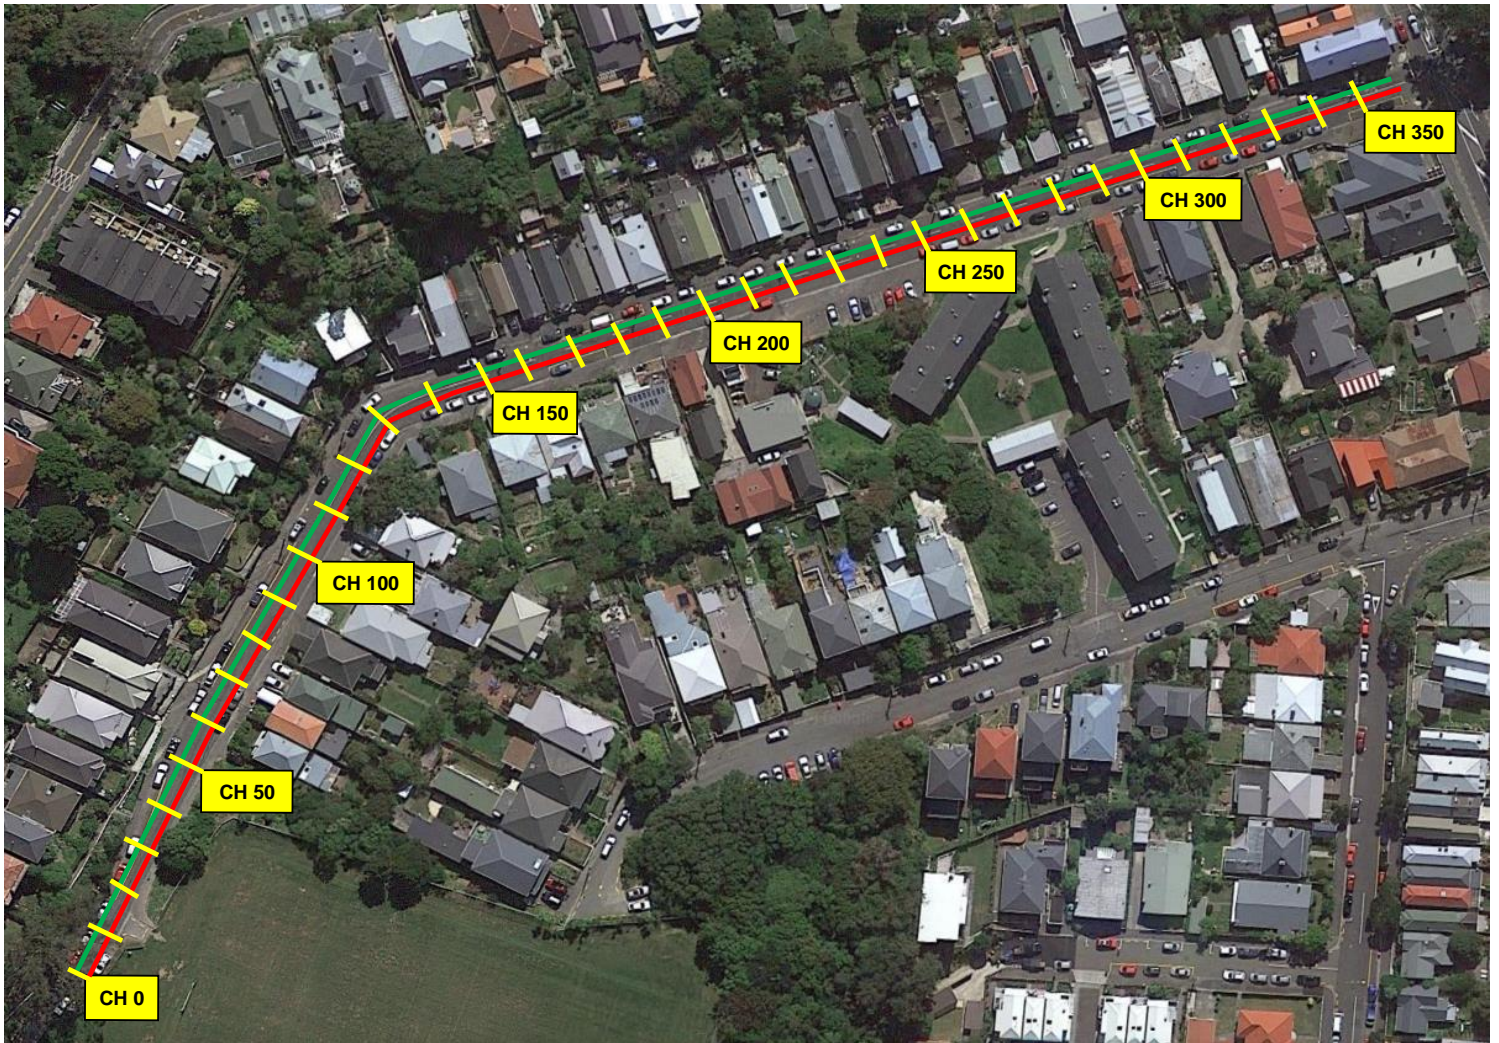
SITE DIAGRAM

CH 0-350 - Mark O'Hare

Chainage marks represent approximate test locations. SE lane marked in red, NW lane marked in green.
Map not drawn to scale.
