Moa Pt WWTP

Damage Assessment Report – Stage 2

Prepared for s7(2)(a) – Privacy
Prepared by Beca Limited

17 April 2026

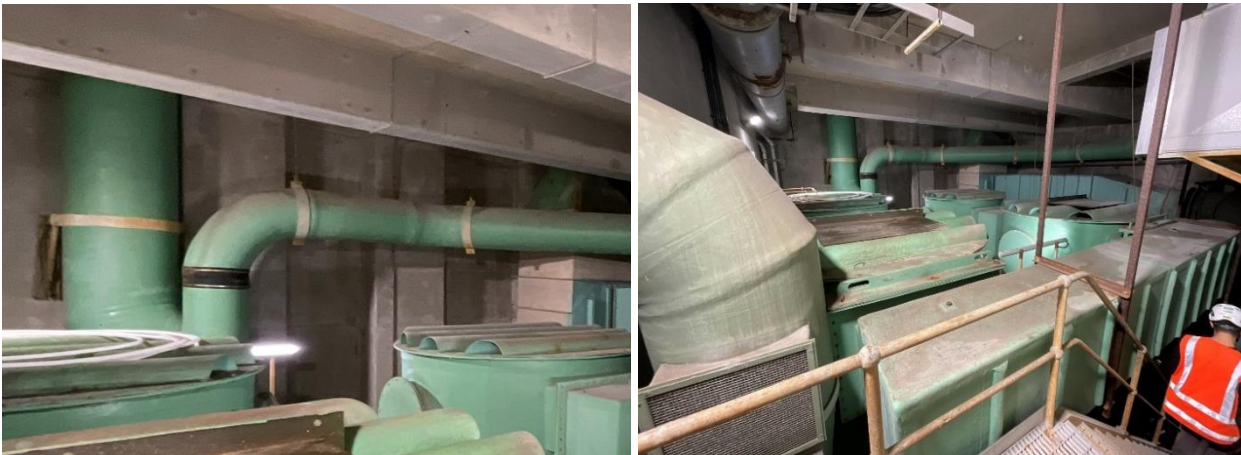
Figure 6: Foul Air Ducting

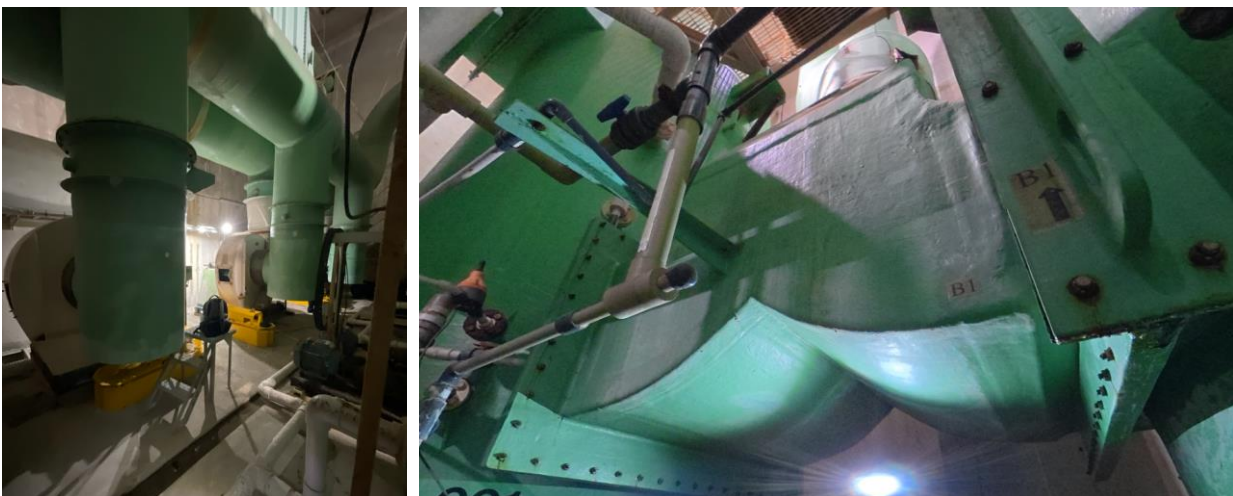
Figure 14: Odour control ducting

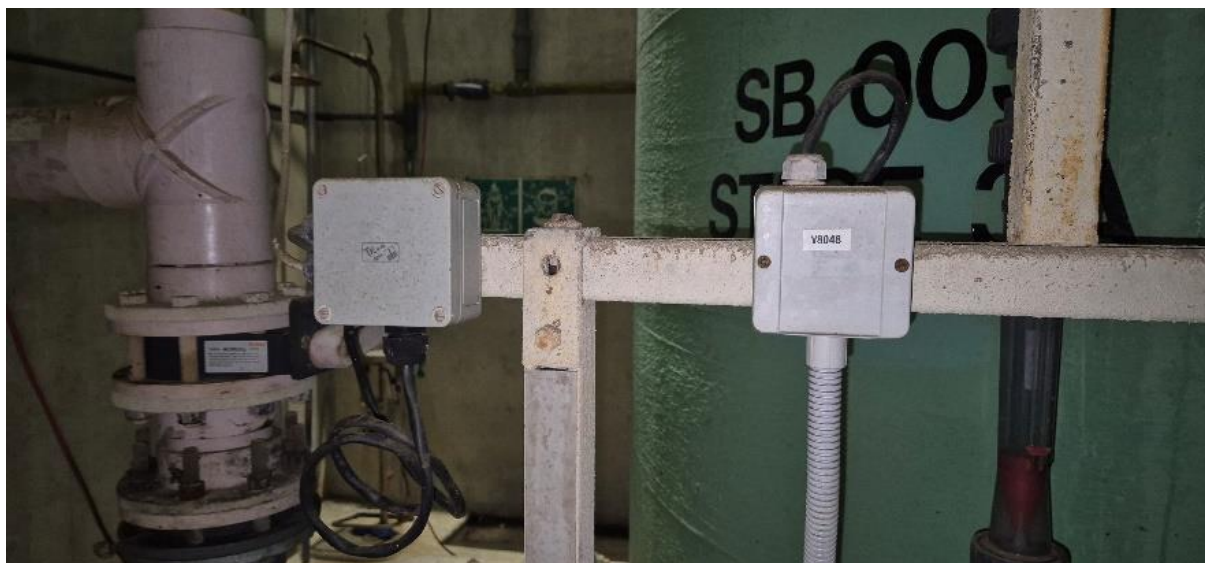
Figure 16: Odour scrubber piping and valves (electrical connection boxes)

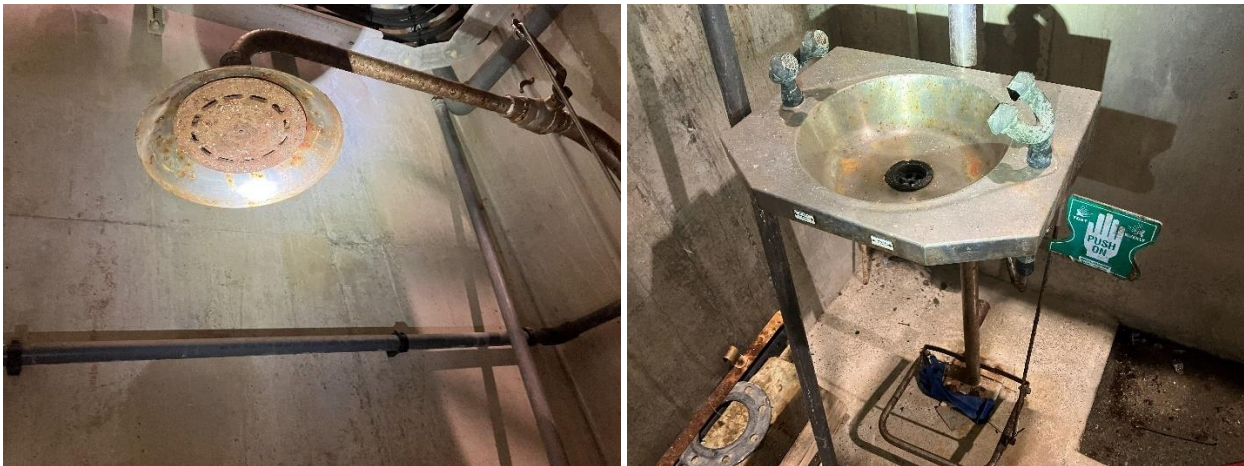
Figure 20: Safety shower and eyewash station

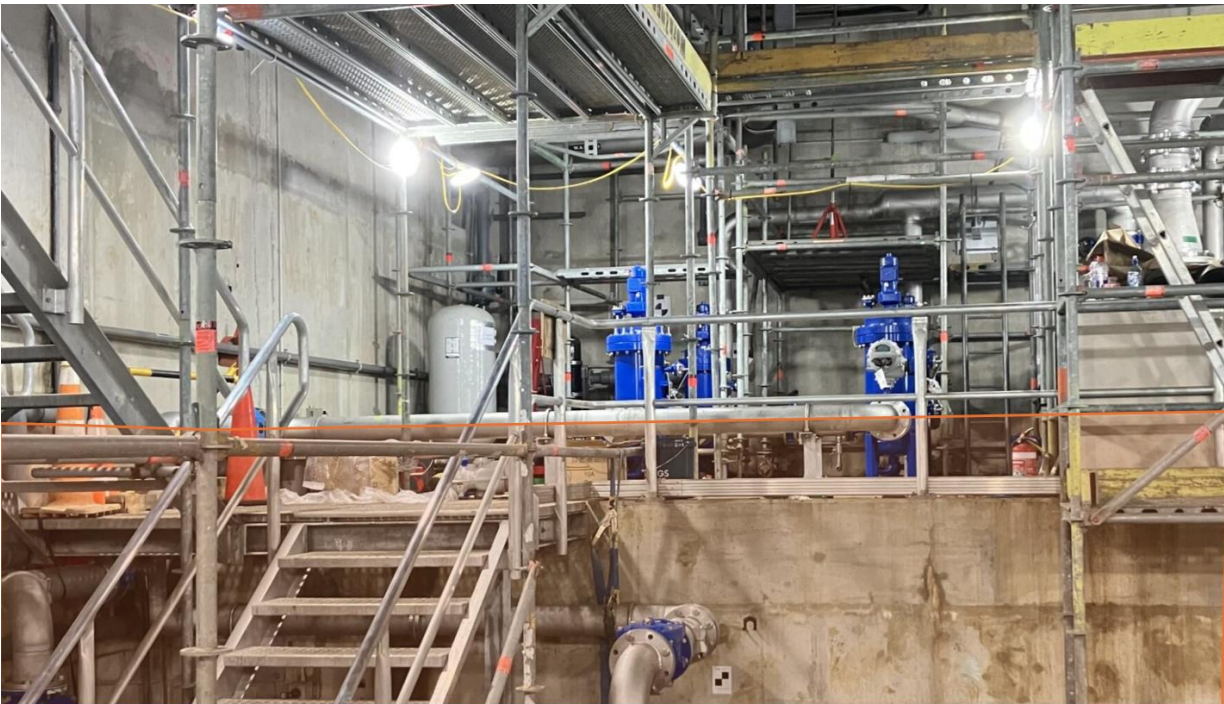
Figure 24: Mezzanine floor indication of the approximate level to which assets were submerged

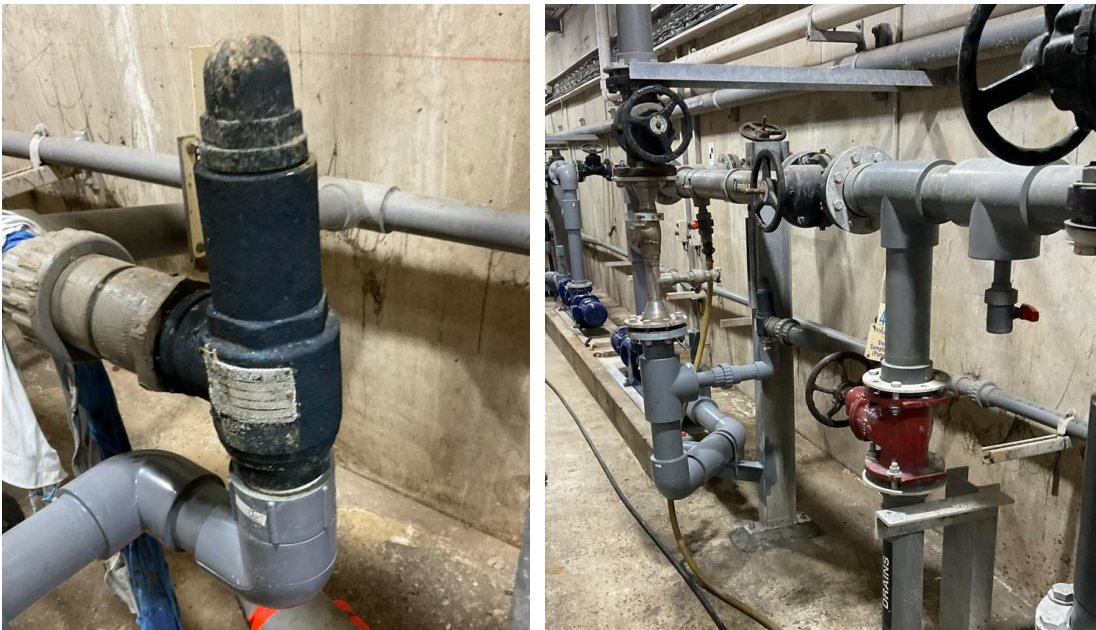
Figure 30: Primary Sludge Pump pressure relief valve (L) and Primary Sludge pipework and valves (R)

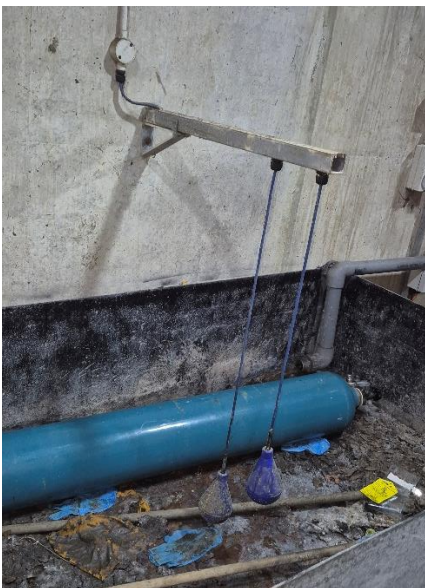
Details of the specific level switch types and construction could not be confirmed at the time of inspection. As a result, the operational condition and continued serviceability of these devices and associated terminations cannot be confirmed based on visual inspection alone.

Figure 31: 25-T004 Primary Sludge Pump Relief Tank level switches and terminal box

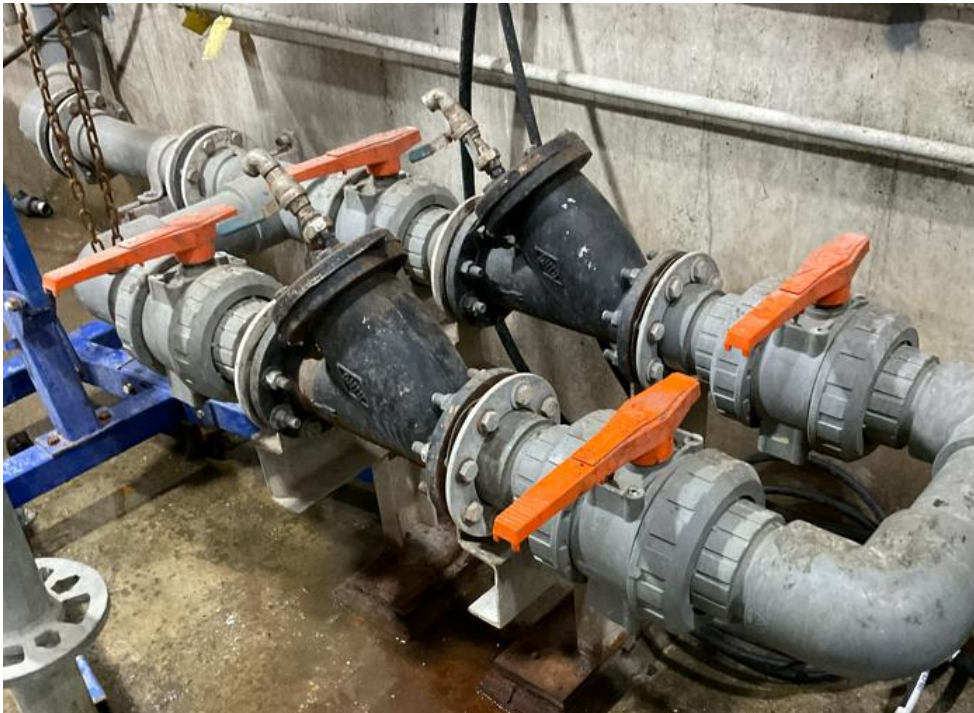
Figure 33: RE Wash Water strainers and pipework

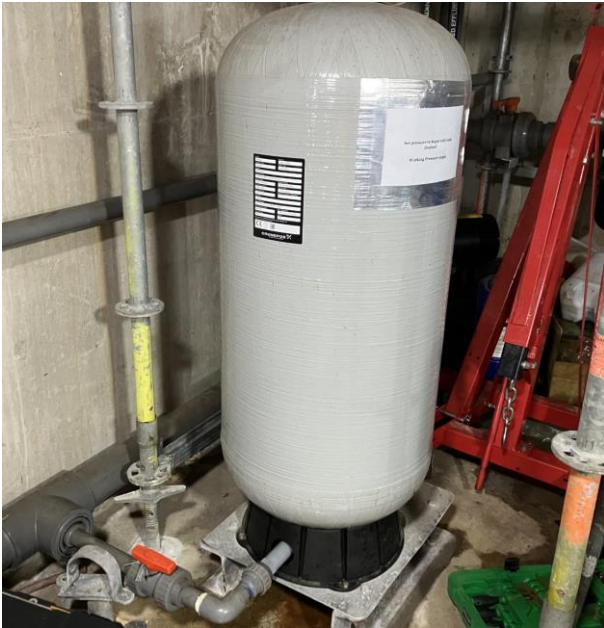
Figure 35: RE Wash Water Accumulator Tank

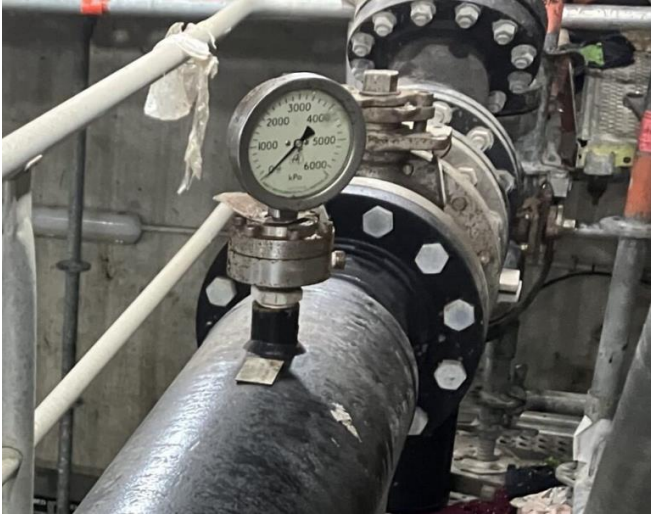
Figure 45: Sludge transport pressure gauge

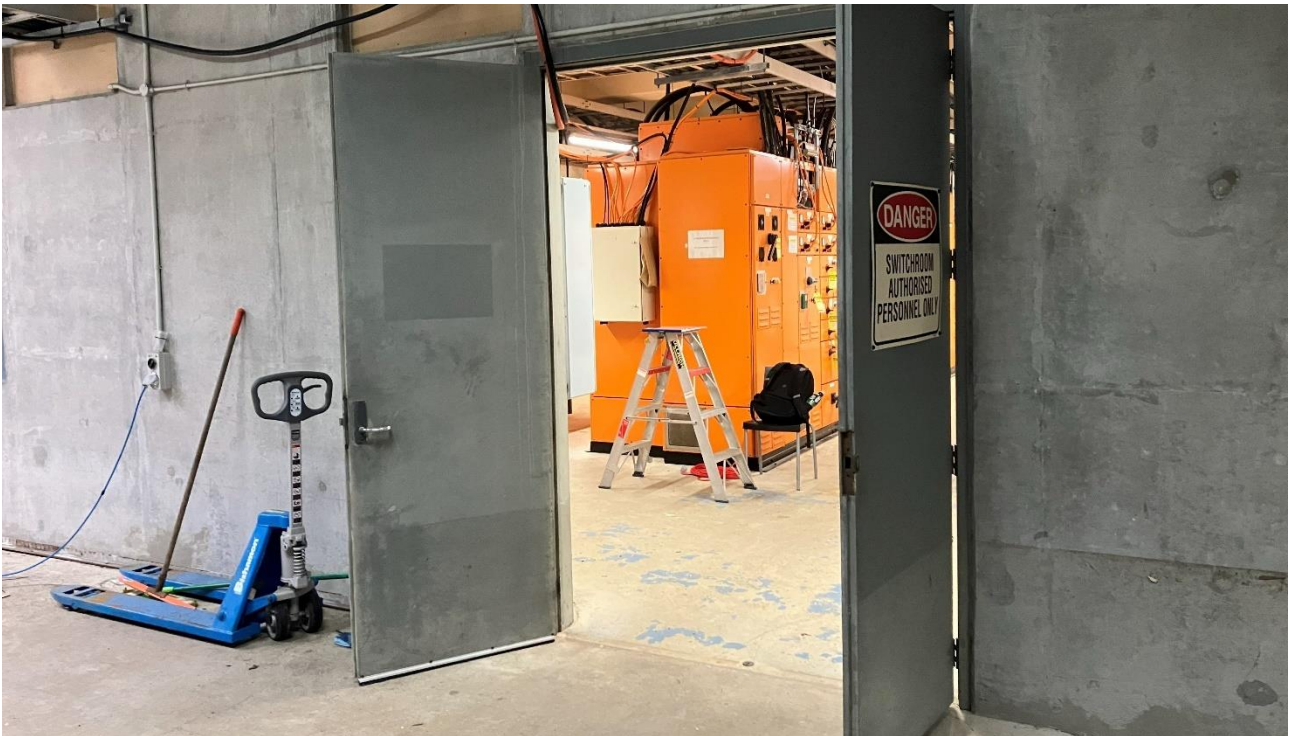
Figure 53: Location of pallet truck in service gallery

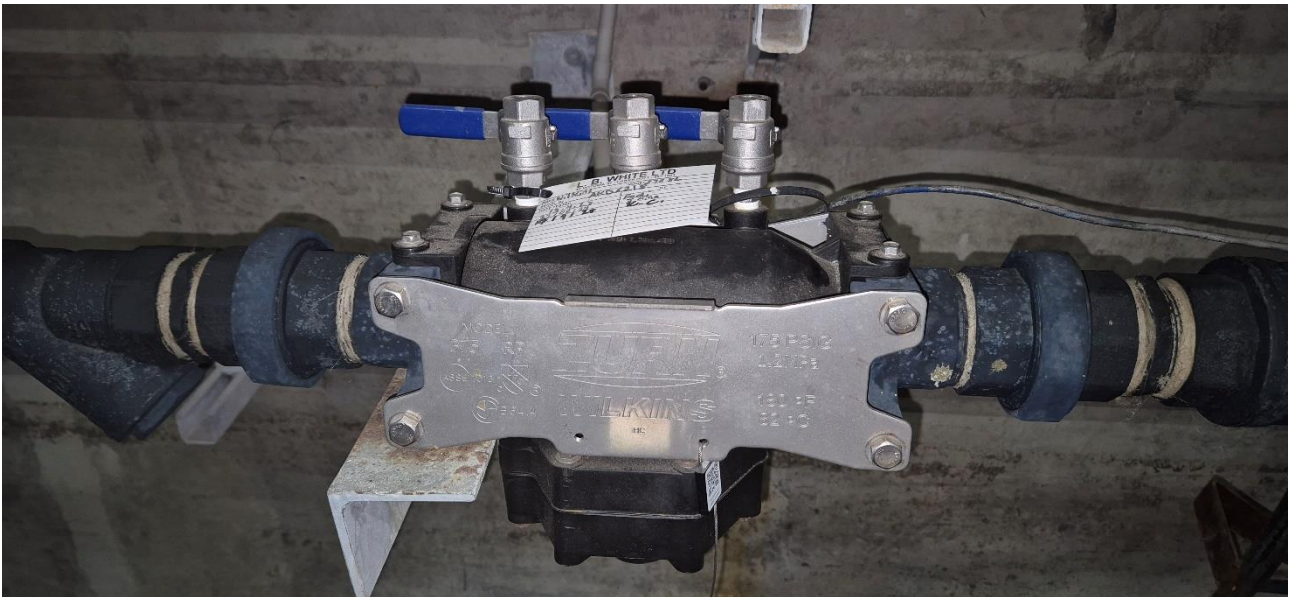
Figure 54: RPZ Backflow Preventer in Service Gallery

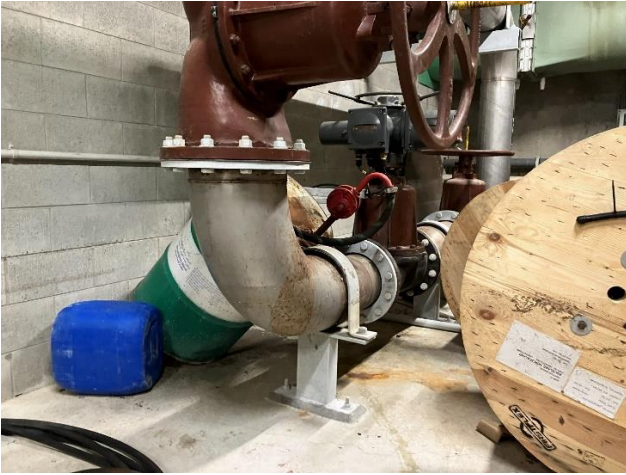
However, given the presence of floodwater within the service gallery, the actuator may have been exposed to elevated moisture levels and high humidity conditions during the flooding event. As a result, the potential for moisture-related impacts to electrical or mechanical components cannot be excluded based on visual inspection alone.

Figure 56: WAS pipework in service gallery

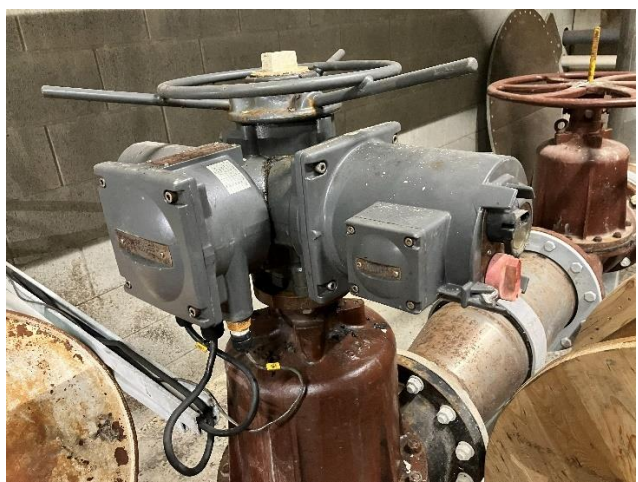
Figure 57: WAS pipework in service gallery

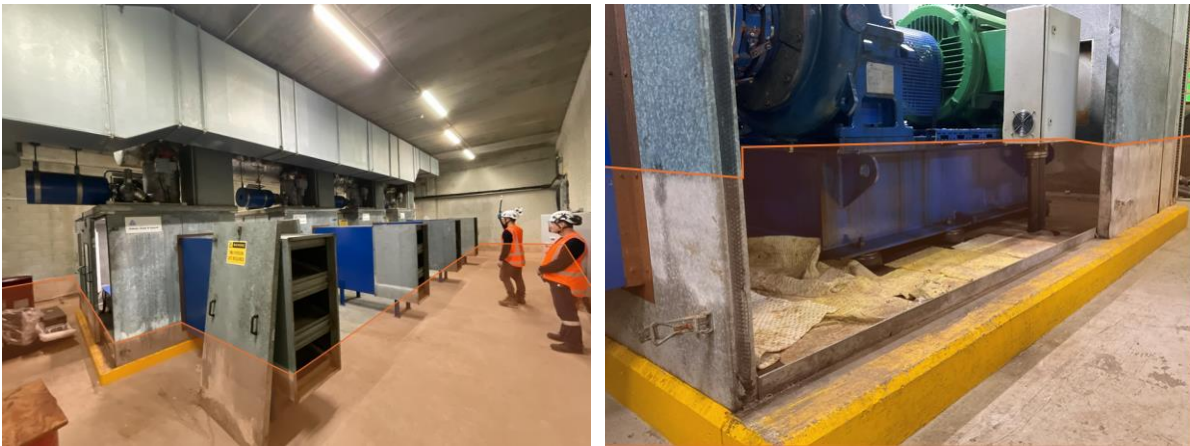
Beca was advised that this location was submerged to a level of 0.55m above floor level. This impact is shown indicatively below in Figure 59.

Figure 59: Blower Room indication of the approximate level to which assets were submerged - Blower room water level (L) and Blower 1 base frame water level (R)

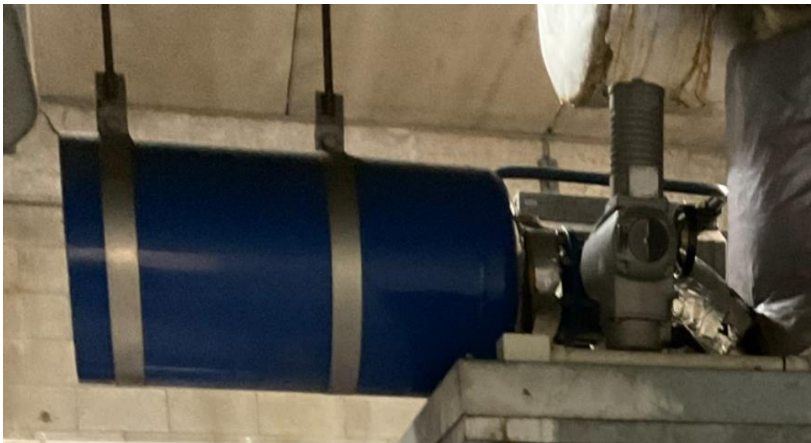
The blower exhaust silencers were located above the blower enclosures and the observed high-water level. The exhaust silencers are not expected to have been impacted.

Figure 60: Blower Exhaust Air Silencer

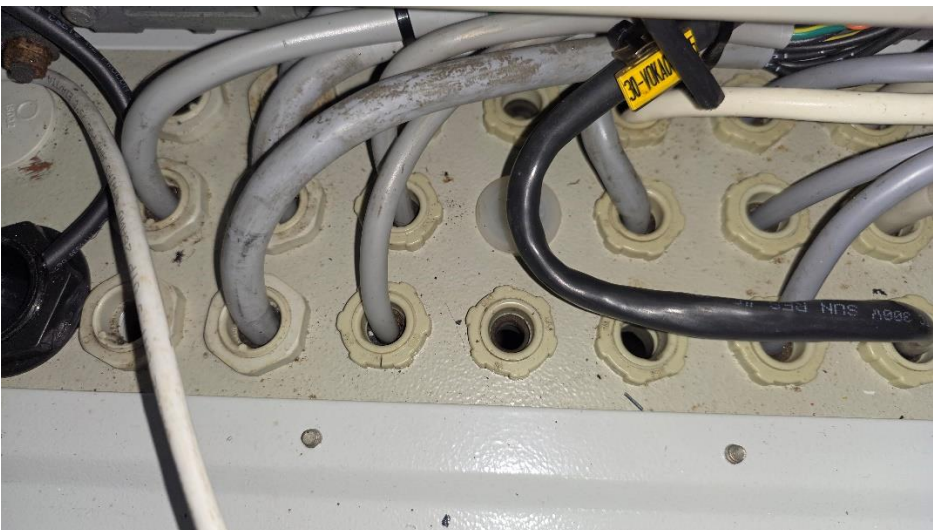
Power and control cables were observed to enter cabinets via bottom-entry glands. Not all unused gland openings were sealed, which would have allowed moisture to enter the cabinet enclosures. As a result, moisture ingress into the cabinets and potential impact to internal components cannot be excluded. In addition, as cabling was submerged up to the base of the cabinets, the potential for moisture tracking upward along cable conductors or insulation is considered possible.

Figure 64: Blower control panel showing unsealed gland holes.

- Where reuse is being considered, inspection and internal assessment of electrical cabinets may be undertaken to evaluate evidence of moisture ingress, corrosion, or component degradation.
- Inspection and verification of cable gland sealing, including closure of unused entries, may be undertaken to restore enclosure integrity.
- Inspection and testing of power and control cabling routed through embedded floor ducts may be undertaken to assess moisture exposure and insulation condition.

- Assessment and management of standing liquid within floor ducts may be undertaken to address continued deterioration risk and health and safety considerations.
- Alternatively, replacement of affected cabinets, internal components, and cabling may be considered where inspection or testing outcomes are inconclusive or where improved reliability and reduced residual risk are preferred.

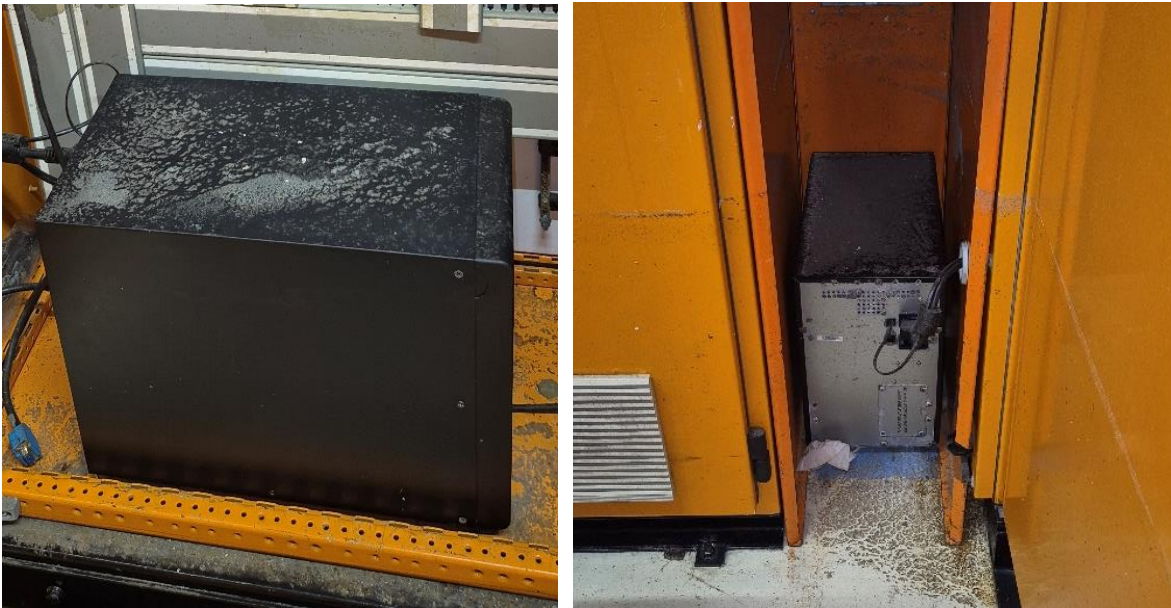
The PLC UPS located in the base of the PLC cabinet and the battery located between the PLC cabinets and the power factor correction cabinets were both fully submerged and not expected to function. The manual changeover switch for the UPS was not affected.

Figure 86: PLC UPS (L) and Battery Pack (R)

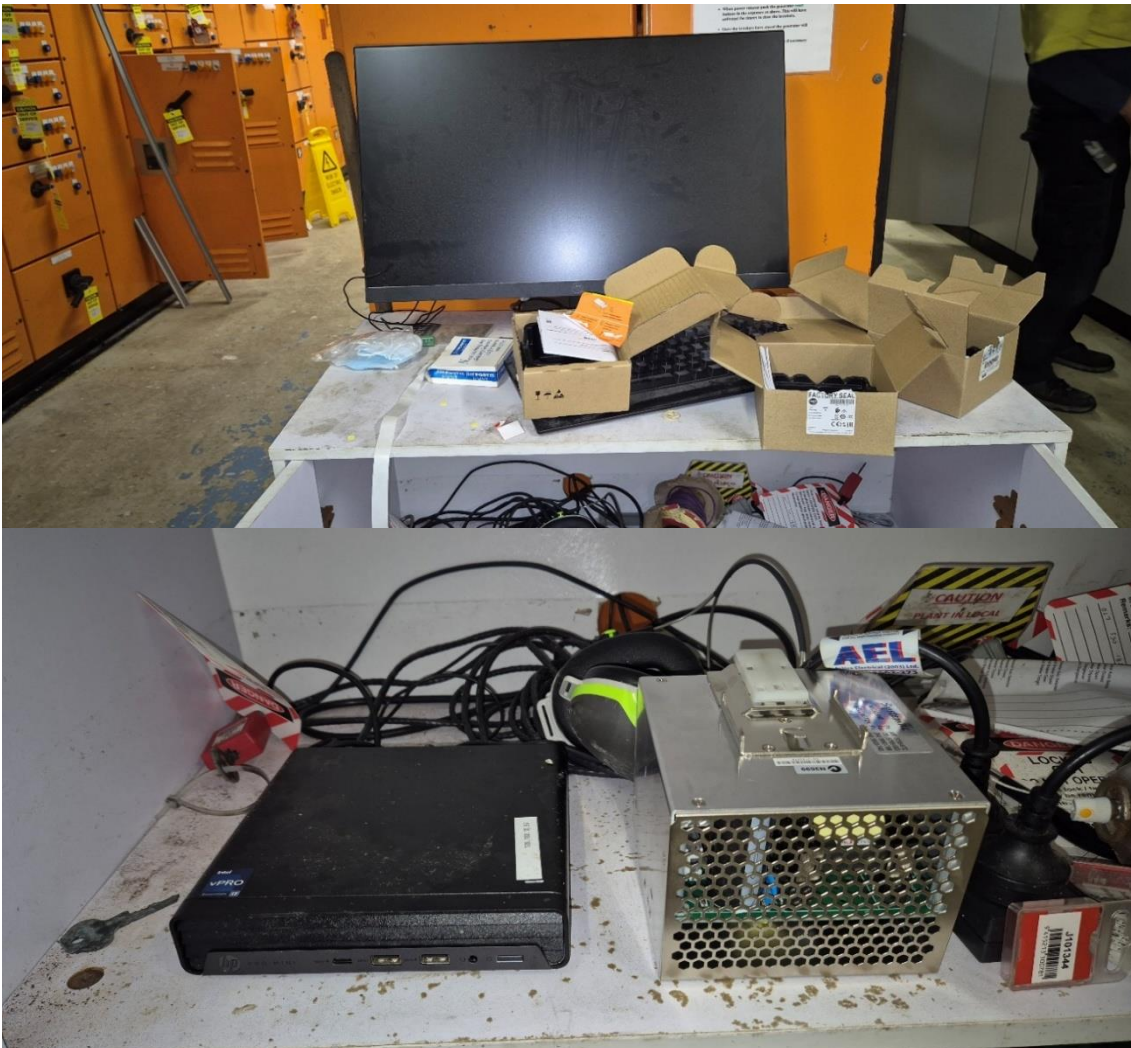
The SCADA client in the switchroom was located on a cupboard adjacent to the PLC cabinets. The PC located in the cupboard and its power supply were fully submerged so not expected to function. The PC monitor on the cupboard was above the high-water level and while it may be operational it will likely have a shortened life.

Figure 87: Switchroom SCADA client PC, power supply and monitor

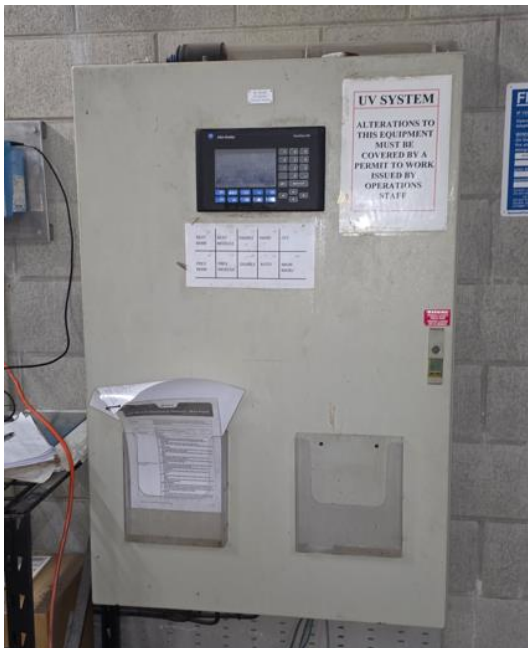
As a result, the condition and continued serviceability of the UV control equipment cannot be fully confirmed based solely on observed physical condition.

Figure 92: UV Control Panel

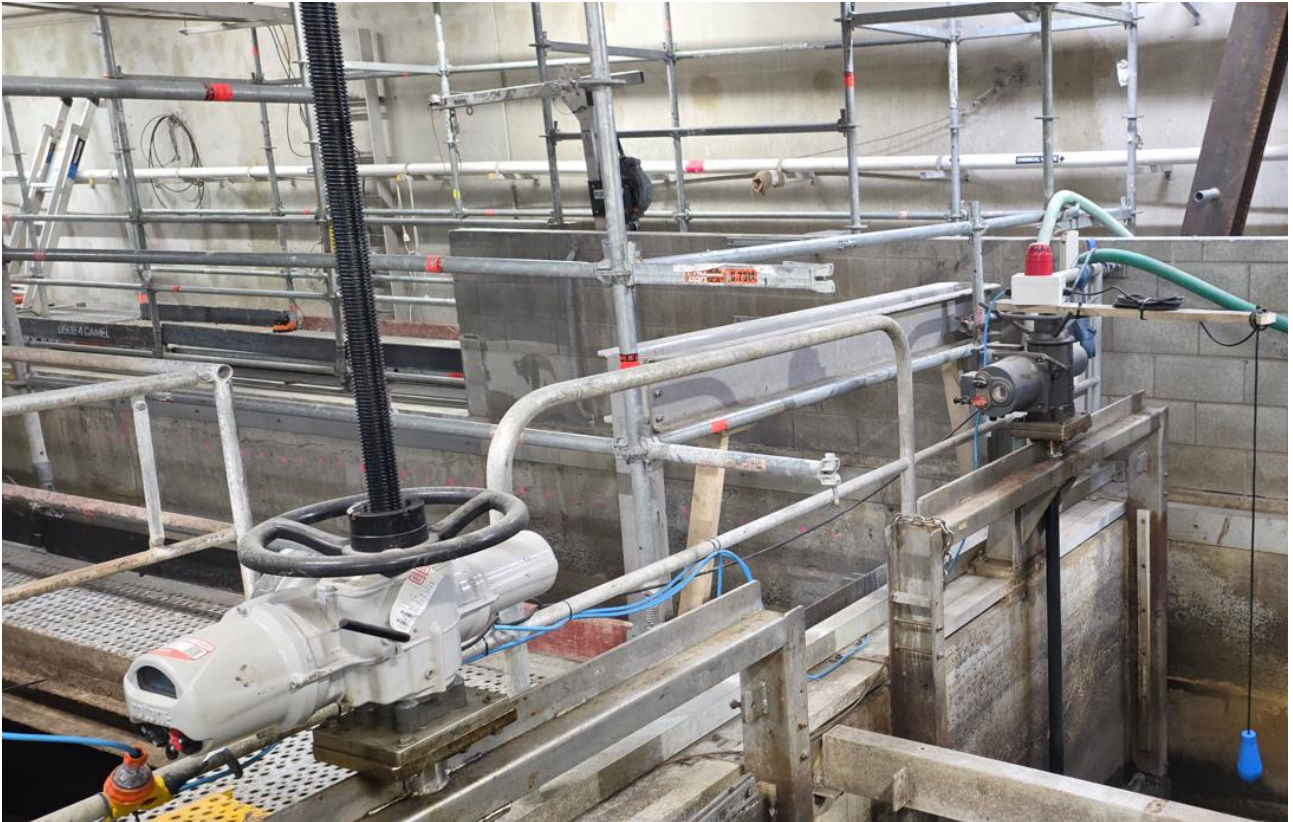
Accordingly, the operational condition and continued serviceability of the actuators cannot be fully confirmed based solely on observed physical condition.

Figure 94: UV System Actuated Penstock Valves
