Moa Point Wastewater Treatment Plant

Annual Resource Consents Report 2020/2021

Document Title: Moa Point Wastewater Treatment Plant Annual Resource Consents
2020/2021

Document generated on: 22nd February 2021
Document title: Moa Point Wastewater Ocean Outfall Pipeline & Seabed Annual Inspection
Document no.: UCL – 2021.02 – WWPT Outfall Pipeline – IR001
Document release: Released for Client review and comment – 12th March 2021

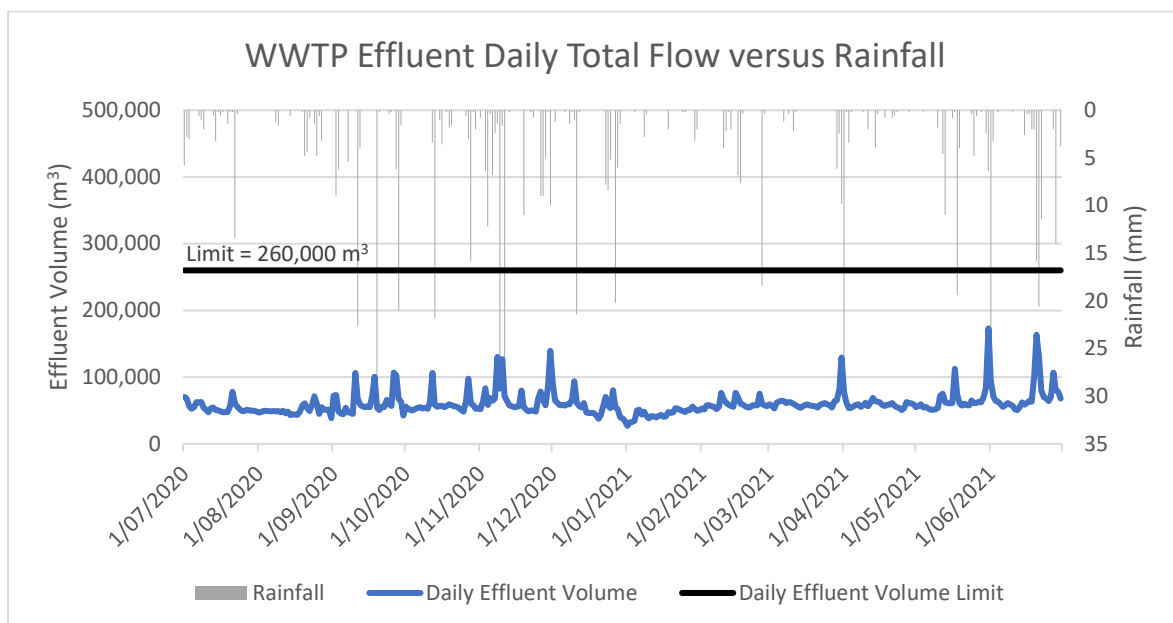
Figure 1: WWTP Effluent Flow versus Rainfall

Although the data requested in Condition (6) is not a requirement for the annual report, the total daily effluent volume is shown with rainfall data.

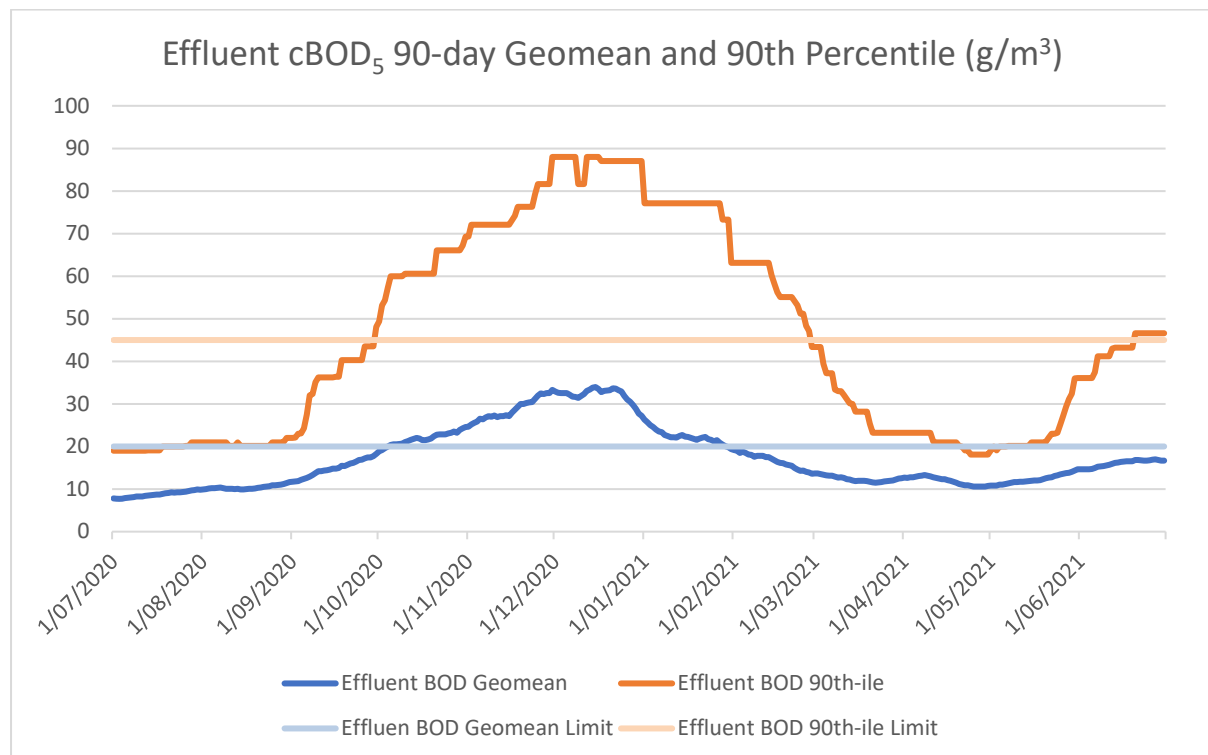
Figure 2: Effluent Carbonaceous Biological Oxygen Demand Results Geometric Mean and 90th Percentile

Below is a summary of the geometric mean and ninetieth percentile for the Carbonaceous Biological Oxygen Demand.

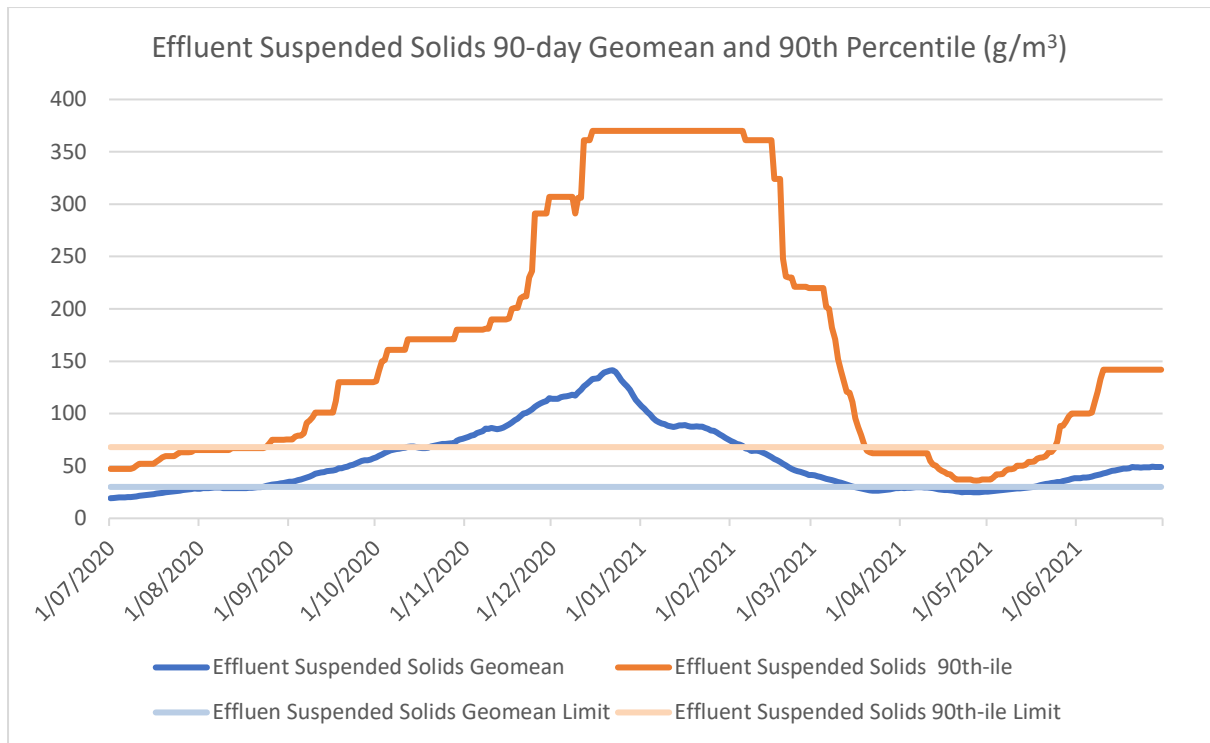
Figure 3: Effluent Suspended Solids Results Geometric Mean and 90th Percentile

Below is a summary of the geometric mean and ninetieth percentile for the Suspended Solids.

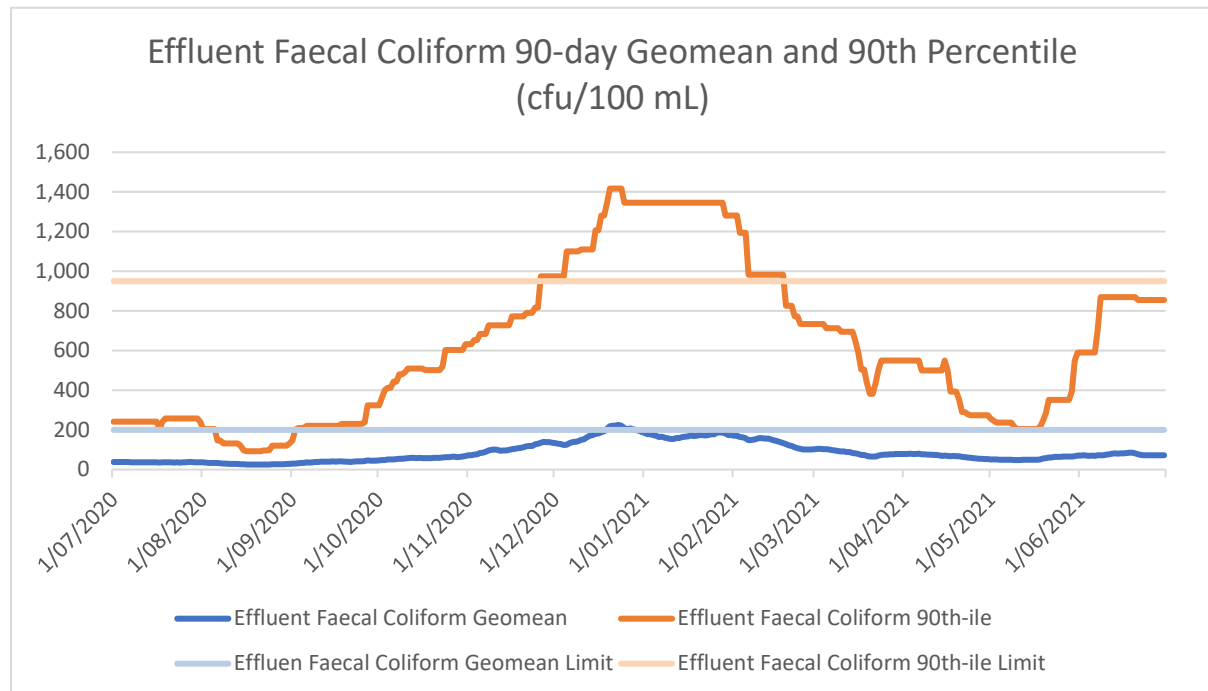
Figure 4: Effluent Faecal Coliform Geometric Mean, and 90th Percentile

Below is a summary of the geometric mean and ninetieth percentile for the Faecal Coliforms.

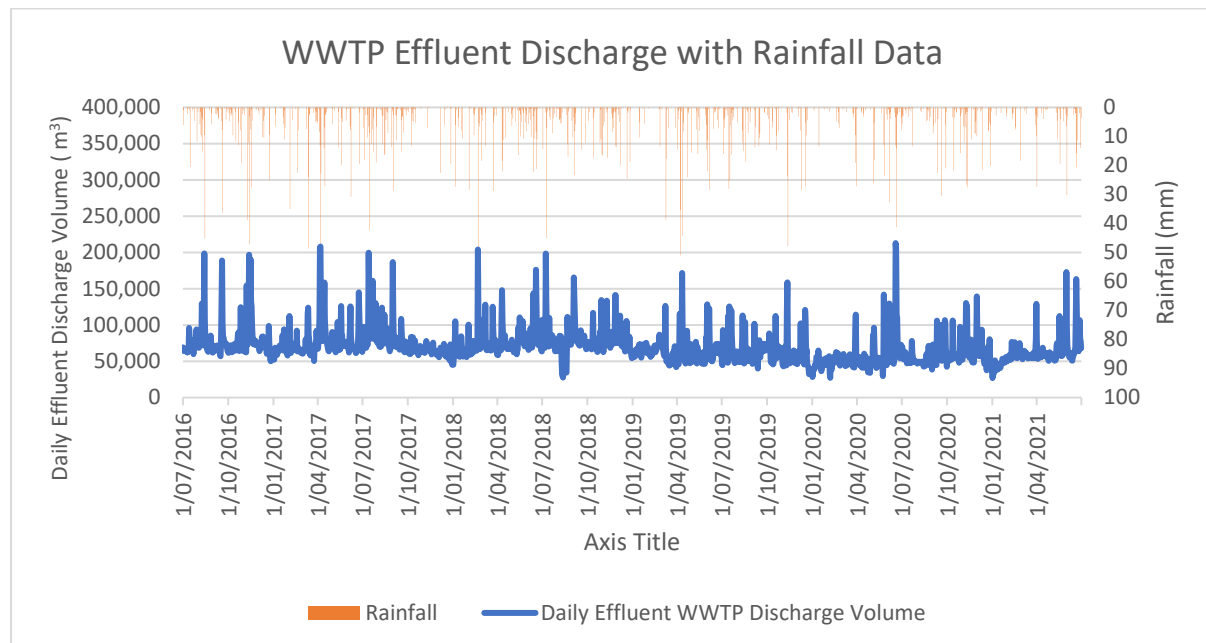
Figure 5: WWTP Effluent Discharge Volume versus Rainfall

WWTP effluent discharge volume is used to establish a trend. Rainfall data from GWRC site is compared with the WWTP effluent daily discharge volume. In figure 5, it can be noted that the plant's effluent discharge volume is affected during wet weather.

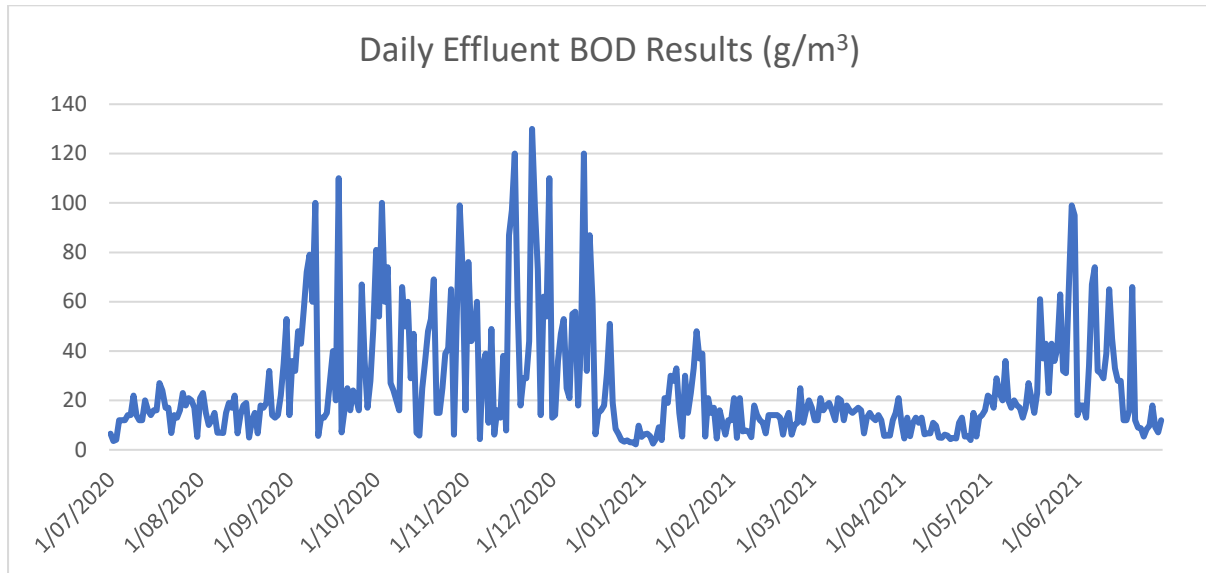
Daily Effluent Carbonaceous Biological Oxygen Demand

In figure 6, it can be noted that the daily effluent BOD₅ had an increase in daily values since August to December 2020 which was due to mechanical issues in the clarifiers. One of the clarifiers was repaired in 23rd December which dramatically improved the plant's effluent quality. In May 2021, the plant's effluent quality started to deteriorate again. Veolia's investigation report stated that the failures in the clarifiers and mechanical failures in the sludge dewatering plant have caused the issue.

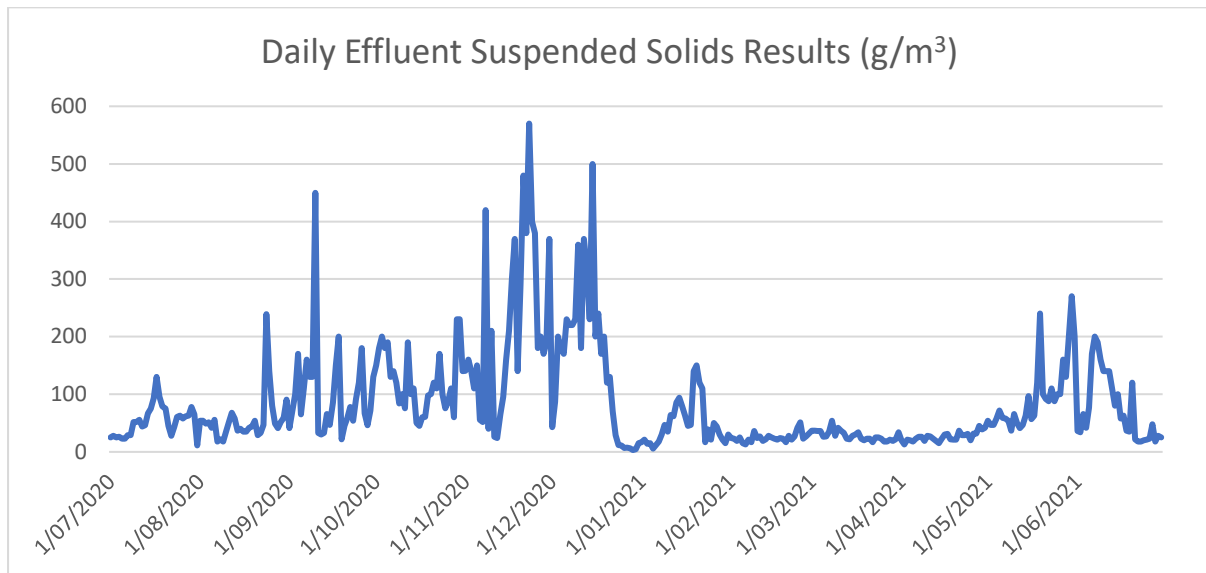
Daily Effluent Suspended Solids Results

In figure 7, it can be noted that the daily effluent suspended solids had an increase in daily values since August to December 2020 which is due to mechanical issues in the clarifiers. One of the clarifiers was repaired in 23rd December which dramatically improved the plant’s effluent quality. In May 2021, the plant’s effluent quality started to deteriorate again. Veolia’s investigation report stated that the failures in the clarifiers and mechanical failures in the sludge dewatering plant have caused the issue.

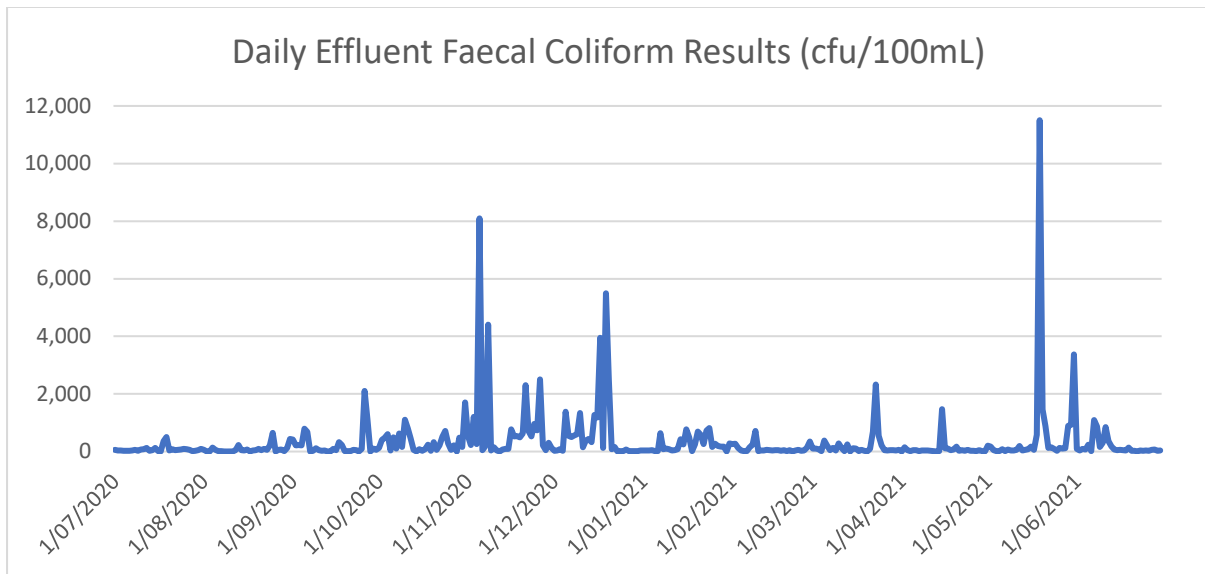
Daily Effluent Faecal Coliforms Results

In figure 8, it can be noted that the daily effluent faecal coliforms had spikes in January and February 2020 due to sludge pipeline failure. It then experienced an increase in daily values since August to December 2020 which is due to mechanical issues in the clarifiers. One of the clarifiers was repaired in 23rd December which dramatically improved the plant's effluent quality. In May 2021, the plant's effluent quality started to deteriorate again. Veolia's investigation report stated that the failures in the clarifiers and mechanical failures in the sludge dewatering plant have caused the issue.

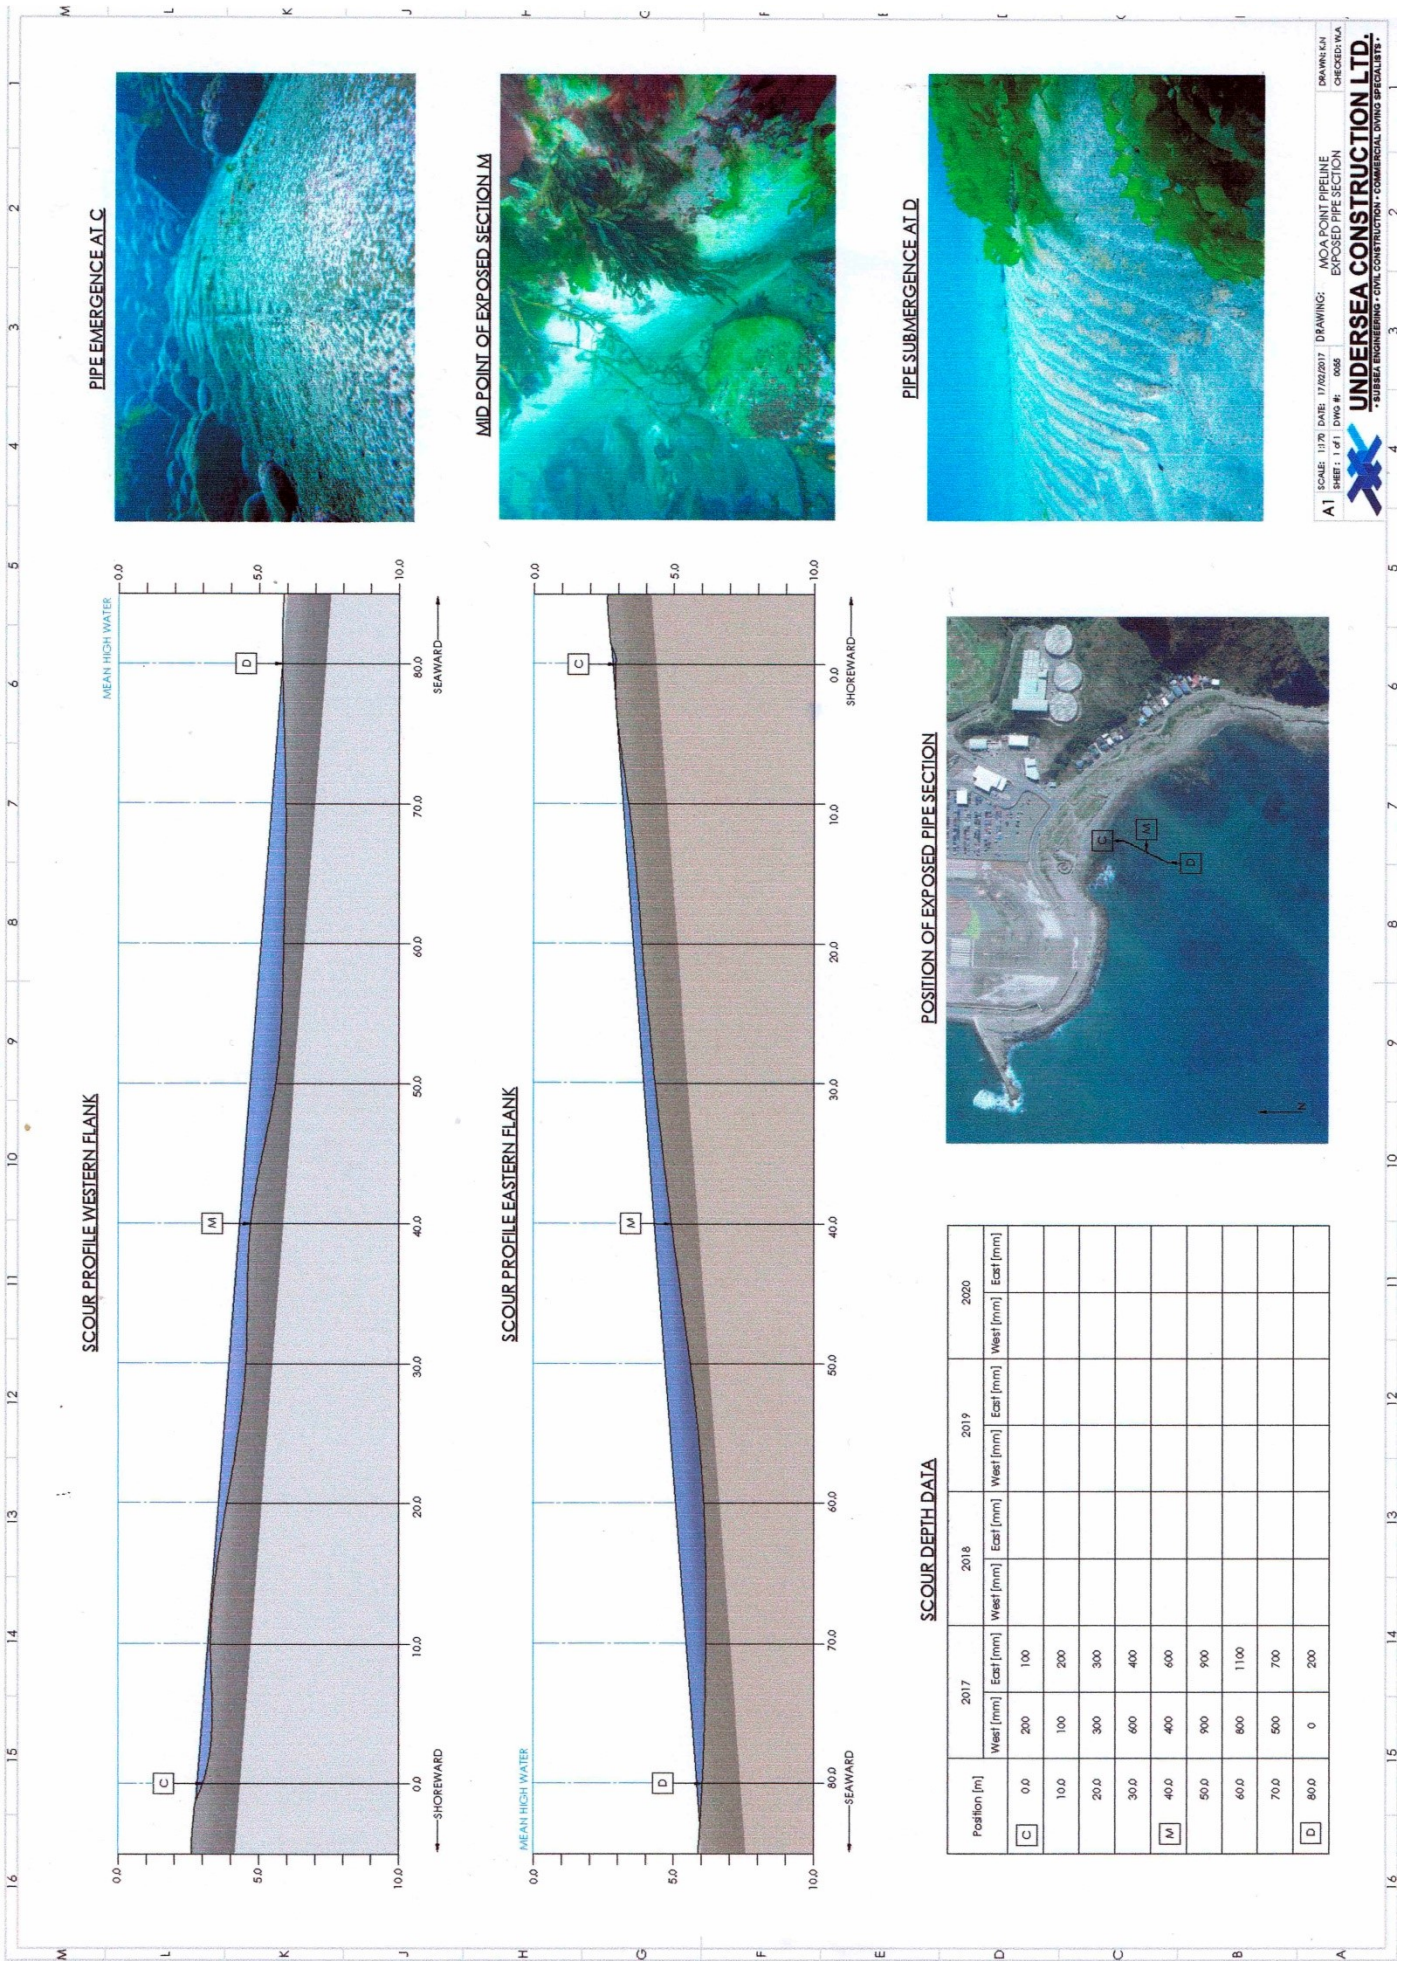
Figure 3: Inshore profile

Exposed Pipeline Section Scour Depth Data									
Test point meterage	Year								Comments
	2019		2020		2021		2022		
	West (mm)	East (mm)	West (mm)	East (mm)	West (mm)	East (mm)	West (mm)	East (mm)	Seafloor composition
Position 'C' 00.0 metres	200	150	100	100	70	100			Formed rock reef with loose packed rock and gravels – in close proximity with pipeline
10.0 metres	200	200	150	200	150	200			As above
20.0 metres	350	400	250	300	350	400			As above
30.0 metres	500	500	350	400	450	450			As above
40.0 metres	700	650	600	650	600	650			As above
50.0 metres	1000	1000	700	750	850	850			As above
60.0 metres	760	1100	600	600	850	900			Formed rock reef with gravel and sand deposits – rock reef structuring standing off 1 – 2 metres from pipeline
70.0 metres	500	750	400	450	400	450			As above
Position 'D' 80.0 metres	200	430	150	150	150	200			Sand and cobbles

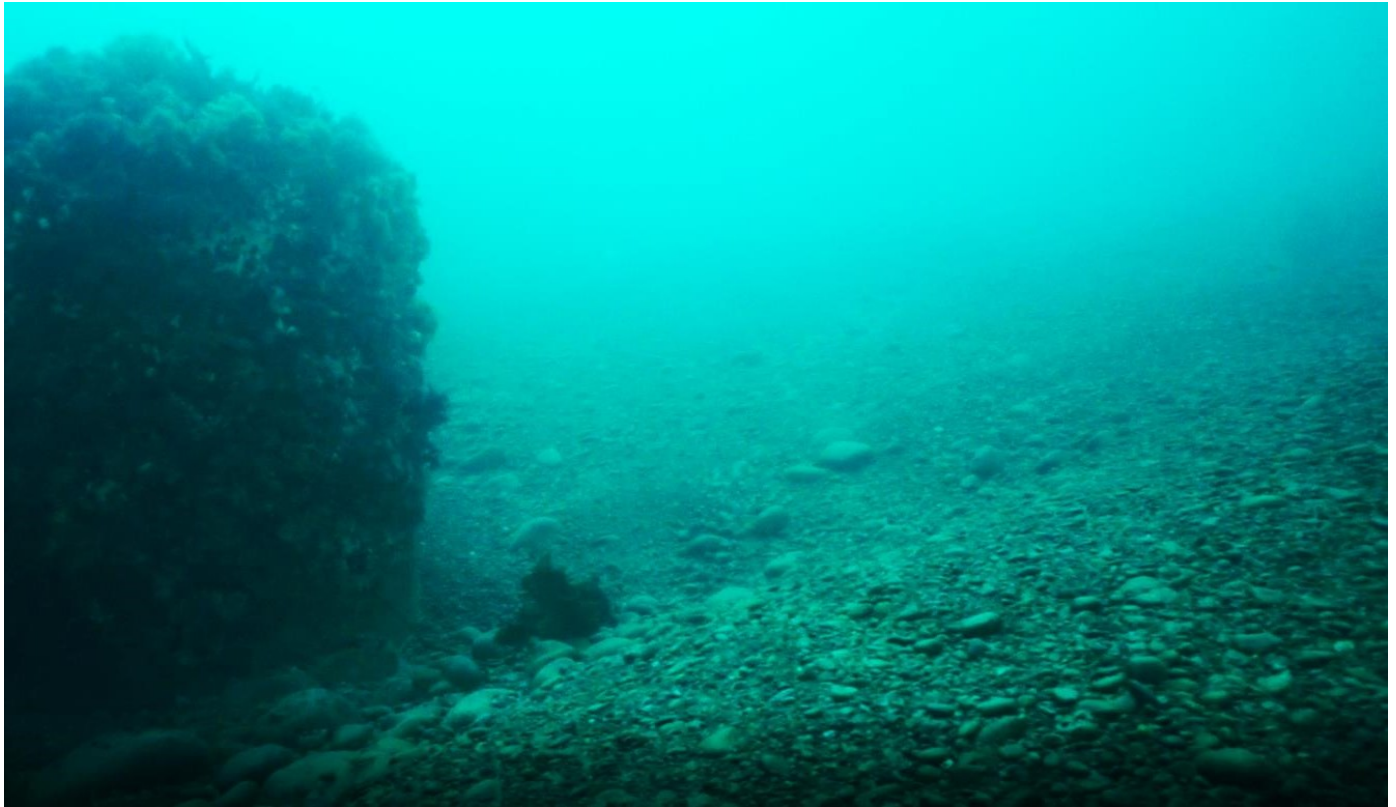
No evidence was observed of any damage or deterioration to any of the 18 diffuser assemblies. Seafloor deposits of rocks, coarse gravels and sand form undulating, peaks and depressions typically of +/- 400mm in west – east (shoreline) orientation around the diffuser positions.

Figure 21: Typical scale of aggregate sizing observed around the Diffuser positions

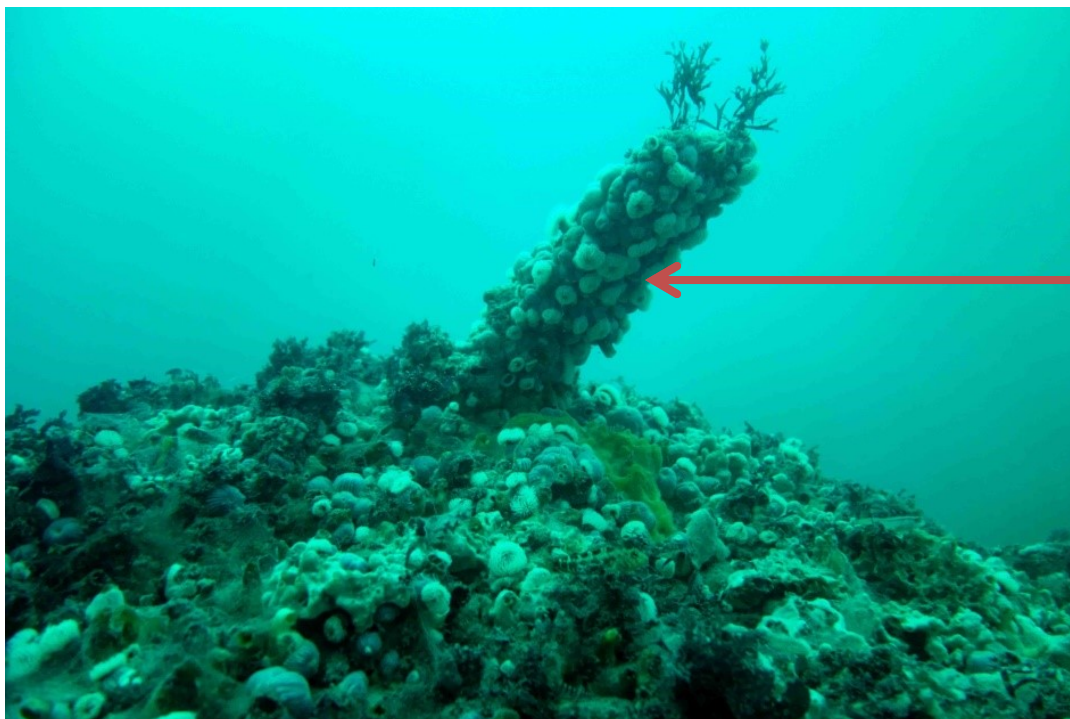
Figure 23:
Diffuser # 1 (seaward southern- most diffuser) – CP test point.
Readings at this position provide evidence of electrical continuity through the diffuser section

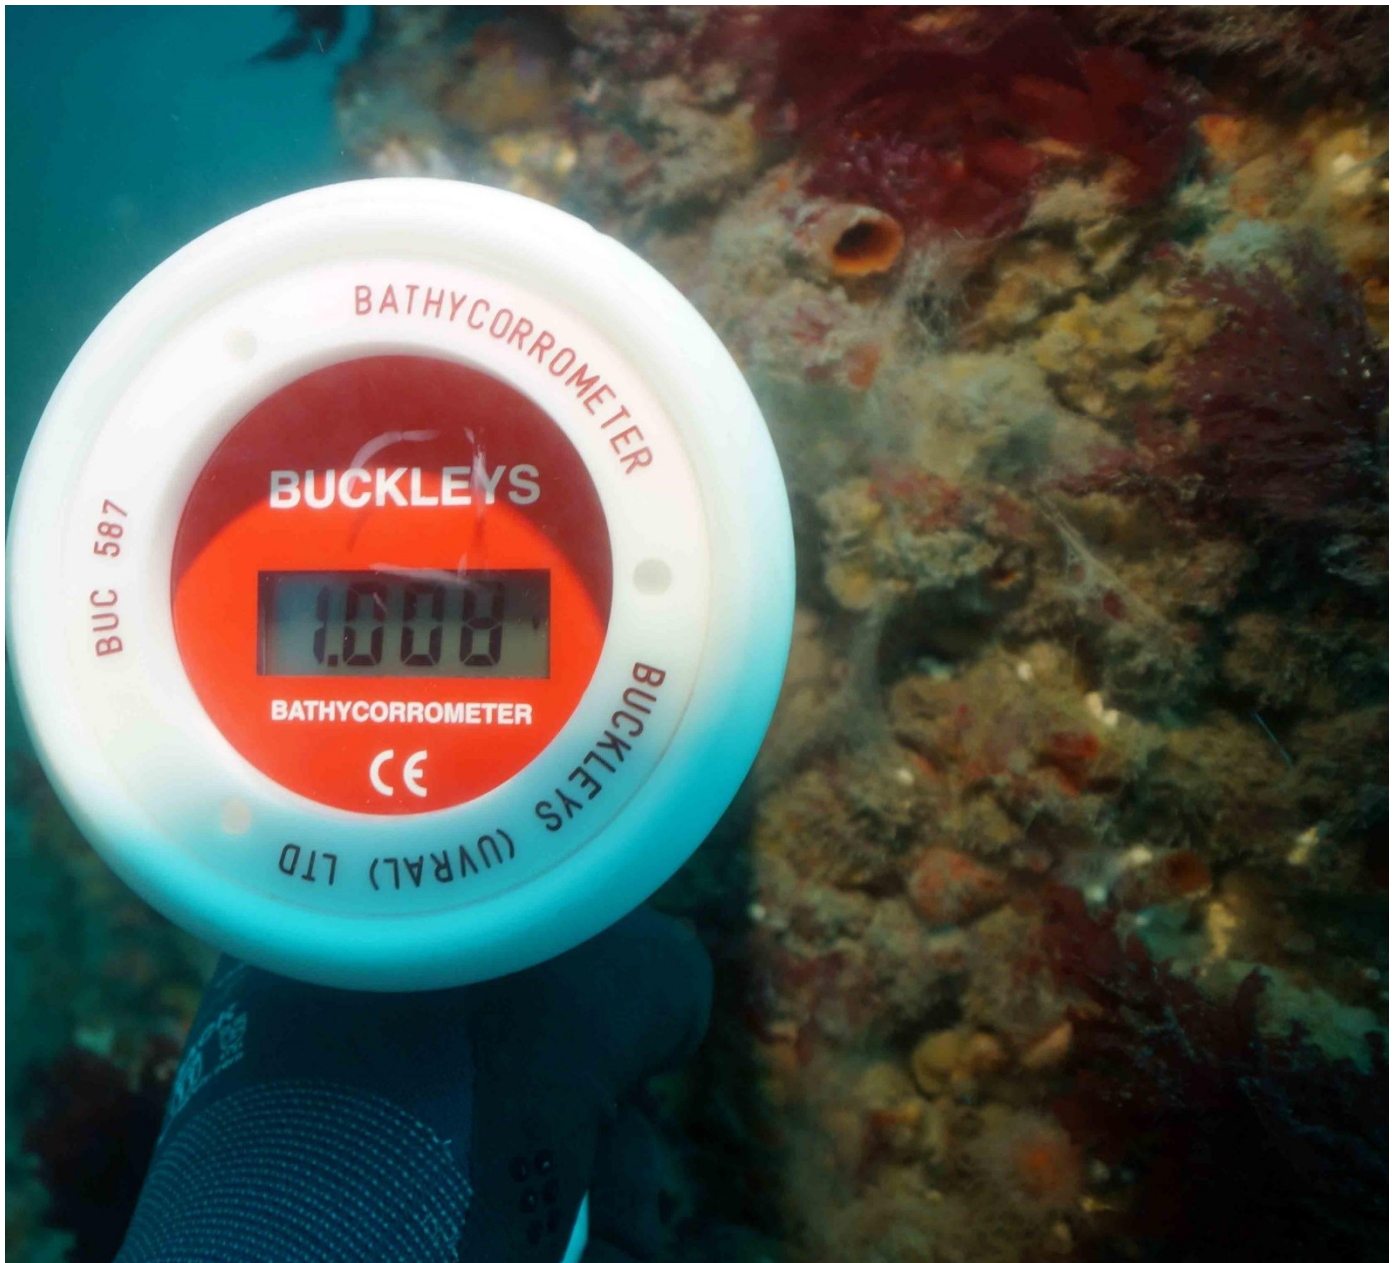
Figure 25: Taking CP reading at Diffuser # 14

All logged cathodic potential readings confirm that the sacrificial anode system in place is providing effective corrosion protection throughout the diffuser section of the pipeline structure.

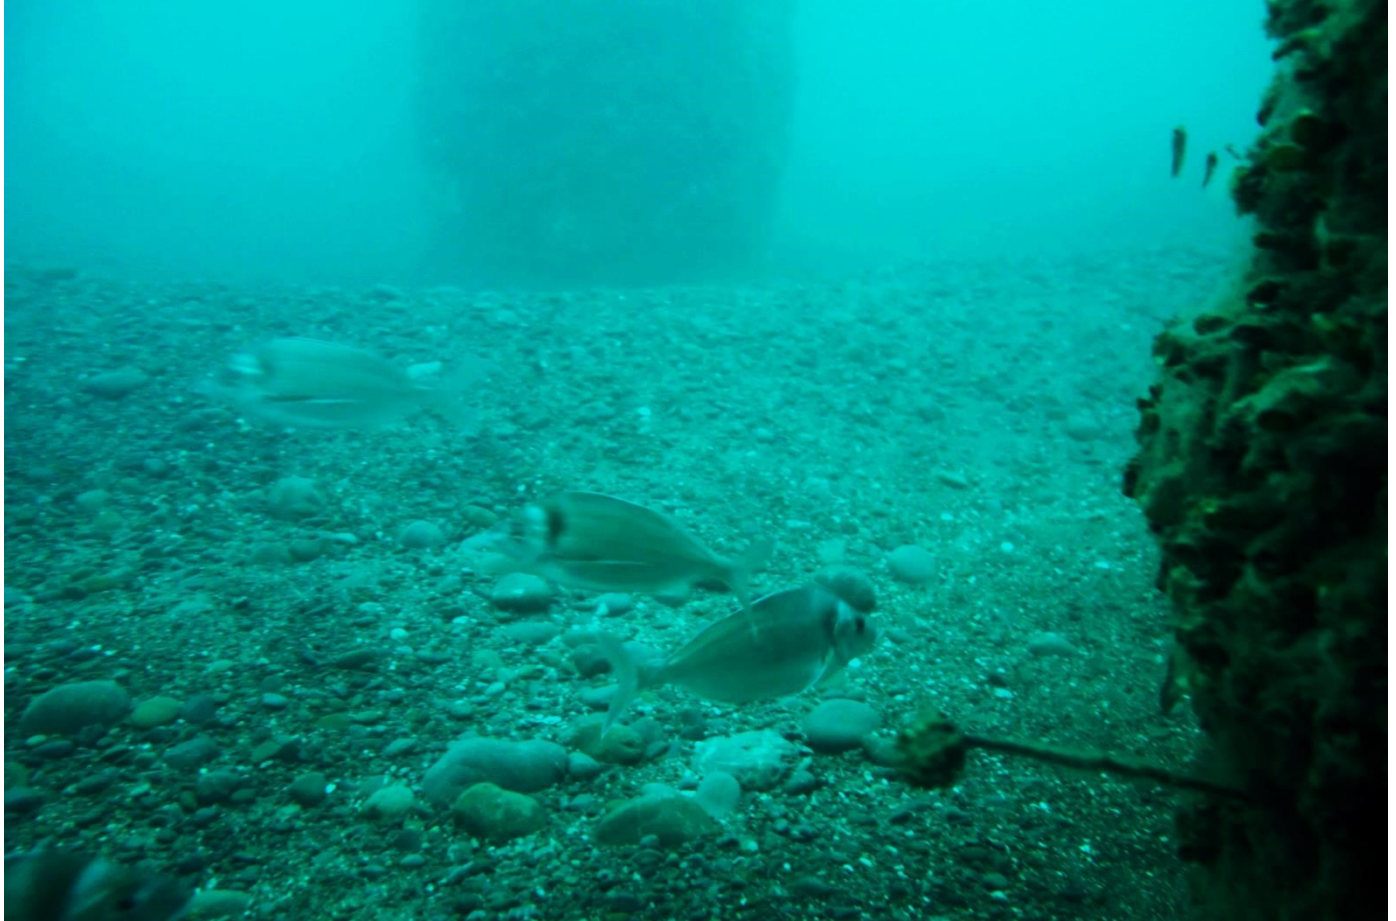
In completing the tasks as detailed within the scope of work UCL personnel didn't observe any evidence of abnormal or aggressive wear, defect, damage, deterioration, or loss of function.

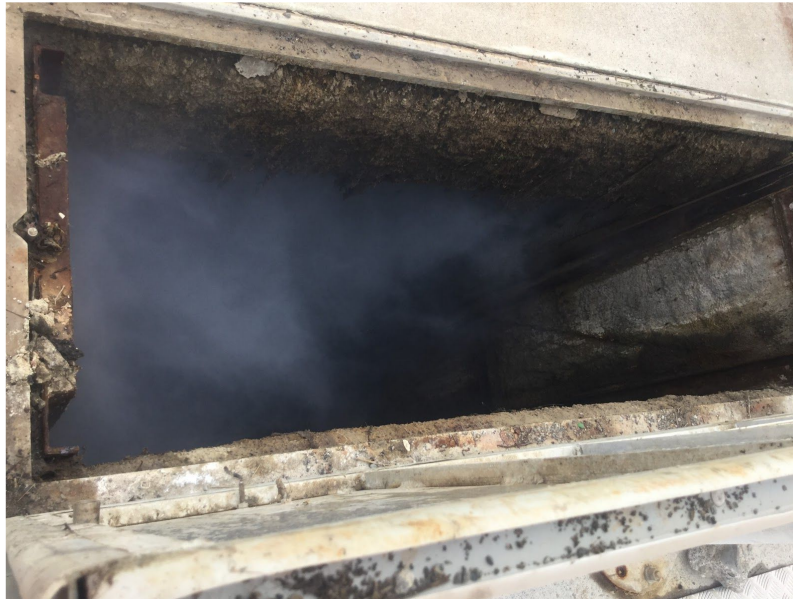
Smoke was generated and discharged into the IPS inlet sampler chamber, the Primary Tank area and Moving Bed Bio Reactors. The hatches and seal were visually checked and photographs were taken. There were no issues with the process or outcome.

Smoke inside inlet well chamber

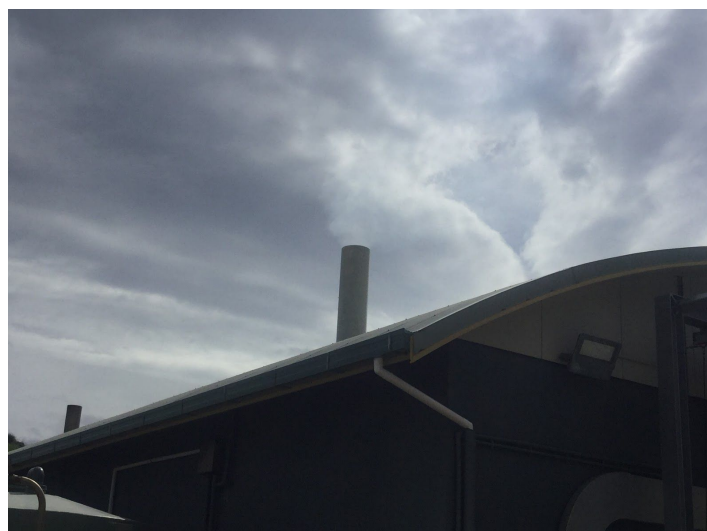
Smoke discharging from the IPS stack

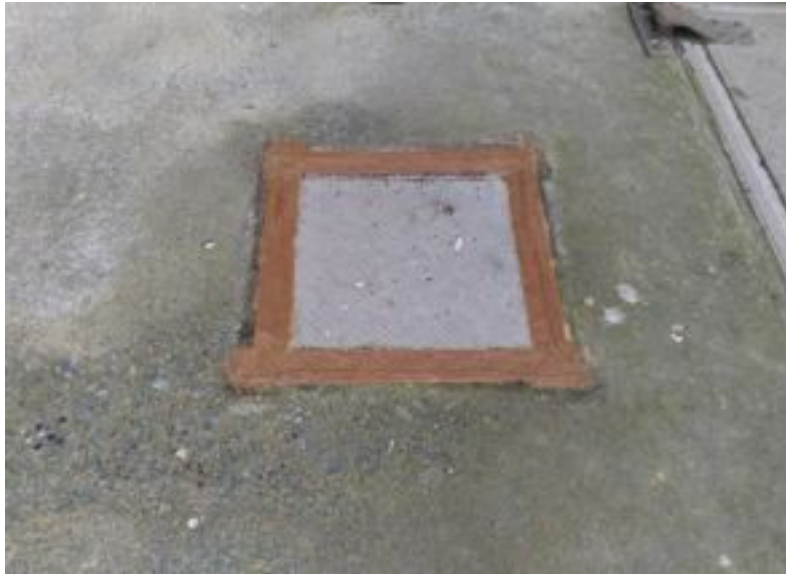
Typical seal around level sensor access hatch

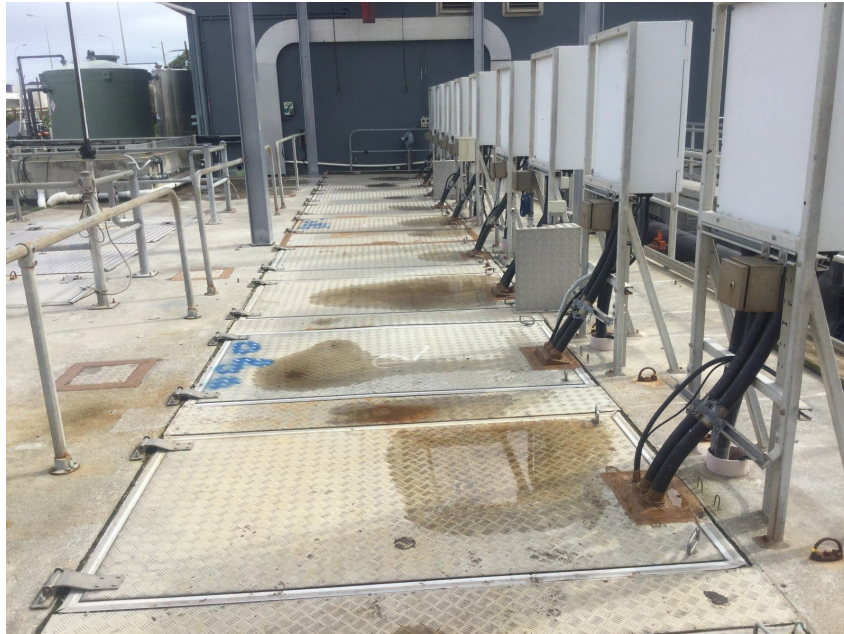
IPS Pump Hatches

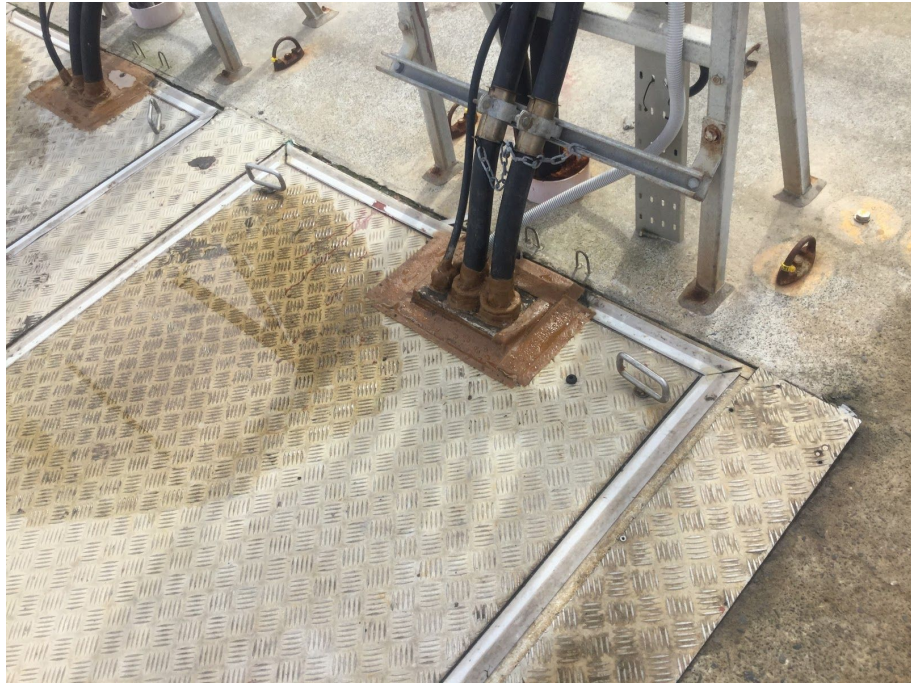
Seal around IPS Pump Cables

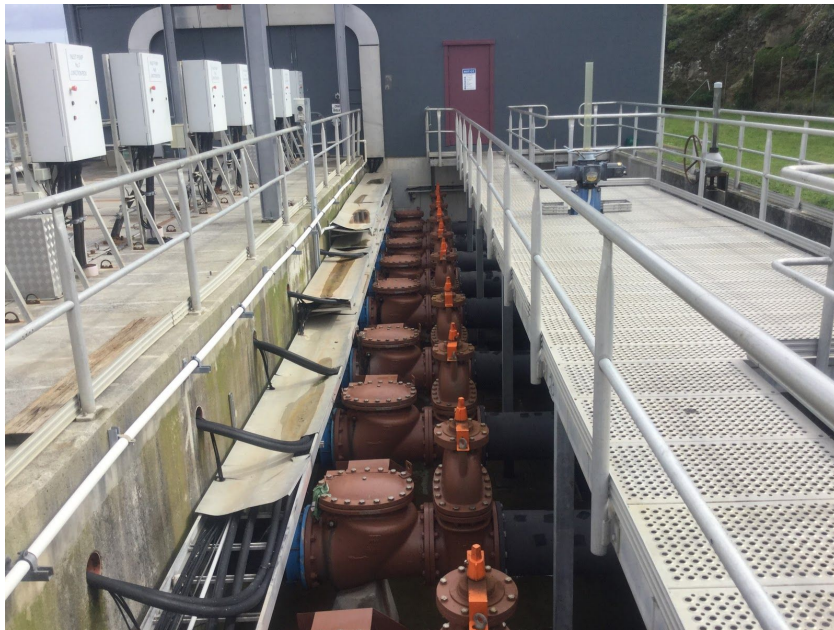
IPS Dry Well

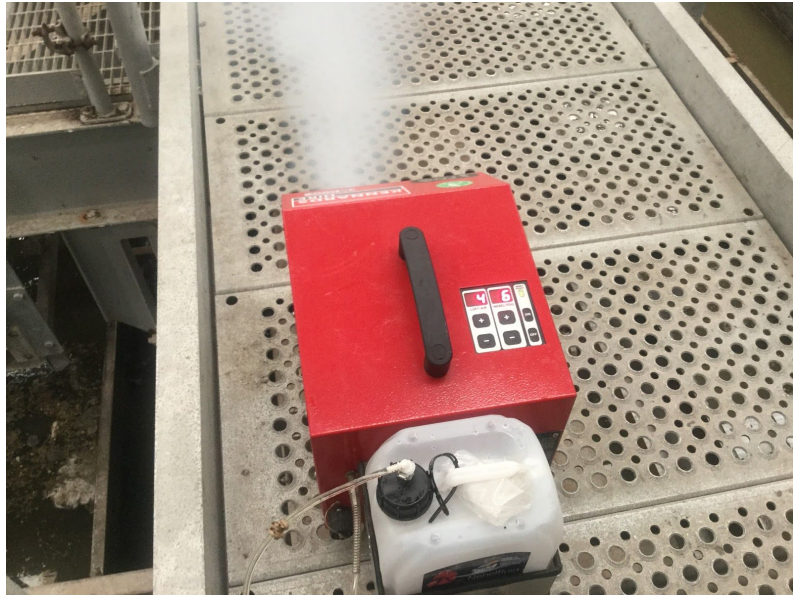
Smoke machine starting to saturate the Primary Tank area

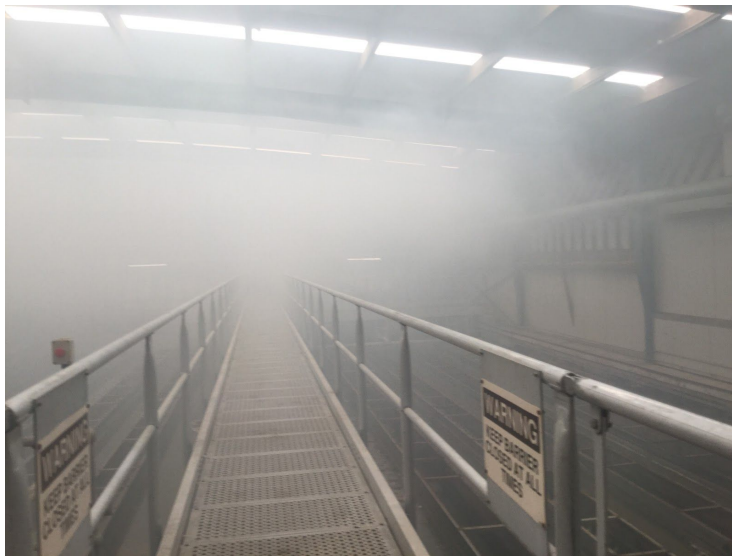
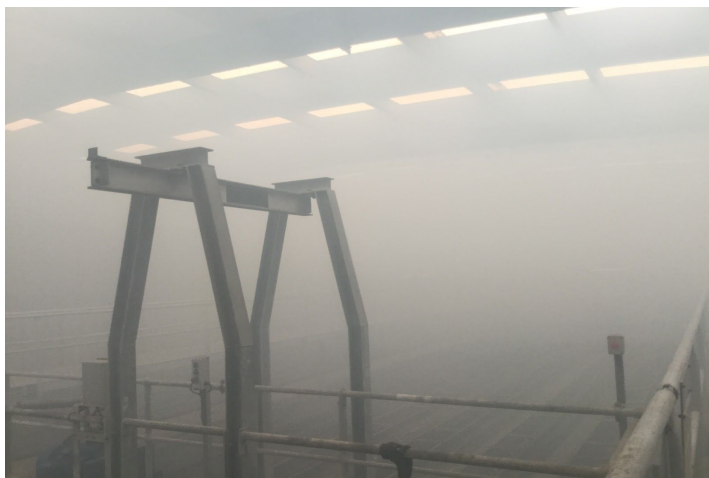
Smoke starting to build up under Primary Tank Roof

The smoke generator was run until sufficient smoke had accumulated to form a smoke cloud on the underside of the roof rafters. Then an external inspection of the roof was carried out and with no smoke leakage observed, no further action was taken.

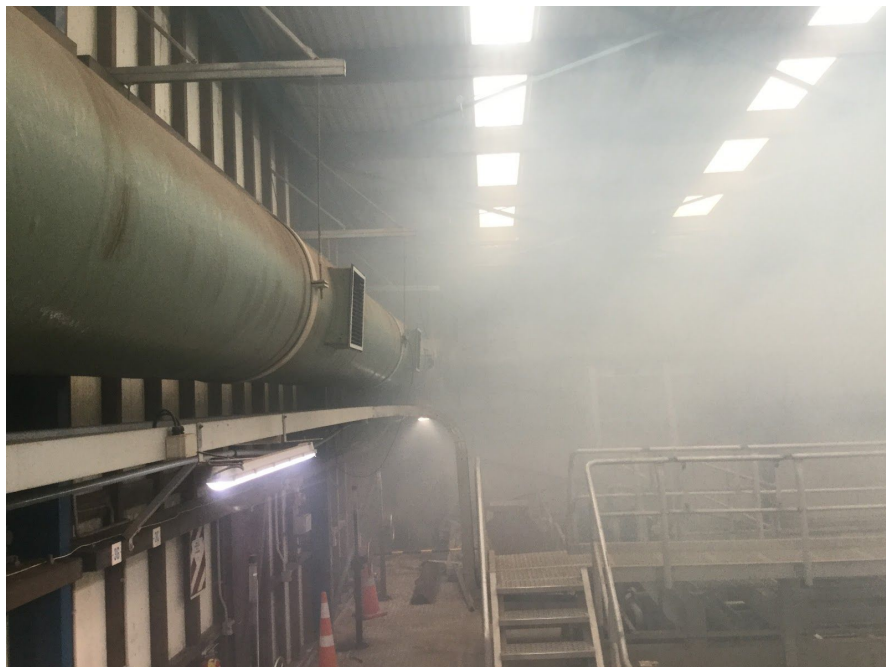
Smoke being drawn into the extract grills

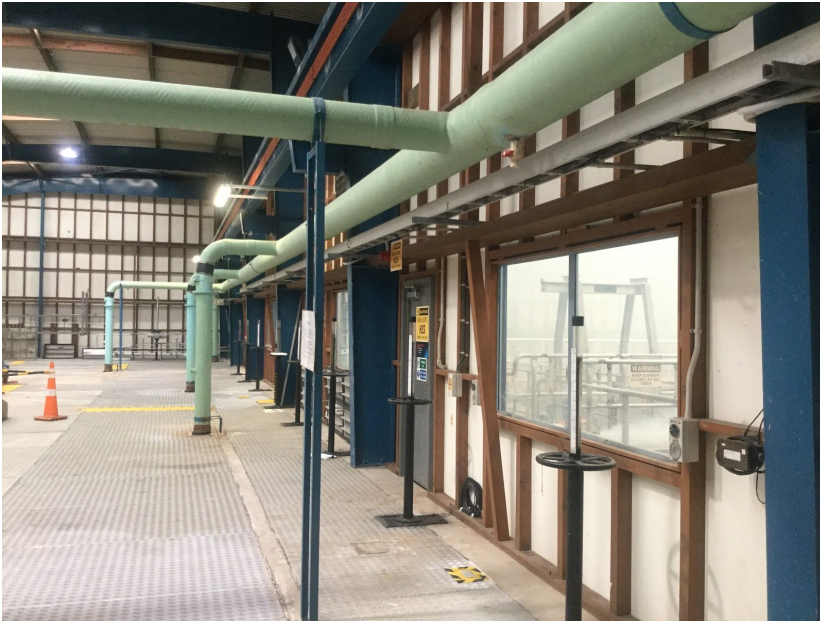
View from the step screen area

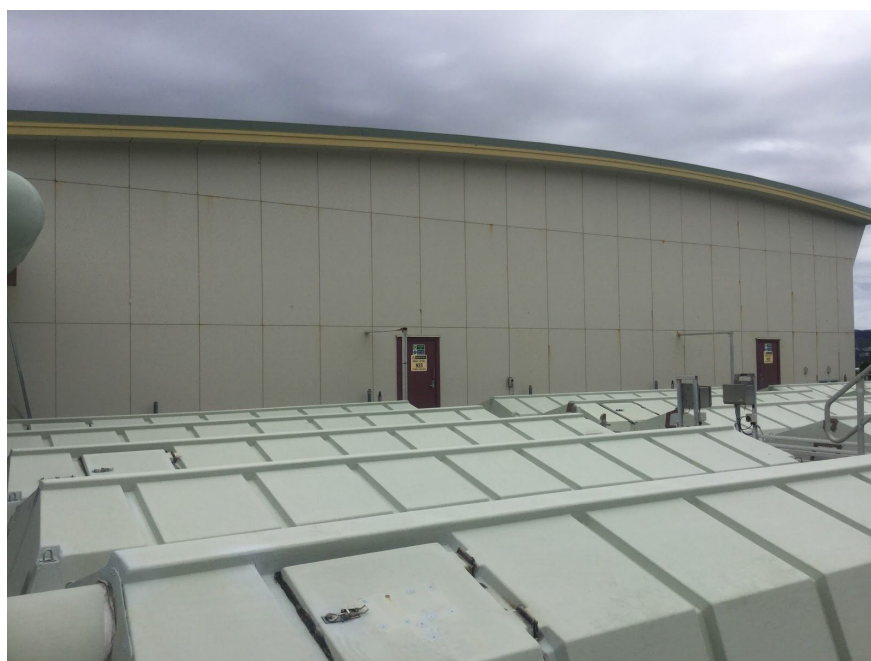
Primary Tank Roof looking west

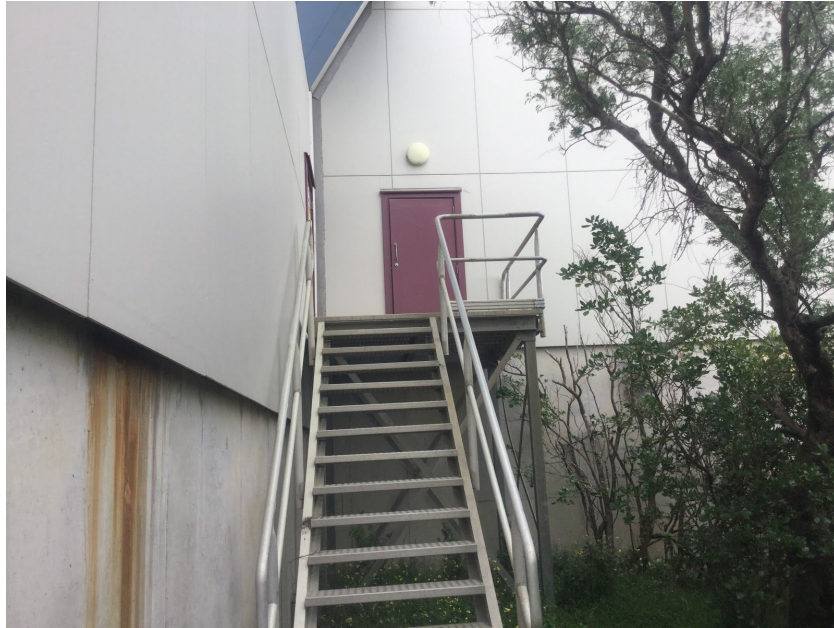
The other door into the Primary tank

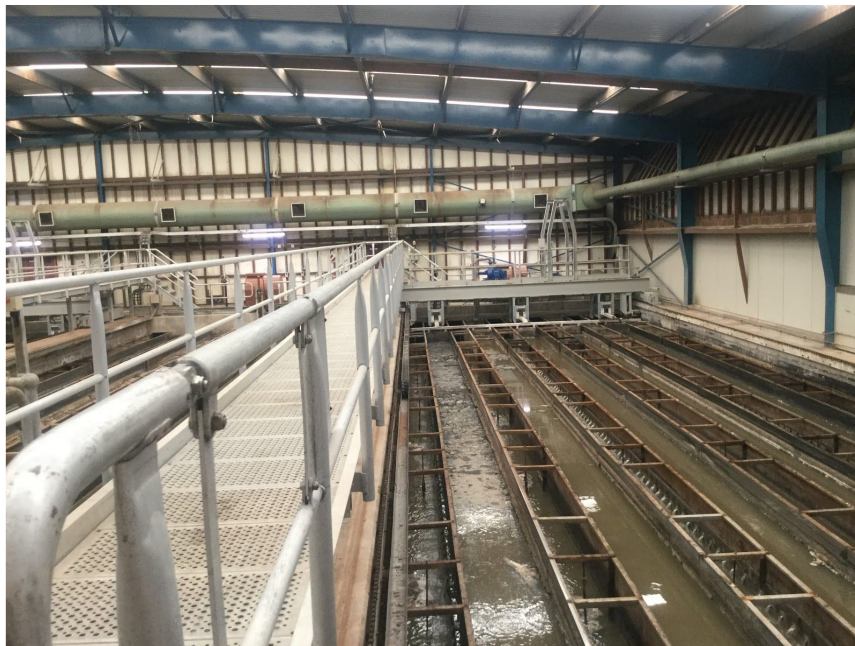
View of the primary tank area after 30minutes we turned off the machine

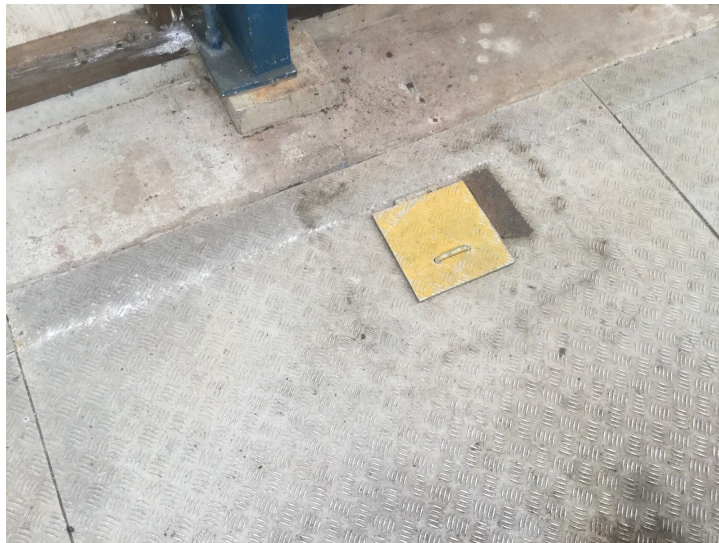
Sample hatch in MBBR common channel
