Moa Point Wastewater Treatment Plant

Annual Resource Consents Report 2020/2021

Document Title: Moa Point Wastewater Treatment Plant Annual Resource Consents
2020/2021

Document generated on: 22nd February 2021
Document title: Moa Point Wastewater Ocean Outfall Pipeline & Seabed Annual Inspection
Document no.: UCL – 2021.02 – WWPT Outfall Pipeline – IR001
Document release: Released for Client review and comment – 12th March 2021

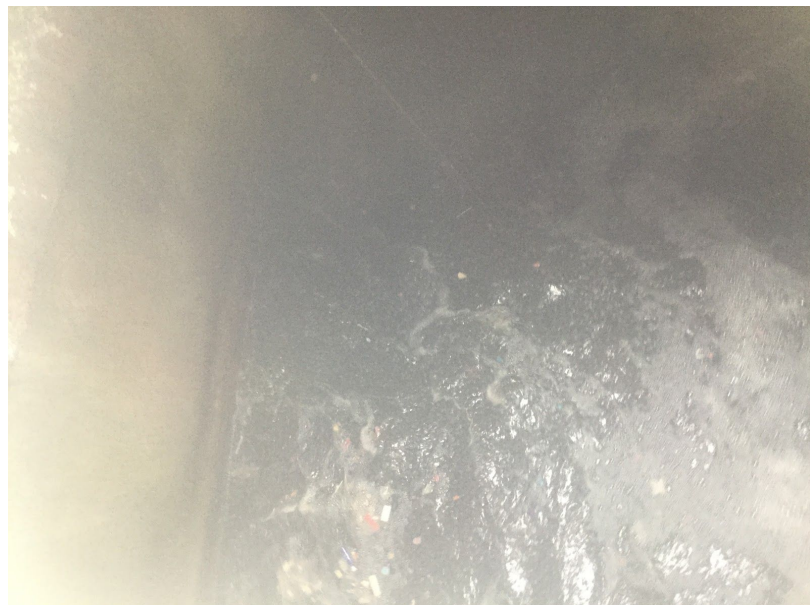
Smoke saturation in MBBR Tank

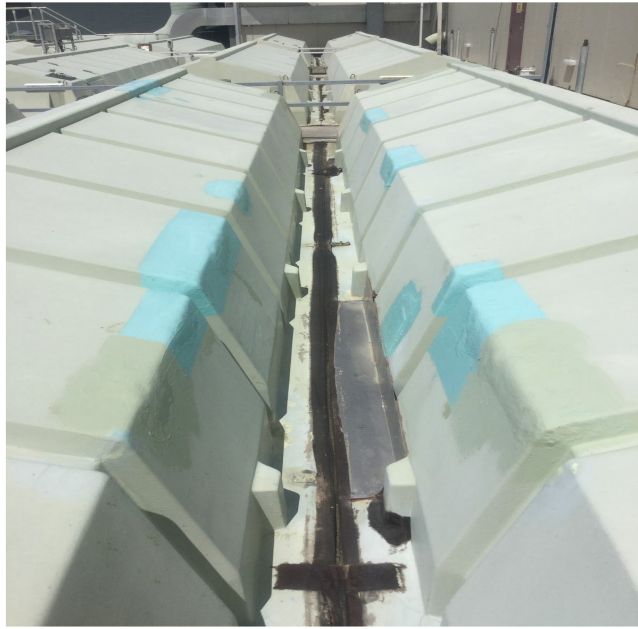
Seal between MBBR Covers

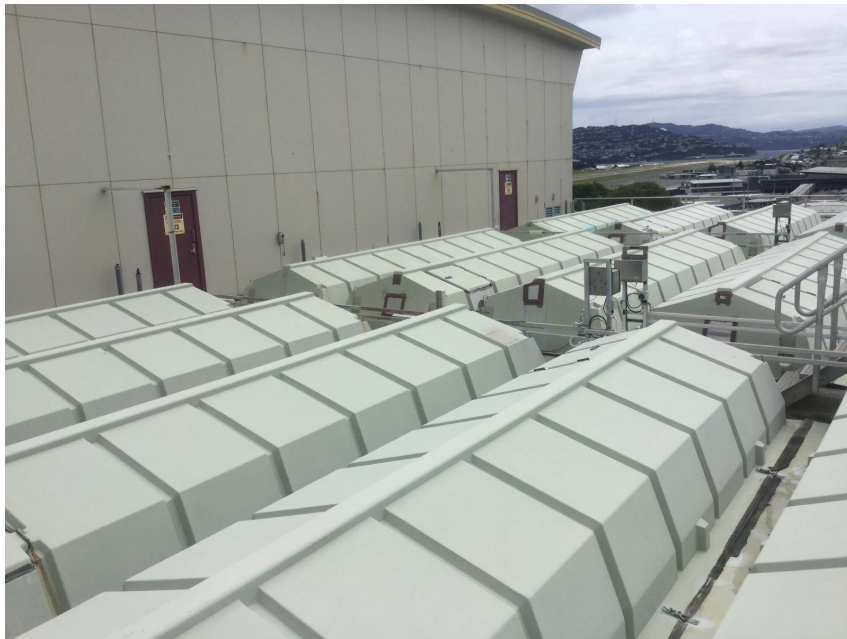
MBBR Covers

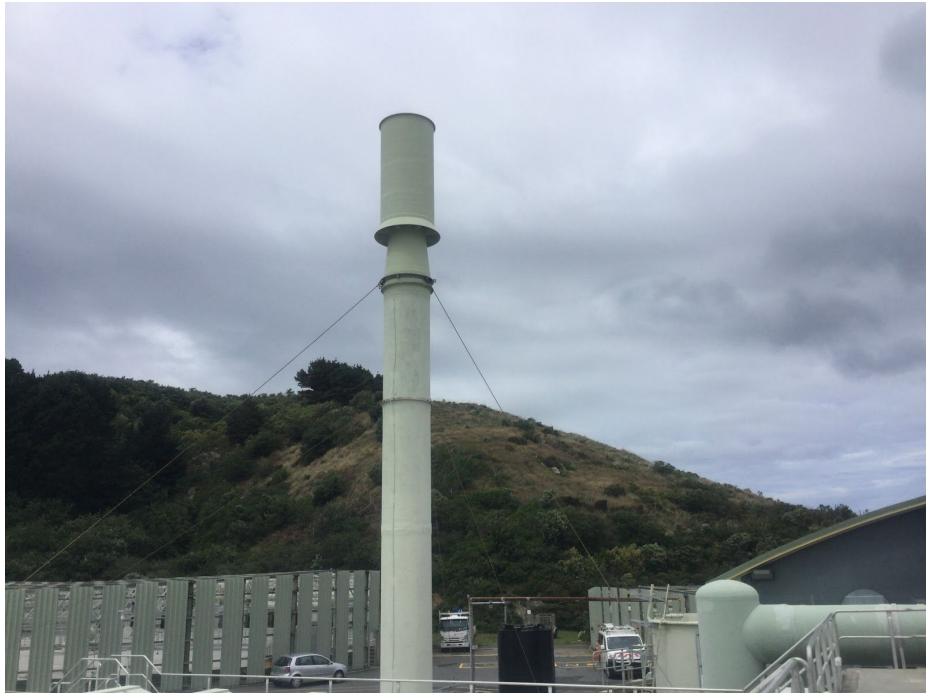
During the testing of the Primary tanks and the MBBR tanks no smoke was observed exiting from the Moa scrubber stack.

Moa Scrubber stack

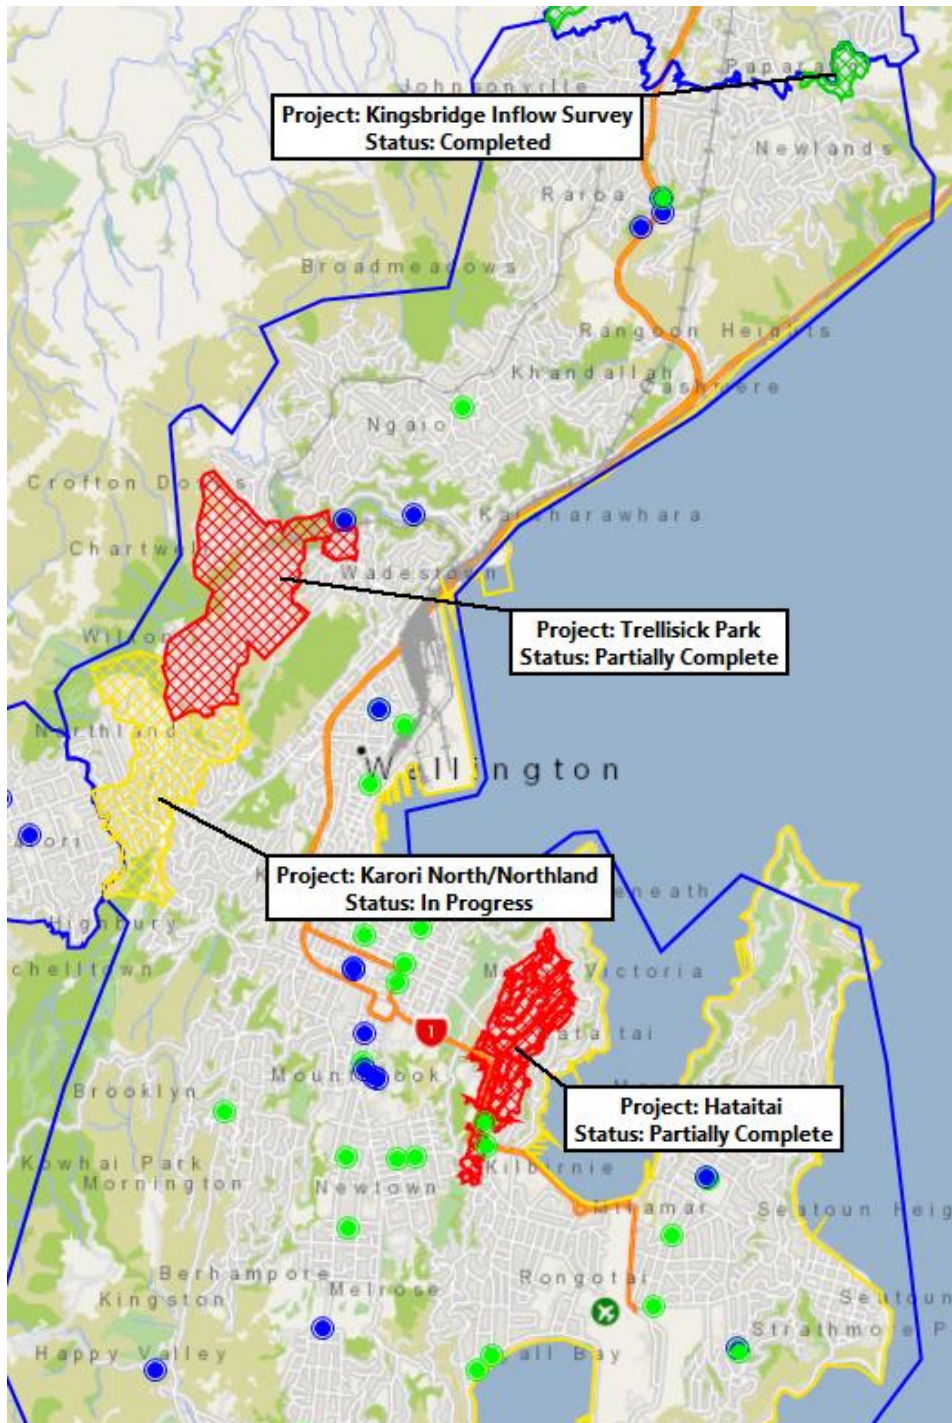
Figure 1 - Inflow Survey Project Locations

Inflow surveys have been undertaken in 2020-2021 financial year in the Moa Point WWTP Catchment. A map showing where the recent inflow surveys projects have commenced is provided in Figure 1. Kingsbridge inflow survey was recently completed and is shown below in green. Karori North/Northland Inflow Survey is currently in progress and is shown below in yellow. Two inflow survey projects commenced in 2017-2018 and were only partially completed, which are shown in red

in Figure 1. These two catchments; Hataitai and Trelisick Park, will be the focus for any new projects that are able to commence in the 2021-2022 financial year.

The final inspections for the Kingsbridge Inflow Survey were completed in December 2020. This catchment was selected for an inflow survey due to significant peak wet weather flows. Two properties in this catchment were found to have their stormwater and wastewater pipes cross-connected which have since been resolved. Post-rehabilitation flow monitoring has not been undertaken, however an affected customer advised since the inflow survey works were completed, there has been no wastewater surcharges in wet weather at their affected property.

The Karori North / Northland Inflow Survey is partially complete with re-inspections planned for the 2021-2022 financial year. This project detected multiple public faults which inhibited the completion of smoke testing. During 2020-2021 the public faults were repaired by the Customer Operations Group (COG) to enable the completion of property inspections. Re-inspections are planned for August and October 2021, with completion of the project scheduled for December 2021.
