## Wellington Water – Seaview Odour Investigation Study

# Odour Assessment

**Document Title:** WWL - Seaview Odour Investigation Study

**Date of issue:** 9 June 2023

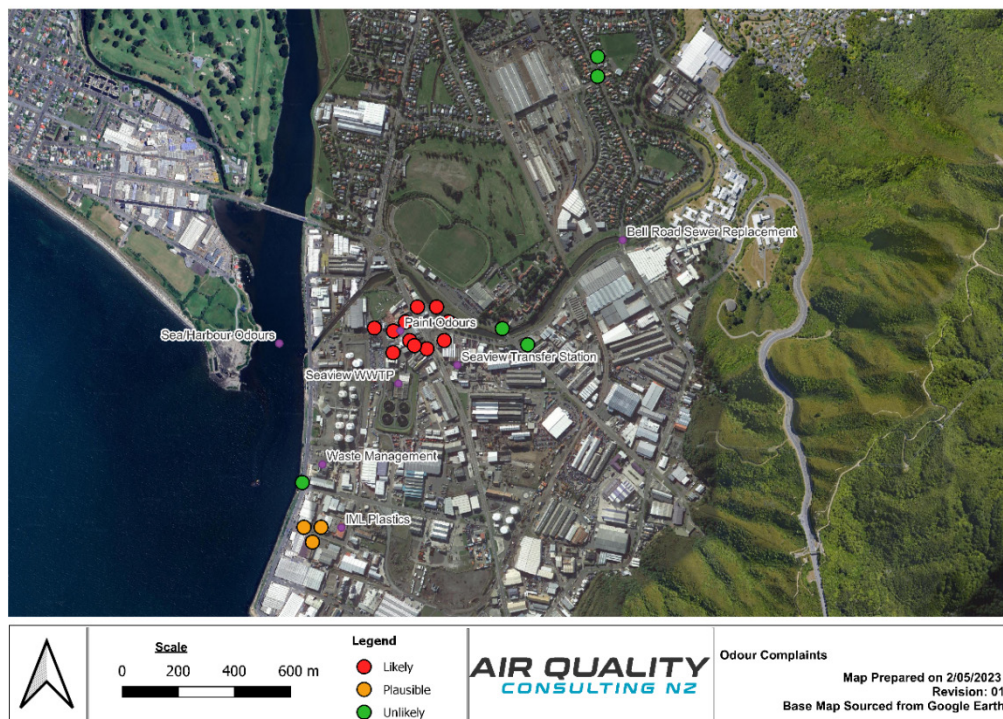
**Figure 2: Odour Complainants – the likelihood of odour being attributed to SWWTP**

Using prevailing wind data at the time of the complaint, AQCNZ has assessed the likelihood of each complaint being attributed to odour from SWWTP. This information is presented in Figure 2, with the coloured dots indicating whether the complaint is considered 'Likely', 'Plausible' or 'Unlikely' to be attributed to SWWTP. AQCNZ has also annotated on the Figure the location of other sources of odour that could cause complaints.

The complaints on Bell Road and Hutt Park Road occurred while the plant was downwind of the complainant, suggesting that these odours were from another source. AQCNZ understands that a significant wastewater network project is currently underway near this location, and construction works have been identified as a source of odour. This odour was observed as part of the independent odour study, as discussed in the following section of the report. Overall, the complaints from these locations are unlikely to be attributed to SWWTP discharges and are more likely related to construction works.

The complaints on Gough Street typically aligned with conditions where the complainant was downwind of the plant. This factor, combined with the limited distance between the plant and the complainant, suggests that the plant is the most likely cause of the complaint. Similarly, the complaints triggered by odours observed near Seaview/Parkside Roundabout are likely from the plant. However, not all of these occurred while the plant was upwind of the complainant, suggesting that some could be related to the Barber Grove to Seaview Wastewater Pipe Duplication Project. For the purposes of this assessment, given the close distance to the plant, AQCNZ has classified all of these complaints to be “likely” caused by SWWTP odours.

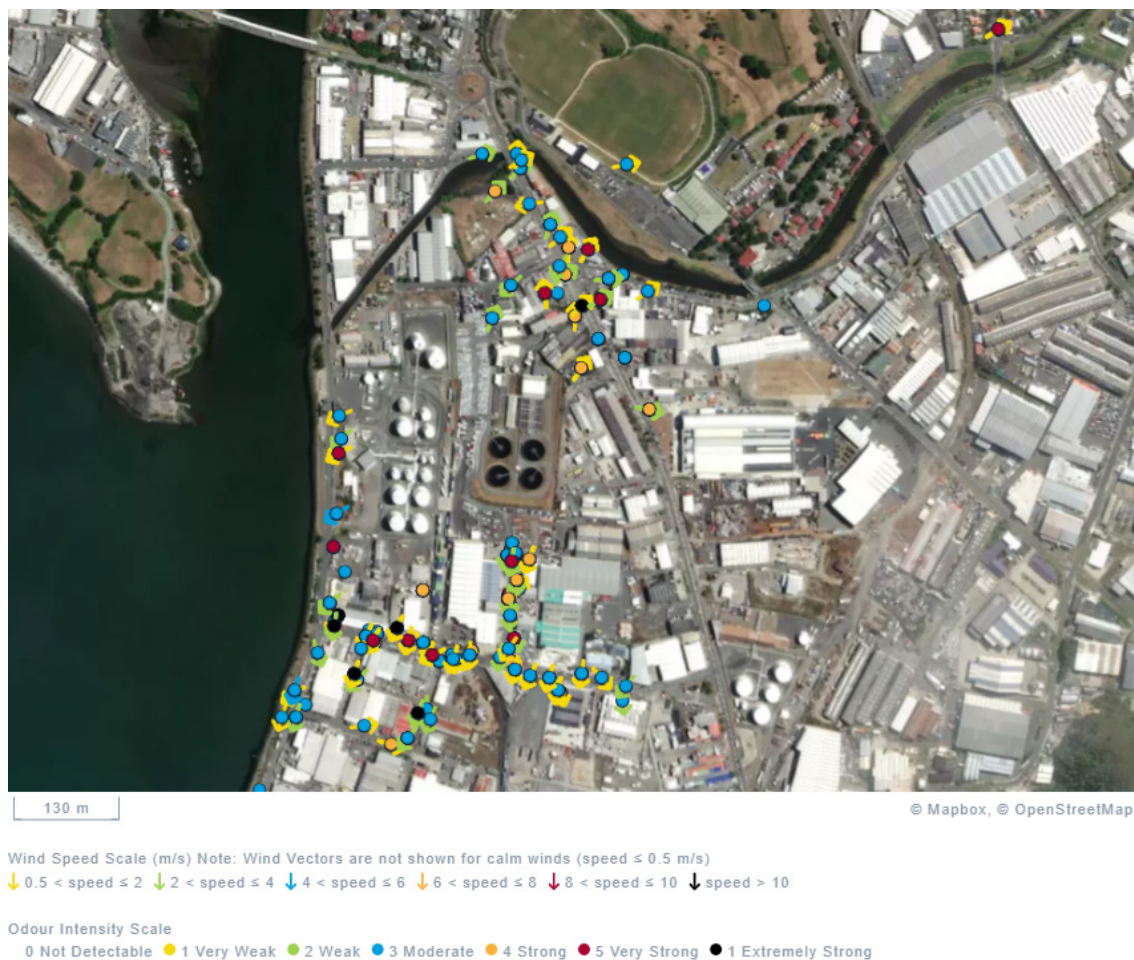
**Figure 4: Odour Survey Results – Odour Intensities  $\geq$  Moderate**

Given that odours with an intensity of “Very Weak” or “Weak” are unlikely to trigger complaints, AQCNZ has focussed on odour intensities “Moderate” and above. Figure 4 shows all of the locations where odour observations detected odours with an intensity of “Moderate” and “Extremely Strong”. This includes all types of odours, including those likely to be attributed to other sources, i.e. construction activities and neighbouring industries etc.

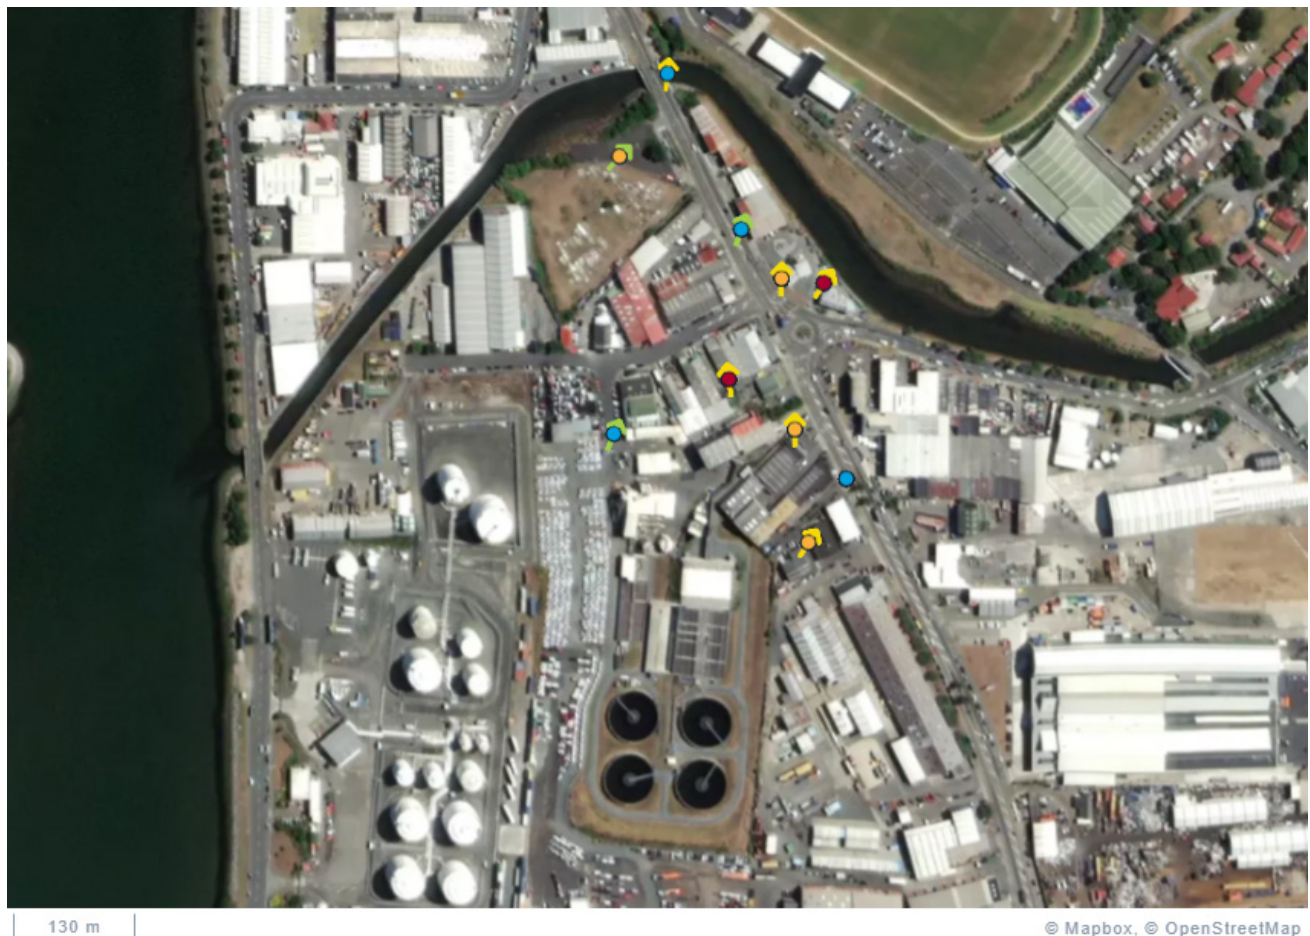
Figure 6: Odour Survey Results – Southerly Wind Direction and Odour Intensities  $\geq$  Moderate

- Moderate intensity odours associated with WWTP can be detected 250 m from the Site boundary.
- Strong intensity odours associated with WWTP can be detected 190 m from the Site boundary.
- Very Strong intensity odours associated with WWTP can be detected 85 m from the Site boundary.

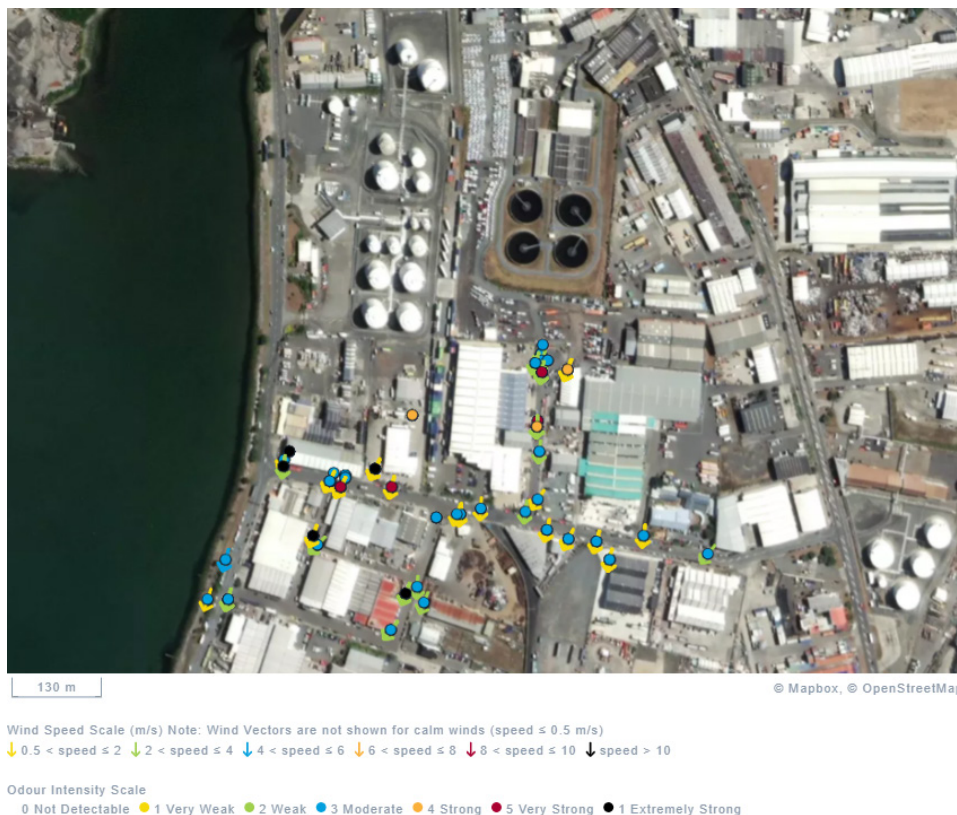
Figure 7: Odour Survey Results – Northerly Wind Direction and Odour Intensities >= Moderate

There were five observations where extremely strong odours were detected. However, only one of these observations identified odour characters associated with SWWTP. For this single observation, odour characters were primarily identified as being related to [redacted] operations, with odour characters such as acrid and putrid being noted with intensities ranging between moderate and extremely strong. Odours identified as being related to SWWTP were detected only 20% of the time, with the odour intensity ranging between “Weak” and “Extremely Strong”.

This location was approximately 300 m from the SWWTP boundary and adjacent to [redacted] on the corner of Port Road and Barnes St. AQCNZ considers there is insufficient information to conclude that “Extremely Strong” odours are frequently present this far from SWWTP.

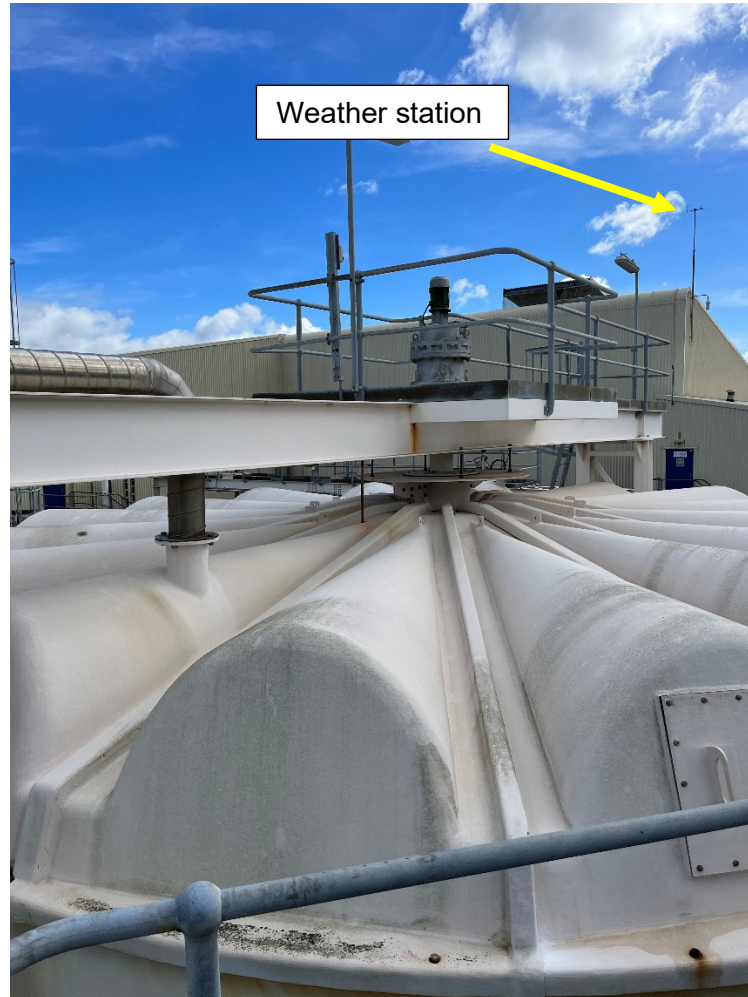
Figure 14: Weather station

While SWWTP has a meteorological station installed at the Site on top of the dryer building, the data for the period reviewed was unavailable due to a fault with the data logging system (Refer to Section 6, where AQCNZ recommended that the system is repaired/replaced to allow for future data collection). AQCNZ has therefore used the nearest publicly available wind data measured at the GWRC's air quality monitoring station at Birch Lane (**Birch Lane AWS**) to assist with analysing the complaints.

- 1) The existing on-site weather station should be replaced with a suitable system to allow wind speed and wind direction data to be recorded to assist with any future complaint investigations.
- 2) AQCNZ noticed that the odour complaint record often didn't identify the complainant's location, making it difficult to investigate the cause of odour. While complainants are often reluctant to provide location information, where possible, WWL/GWRC should encourage the complainant to at least provide their general location, i.e., the odour was observed to the northeast of the site. This will protect their identity while still providing helpful information to investigate the complaint.

It is recommended that the existing site weather station (Figure 14) should be replaced with a suitable system to allow wind speed and wind direction data to be recorded. This will help with future complaint investigations and inform site odour surveys.
