CATHODIC PROTECTION SYSTEM ASSESSMENT MOA POINT WASTE WATER OUTFALL PIPELINE

WELLINGTON WATER LIMITED MOA POINT WWT PLANT

DOCUMENT NUMBER: CCE-R-2403-0393-0100A

DATE: 21 March 2024

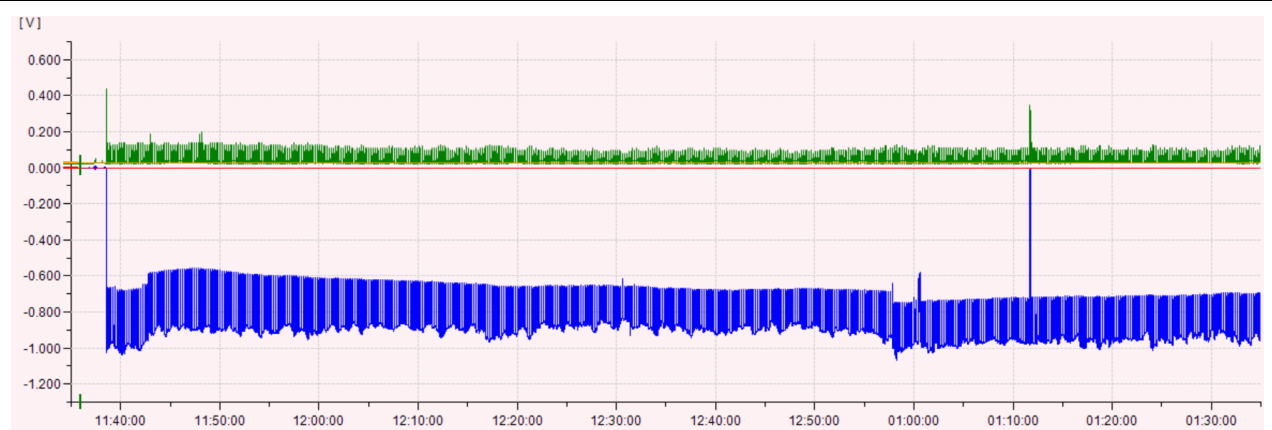
Figure 2, Datalogging of Temporary Coupon Potentials (Depolarization)

Appendix A, Figure-3, provides a representative extract of potential measurements for the coupon while carrying out a depolarization test.

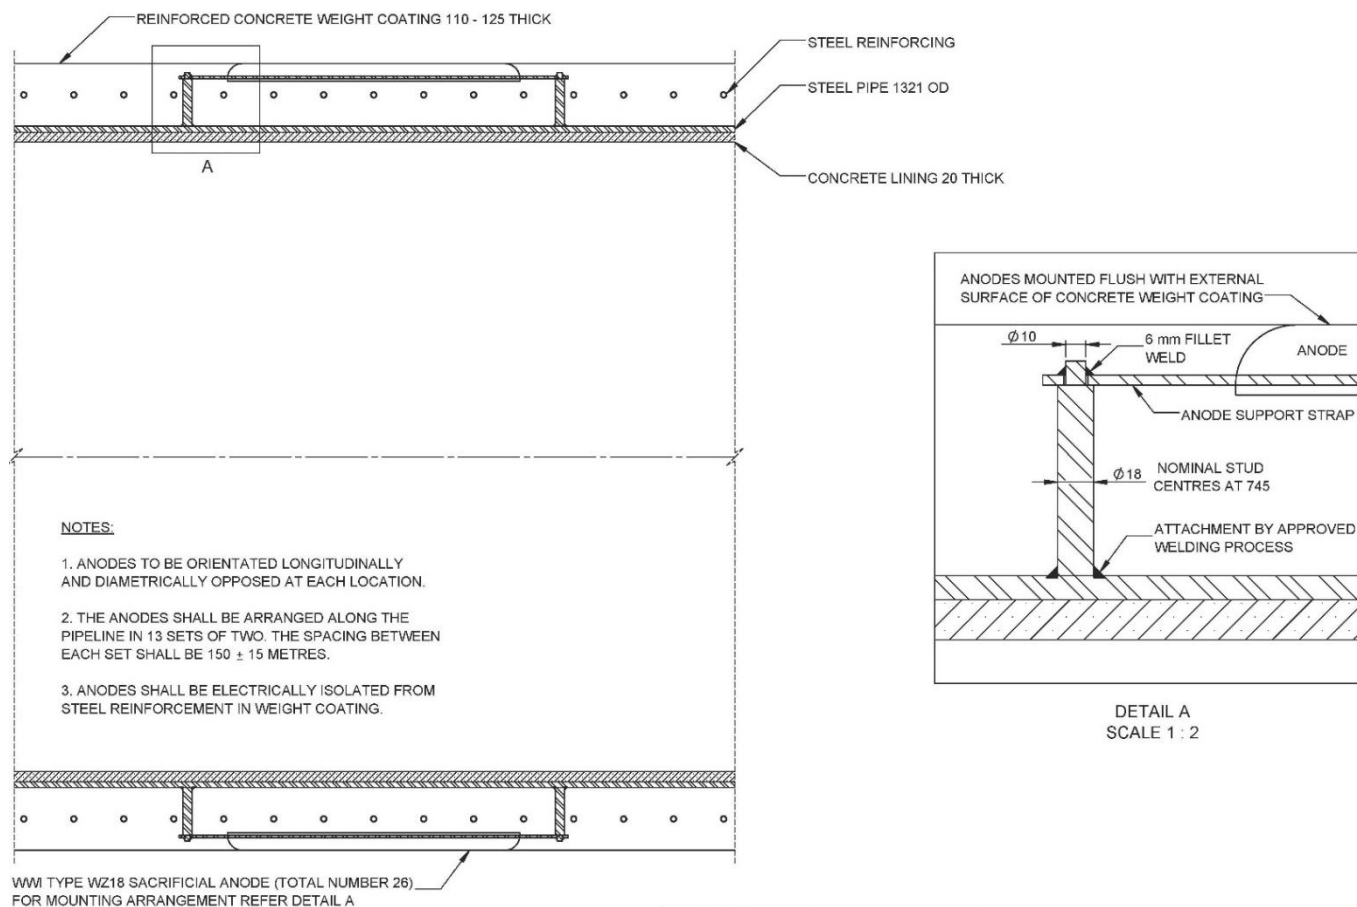
Figure 15: CP Sacrificial Anode Design Arrangement

Each anode is embedded longitudinally in the concrete weight coating, with the outer face exposed end flush with the concrete external surface. Each anode is in electrical contact with the pipeline by two studs at the appropriate height and spacing centres. Each stud is attached to the pipe surface by means of weld process. Anodes are electrically isolated from all weight coating steel reinforcement.

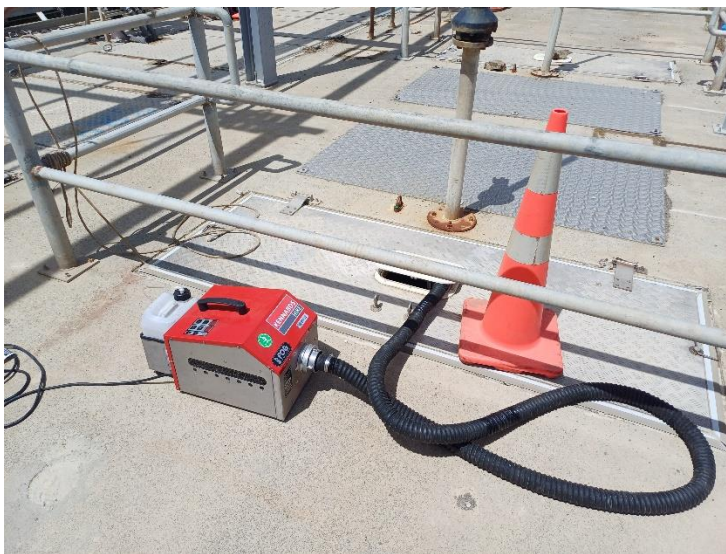
■ **Figure 1: Moa Pt IPS Smoke Machine, 26 January 2024**

On 26 January 2024, the annual smoke testing of the Moa Pt WTP IPS was carried out to identify any potential fugitive odour emissions. The outlet from an industrial smoke machine was inserted into an inspection hatch above of one of the wet well (see Figure 1) and allowed to fill the chamber for approximately 30-minutes. Within a few minutes, light smoke was observed exiting the IPS scrubber stack as depicted in Figure 2. Unfortunately, the smoke was very light and was not captured by the photo.

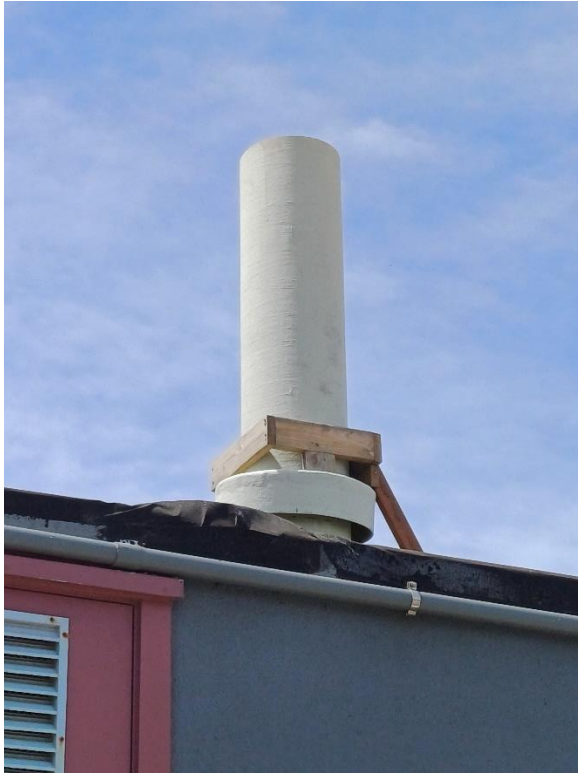
■ **Figure 2: Moa Pt IPS Scrubber Stack, 25 November 2022**

Despite the poor condition of the seal, there were no visible smoke emissions, confirming the IPS odour control system was maintaining negative pressure and therefore minimising the potential for fugitive odour emissions.

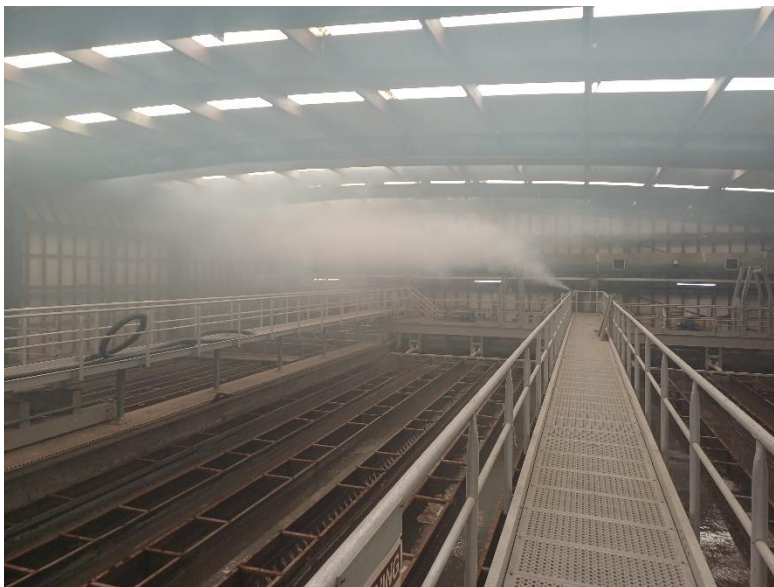
■ **Figure 4: Moa Pt Primary Tanks, 26 January 2024**

On 26 January 2024, the annual smoke testing of the Moa Pt WTP primary treatment room was carried out to identify any potential fugitive odour emissions. The industrial smoke machine was placed at the inlet end of the primary treatment room (see Figure 4) and allowed to fill the room for approximately 45-minutes. Once the building was full of smoke, the exterior of the building, including the roof, was observed to identify any discharges of smoke indicative of potential fugitive emissions. The assessment found no smoke discharges, confirming compliance with Condition 10 of the Company's resource consent.

The buildings ventilation rate was estimated by determining the time taken to clear 95 % of the smoke. On 26 January 2024, this took approximately 30-minutes indicating a ventilation rate of two-room changes per hour, which was lower than measured in November 2022 and was low for this type of process with engineering specifications ranging 3 to 5 room changes per hour, up to 10 room changes in cases where workers are required to routinely enter the area.

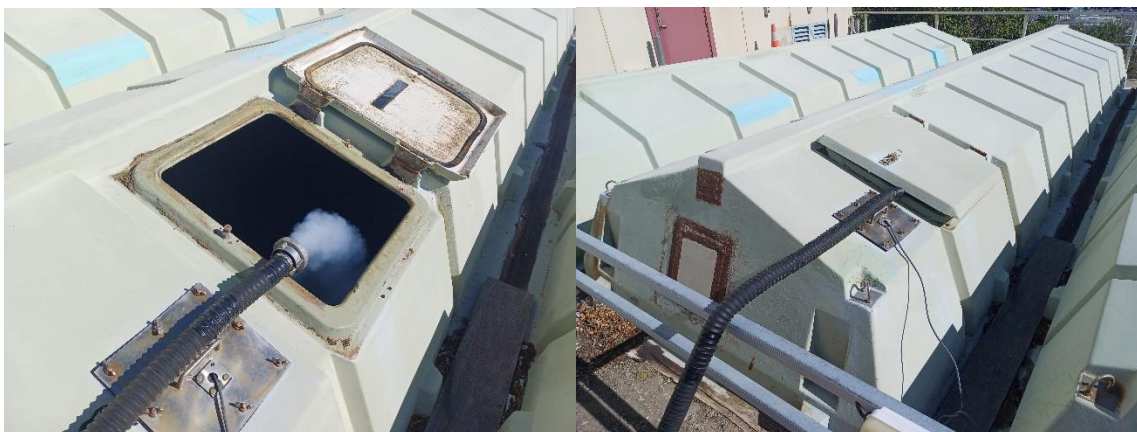
■ **Figure 6: Moa Pt MBBR Tanks Smoke Test, 26 January 2024**

After 30-minutes, a visual assessment of the tank covers did not identify any smoke, confirming the odour control system was providing sufficient extraction to minimise the potential for fugitive odour emissions. The lack of visible emissions demonstrates compliance with Condition 10 of the Company's resource consent.

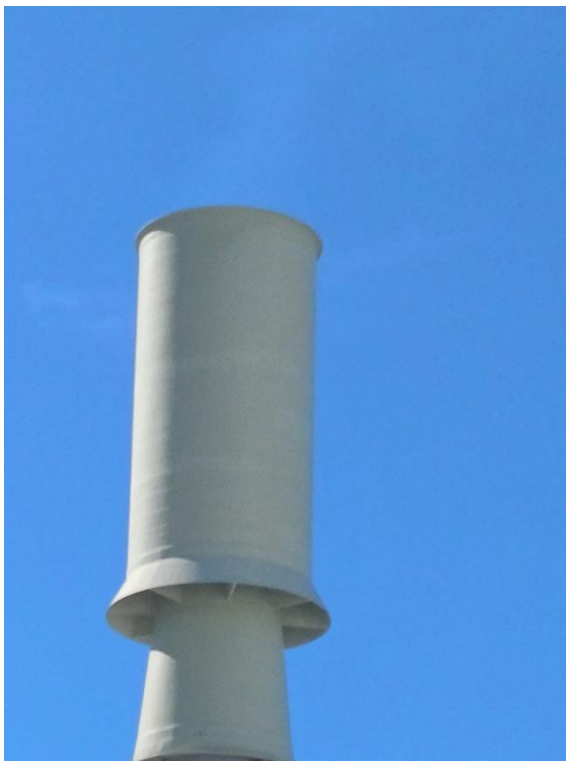
■ **Figure 8: Moa Pt Main Scrubber Stack, 26 January 2024**

On 26 January 2024, the annual smoke testing of the Moa Pt WTP secondary treatment processes was carried out to identify any potential fugitive odour emissions. The outlet of the industrial smoke machine was placed in one of the hatches of the MBBR tanks (see Figure 6) and allowed to fill the chambers for approximately 30-minutes. The process was then repeated for the RAT with the outlet of the smoke machine inserted into an access hatch as depicted in Figure 7. Within a few minutes, light smoke was observed exiting the main scrubber stack (see Figure 8), however, the smoke was very light and difficult to captured in a photo.

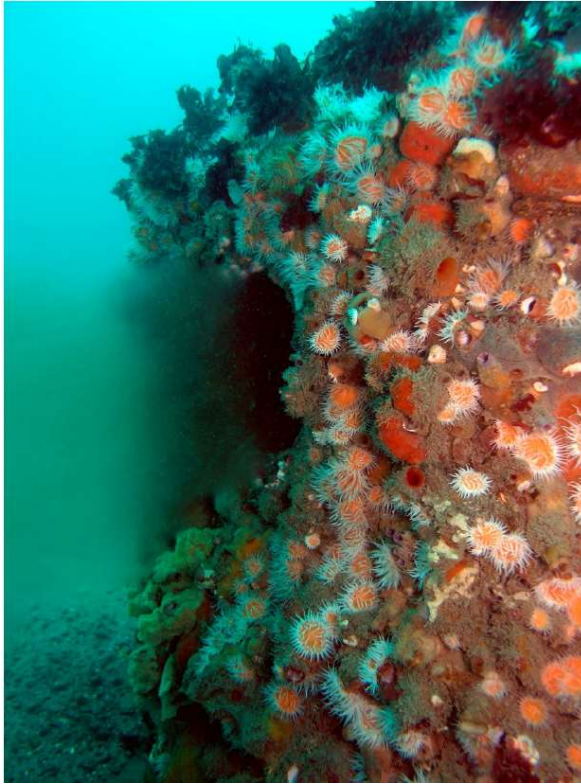
The seabed around the risers consisted of gravels, pebbles and cobbles (up to 30 cm diameter) and small patches of smaller gravel or coarse sand (Plate 2). Disturbance of the sediments by divers showed that there was a small amount of fine, easily suspended material within the matrix of gravel and pebble. Structurally, the bed featured large ripples created by wave action and possibly tidal currents. The lower parts of some risers were not fouled, and this may be the result of abrasion by coarse sediments moved by water currents.

Plate 1: View of a diffuser riser and fouling assemblage, May 2018

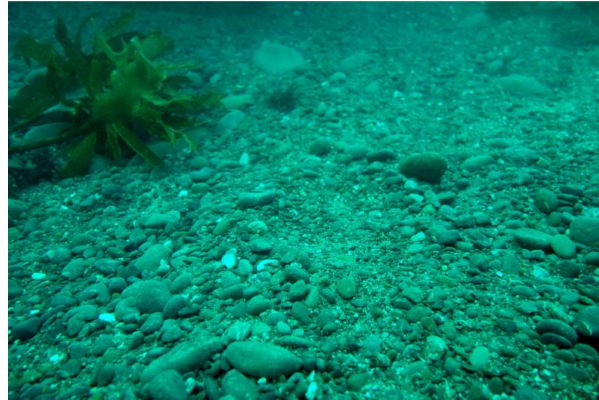
Plate 2: Seabed deposits of cobbles, gravel and sands forming undulating peak and depressions around the diffuser position, May 2018

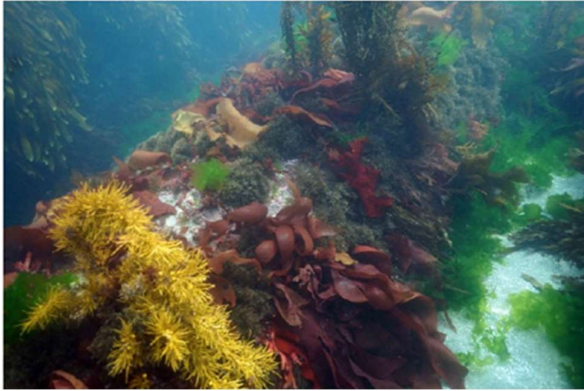
The annual pipeline inspection repeated in February 2021 providing a photographic record of the condition of the pipeline, diffusers, and surrounding seabed during and after a sustained period of sub-optimal discharge quality (Undersea Construction Ltd, 2021). Plates 3 and 4 show the shoreward end of the pipe approximately 30m and 60m from shore. The authors observed that the first 80m of the shoreward section is exposed but beyond that the pipeline is buried under the seabed, except for the risers on the diffuser section at the seaward end.

Plate 3: View of the pipeline 30m from shore, Feb 2021

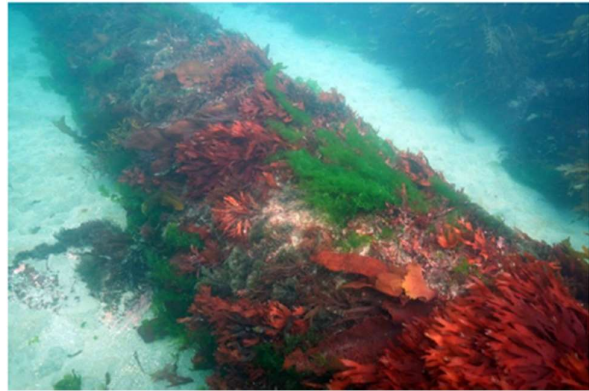
Plate 4: View of the pipeline 60m from shore, Feb 2021

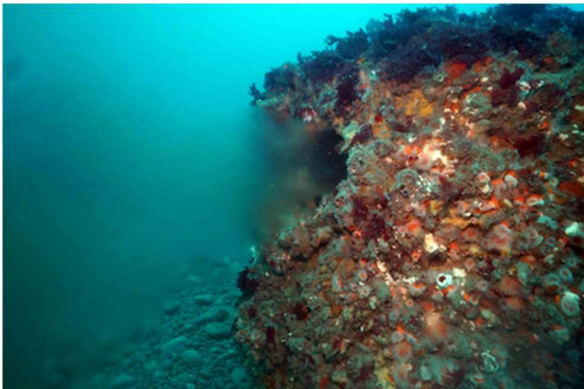
Plate 5 shows the fouling assemblage on a diffuser riser near the seaward end of the pipeline in February 2021 which appears to be similar to that recorded on a riser in May 2018 (it is not clear whether this is the same riser or an adjacent one), and Plate 6 shows the seabed surrounding a diffuser consisting of cobbles, gravel and sands, which is similar to that recorded in May 2018.

Plate 5: View of a diffuser riser and fouling assemblage, Feb 2021

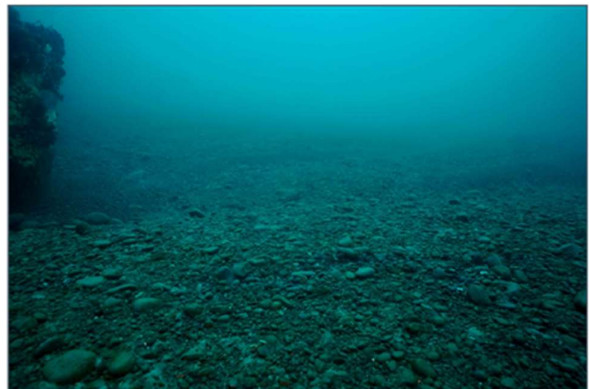
Plate 6: Seabed deposits of cobbles, gravel and sands around the diffuser position, Feb 2021.
