<b>Document Title</b>	UCL – QMS – IMS – Moa Point Waterwater Outfall Pipeline – Annual Inspection
<b>Document No.</b>	QMS – Item: Inspection – Moa Point Pipeline – March 2025 – Rev. 0
<b>Date Developed</b>	February 2025
<b>Last Review Date</b>	March 2025
<b>Date of Client Issue</b>	13 <sup>th</sup> May 2025

## MOA POINT WASTEWATER OUTFALL PIPELINE – ANNUAL INSPECTION

March 2025

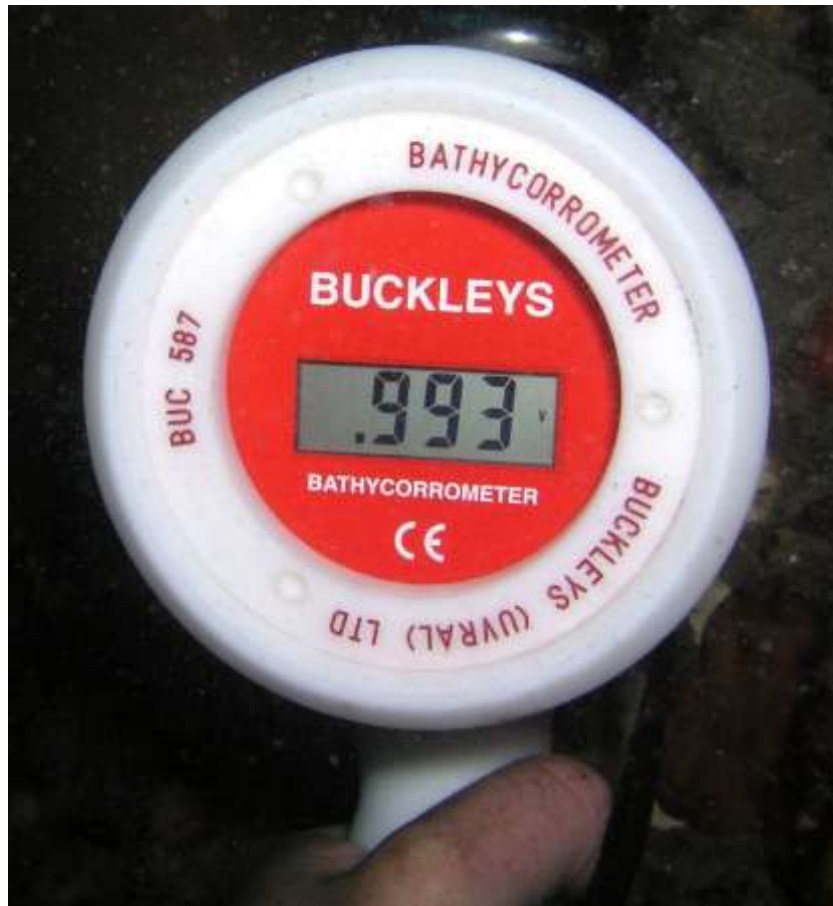
Figure 20: BCM (Cathodic Potential Meter) in operation

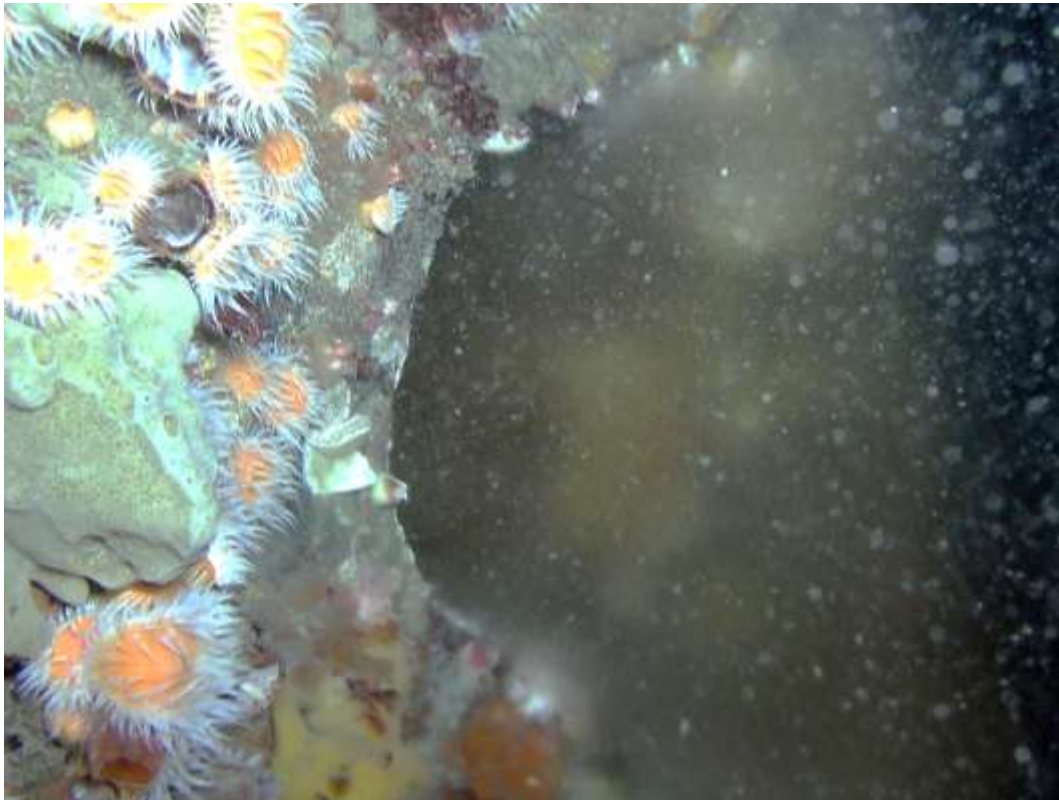
<b>MOA POINT WASTE WATER OUTFALL PIPELINE OFFSHORE DIFFUSER SECTION CATHODIC PROTECTION TESTING</b> 27 <sup>th</sup> March 2025			
<b>CP Instrument</b>		<b>Calibration Check Values</b> Against Zinc Alloy Test Block	
Buckleys BCM (Cathodic Potential Meter) Reference Electrode: Ag/AgCl		<u>Prior</u> -1.050V	<u>Post</u> -1.048V
<b>Diffuser #</b>	<b>Discharge Nozzle or Test Plate</b>	<b>Pipe Potential verses Ag/AgCl reference</b>	<b>Time: (NZDST) approx. only</b>
1	Test Plate	-1.007V	09.45
3	West	-1.001V	09.48
7	West	-1.002V	09.53
11	East	-0.993mV	09.59
17	East	-1.005V	10.05

Figure 21: Diffuser nozzle steel port face, where CP values are checked
