# Moa Point Wastewater Treatment Plant

Annual Resource Consents Report 2021/2022

**Document Title:** Moa Point Wastewater Treatment Plant Annual Resource Consents 2021/2022

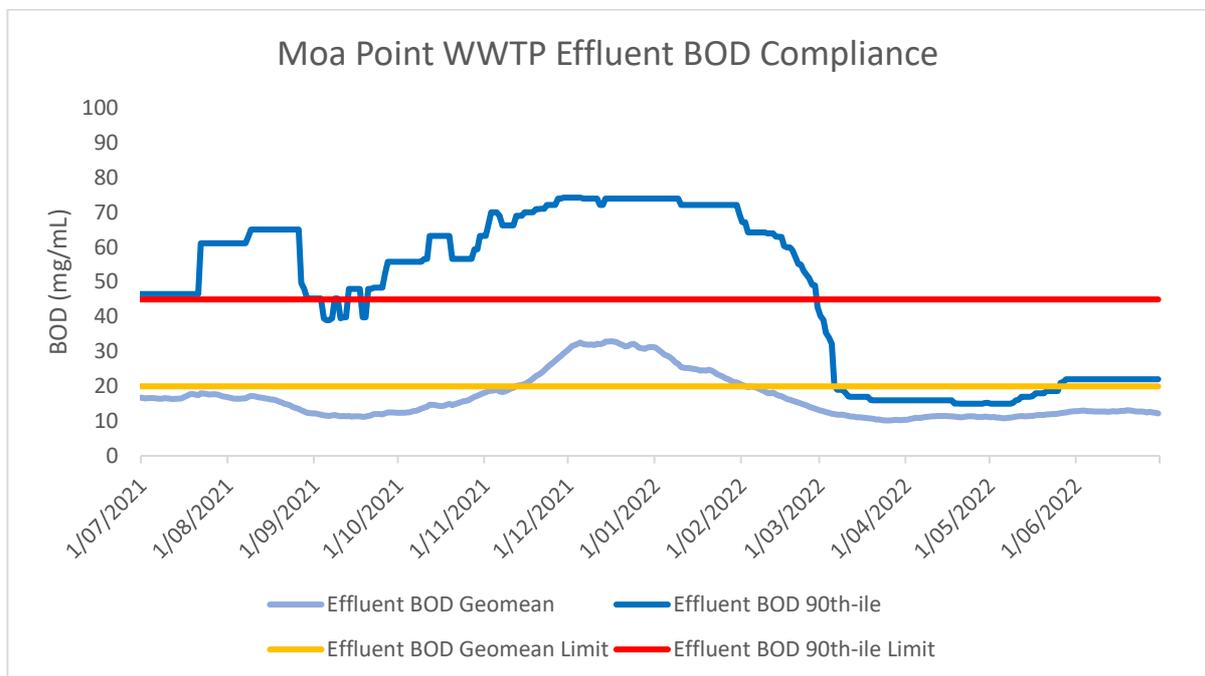
Figure 2: Effluent Carbonaceous Biological Oxygen Demand Results Geometric Mean and 90th Percentile

The plant was not able to consistently meet the consent requirements for effluent quality for this reporting period due to BOD, faecal coliforms and suspended solids non-compliances. The exceedances can be majorly attributed to asset failures. A please explain letter was received on the 3<sup>rd</sup> of March 2022, and a response was forwarded to the regional council on the 8<sup>th</sup> April.

There were exceedances in the effluent BOD results in the past two financial years which can be majorly attributed to a series of asset failures in the treatment plant. The daily results are now returning to be below consent limits since the end of FY2021/2022.

Asset failures were rectified as soon as it was confirmed that it was causing non-compliance to the treatment plant. There were delays on the repair due to disruption brought by COVID19.

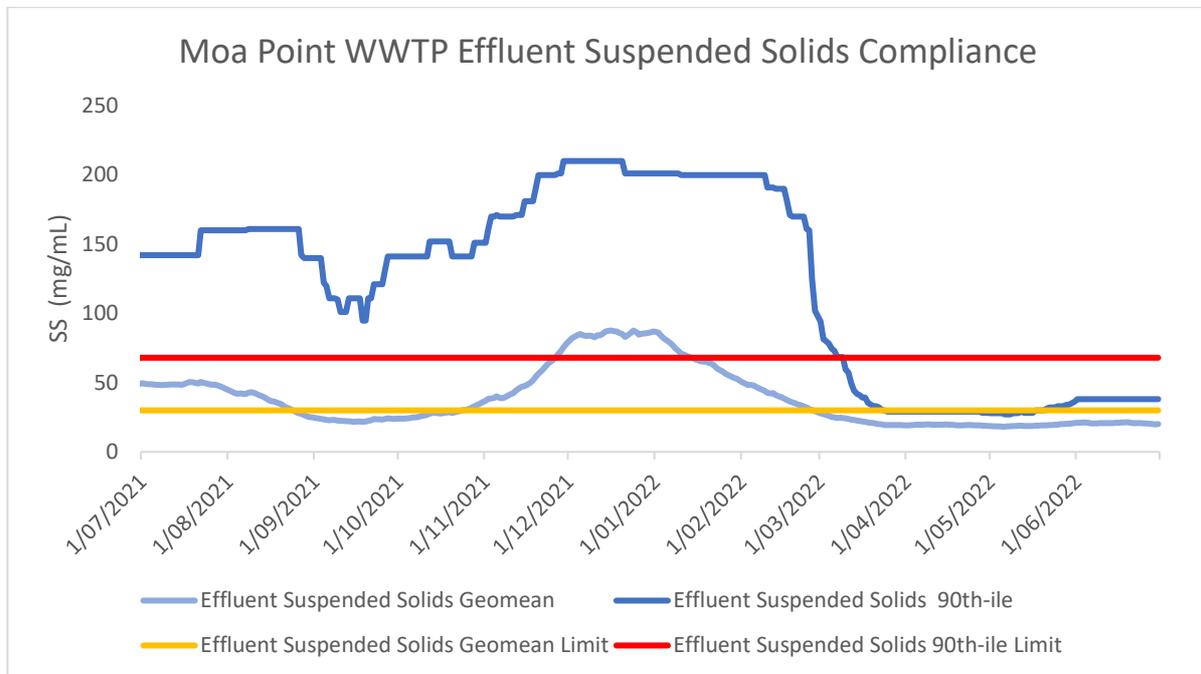
**Figure 3: Effluent Suspended Solids Results Geometric Mean and 90th Percentile**

There were exceedances in the effluent suspended solids results in the past two financial years which can be majorly attributed to a series of asset failures in the treatment plant. The daily results are now returning to be below consent limits since the end of FY2021/2022.

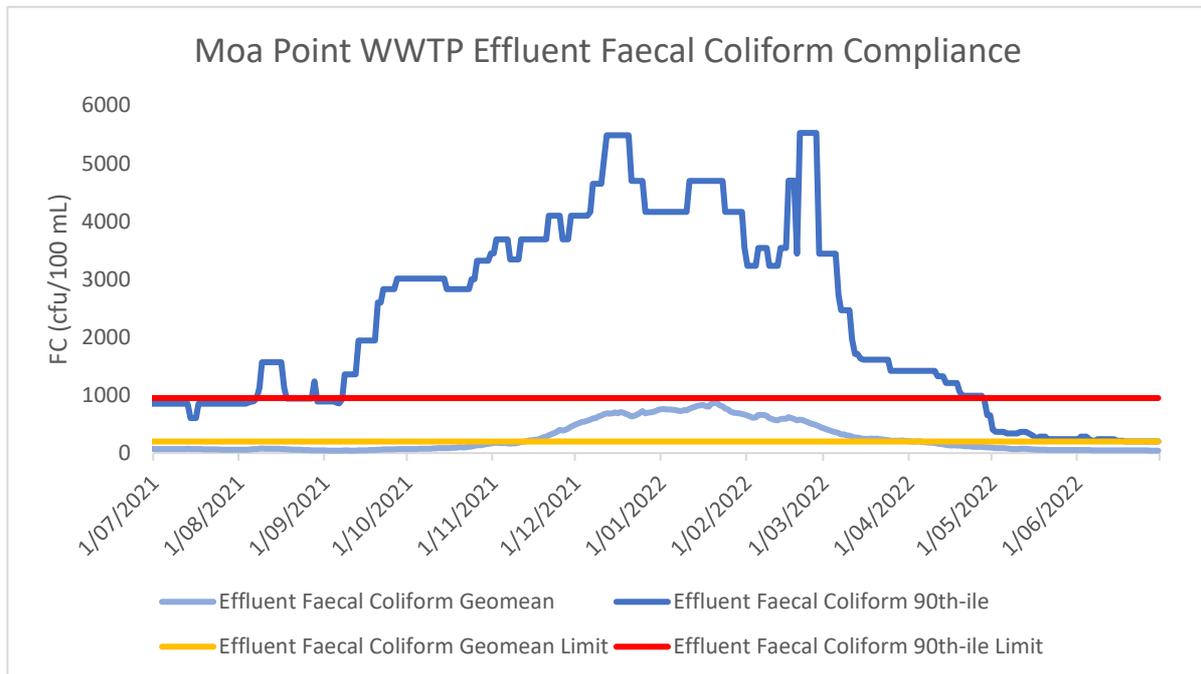
**Figure 4: Effluent Faecal Coliform Geometric Mean, and 90th Percentile**

There were exceedances in the effluent faecal coliform results in the past two financial years which can be majorly attributed to a series of asset failures at the treatment plant. The daily results are now returning to be below consent limits since the end of FY2021/2022.

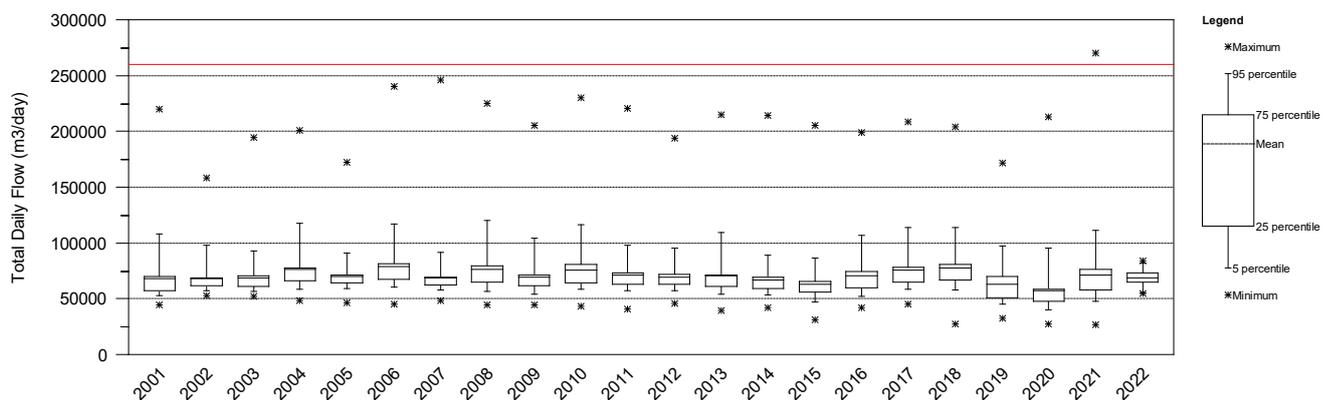
**Figure 3-1:** Total daily effluent flow rate from Moa Point WWTP (maximum permitted flow indicated by red line)

Condition 2 of the continuous discharge consent states that: “*The rate of discharge shall not exceed 260,000 cubic metres per day (m<sup>3</sup>/day)*”. Figure 3-1 shows a single data point above that limit (red line) on 6 December 2021 when the flow volume was 270,060 m<sup>3</sup>. This occurred during a period of sustained heavy rainfall and is the only exceedance on record. Perhaps more importantly, the box plots show that wastewater flows have not increased over the last 20 years despite significant population growth in the wastewater catchment over that period.

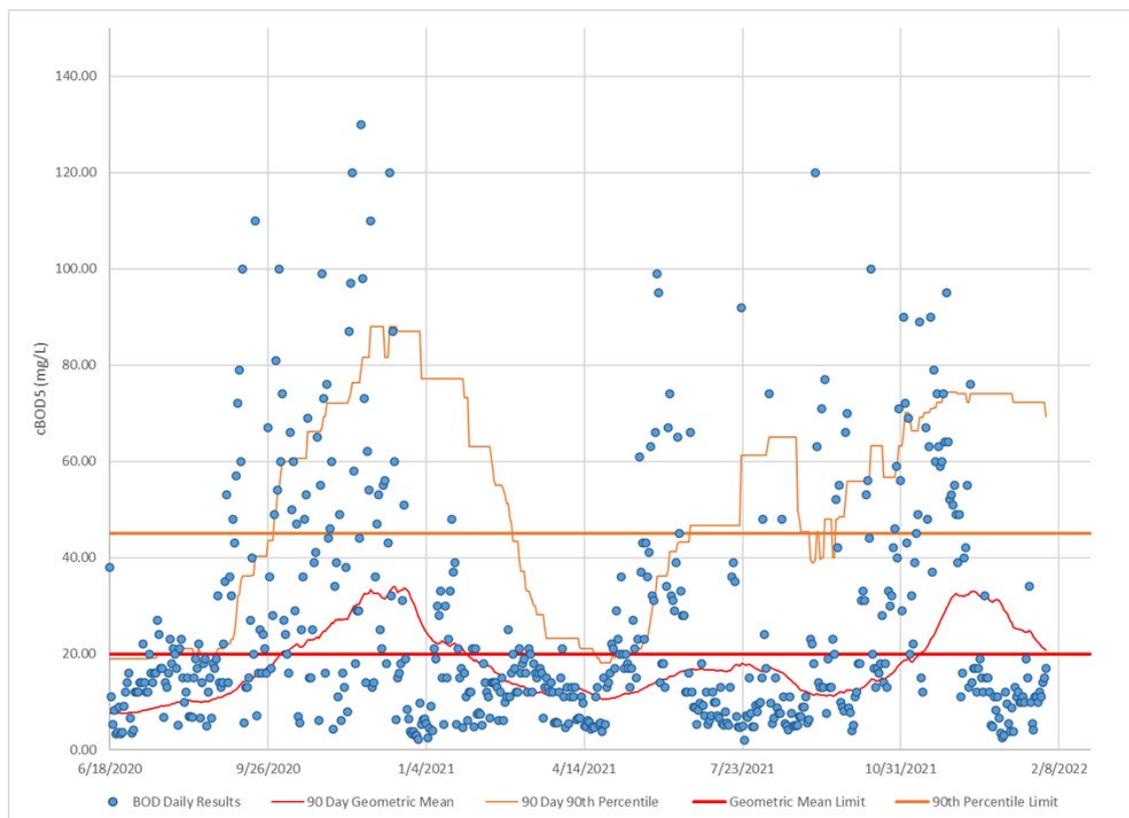
**Figure 3-3:** Daily treated wastewater cBOD<sub>5</sub> (mg/L), 90-day geometric means and 90-day 90<sup>th</sup> percentiles

Figure 3-2 summarises the daily monitoring results for cBOD<sub>5</sub> showing fairly consistent results for years 2001 until 2019, and a marked increase for years 2020 and 2021. Figure 3-3 focuses in on the 2020 to 2022 period, showing persistent exceedance of the geometric mean and 90<sup>th</sup> percentile consent limits. Table 3-1 shows that median and upper percentile values increased sharply over that period with a maximum cBOD<sub>5</sub> concentration of 310 mg/L.

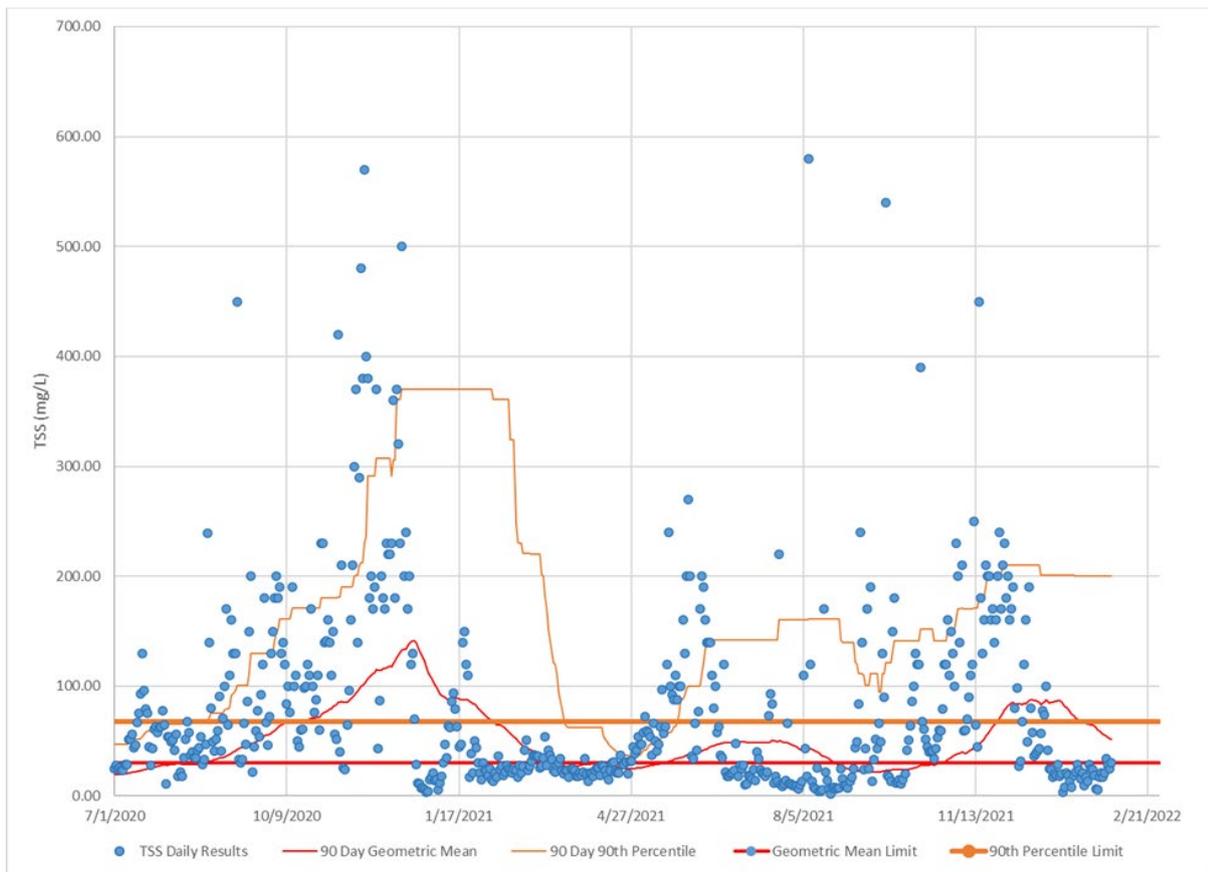
**Figure 3-5:** Daily treated wastewater TSS (mg/L), 90-day geometric mean and 90-day 90<sup>th</sup> percentile

Figure 3-4 summarises the daily monitoring results for Total Suspended Solids (TSS) showing relatively consistent results for years 2001 to 2019, and a marked increase for years 2020 and 2021. Figure 3-5 shows extensive exceedance of the geometric mean and 90<sup>th</sup> percentile consent limits during 2020 and 2021. Median and upper percentile TSS values increased sharply over this period with maximum concentrations at nearly 600 mg/L (Table 3-2).

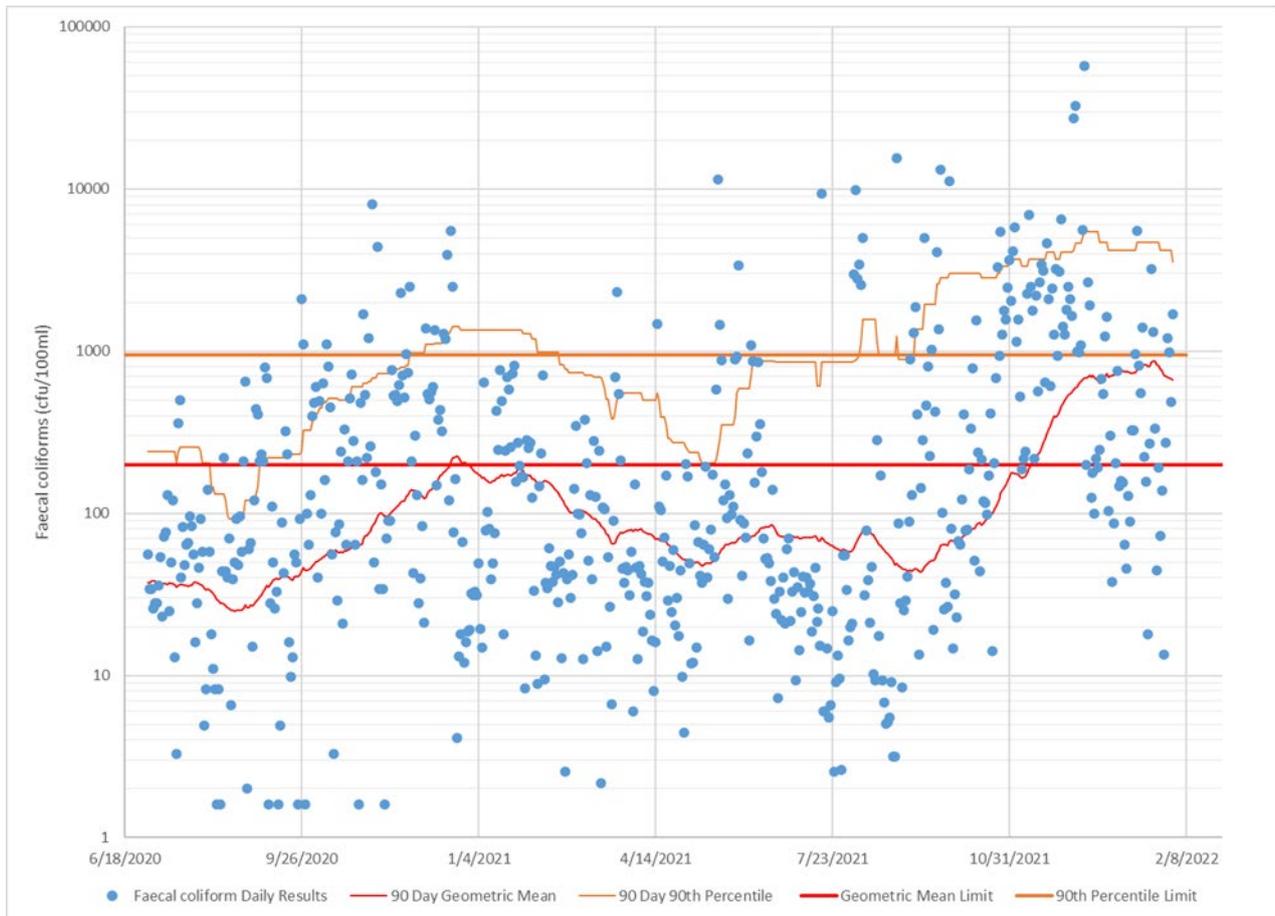
**Figure 3-7:** Summary of daily treated wastewater faecal coliform results (cfu/100ml) on a log scale

Figure 3-6 summarises the daily monitoring results for faecal coliforms by year showing a progressive increase in upper percentile values during 2019, 2020, 2021 and 2022. Figure 3-7 shows significant exceedance of the geometric mean and 90th percentile consent limits, especially from late 2021. Median and upper percentile values increased sharply over that period with maximum faecal coliform concentrations close to 60,000 cfu/100 ml (Table 3-3).

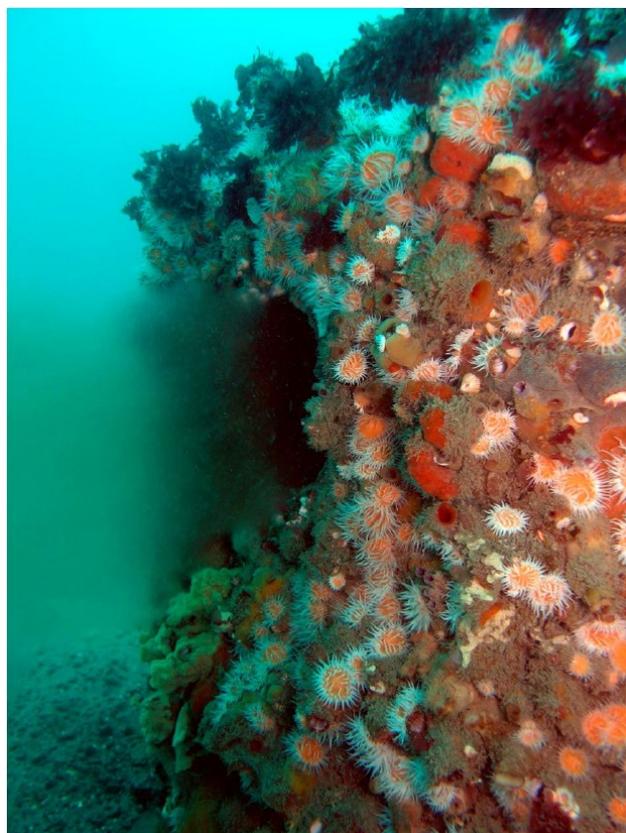
An ecology survey was conducted around the outfall diffuser by Cawthron marine ecologists on 7 May 2018 (Morrissey, 2018). The ecological survey was conducted in parallel with the annual pipeline condition survey conducted during April and May 2018 by Undersea Construction Ltd (2018). In combination the 2018 survey reports described the condition of the pipeline, the surrounding seabed, and the marine ecology prior to the start of non-compliant discharges, i.e., during a period of normal operation. The Cawthron divers observed that all risers were covered in diverse and apparently healthy fouling assemblages, including sponges, anemones, colonial and solitary ascidians, hydroids, barnacles and red, green and brown algae (Plate 1). Free living organisms included kina, cushion stars, seven armed stars and various gastropods including the large duck's bill limpet and the warty sea slug were also common. The only fish seen during the dives were species of triplefins (family Trypetygiidae). The assemblages were similar to those previously described in an earlier survey by Barter, *et al.*, (2006).

**Plate 1:** View of a diffuser riser and fouling assemblage, May 2018

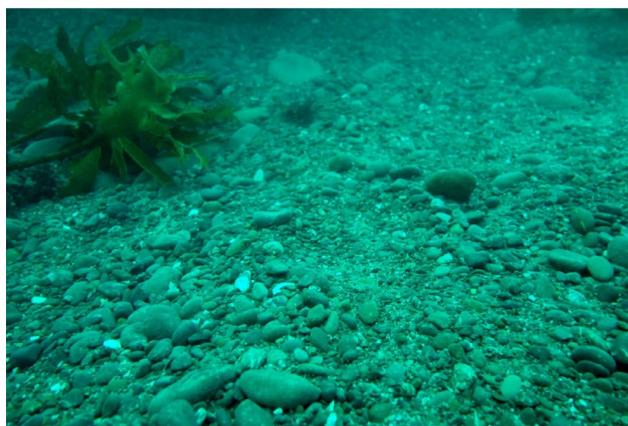
The seabed around the risers consisted of gravels, pebbles and cobbles (up to 30 cm diameter) and small patches of smaller gravel or coarse sand (Plate 2). Disturbance of the sediments by divers showed that there was a small amount of fine, easily suspended material within the matrix of gravel and pebble. Structurally, the bed featured large ripples created by wave action and possibly tidal currents. The lower parts of some risers were not fouled, and this may be the result of abrasion by coarse sediments moved by water currents.

**Plate 2:** Seabed deposits of cobbles, gravel and sands forming undulating peak and depressions around the diffuser position, May 2018

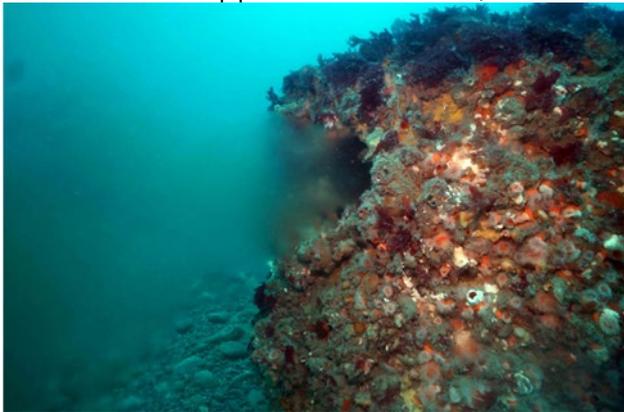
Plate 5 shows the fouling assemblage on a diffuser riser near the seaward end of the pipeline in February 2021 which appears to be similar to that recorded on a riser in May 2018 (it is not clear whether this is the same riser or an adjacent one), and Plate 6 shows the seabed surrounding a diffuser consisting of cobbles, gravel and sands, which is similar to that recorded in May 2018.

**Plate 5:** View of a diffuser riser and fouling assemblage, Feb 2021

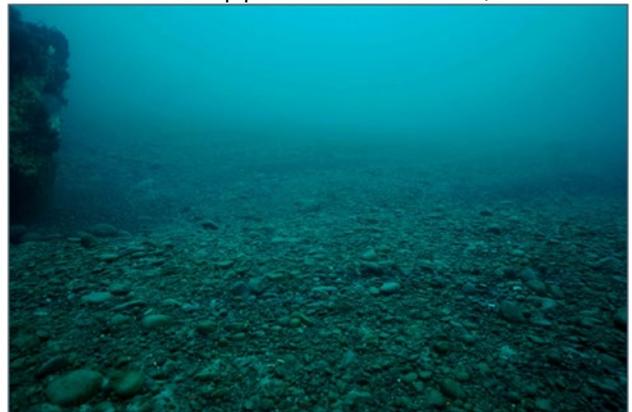
**Plate 6:** Seabed deposits of cobbles, gravel and sands around the diffuser position, Feb 2021.

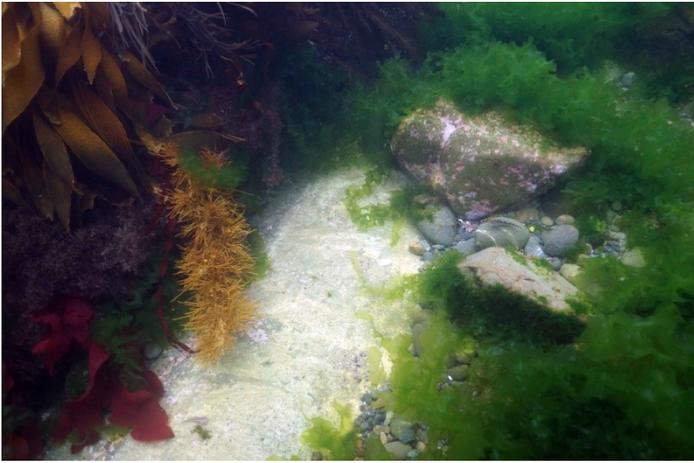
Figure 4: -03.0 metres

Test point meterage	Year								Comments
	2019		2020		2021		2022		
	West (mm)	East (mm)	West (mm)	East (mm)	West (mm)	East (mm)	West (mm)	East (mm)	
-03.0 metres							100	100	Formed rock reef with loose packed rock and gravels – in close proximity with pipeline
Position 'C' 00.0 metres	200	150	100	100	70	100	100	150	As above
10.0 metres	200	200	150	200	150	200	200	250	As above
20.0 metres	350	400	250	300	350	400	400	400	As above
30.0 metres	500	500	350	400	450	450	500	550	As above
40.0 metres	700	650	600	650	600	650	800	800	As above
50.0 metres	1000	1000	700	750	850	850	900	900	As above
60.0 metres	760	1100	600	600	850	900	850	850	Formed rock reef with gravel and sand deposits – rock reef structuring standing off 1 – 2 metres from pipeline
70.0 metres	500	750	400	450	400	450	500	500	As above
Position 'D' 80.0 metres	200	430	150	150	150	200	250	250	Sand and cobbles

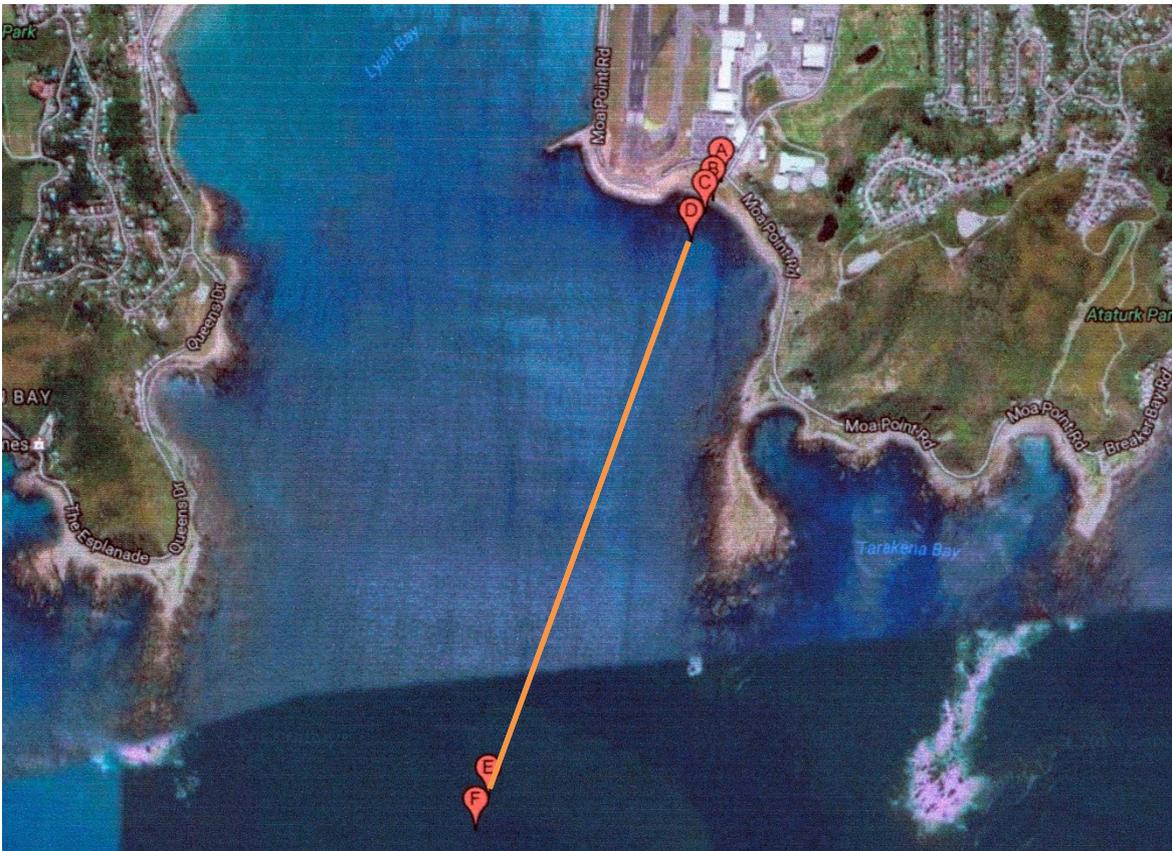
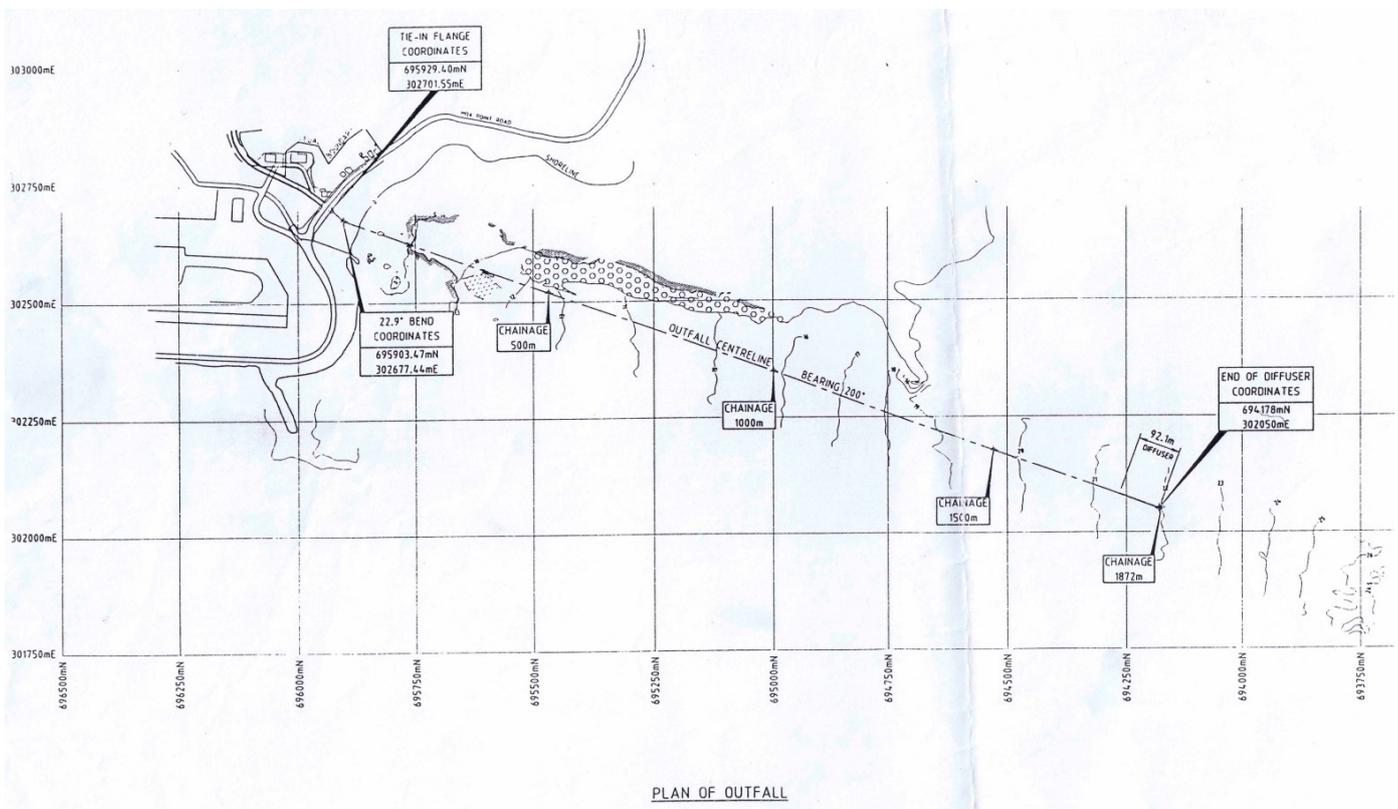
Figure 15: Pipeline route

Prior to underwater inspection of the buried pipeline outfall route and seabed UCL personnel dropped anchored marker buoys at positions 'D & E', and placed a survey tripod with prism set at position 'B' as a backsight alignment. From the survey vessel used for the pipeline inspection, a diver equipped with a manta-board tethered to the vessel was dropped in the water at position 'E' where he descended to the seabed and readied for the tow along the pipeline route. The vessel proceeded slowly on a heading of 18° East of True North towing the diver who also had his underwater computer compass aligned to the same heading.

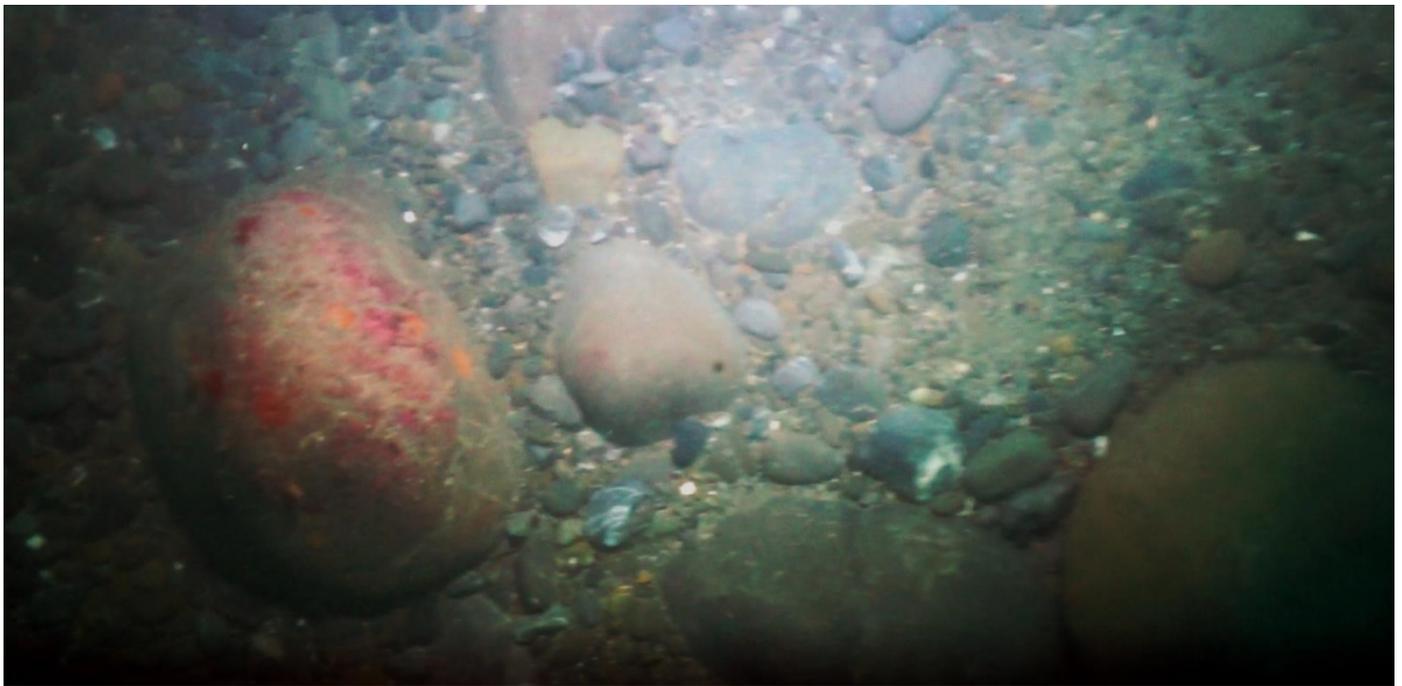
Seafloor deposits of gravel and sand in the form of undulating, peaks and depressions are typical and commonplace in this type of coastal environment.

The result of the underwater tow inspection being; no areas for concern observed.

Figure 16: Typical seabed composition – offshore route – Position E

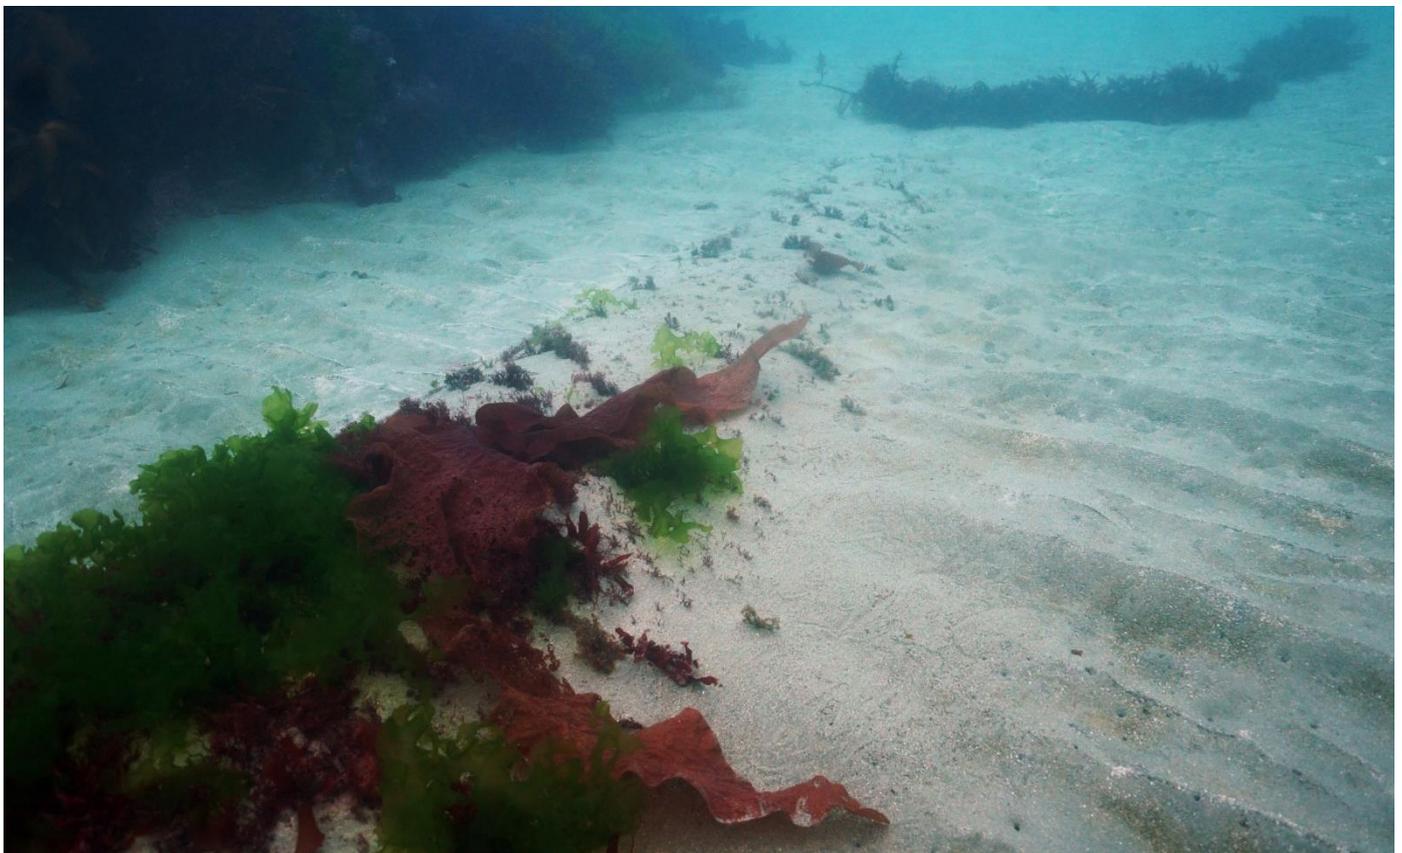
Figure 17: Typical seabed composition – offshore route – Position D

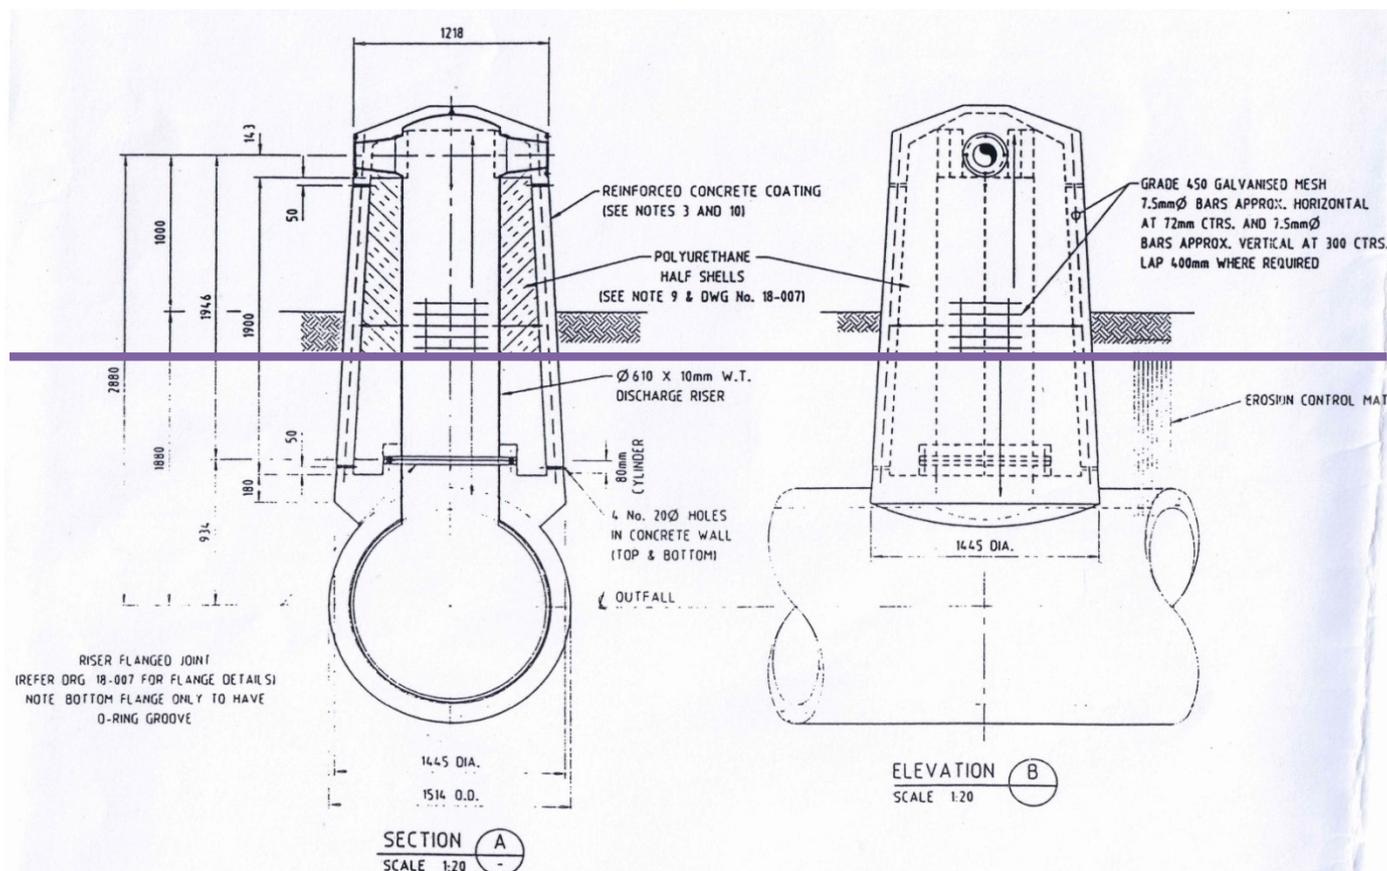
Maximum current scour depth / seafloor level

Figure 19: Diffuser detail

No evidence was observed of any damage or deterioration to any of the 18 diffuser assemblies. Seafloor deposits of rocks, coarse gravels and sand form undulating, peaks and depressions typically of +/- 300mm in west – east (shoreline) orientation around the diffuser positions.

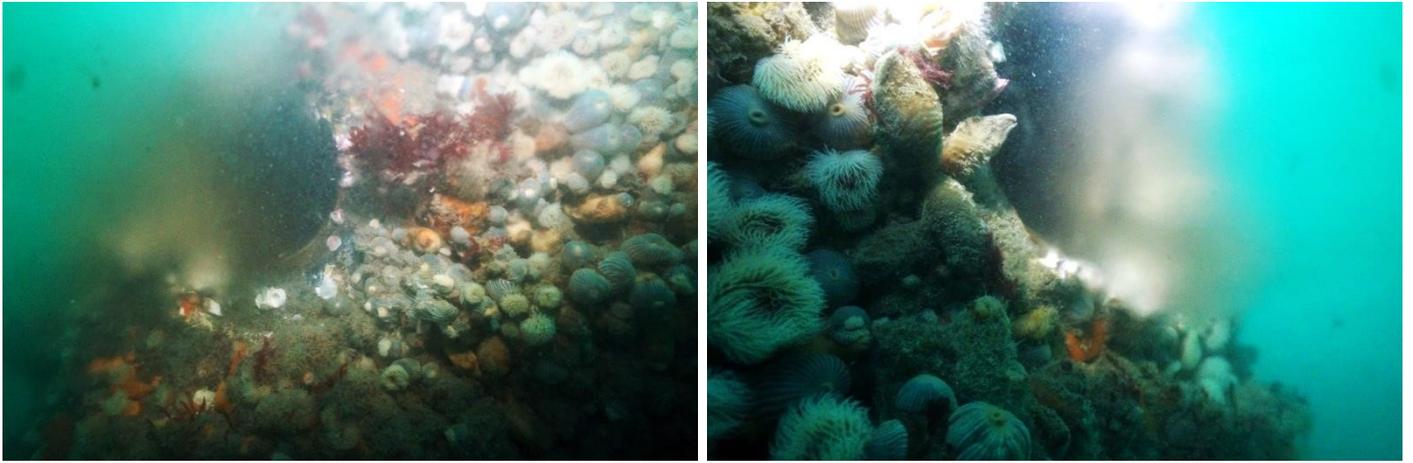
Figures 21 & 22: Typical flow discharge flume from a diffuser nozzle

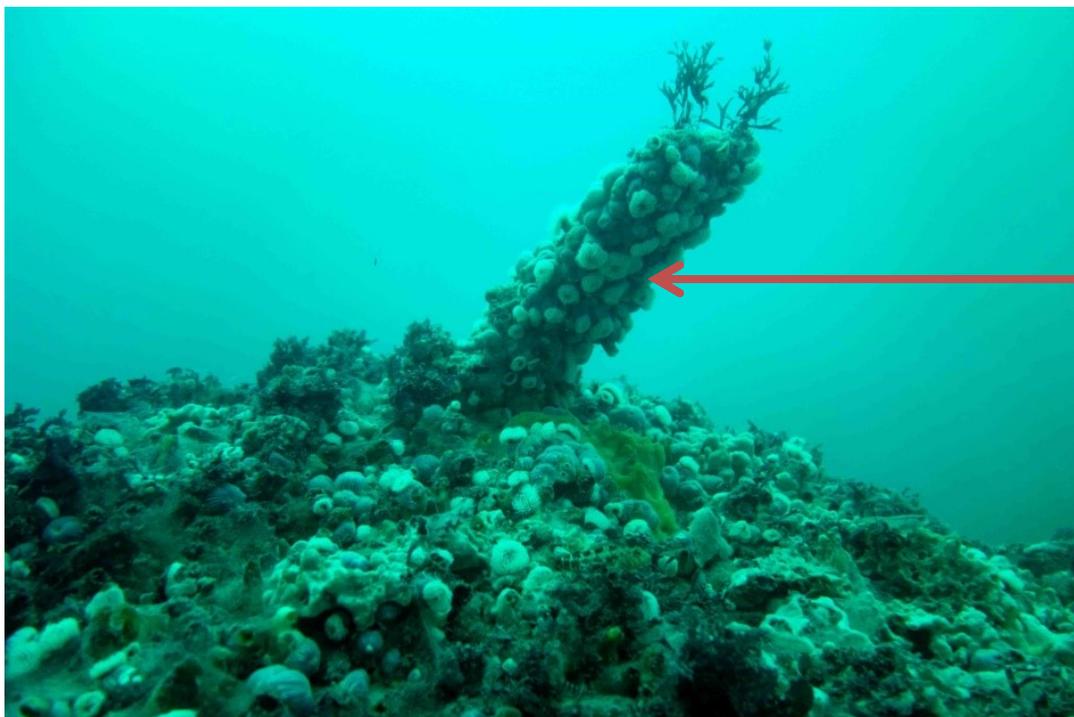
Figure 23:  
Diffuser # 1 (seaward southern- most diffuser) – CP test point.  
Readings at this position provide evidence of electrical continuity through the diffuser section

It's the Test Point at the top of Diffuser # 1 (position 'F') that provides the most accurate Cathodic Potential readings. Although representative readings are obtained at several diffuser outlet nozzles across the diffuser section; variations in water salinity at nozzle flange locations, and / or significant changes in water temperature can subsequently cause Potential differences.

All logged cathodic potential readings confirm that the sacrificial anode system in place is providing effective corrosion protection throughout the diffuser section of the pipeline structure.

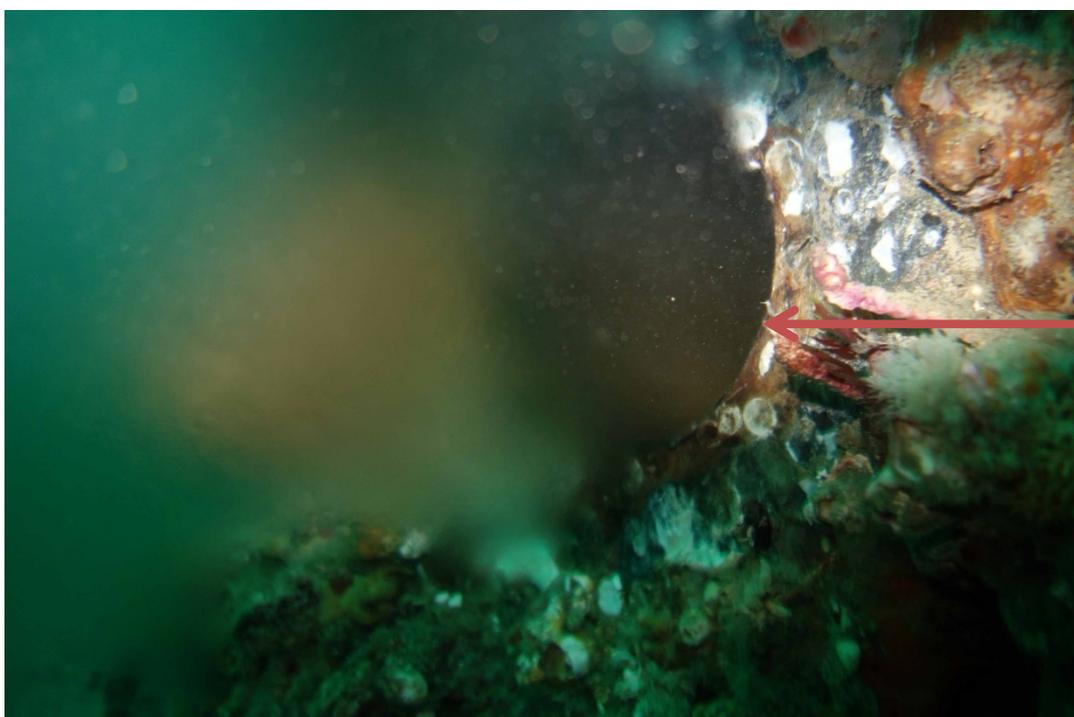
Figure 24:  
The steel diffuser nozzle outer flange is where the diver makes contact with the Bathythermograph to obtain the Cathodic Potential values

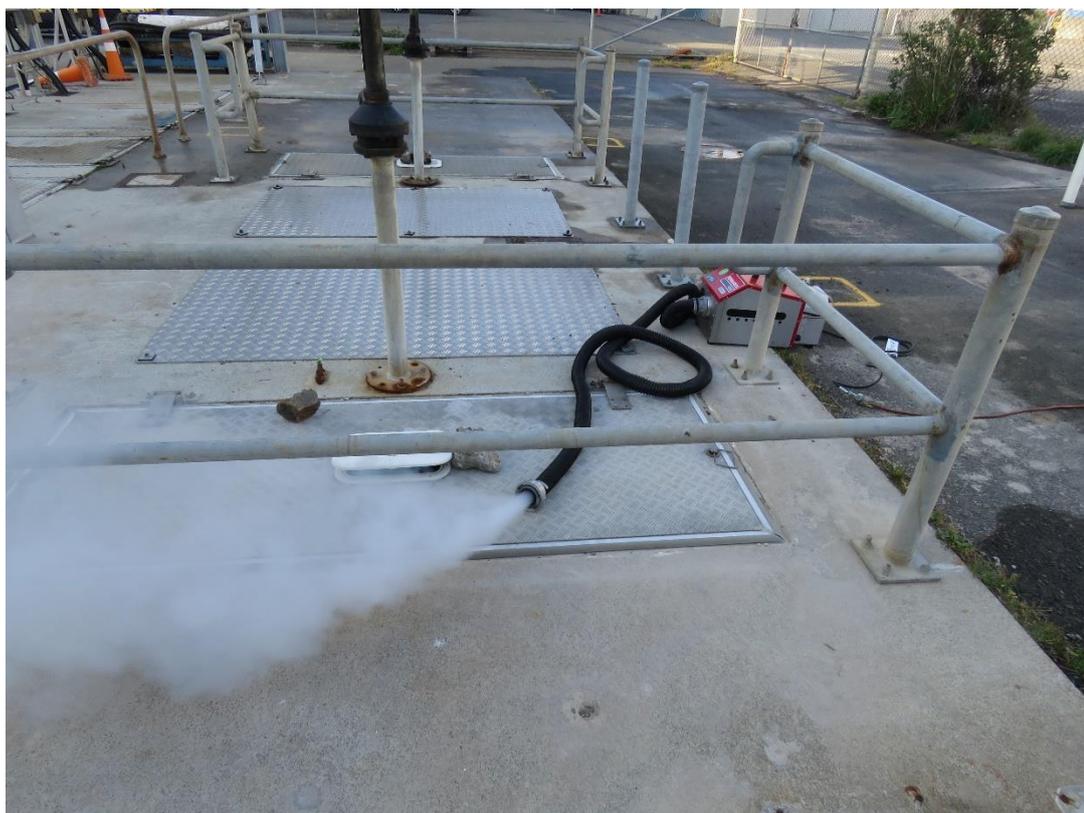
On 18 March 2022, a smoke test was conducted on the Moa Pt WTP IPS to assess any fugitive emissions. The smoke machine was inserted into an inspection hatch and allowed to fill the inlet chambers. Figure 1 depicts the volume of smoke discharged by the smoke machine which was quickly able to fill the IPS wet wells.

■ **Figure 1: Moa Pt IPS Smoke Machine, 10 March 2022**

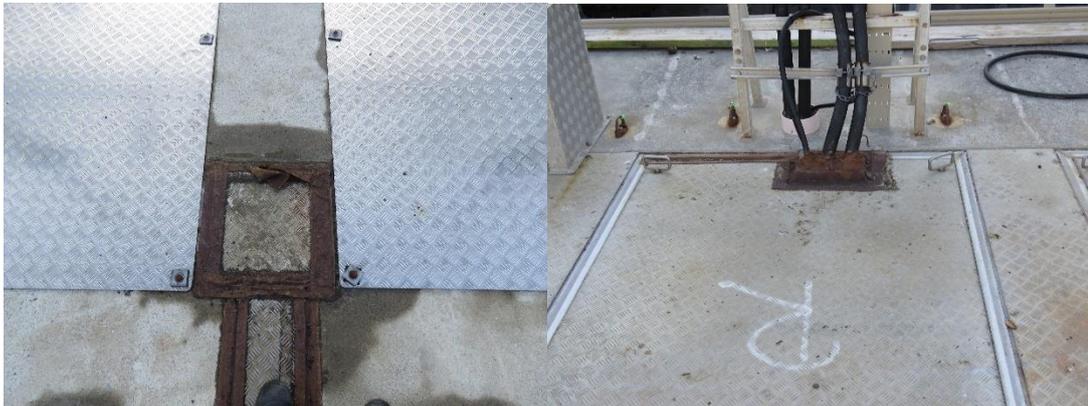
Within a few minutes, smoke was observed exiting the IPS scrubber stack (See Figure 2). A site walk around was conducted to assess the seals and try to identify any potential leaks. While one of the seals (See Figure 3) exhibited minor damage, the remainder were all in good working order. There were no visible discharges from any of the seals or any other locations, confirming the foul air within the IPS was being extracted at a ventilation rate significant enough to prevent any fugitive discharge.

■ **Figure 3: Moa Pt IPS Seals, 10 March 2022**

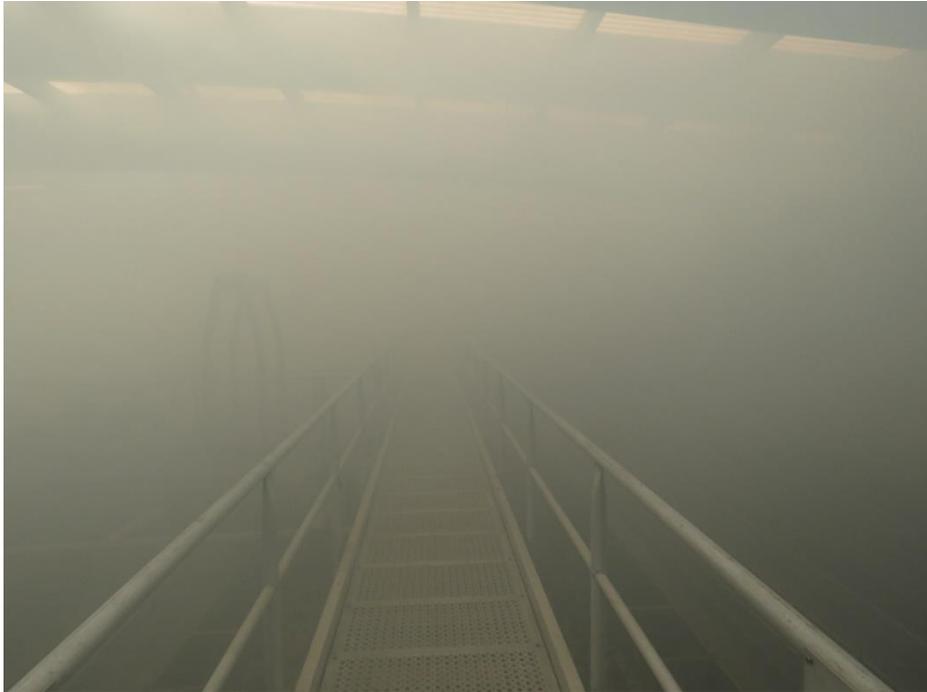
On 18 March 2022, a smoke test was conducted on the Moa Pt WTP Primary Tanks to assess any fugitive emissions. The smoke machine was placed in the Primary Tanks and allowed to fill the building (Figure 4). After about 30 minutes the building was full of smoke (Figure 5) and the smoke machine was turned off to determine how long it would take to remove the build-up of smoke. While the smoke was clearing (Figure 6), a site walk around was conducted with no visible emissions of smoke being observed. After about 20 minutes, 95 % of the smoke had cleared (Figure 7) indicating a ventilation rate of approximately three room changes per hour. Given the large volume of the building, limit requirement for access and good seals, three room changes per hour should be sufficient to prevent fugitive emissions.

■ **Figure 5: Moa Pt Primary Tanks Full, 10 March 2022**

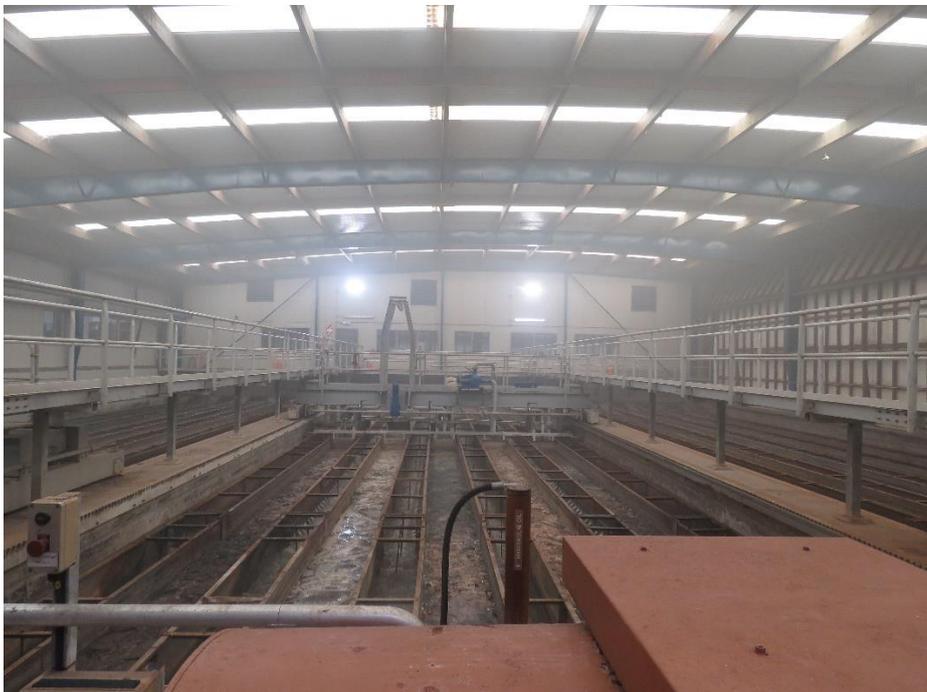
■ **Figure 6: Moa Pt Primary 95% Removed, 10 March 2022**

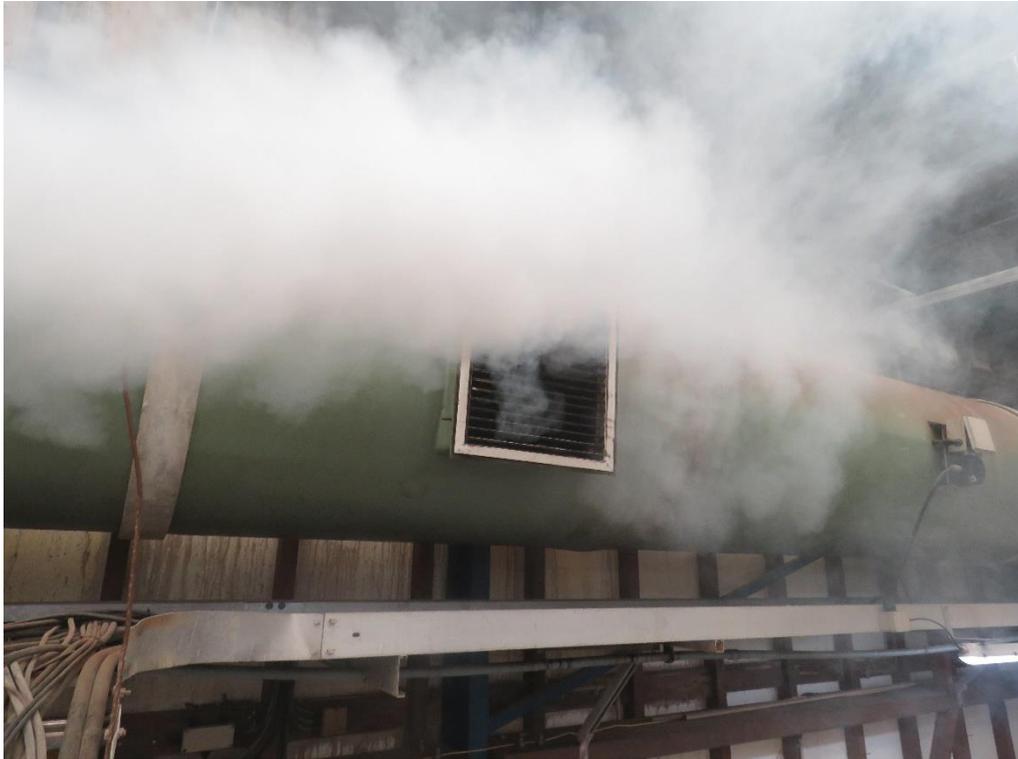
The smoke machine was then relocated to the eastern wall of the building where the extraction ducting is located. Smoke was observed being extracted by the system (Figure 7) indicating suitable ventilation.

■ **Figure 7: Moa Pt Primary Extraction Ducting, 10 March 2022**
