# Moa Point Wastewater Treatment Plant

Annual Resource Consents Report 2021/2022

**Document Title:** Moa Point Wastewater Treatment Plant Annual Resource Consents 2021/2022

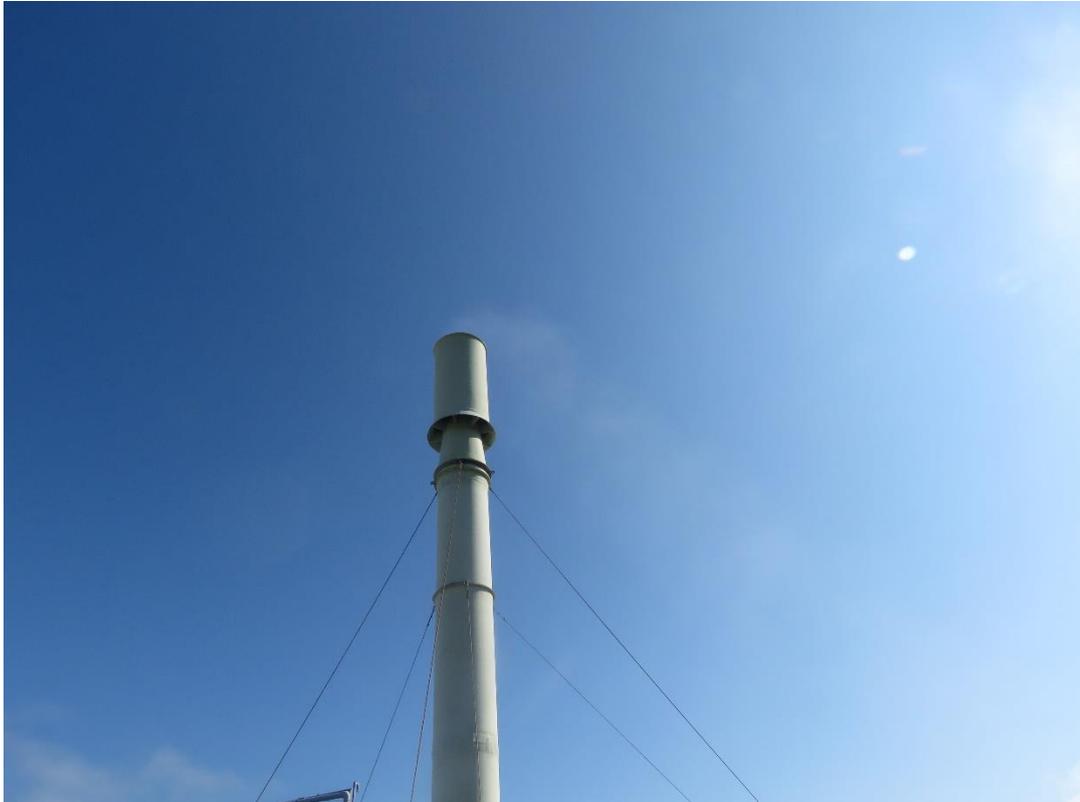
On 18 March 2022, a smoke test was conducted on the Moa Pt WTP MBBR Tanks to assess any fugitive emissions. The smoke machine was placed at four different locations at access ports on the MBBR Tank covers. Figure 8 depicts the smoke machine filling the tanks and it can be clearly seen the smoke was being sucked into the tank indicating the covers are under negative pressure. After a few minutes, smoke was observed being discharged from the Moa Pt main scrubber stack (Figure 9).

■ **Figure 9: Moa Pt Main Scrubber Stack, 10 March 2022**

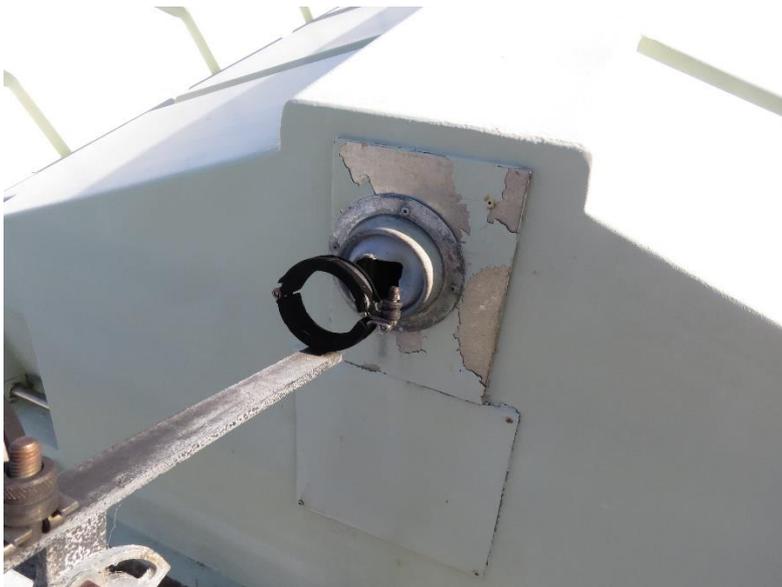
A site walk around was conducted to try and identify any potential sources of fugitive emissions. The seals were also inspected and while they were more weathered than the IPS, they were still fit for purpose with no visible smoke emissions observed (Figure 10). There were a number of minor gaps, but these were tested with smoke tubes and found to be under negative pressure preventing any fugitive emissions. However, one of the old instrument ports had not been sealed (Figure 11) which had the potential to allow fugitive emissions. It is recommended that this port and any other worn seals be replaced.

- **Figure 11: MBBR Instrument Port, 10 March 2022**

In summary, the smoke testing of the MBBR tanks demonstrated that the system was under sufficient negative pressure to prevent fugitive emissions of foul air. However, it is recommended that the replacement of worn seals be conducted as needed.
