# Moa Point WWTP

## Assessment of Effects of Reduced Hydraulic Capacity

PREPARED FOR Wellington Water | July 2023

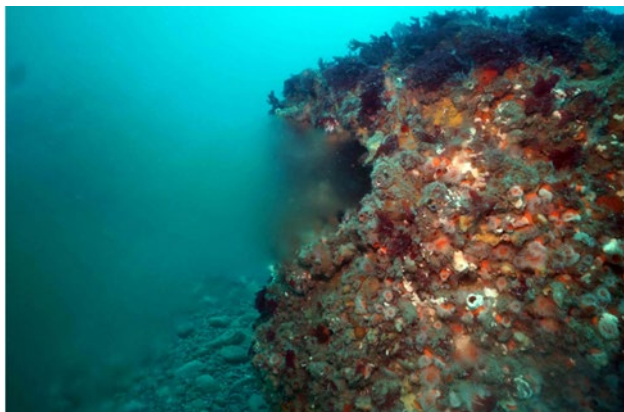
**Plate 5-1:** View of a diffuser riser and fouling assemblage, February 2021

The risk of sediment deposition on the seafloor is also low. An annual pipeline inspection conducted in February 2021 notes that the seabed consists of cobbles, gravel, and sands (Undersea Construction Ltd, 2021). It also notes the

existence of large ripples in the seabed, indicating relatively strong seawater currents capable of transporting fine sediments away from the diffuser. Plates 5-1 and 5-2 show a diffuser riser and the surrounding seabed.

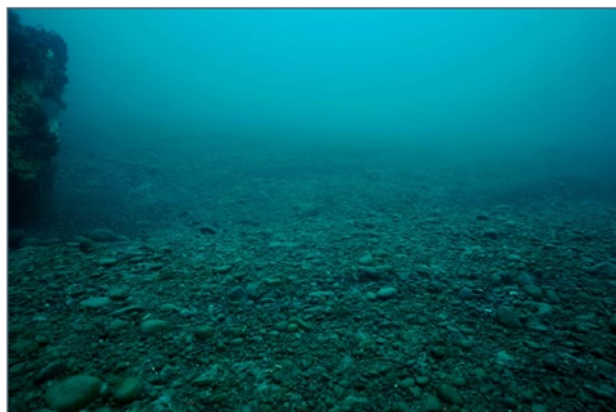
**Plate 5-2:** Seabed deposits of cobbles, gravel and sands around the diffuser position, February 2021
