Attention:	Mel Wykes
Company:	Beca
Date:	27 February 2020
From:	Jeremy Garrett-Walker
Message Ref:	Omāroro – Revegetation Buffer Zone Encroachment, Waitangi Tributary.
Project No:	W16117

As requested, the following memo considers the ecological issues associated with encroaching on the Waitangi Stream buffer zone for the stormwater inlet works, the installation of the valve and flow chambers, and the construction access track at the downstream end of the Waitangi Stream tributary for Omāroro Reservoir. This encroachment will require a change in WCC consent conditions (DC.33) prior to commencement. Maps and photos of the site are attached.

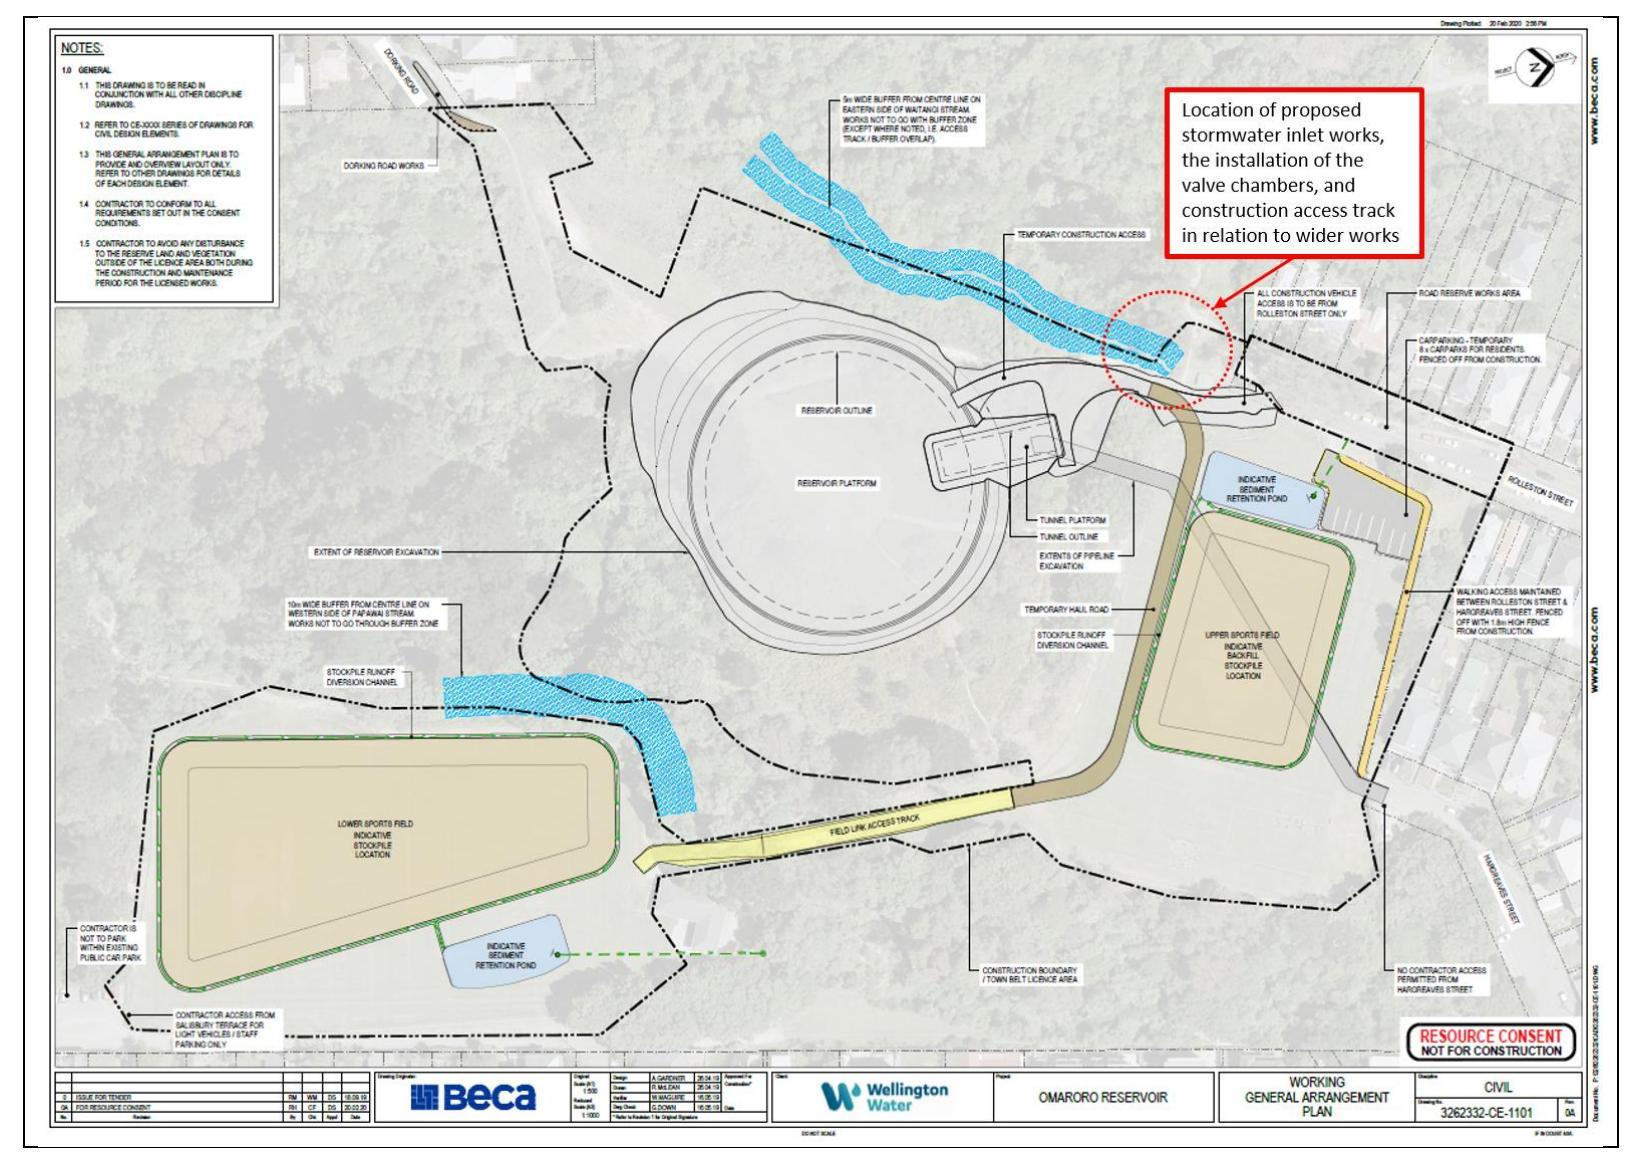
Map 1: Approximate location of the proposed buffer encroachment works in relation to the Omāroro Reservoir works

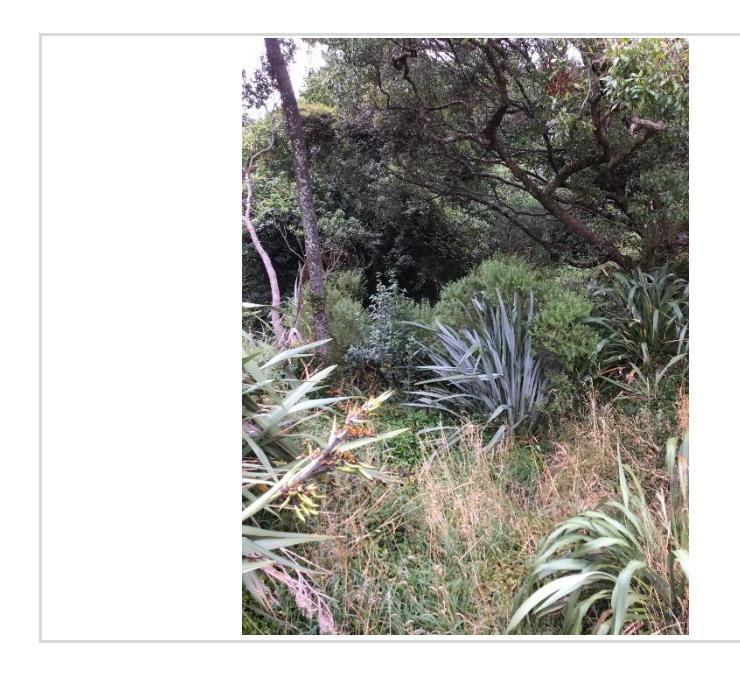
Photo 3: The riparian vegetation which is expected to be outside (upstream) of any earthworks where native canopy cover begins to dominate.
