# Seaview Wastewater Treatment Plant

Annual Resource Consents Report 2023/2024

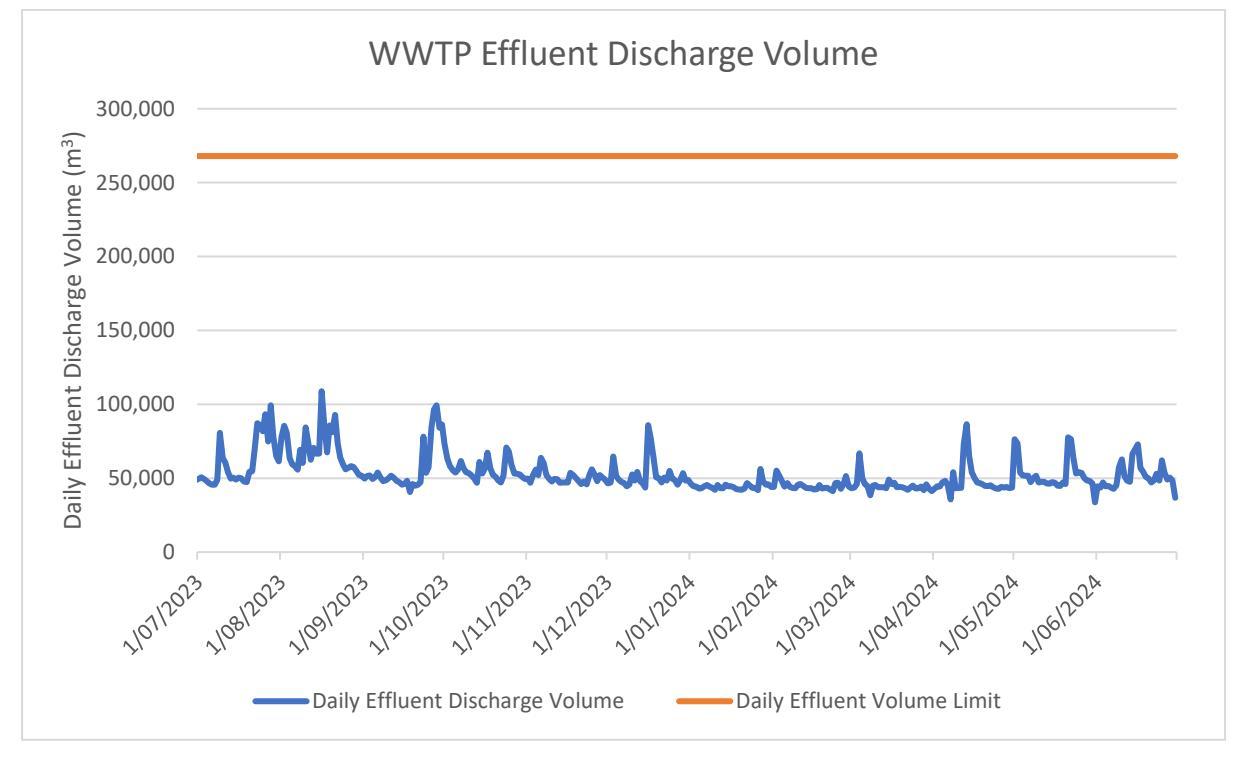
Figure 1: WWTP Effluent Flow Summary

Figure 1 below is a summary of the effluent flow for FY2023/2024. The flows are below the consent limit of 268,000 cubic metres/day.

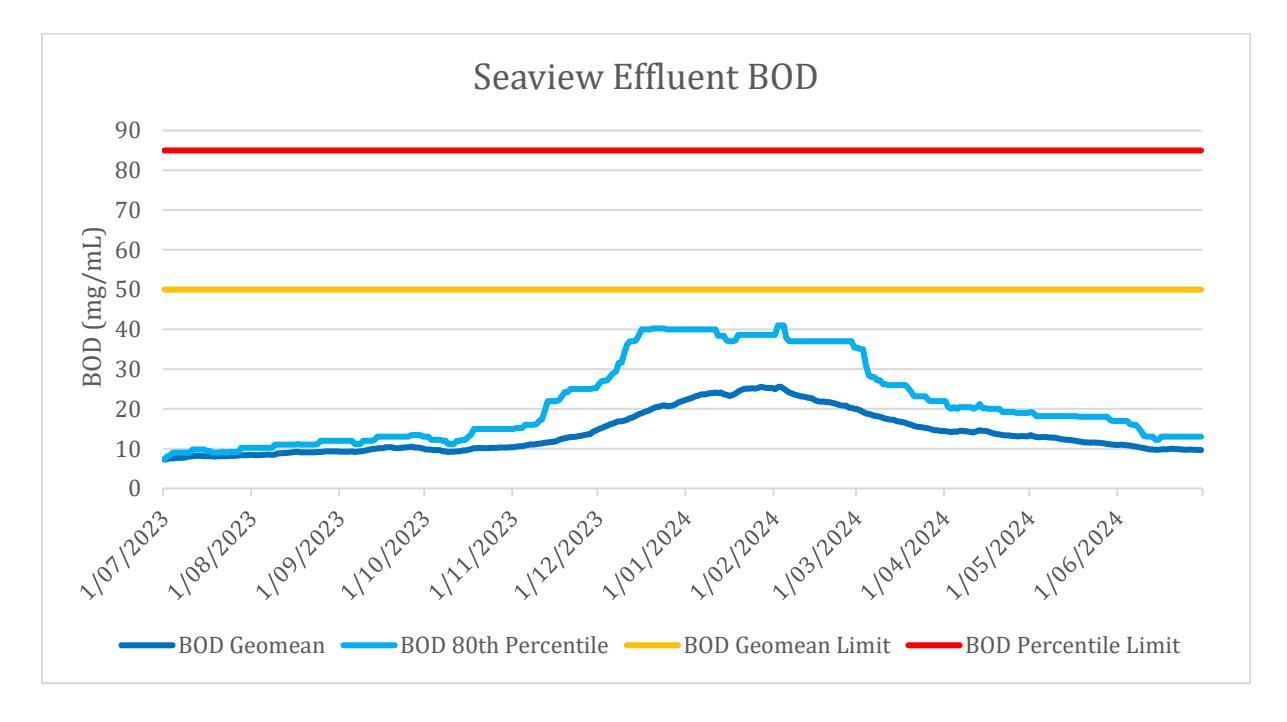
Figure 2 below is a summary of the 90-day geometric mean and 90-day 80<sup>th</sup> percentile for the effluent Carbonaceous Biochemical Oxygen Demand (cBOD5). The facility has been compliant to cBOD5 requirements this FY2023/2024.

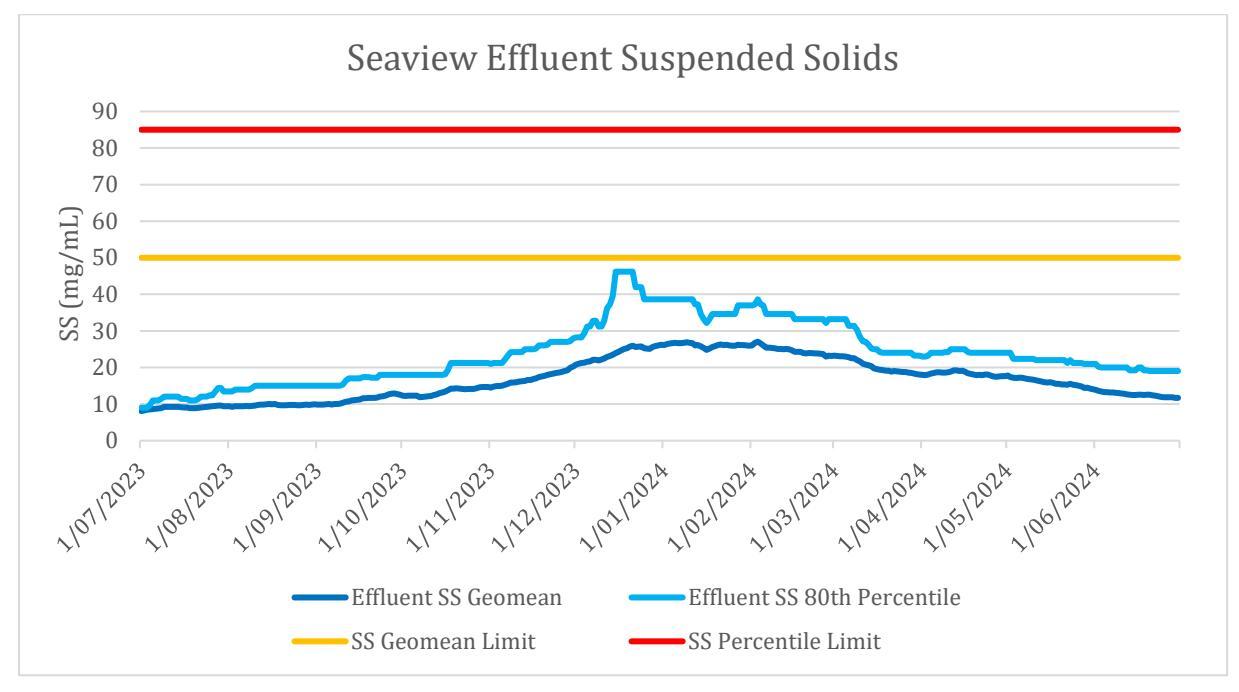
Figure 3: Effluent TSS Summary

Figure 3 below is a summary of the 90-day geometric mean and 90-day 80<sup>th</sup> percentile for the effluent total suspended solids. The facility has been compliant to the effluent suspended solids requirements this FY2023/2024.

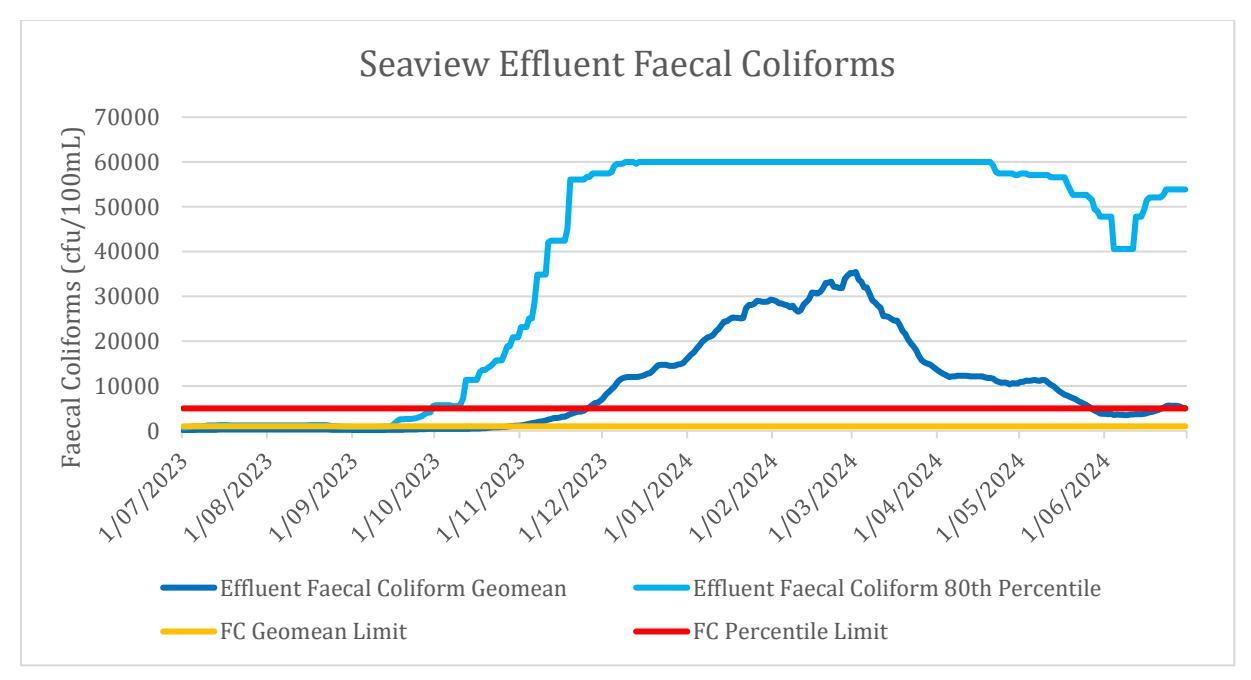
Figure 4: Effluent Faecal Coliform Summary

Figure 4 below is a summary of the 90-day geometric mean and 90-day 80<sup>th</sup> percentile for effluent faecal coliform.

The plant was non-compliant for the faecal coliform requirements during this consent period.

The non-compliance was caused by reduction of UV disinfection effectiveness due to the following reasons:

- The UV system is nearing the end of its expected life (a major refurbishment is scheduled for July/August 2025 and the UV renewal project expected to be completed within the 3-year LTP period)
- Petrochemical contamination entering the plant has reoccurred multiple times throughout the year negatively impacting the biological treatment process, most notably the UV system performance
- Significant wet weather events elevate faecal coliform levels
- Various mechanical failures in the primary sedimentation tanks (PST) which negatively impacted the downstream processes including the UV system.

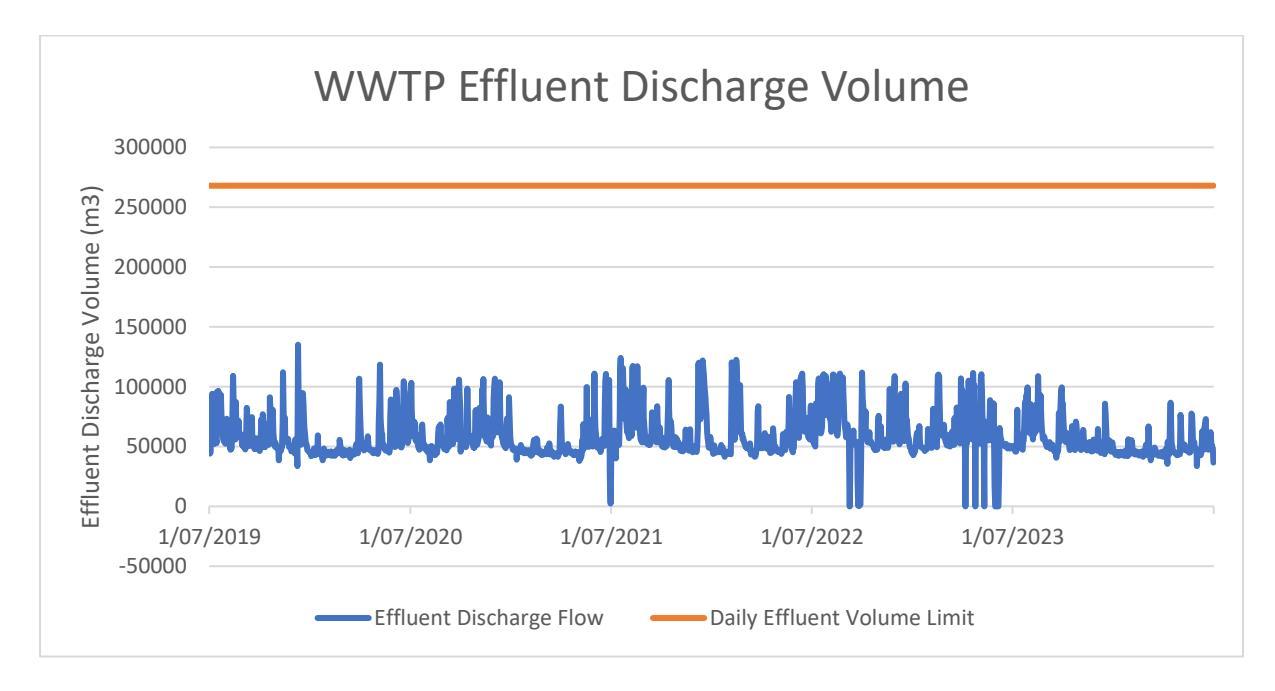
Figure 5: Effluent Discharge Flow

WWTP effluent discharge volume is used to establish a trend. In figure 5, it can be noted that the plant's effluent discharge volume is affected during wet weather.

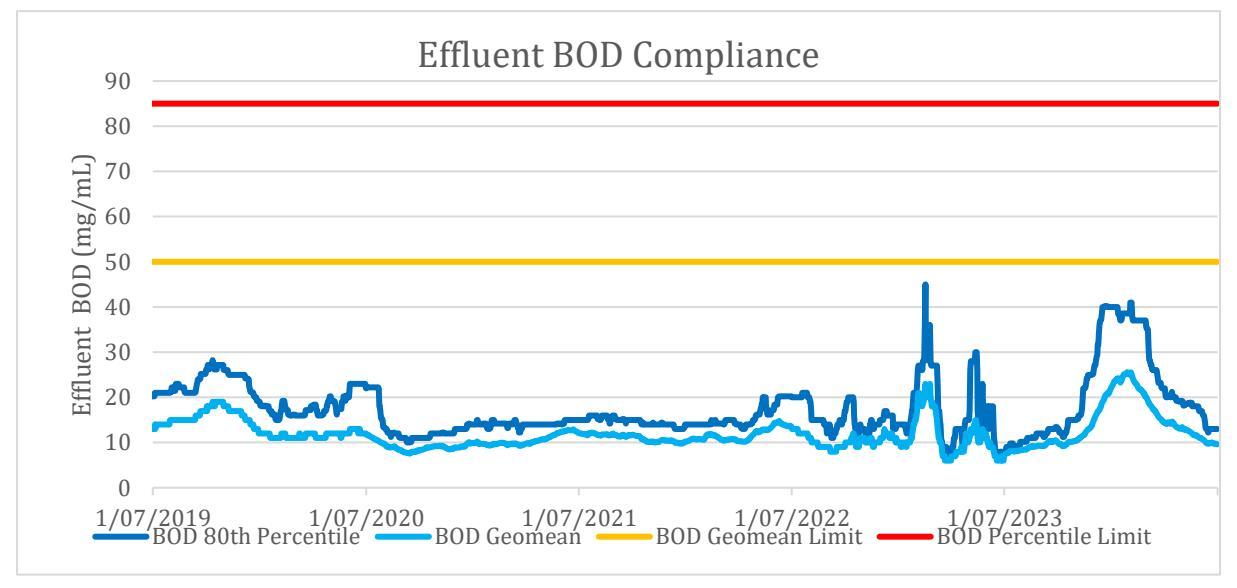
Figure 5: Effluent cBOD5 Compliance

To establish a trend, effluent BOD₅ 90-day rolling geometrical mean and 80<sup>th</sup> percentile in the last five financial years has been used. The plant is below the compliance limits.

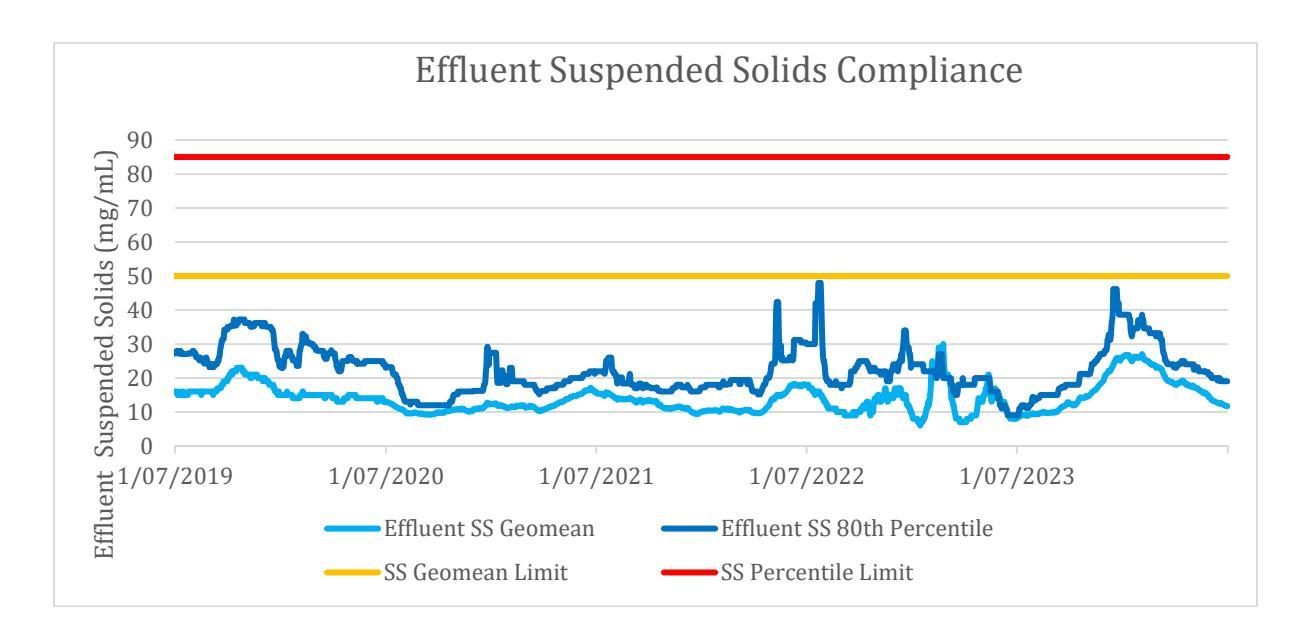
Figure 6: Effluent Suspended Solids Compliance

To establish a trend, effluent suspended solids 90-day rolling geometrical mean and 80<sup>th</sup> percentile in the last five financial years has been used. The plant is below the compliance limits.

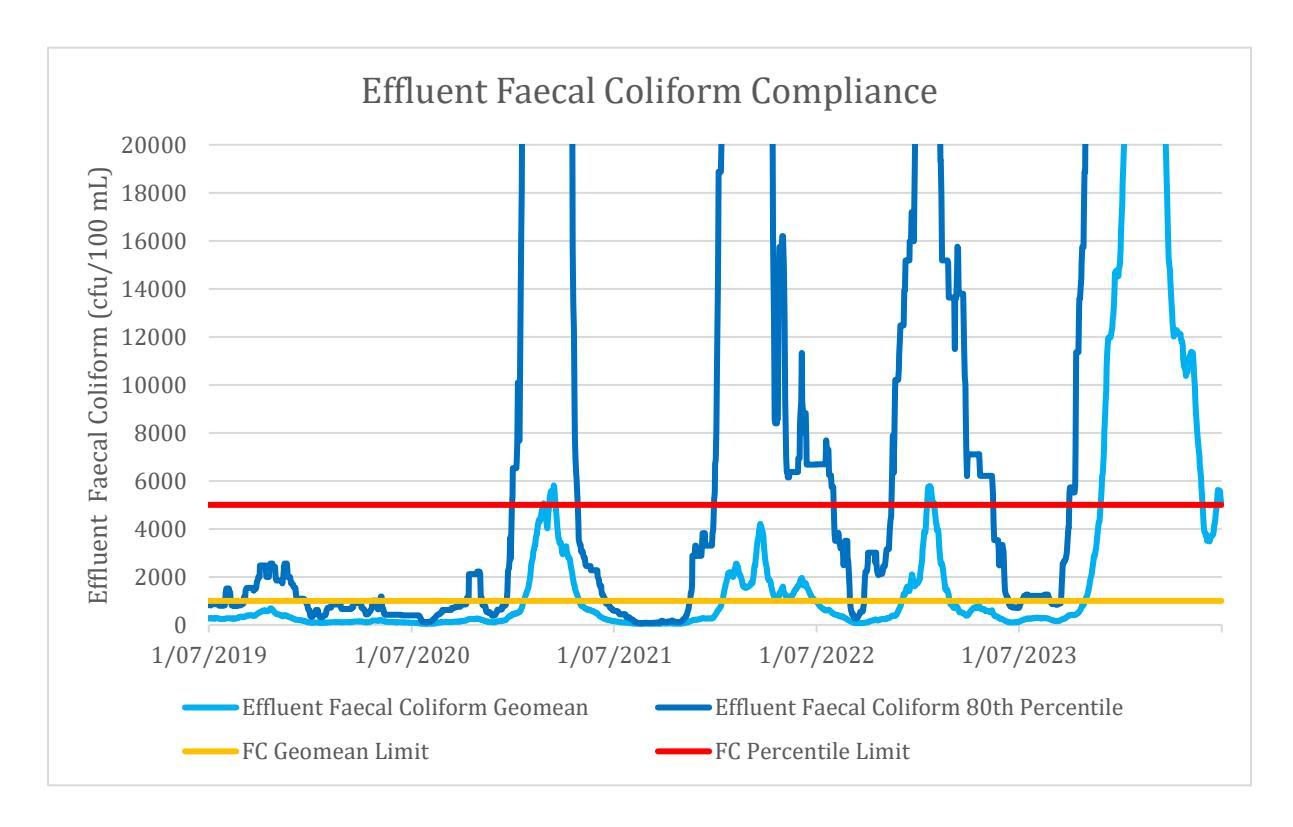
#### Figure 7: Effluent Faecal Coliform Compliance

To establish a trend, effluent faecal coliform 90-day rolling geometrical mean and 80<sup>th</sup> percentile in the last five financial years has been used. The plant has failed to consistently meet the effluent faecal coliform requirements since FY2020/21. The failure to meet consistent compliance can be attributed to the poor condition of the assets in the treatment plant especially the UV system, environmental factors such as proliferation of algae during summer, treatment process issues and presence of petrochemicals in the wastewater.

In summary the non-compliance was caused by a reduction of UV disinfection effectiveness due to the following reasons:

- The UV system is nearing the end of its expected life
- Petrochemical contamination entering the plant has occurred multiple times throughout the year, negatively impacting the biological treatment process, most notably the UV system performance
- Significant wet weather events elevate faecal coliform levels
- Various mechanical failures in the primary sedimentation tanks (PST) which negatively impacted the downstream processes including the UV system.

The poor compliance performance can mostly be attributed to poor condition of the assets across the treatment plant. These assets have been identified and programmed for renewal subject to councils funding.

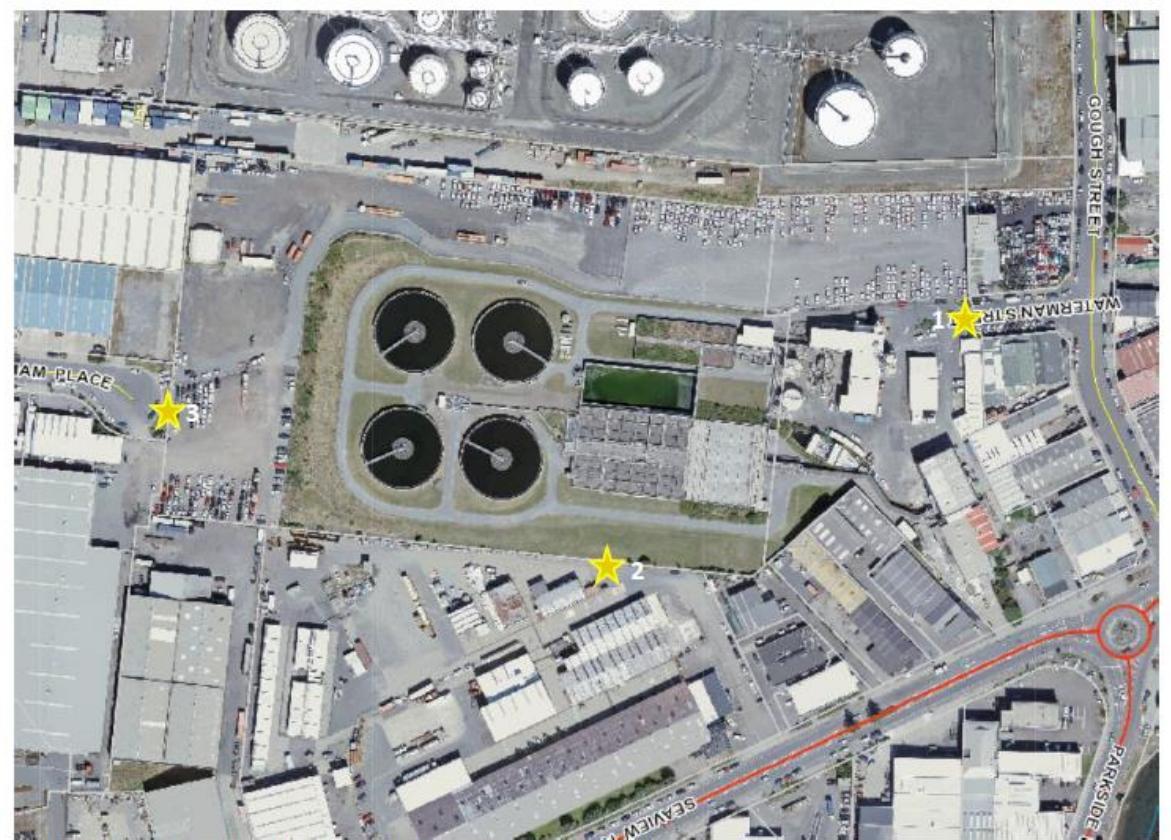
Figure 1: sampling locations for airborne pathogen testing

- All sampling shall be taken at the boundary;
- 1. At the gate of the plant
- 2. At the eastern boundary
- 3. Southern boundary near Wareham place
- 4.1 x downwind location (determined on day of sampling)

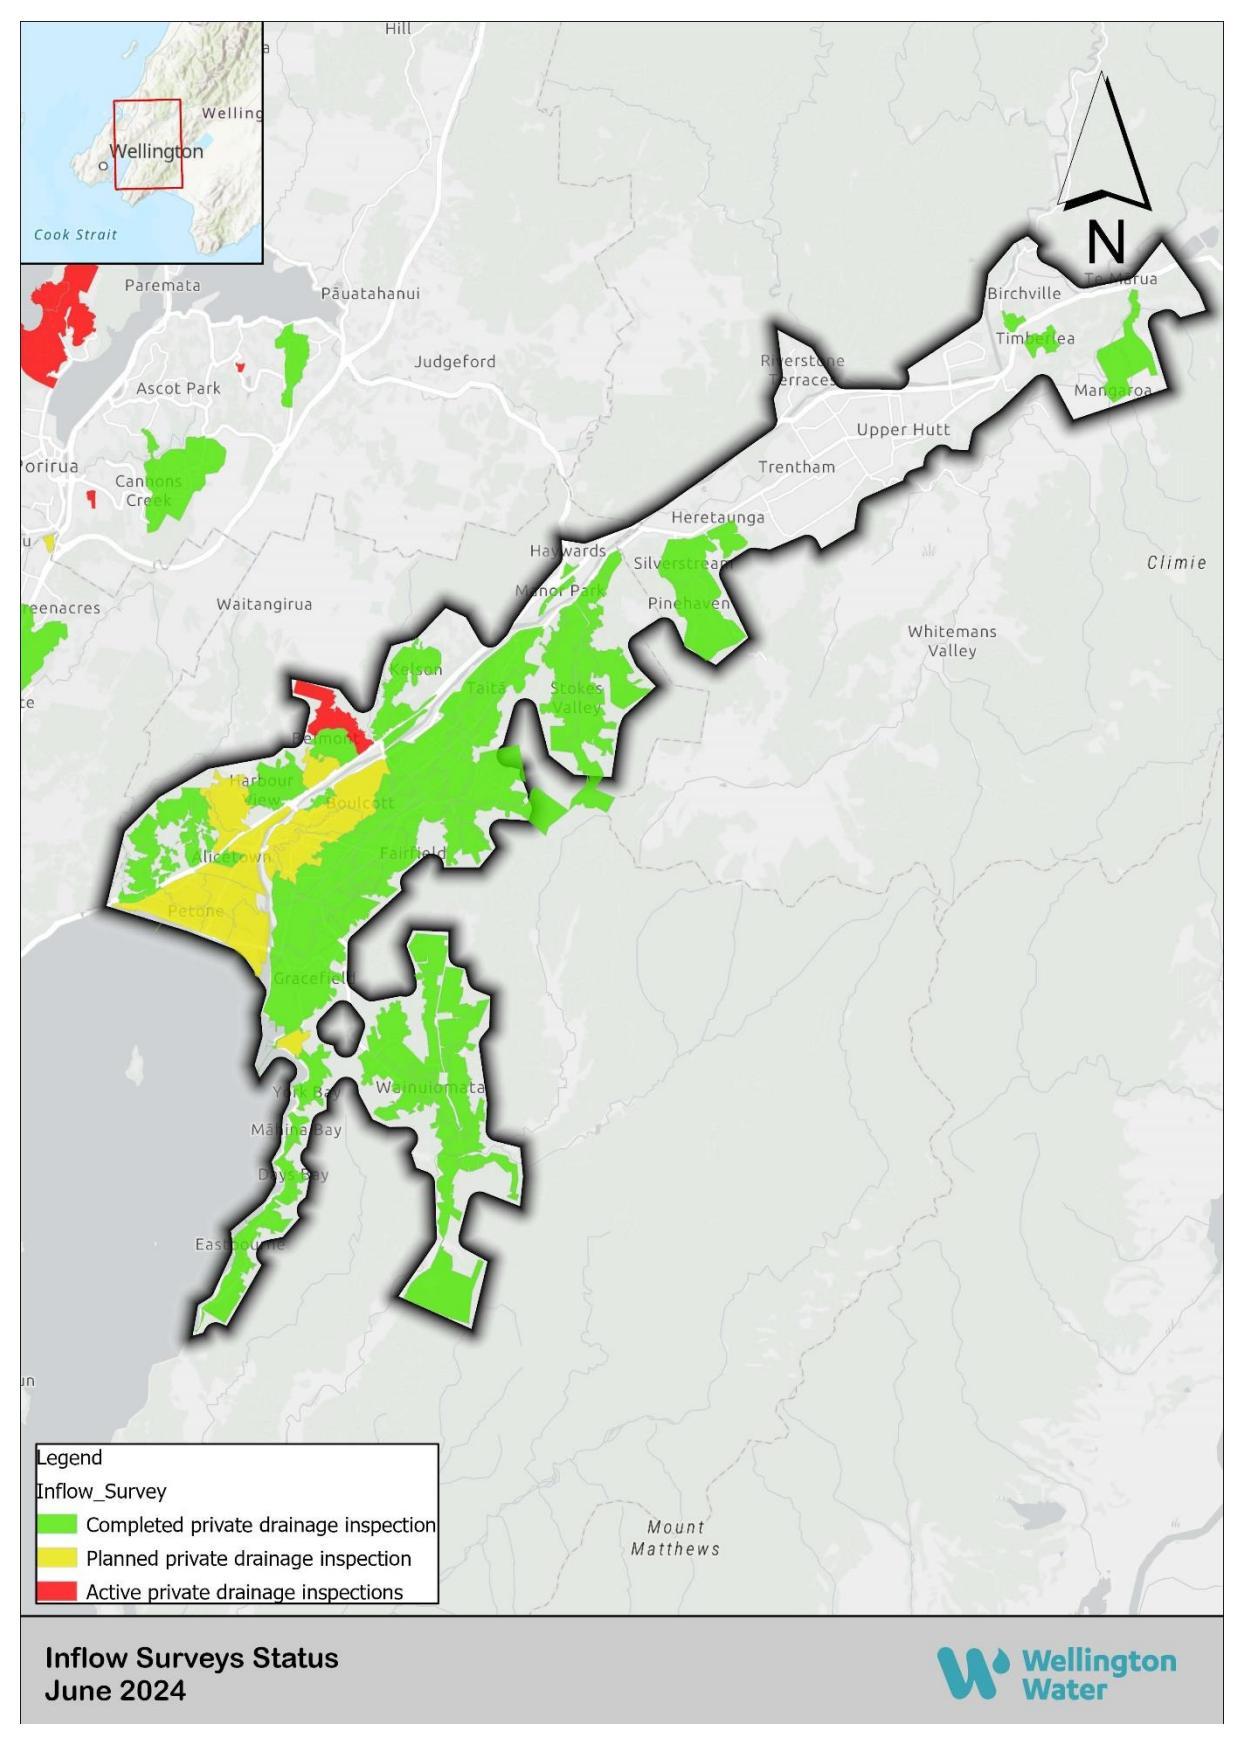
Figure 1 - Inflow Survey Project Locations for Seaview WWTP catchment

The Belmont catchment is currently in progress. The various catchments shown in green have all previously had an inflow survey completed over the last 20 years by HCC.

In addition to works completed by HCC, the Drainage Investigation Team at Wellington Water also completed smoke/dye testing and CCTV inspections for both wastewater and stormwater assets. The investigations were able to identify private and public faults. The inspections completed for HCC areas focused on Waiwhetu, Fairfield and Naenae.

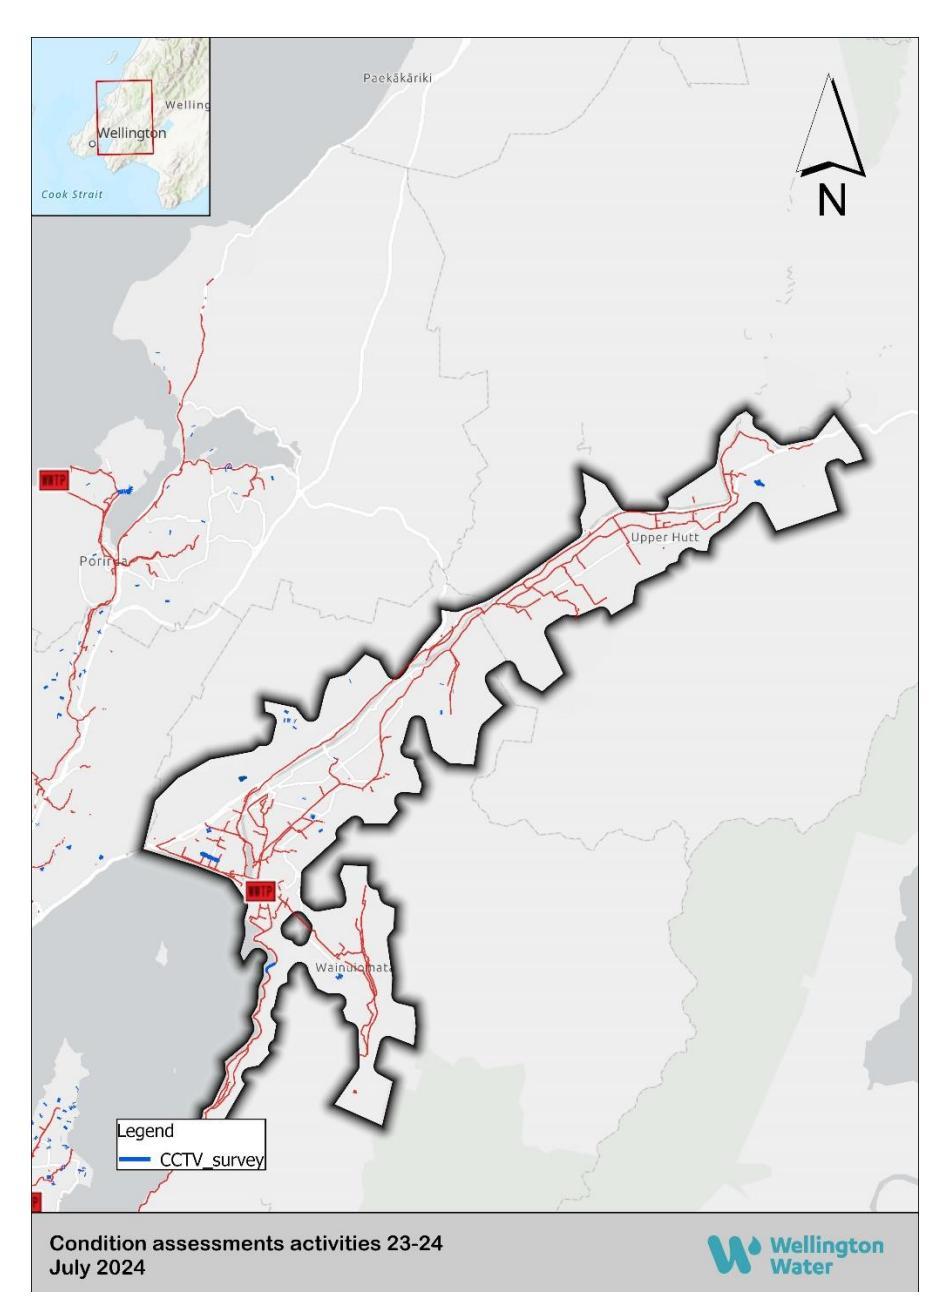
Figure 3 - Map of CCTV of UHCC and HCC Wastewater and Stormwater Mains undertaken as of June 2023

Condition Assessment involves using closed-circuit television (CCTV) footage or other inspection techniques of pipe networks to identify faults, determine the condition of assets, and inform repair and renewal programs.

Condition assessments completed as of June 2023 are shown in Figure 3 below. The primary inspection techniques were CCTV and laser profiling for wastewater pipes and CCTV for stormwater pipe assets. The western hill culvert in Udy Street was successfully inspected after some attempts, the condition assessment results will provide insights and enable engineering to propose options to reduce the risk of failure. Sewer inspection in Jackson Street was undertaken to inform an opportunistic renewal to combine stormwater and wastewater. Inspection in Belmont is still underway to remediate the risk of sewer overflow toward the reserve. Furthermore, other proactive inspections have been carried out in Panorama Grove and Marine Drive to understand the condition of aged assets. In the Upper Hutt inspection of the sewer and stormwater will help to determine the solutions to resolve flooding issues.
