OIA IRO-801 and 25-006

Request for information: annual CLG meeting for Porirua WWTP

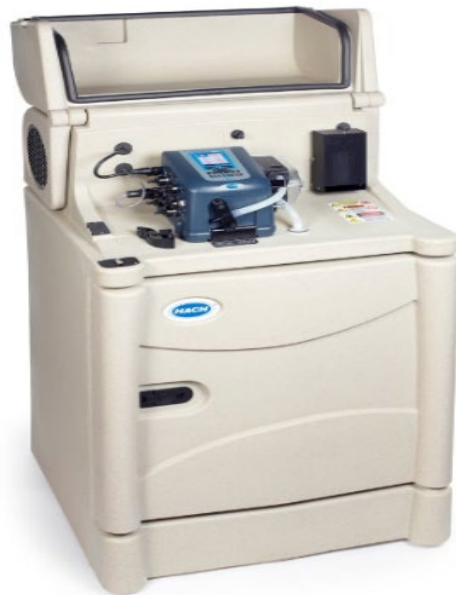
Condition 7 indicates a composite sample over a 24-hour period, this is performed automatically by a composite autosampler. These devices are used commonly in water and wastewater plants worldwide. It is connected to the effluent channel and draws up effluent via small tubes on an hourly basis into a bucket inside the cabinet (see image below). This forms the composite sample that is collected.
